**YEAR 1 of 5 Monitoring Report
Tributaries of Wicker Branch Stream Restoration
Union County, North Carolina
DMS Project Number: 95022
Contract No: 003982
USACE Action Id No: SAW 2013-01680**

**Data Collection Period October 2015
Submitted: March 2016**

AECOM

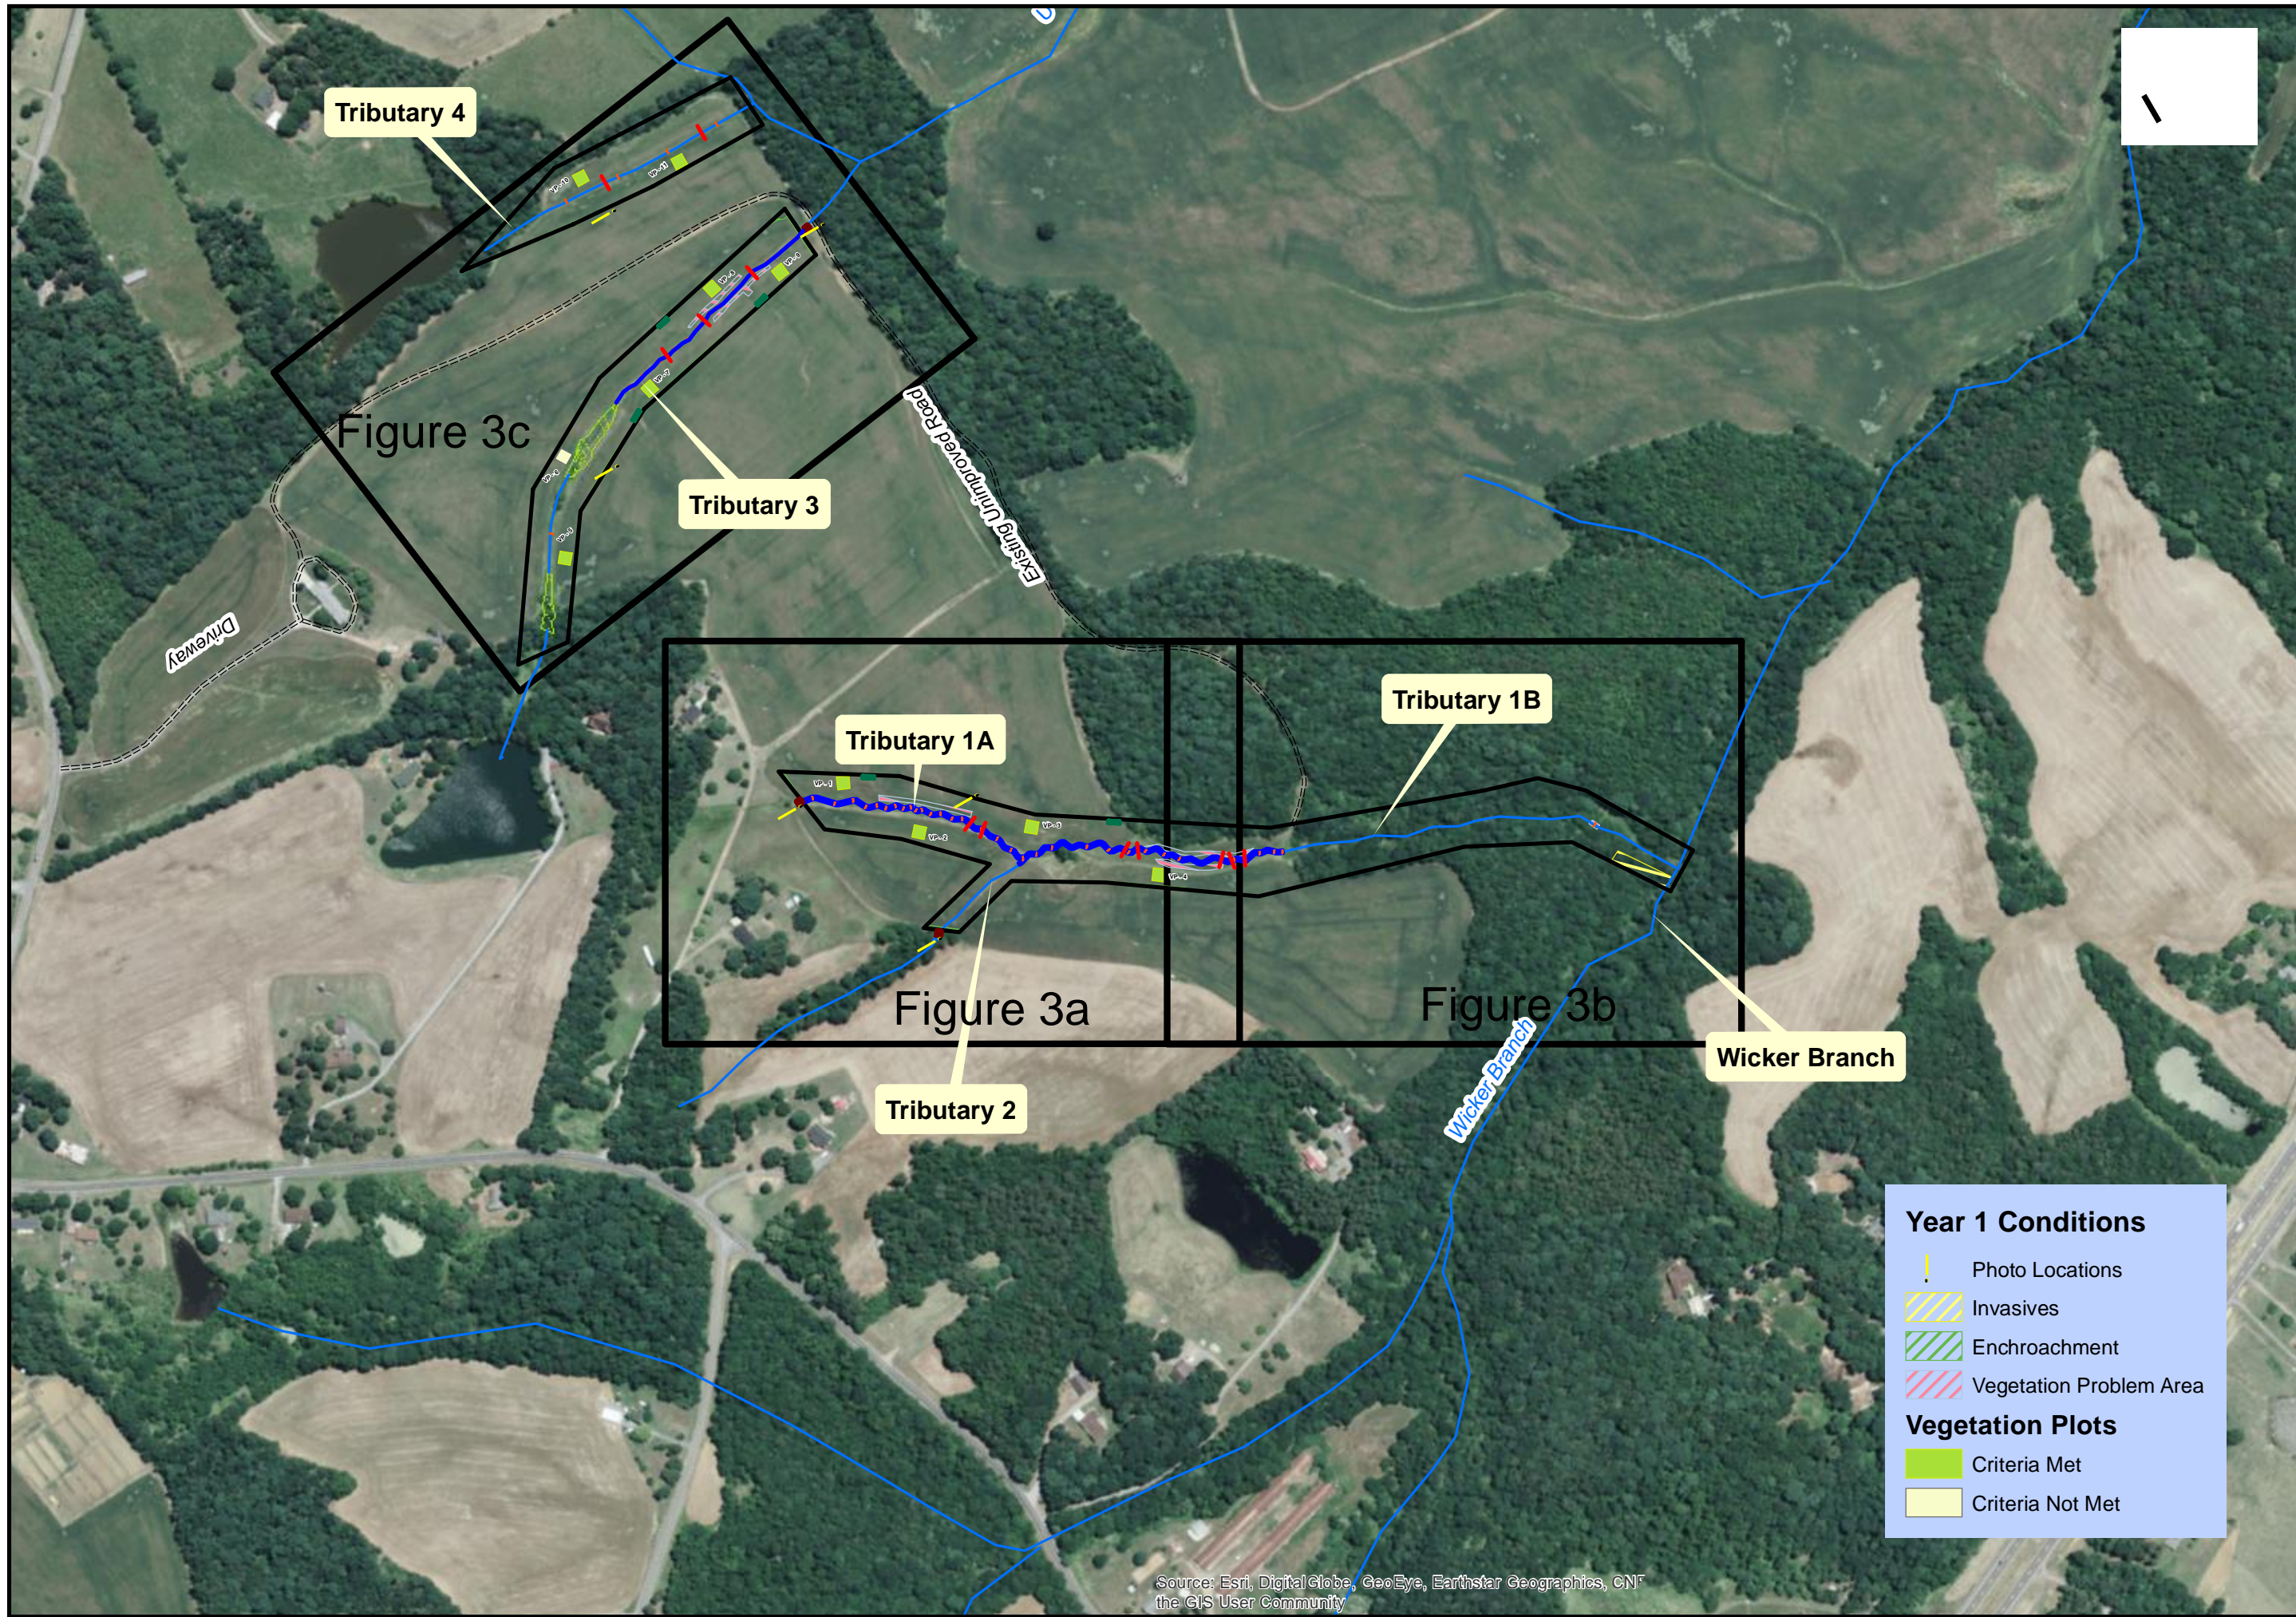
Figure 3: Current Condition Plan View

These repair areas are shown on **Figure 3** in **Appendix B** as vegetation problem areas as the repairs removed the woody stems from these areas. These areas will be replanted in February of 2016 during the dormant growth period.

The adjacent fields were planted in corn prior to establishing all the signage along the edge of the easement. This resulted in slight encroachments along the edges of the easement in several locations as it was difficult to determine the exact edge of the easement due to contours in the land. Additional signage will be installed prior to the 2016 planting season to help eliminate the encroachment. The areas of encroachment are shown on **Figure 3** in **Appendix B**.
