**YEAR 3 of 5 Monitoring Report  
Tributaries of Wicker Branch Stream Restoration  
Union County, North Carolina  
DMS Project Number: 95022  
Contract No: 003982  
USACE Action Id No: SAW 2013-01680**

**Yadkin River  
03040105**

**RE: Year 3 (2017) Monitoring Report the Tributaries of Wicker Branch Project (DMS Project # 95022)**

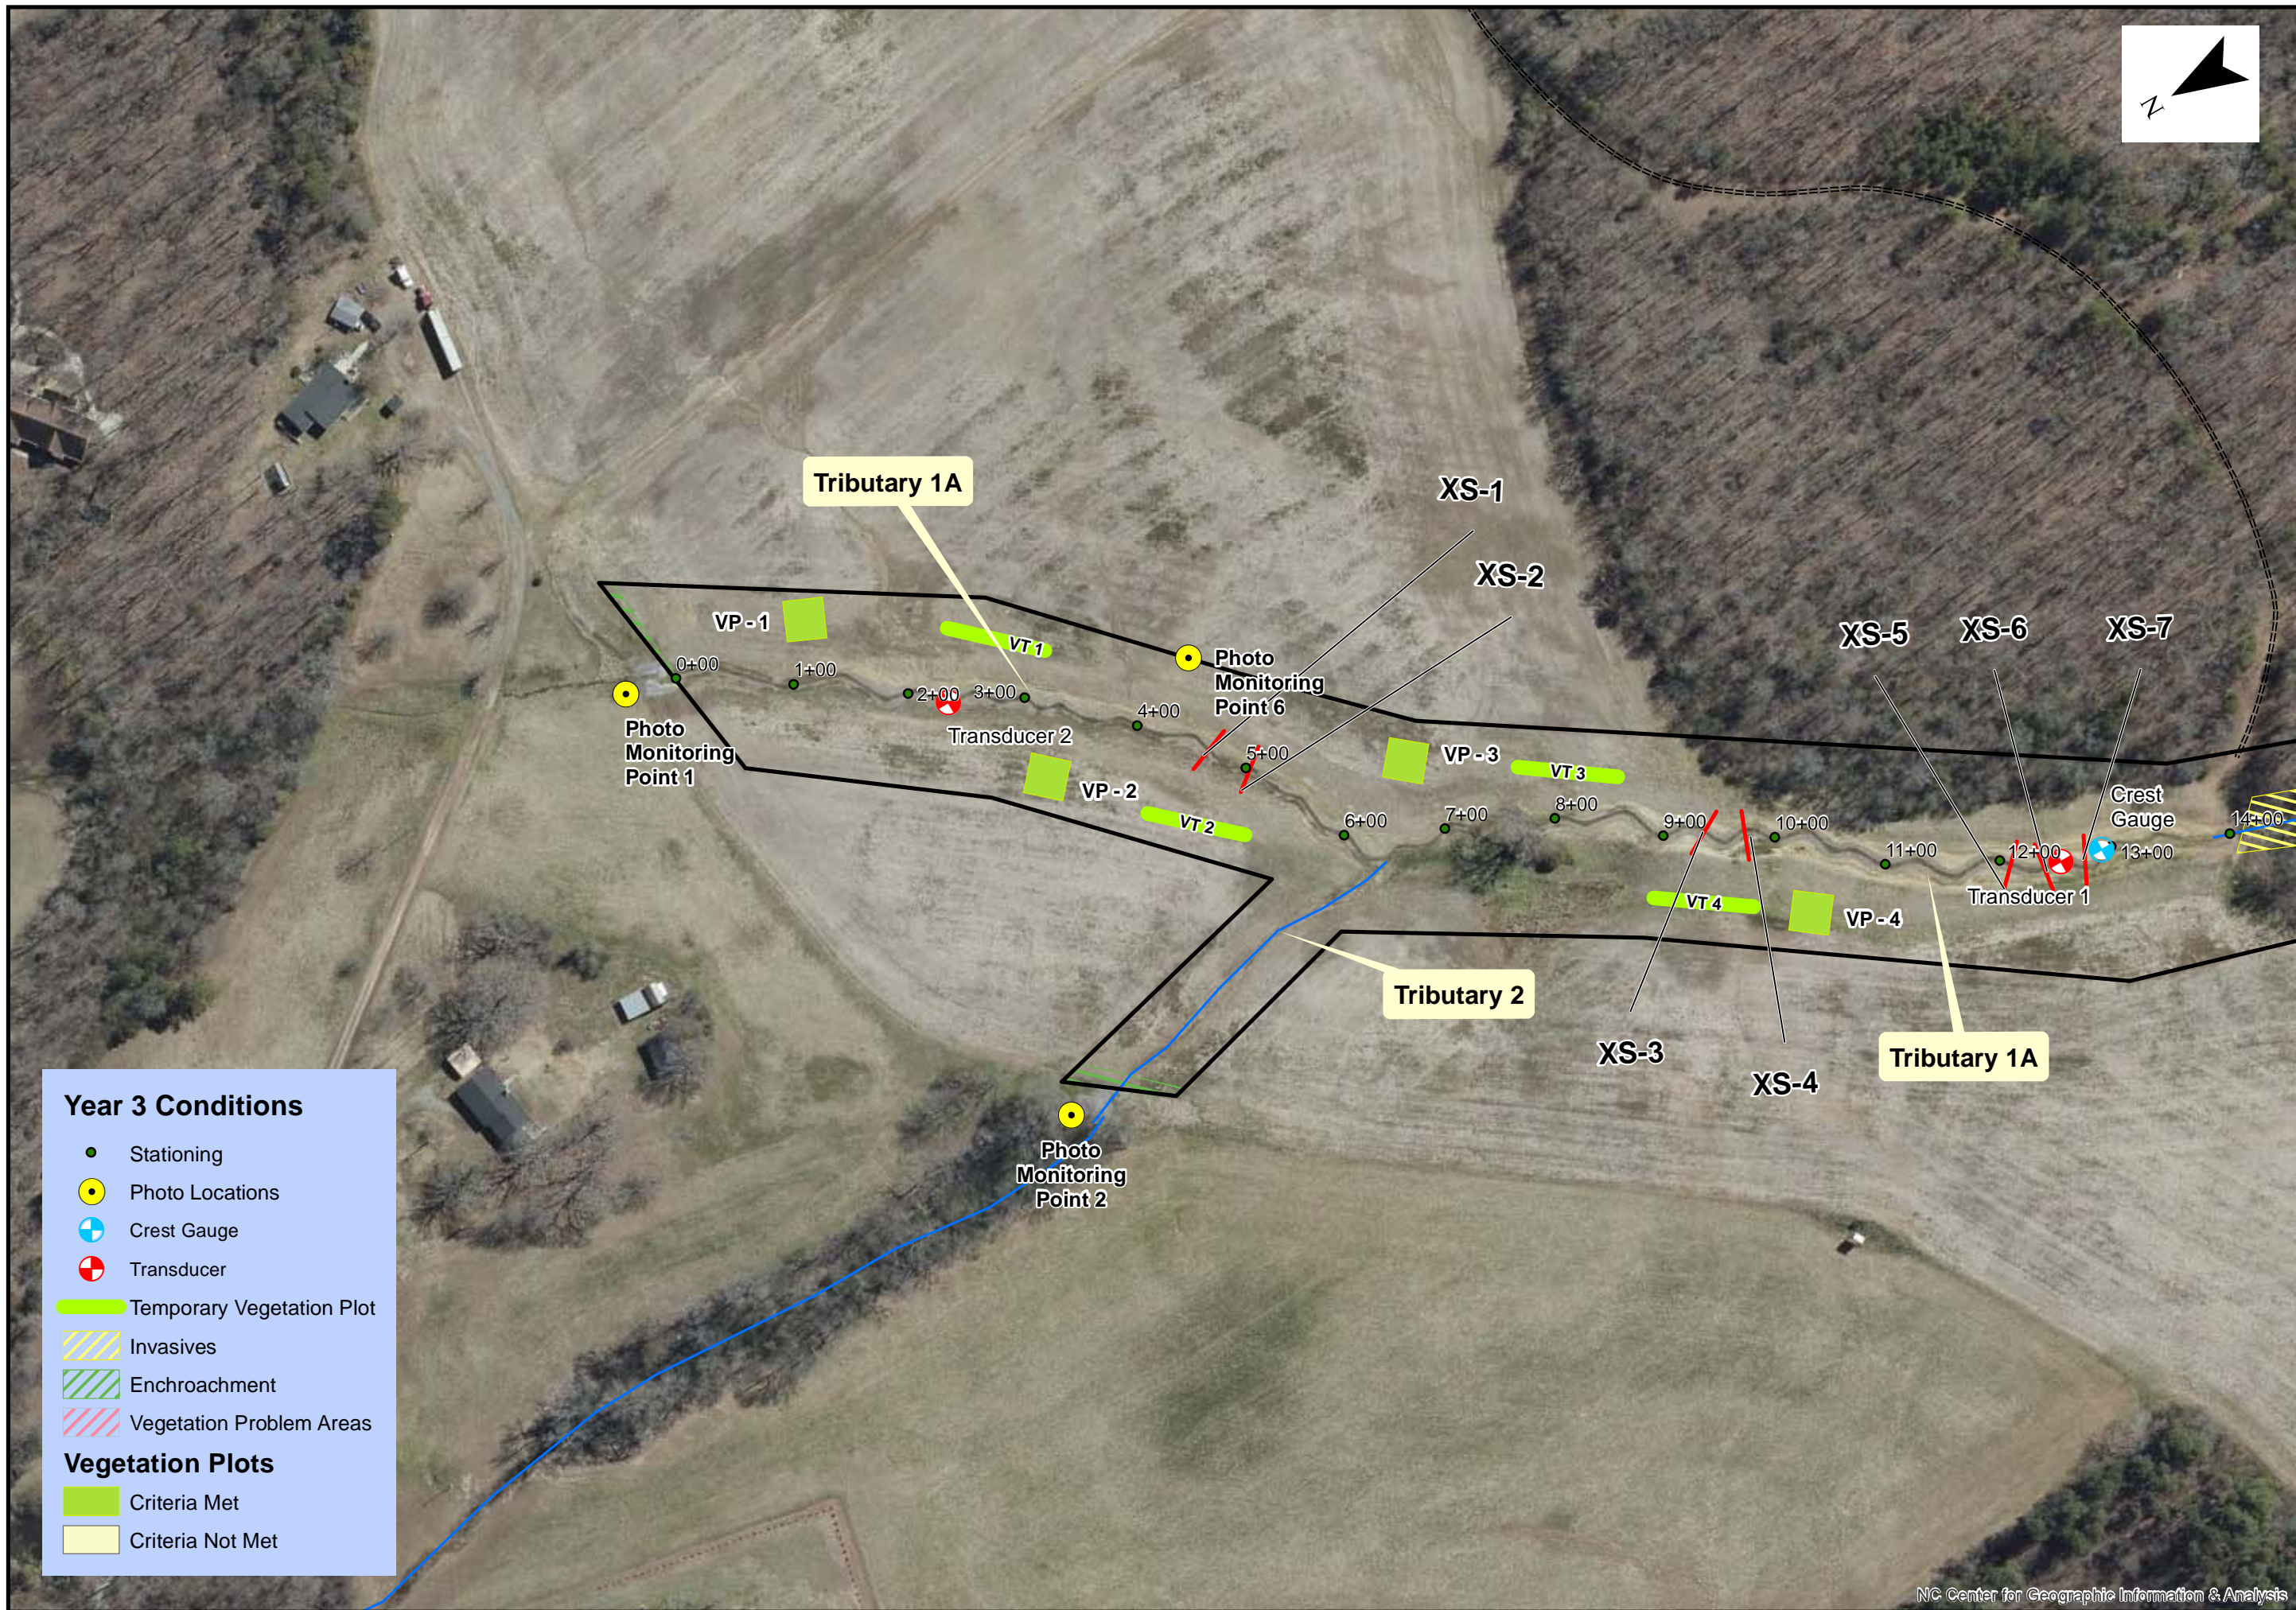
**FIGURE 3**

The adjacent fields were planted in corn in 2017. Additional signage installed in the spring of 2016 was augmented in 2017. Only minor encroachment at the crossings of Tributary 2 and 3 is occurring and AECOM will continue to work with the landowner and the current farmer to address these minor encroachments. The areas of encroachment are shown on **Figure 3** in **Appendix B**.

**Easement violations** – AECOM has periodically met with the farmer in 2017 to discuss the equipment crossings and will continue to monitor, post/repost boundary markings as necessary to ensure compliance.
