Trout Cove Branch and Tributary Stream Restoration

NCEEP Project Number: 388

Monitoring Year 4

2008 Final Report

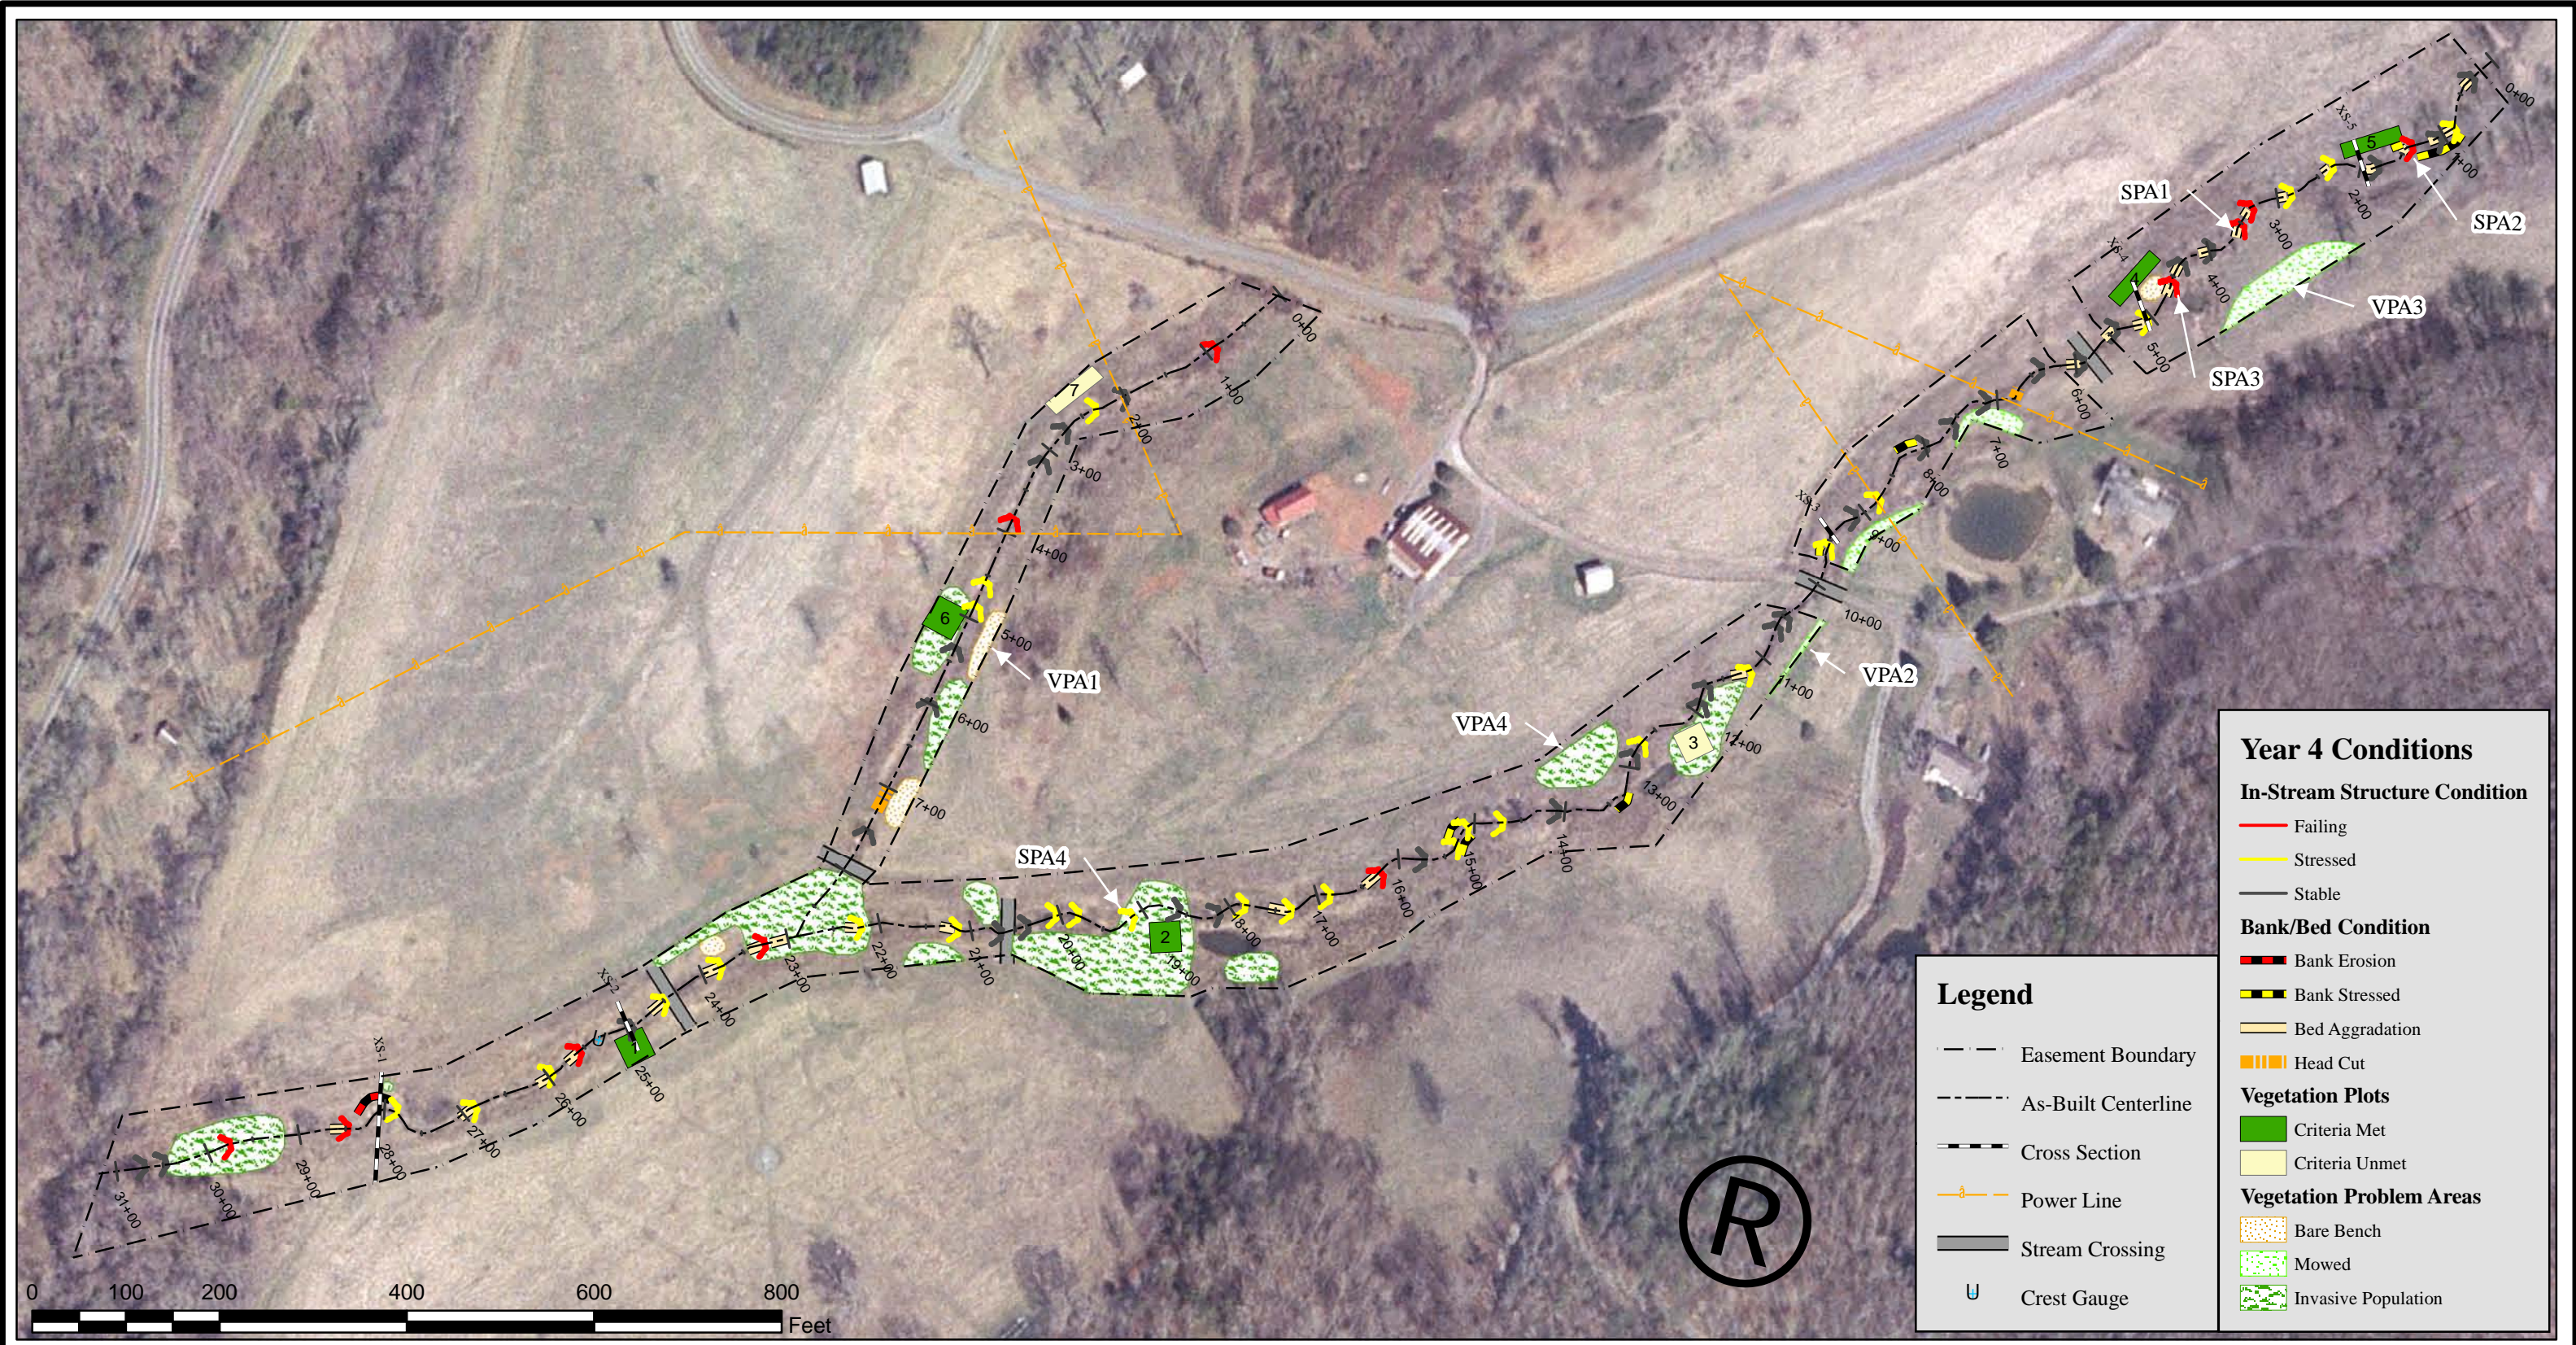
Appendix D
Trout Cove Branch
Integrated Current Condition Plan View

substrate. The bare floodplain problem areas noted are the result of unauthorized mowing and livestock fencing extending into the easement area. An additional problem was identified during the final site visit in November 2008. Mary Jo Deck, one of the existing landowners, indicated that the electrical company recently attempted to mow the existing power line crossings along the upper portion of the project site. A small area was mowed within the easement area prior to the landowners stopping progress. This issue will need to be resolved to prevent potential impacts to the riparian vegetation in proximity to the existing power line crossings. The most significant change in vegetation problem areas between MY 4 and previous monitoring efforts is associated with the extent of invasive/exotic species noted in 2008. The MY 4 efforts documented isolated, dense patches of Japanese honeysuckle (*Lonicera japonica*) and Multiflora rose (*Rosa multiflora*). In particular, Japanese honeysuckle largely accounted for the vine strangulation reported in four of the seven monitoring plots. The species most negatively affected by vine strangulation were Silky dogwood (*Cornus amomum*) and Tag alder.

The majority of the stream problem areas identified during the MY 4 visual assessment had been identified during previous monitoring years. Problem areas were primarily associated with stressed or failing engineered structures, which have resulted in areas of bank erosion and stream aggradation. Table B1 in Appendix B provides categorical feature issues by station, the suspected cause, and denotes the number of a representative photo.
