Trout Cove Branch and Tributary Stream Restoration

NCEEP Project Number: 388

Monitoring Year 5

2009 Final Report

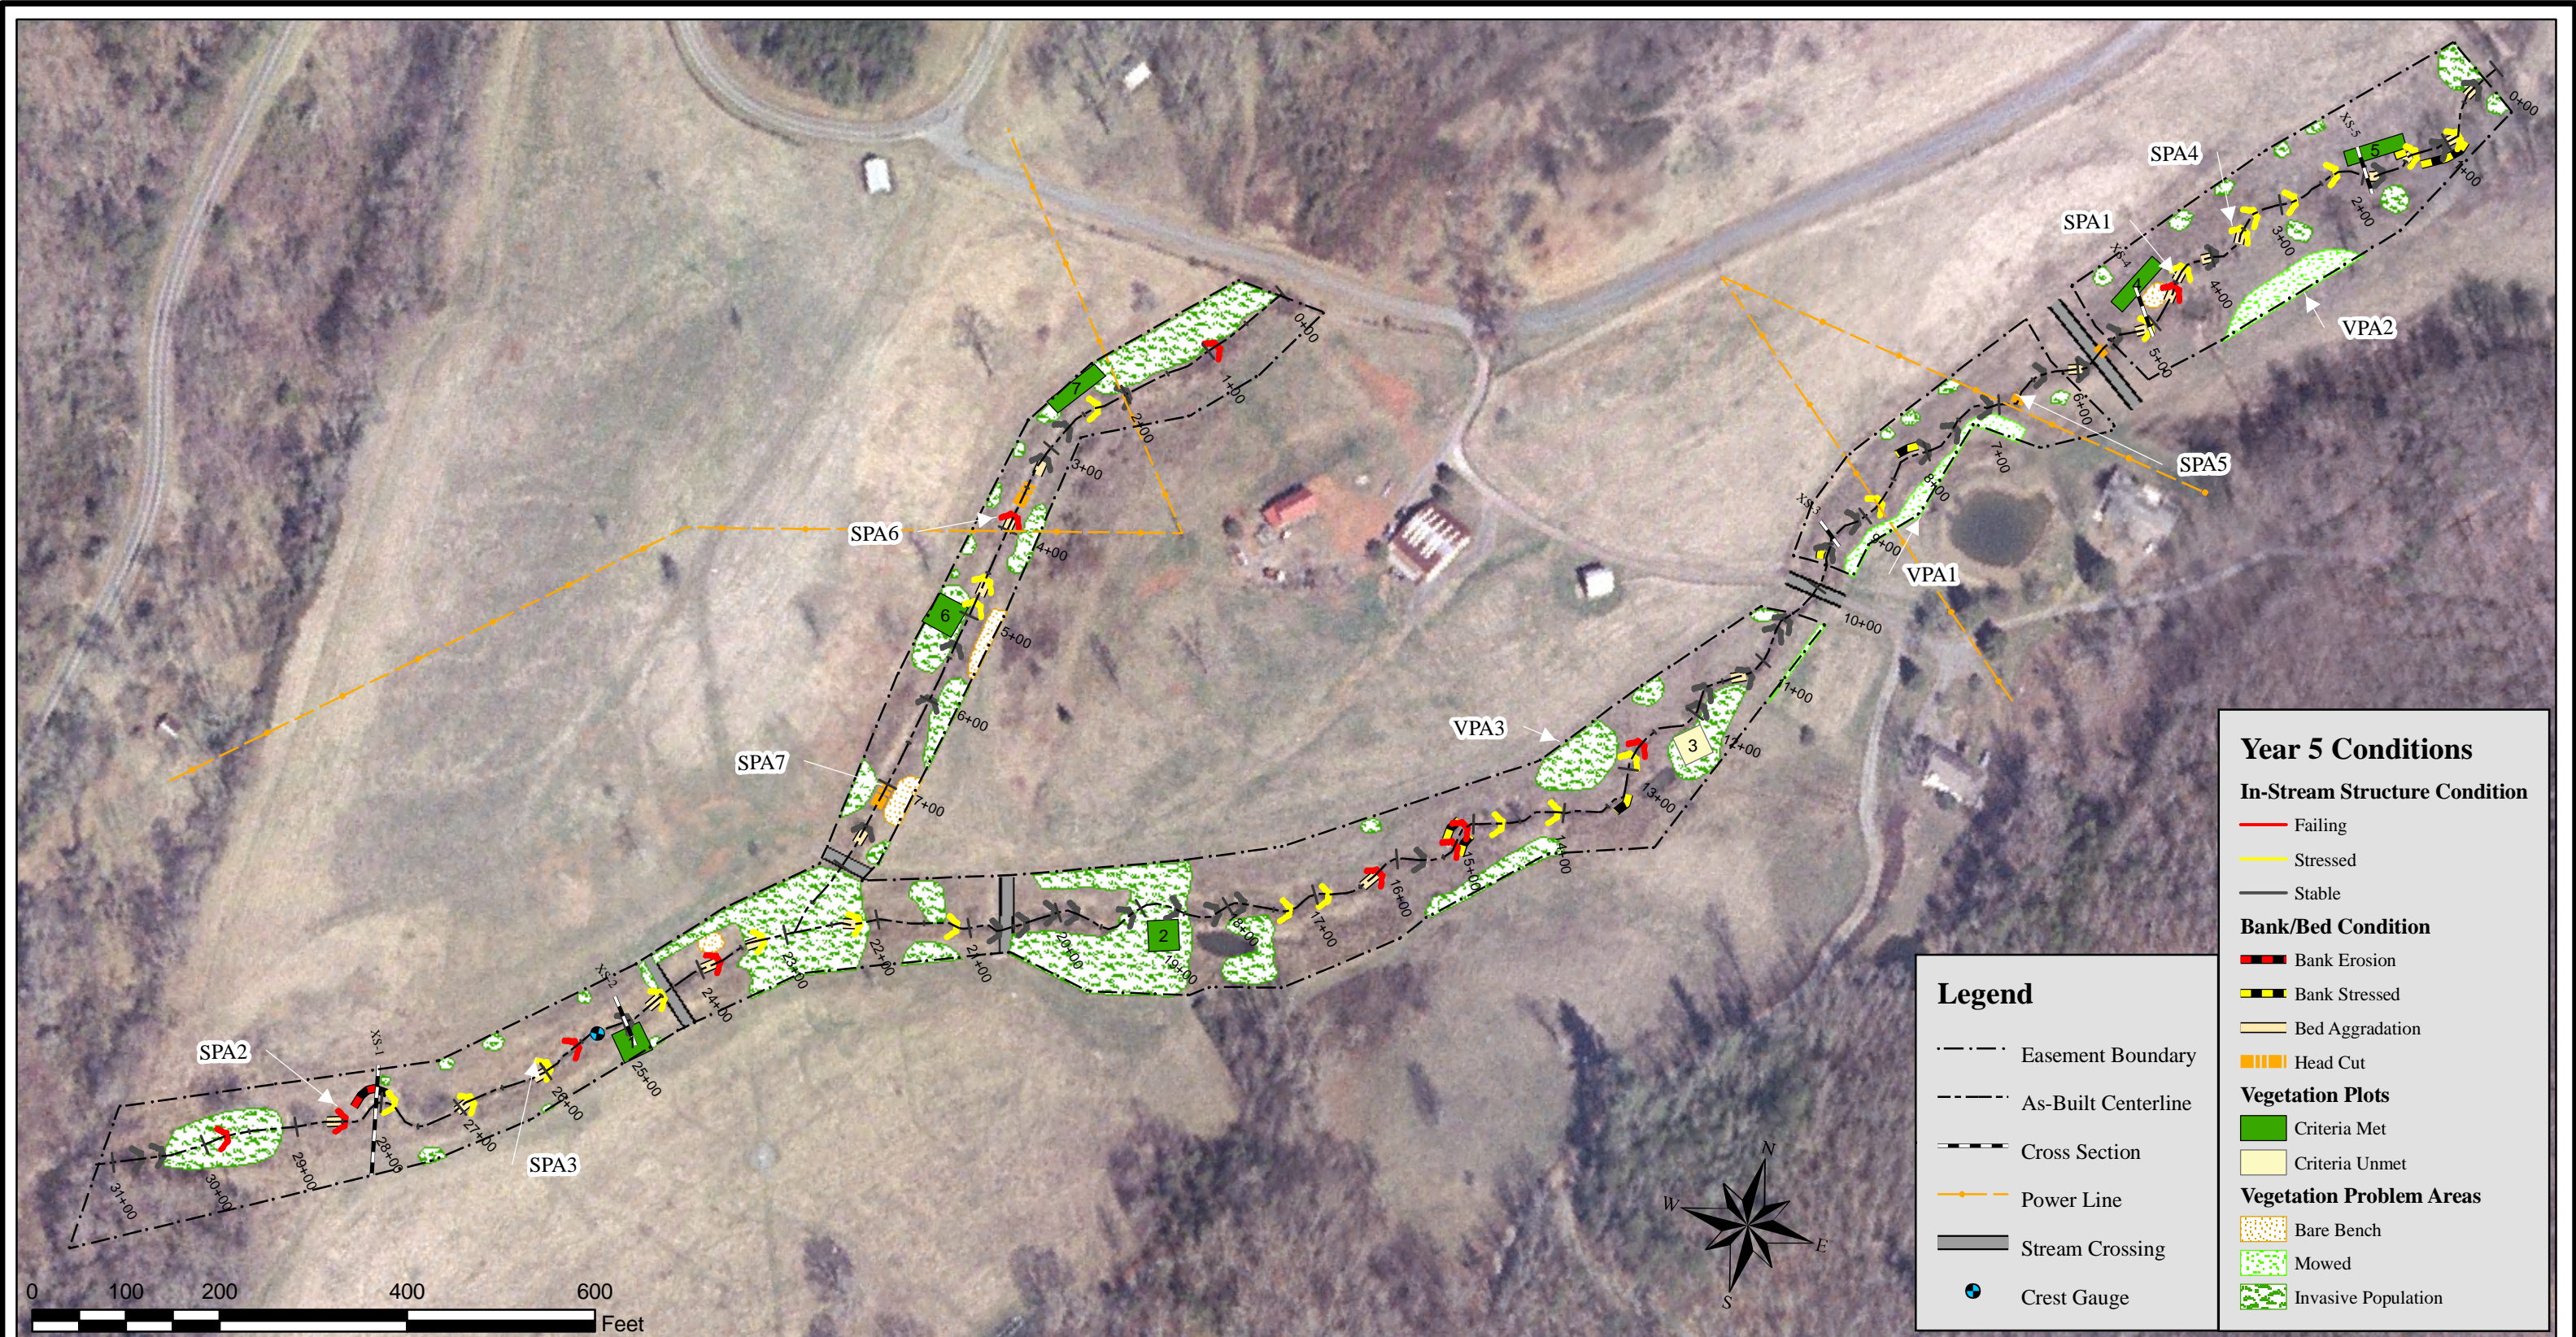
Figure 2. Integrated Current Condition Plan View Final

Stream longitudinal profiles have remained relatively stable among monitoring years. The two main issues observed during MY5 and as seen in previous years were pool aggradation and water piping through structures. All other morphological metrics indicated performance percentages averaging between 92 and 99%. The extent of pool aggradation observed during MY4 was primarily attributed to historic low flows preventing pool scour and sediment transport. While stream flows in MY5 appeared normal and included two bankfull events, pool aggradation was still common and was independent of structure condition. Limited upstream observations indicated poor land use activities which may be overwhelming the restored reaches ability to sufficiently transport the existing bed load within the watershed. Approximately half the structures surveyed had some level of piping, but the visual observations and the profile plots indicate no significant or systemic loss of grade.

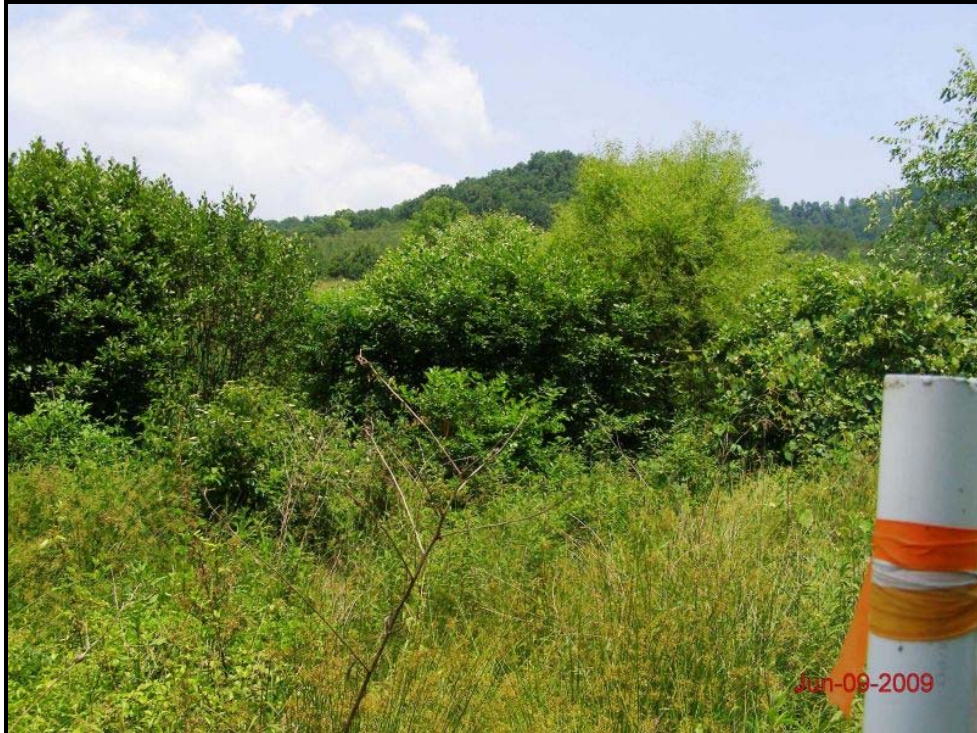
Vegetation Monitoring Plot #3
Monitoring Year 5 – June 9, 2009

Table 5. Vegetation Plot Mitigation Success Summary Trout Cove Branch / Project No. 388		
Vegetation Plot ID	Vegetation Survival Threshold Met?	Tract Mean
1	Yes	86%
2	Yes	
3	No	
4	Yes	
5	Yes	
6	Yes	
7	Yes
