Year 3 Monitoring Report

Tulula Stream & Wetland Restoration

February 2006
S&EC Project No. 9444.D1
EEP Project No. 00035

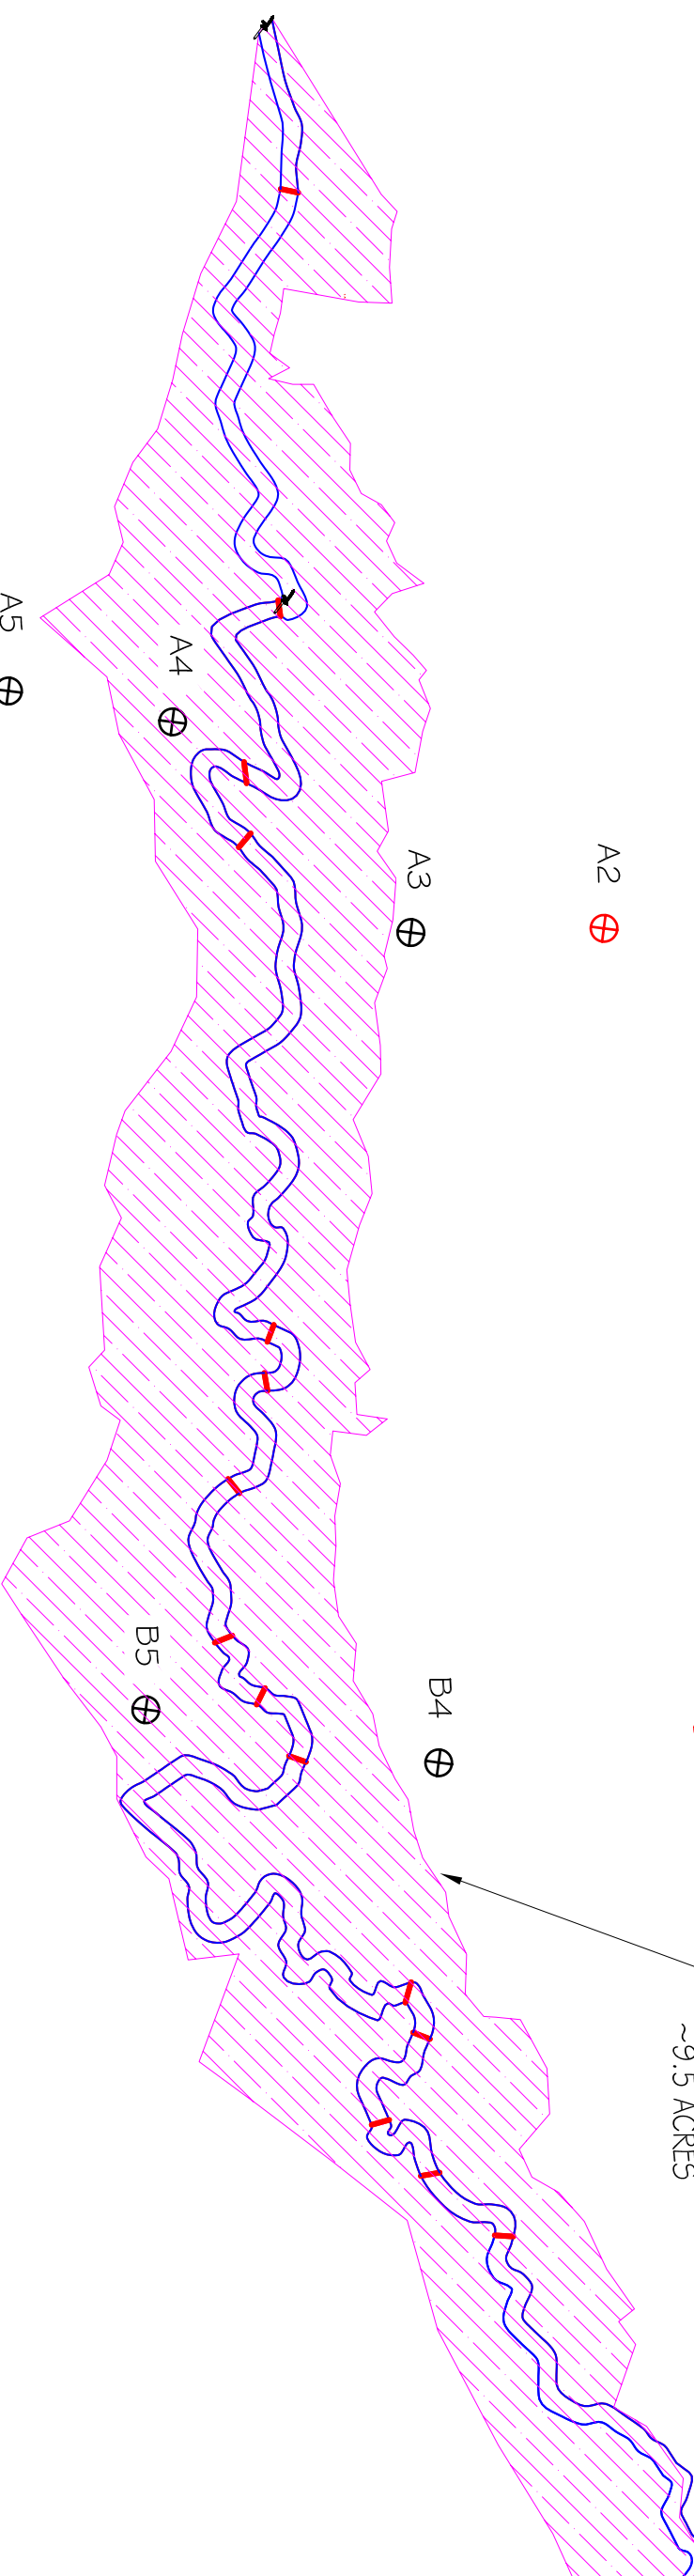
PROBLEM AREA PLAN VIEW

An assessment of channel stability was performed on July 19 and 20, 2005, by S&EC. Areas of concern that were observed and documented included localized bank scour, debris and beaver dams, and stressed or failing structures. These problem areas are shown on Sheets 5 through 8 (Problem Area Plan View).

As shown on the Problem Area Plan View (Sheets 5 through 8), twenty (20) of the twenty-nine (29) gauges on-site achieved wetland success criteria of saturation for 12.5% of the growing season (29 days). The nine (9) gauges that did not meet criteria were consistent with those failing to meet hydrology in 2004.

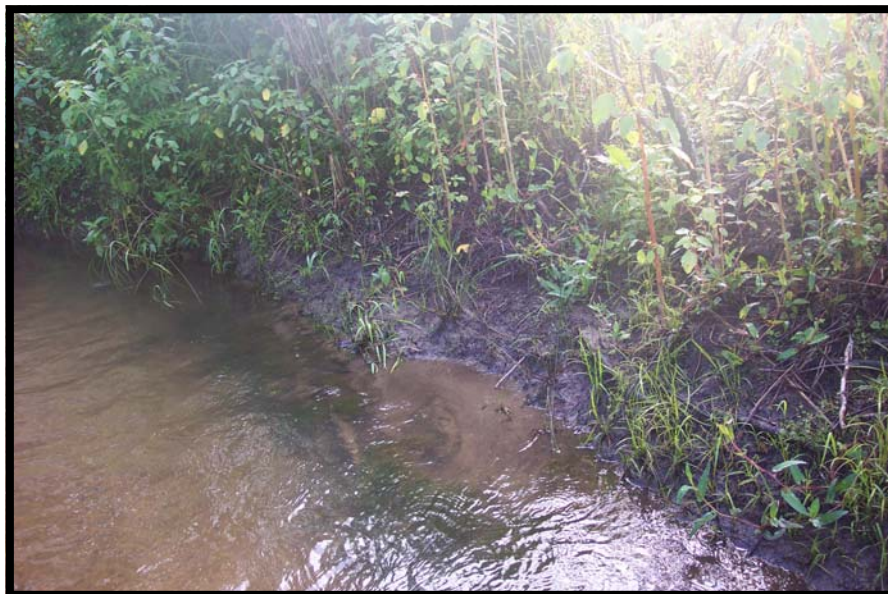
During a field inspection on July 19 and 20, 2005, an area of bare stream bank was observed. It is believed this area is due to excessive grazing. A photo is included in Appendix A.

Table VII: Vegetative Problem Areas Tulula Stream and Wetland Restoration Site (EEP Project #00035)			
Feature Issues	Number	Suspected Cause	Photo number
Bare Bank	1	Excessive browsing	1

Figure 1— Bare Bank 1

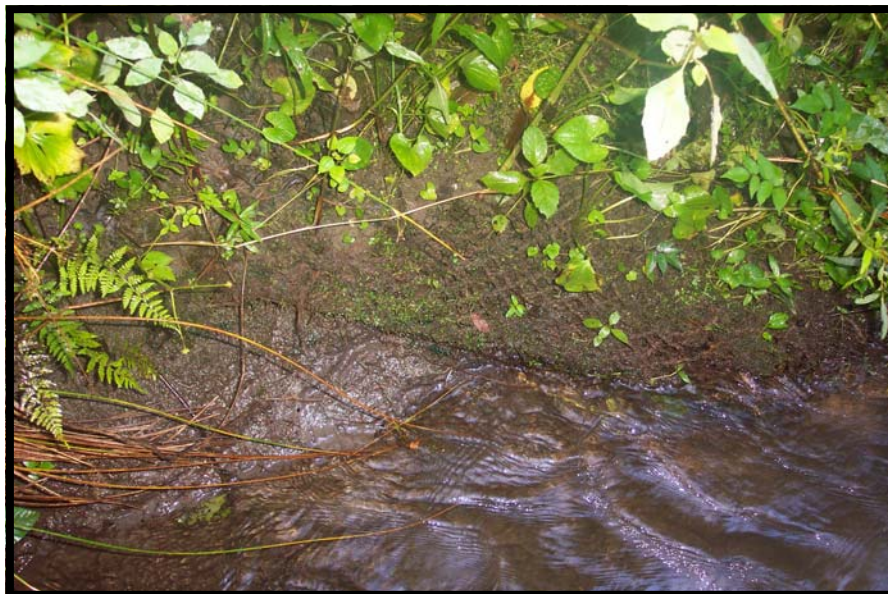
Table IX: Stream Problem Areas Tulula Stream and Wetland Restoration Site (EEP Project #00035)			
Feature Issues	Number	Suspected Cause	Photo number
Bank Scour	1	Coir failure	1-2
	2	Coir Failure	
	3	Outside meander / drainage from bank	
	4	Outside meander / coir failure	
Failing Structures	1	Undercut Crossvane	N/A
	2	High Invert (crossvane) / Debris Jam	N/A
Debris Jam	1	Debris Jam – should be removed	3
Headcut	1	Small headcut	4

Figure 1— Typical Bank Scour

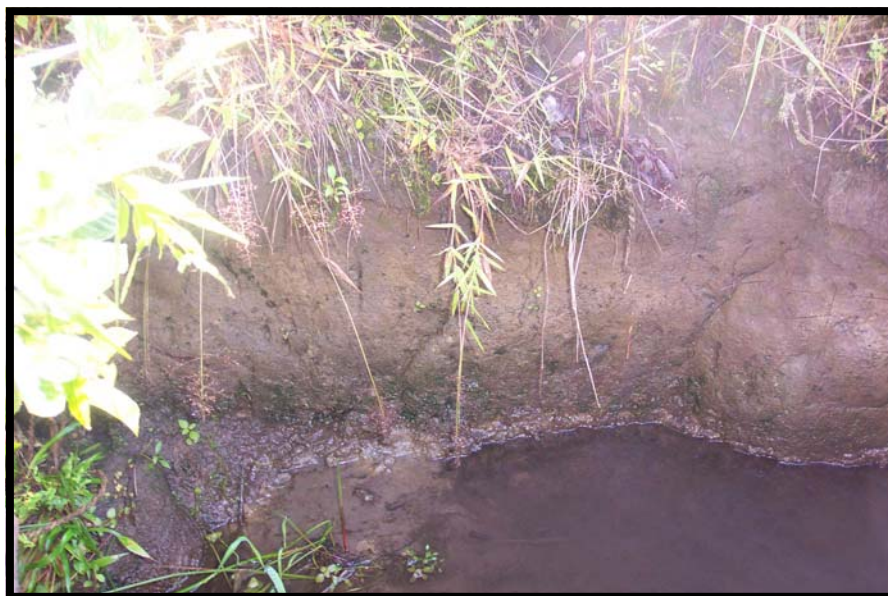
Figure 2—Typical Bank Scour

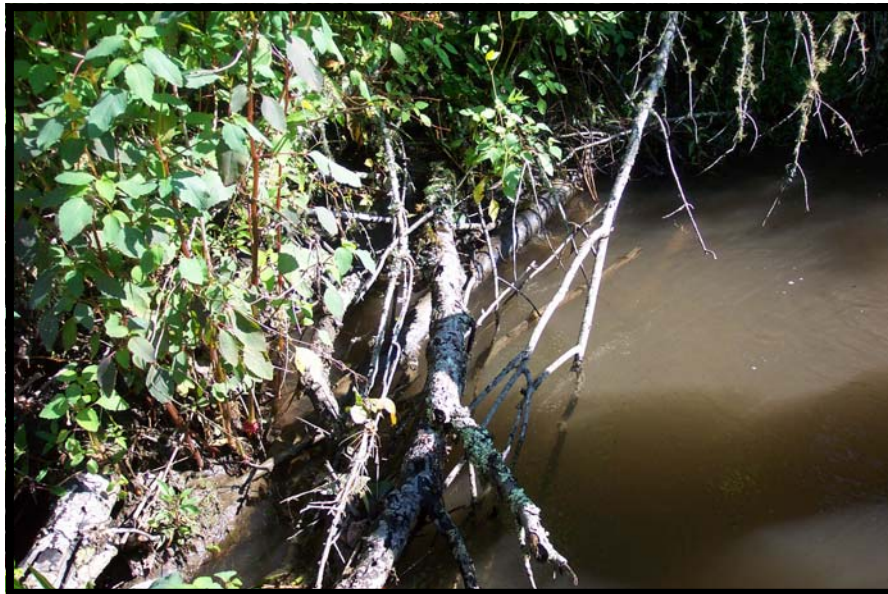
Figure 3—Debris Jam

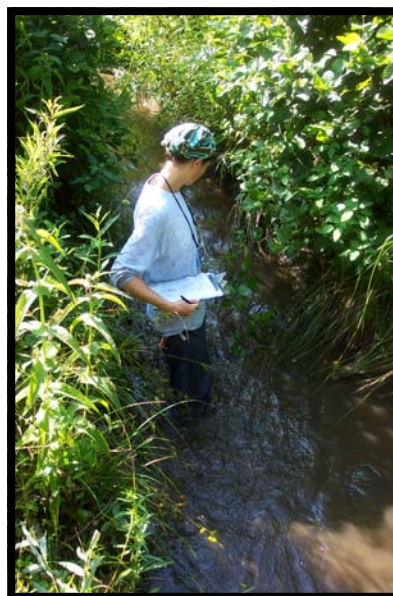
Figure 4—Head Cut
