# **Year 4 Monitoring Report**

## **Tulula Stream & Wetland Restoration**

**January 2007**  
**EEP Project No. 392**

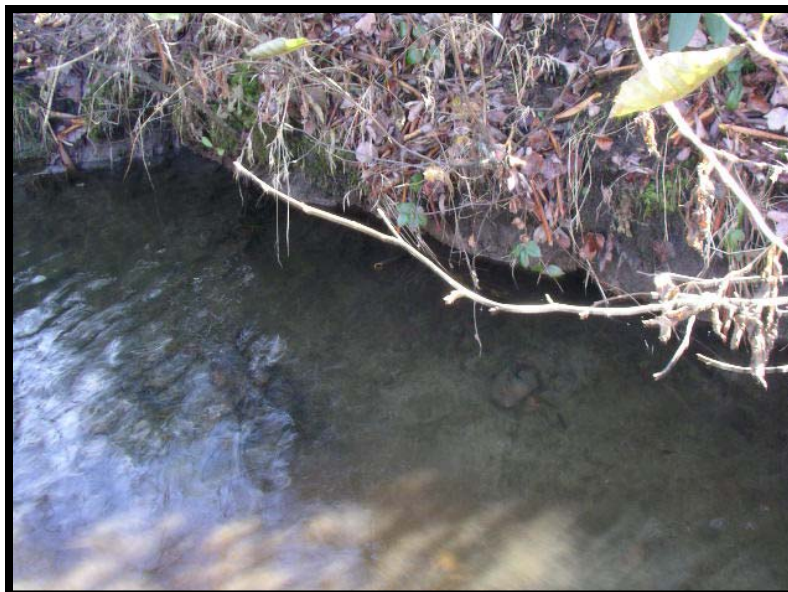
| Table IX: Stream Problem Areas<br>Tulula Stream and Wetland Restoration Site (EEP Project #392 ) | | | |
|--|---|---|---|
| Bank Scour | 1 | Coir failure | 1-6 |

Figure 4—Typical Bank Scour

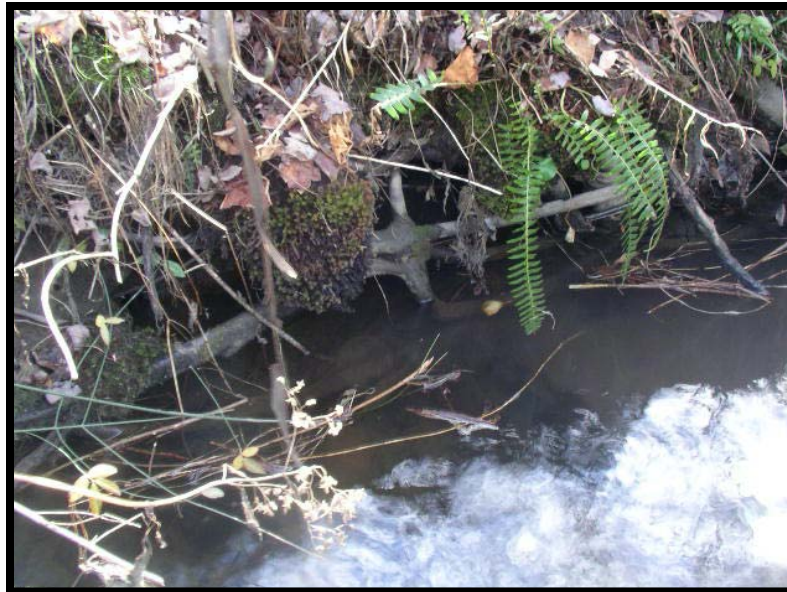
Figure 5—Typical Bank Scour

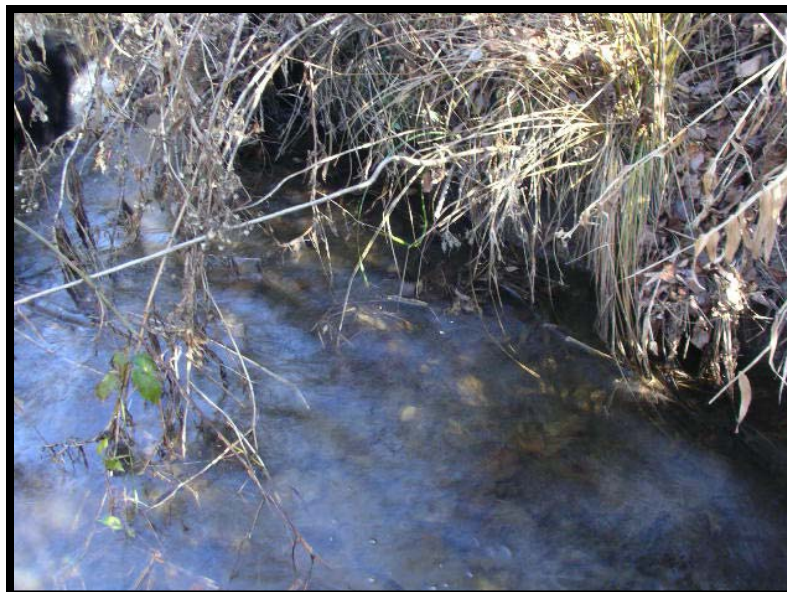
Figure 6—Typical Bank Scour
