Year 5 Monitoring Report

Tulula Stream & Wetland Restoration

March 2008
EEP Project No. 392

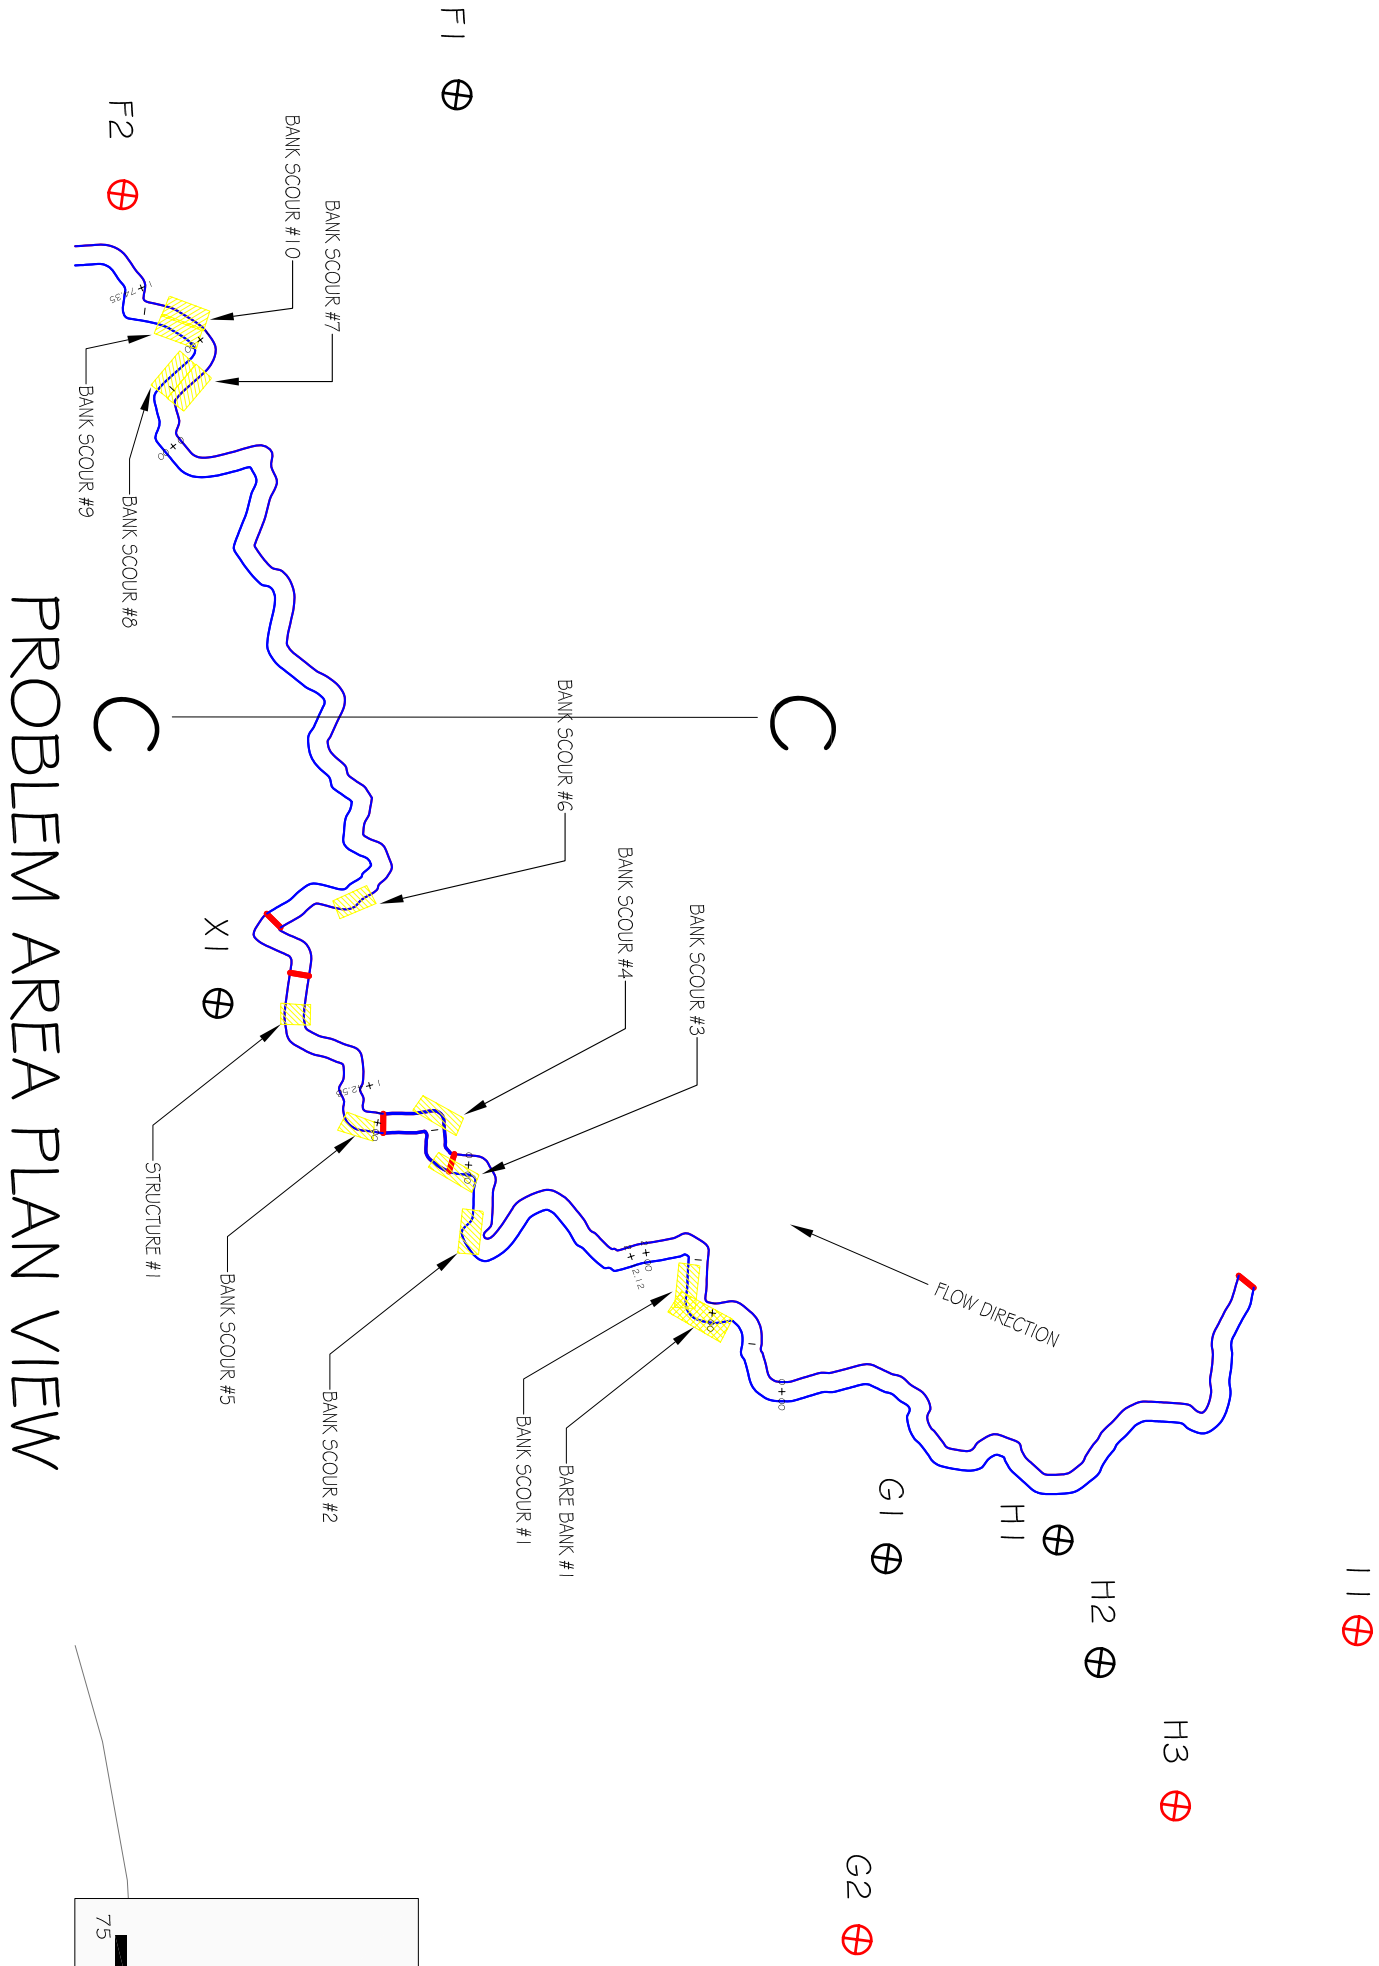
PROBLEM AREA PLAN VIEW

As shown on the Problem Area Plan View (Sheets 5 through 8), twenty (20) of the twenty-nine (29) gauges on-site achieved wetland success criteria of saturation for 12.5% of the growing season (29 days). Nine (9) gauges did not meet hydrology in 2007, to include gauges: A2, B1, B3, D1, F2, F3, G2, H3, and I1. The nine (9) gauges that did not meet criteria were consistent with those failing to meet hydrology in 2006 and 2005.

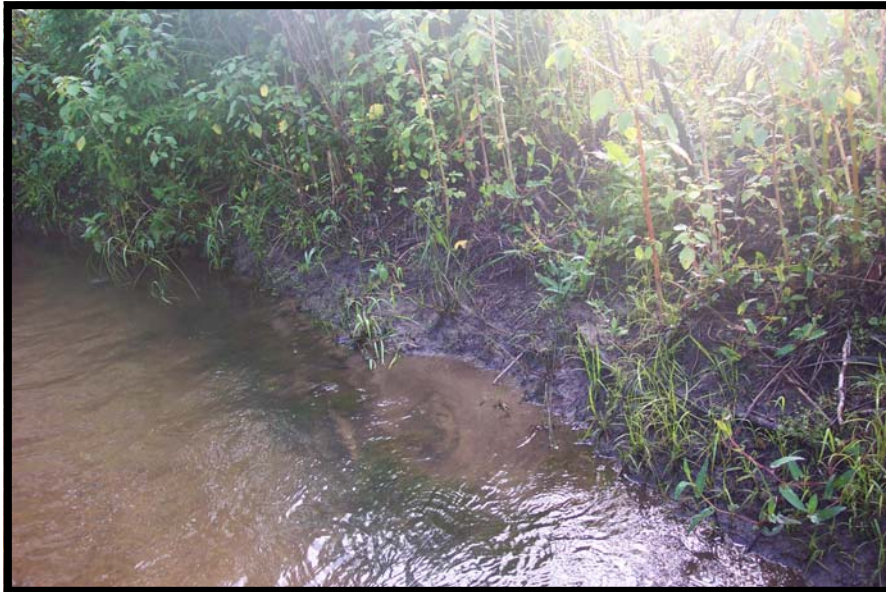
During a field evaluation in June, 2007, a single area of bare streambank was observed. It appears this may be due to excessive wildlife grazing, traffic, and/or undercutting banks. A representative photo is included in Appendix A.

Table VII: Vegetative Problem Areas Tulula Stream and Wetland Restoration Site (EEP Project #392)			
Feature Issues	Number	Suspected Cause	Photo number
Bare Bank	1	Undercut Banks/Beaver Activity/Bank Gradient	1
	Reach 1 (0+98 - 1+20)

Figure 1 — Bare Bank 1 (July 12, 2007)

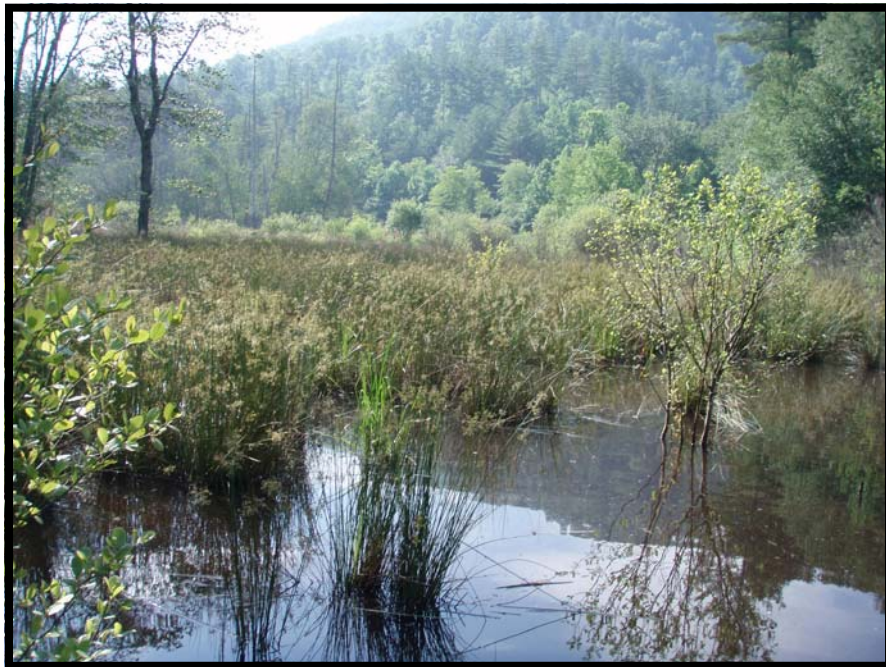
The two plots with no original planted stems remaining (Plot 3 and Plot 5) are close to the lower end of the site where the largest beaver dams are located and where water levels have continued to rise during the monitoring period. Tree species that cannot tolerate these water depths have died and been replaced by areas of open water, soft rush (*Juncus effusus*), willow (*Salix sp.*) and tag alder (*Alnus serrulata*). Excluding Plots 3 and 5, the Average Stem Density for the remaining plots is 575 stems per acre. All observations to date indicate strong vegetative success on the project site. According to EEP,

Vegetation Monitoring Plot #3—Year 5 (June 12, 2007)

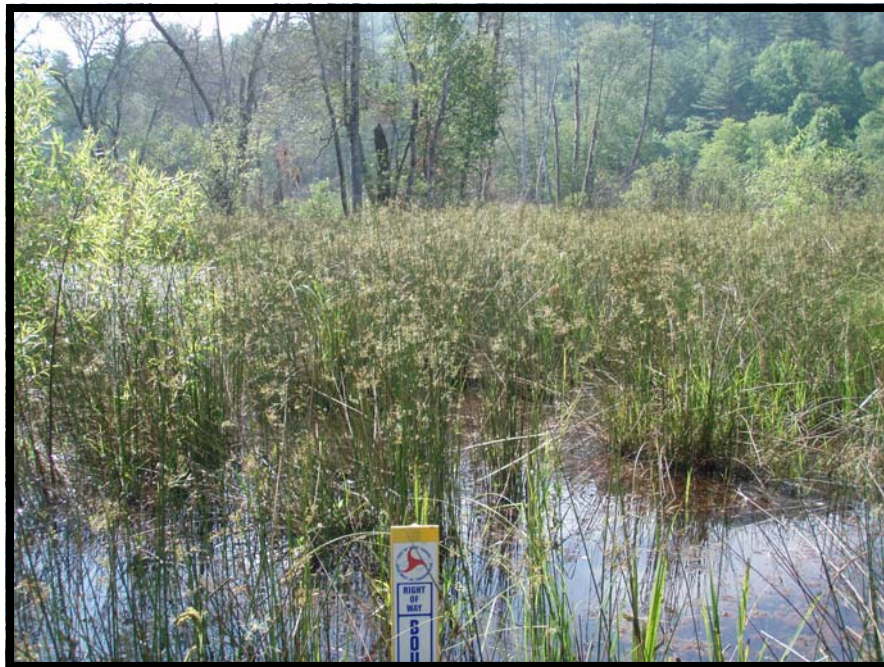
Vegetation Monitoring Plot #5—Year 5 (June 12, 2007)

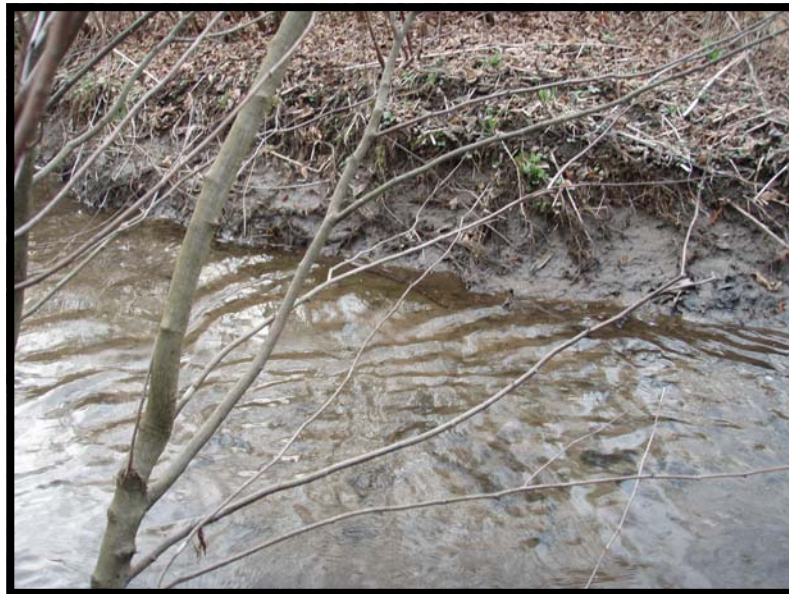
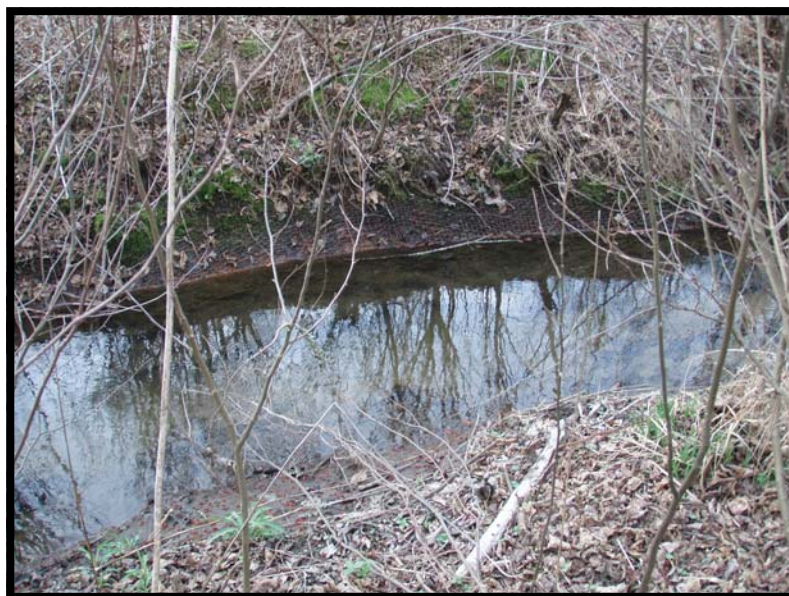
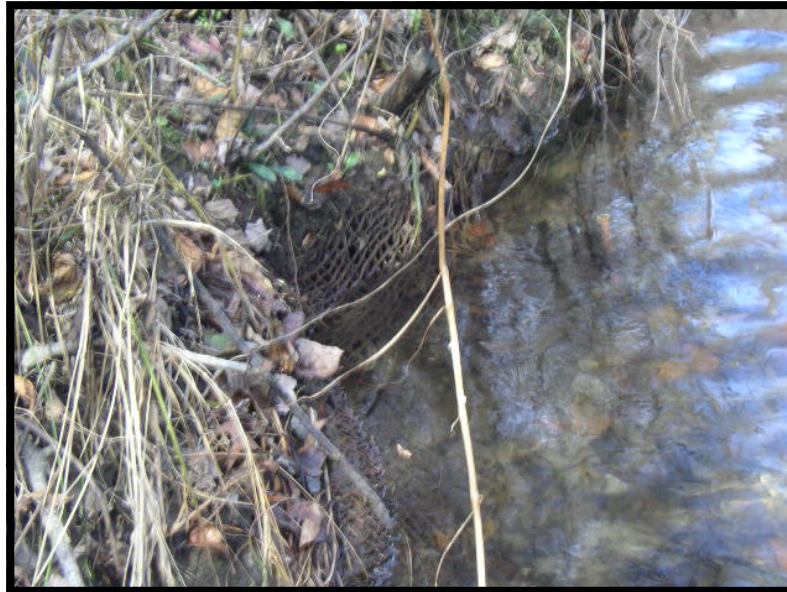
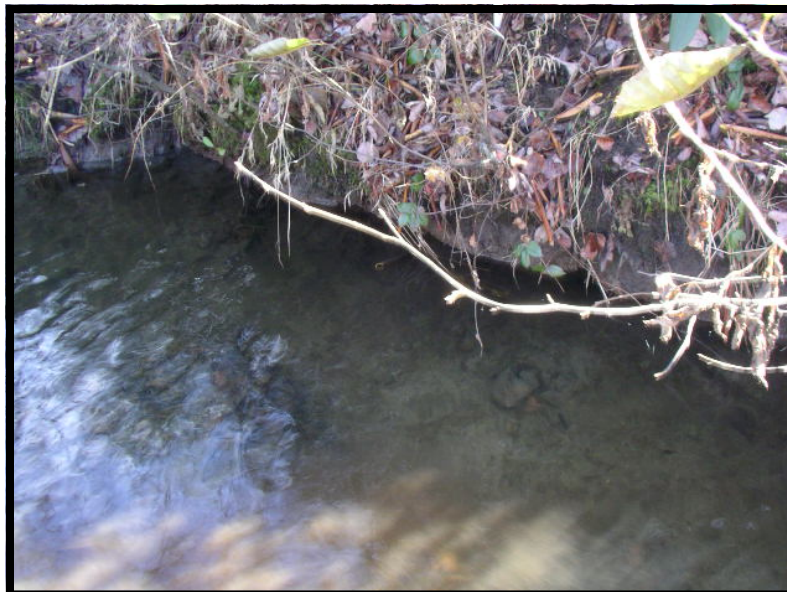
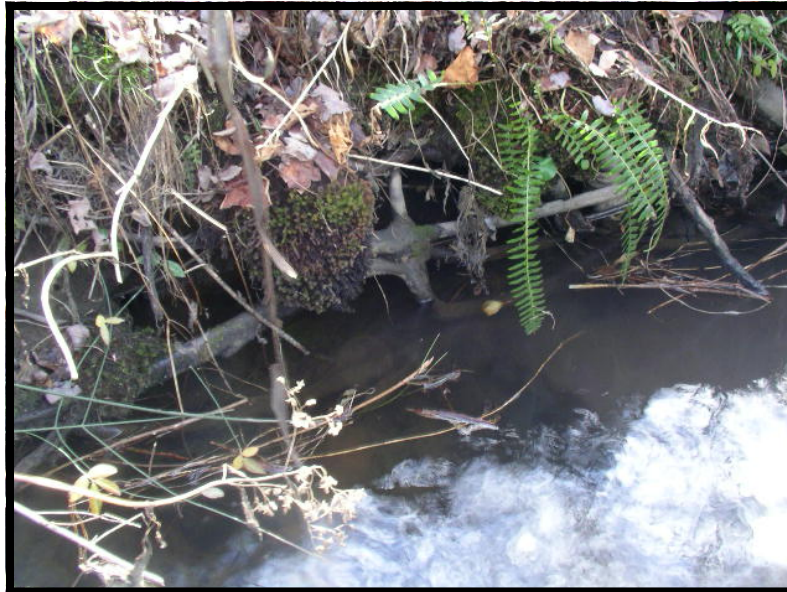
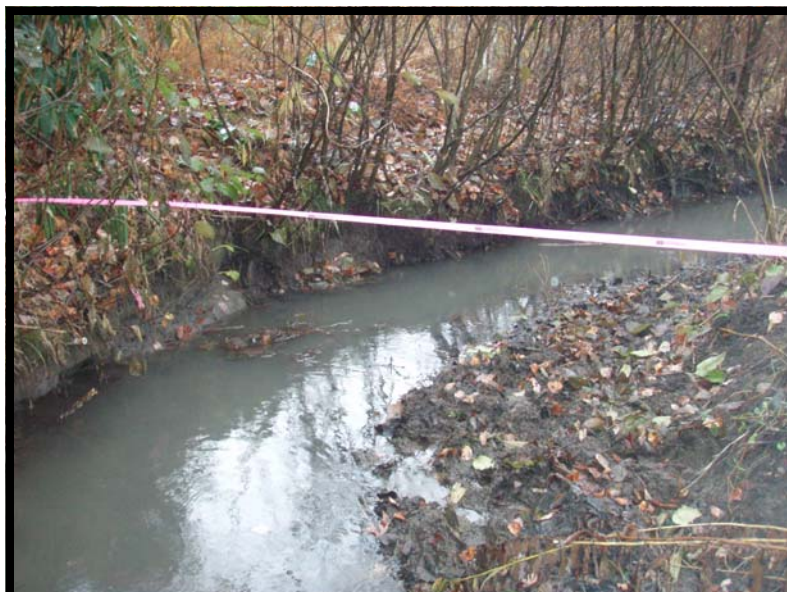
An assessment of channel stability was performed in June, 2007, by S&EC. Areas of concern that were observed and documented included localized bank scour, debris and beaver dams, and stressed or failing structures. These problem areas are shown on Sheets 5 through 8 (Problem Area Plan View). According to EEP, additional control and dam removal efforts are being implemented by the agencies wildlife control contractor to remove beaver from the site and remove remnant dam materials.

Table IX: Stream Problem Areas Tulula Stream and Wetland Restoration Site (EEP Project #392)			
Feature Issues	Number	Suspected Cause	Photo number
Bank Scour	1	Coir failure	1-6
	Reach I (1+10 – 1+30)		
	2	Coir Failure	
	N/A		
	3	Undercut banks / coir failure	
	Reach IA (0+00 – 0+15)		
	4	Outside meander / coir failure	
	Reach IA (0+30 – 0+60)		
	5	Undercut banks / coir failure	
	Reach IA (1+00 - 1+20)		
	6	Undercut banks / coir failure	
	N/A		
	7	Outside meander / coir failure	
Reach II (0+45 - 0+65)			
8	Coir failure		
Reach II (1+00 - 1+35)			
Failing Structures	1	Undercut Crossvane	N/A
	N/A		
	N/A

Figure 1—Typical Bank Scour (November 13, 2007)

Figure 2—Typical Bank Scour (November 13, 2007)

Figure 3— Typical Bank Scour (November 13, 2007)

Figure 4— Typical Bank Scour (November 13, 2007)

Figure 5—Typical Bank Scour (November 13, 2007)

Figure 6—Typical Bank Scour (November 13, 2007)
