Tulula Stream & Wetland Restoration
NCEEP Project Number: 392
Monitoring Year 6
2008 Final Report

Submitted to
Ecosystem Enhancement Program
North Carolina Department of Environment and Natural Resources
May 2009

Tulula Stream and Wetland Restoration – 2008 Monitoring Report (MY 6)

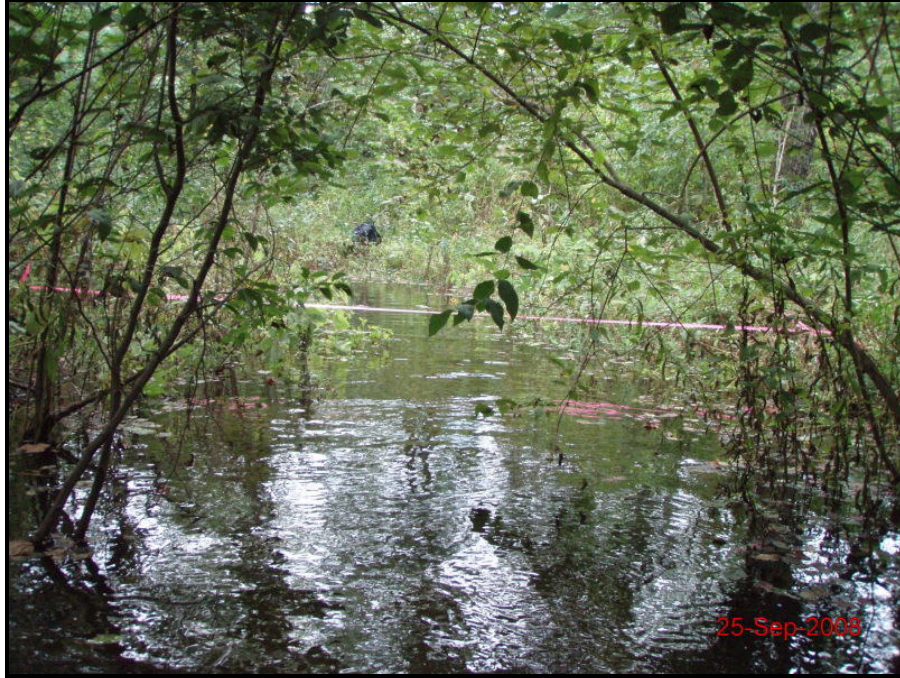
Reach II – Cross Section #1 – Riffle
Looking Downstream
Monitoring Year 6 – September 25, 2008

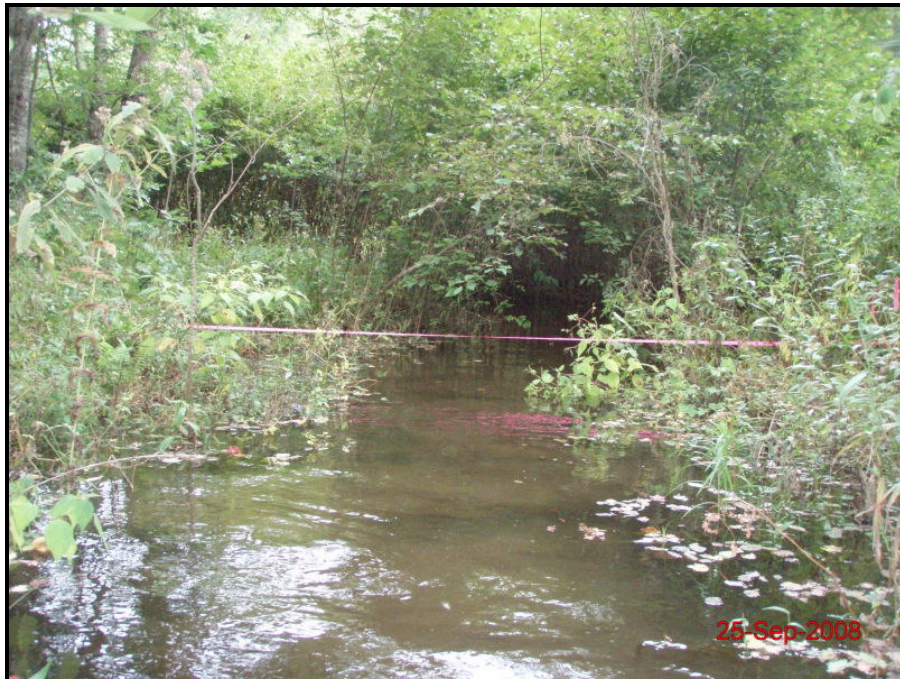
Reach II – Cross Section #1 – Riffle
Looking Upstream
Monitoring Year 6 – September 25, 2008

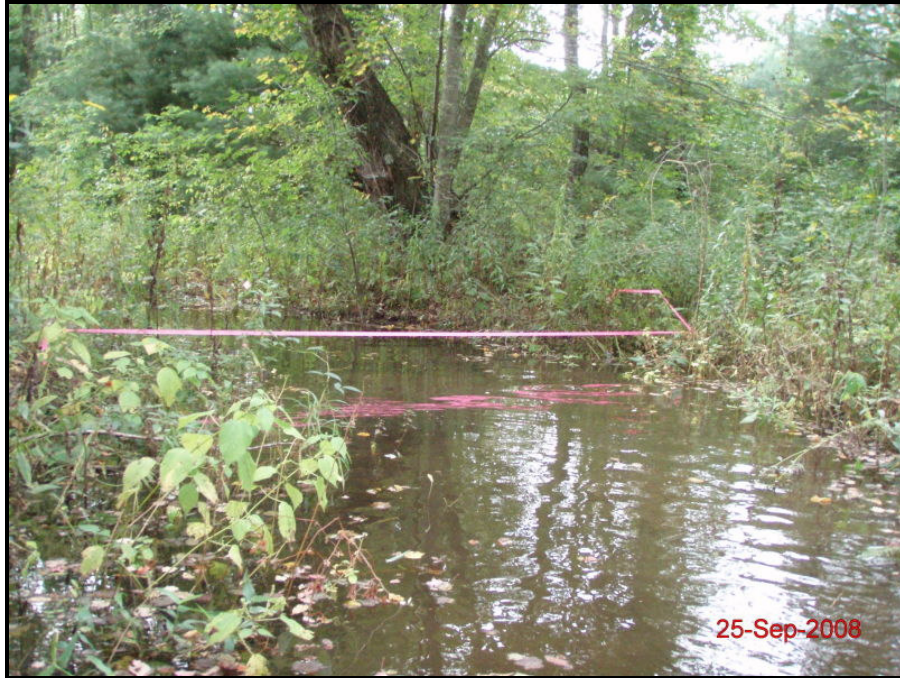
Reach II – Cross Section #2 – Pool
Looking Downstream
Monitoring Year 6 – September 25, 2008

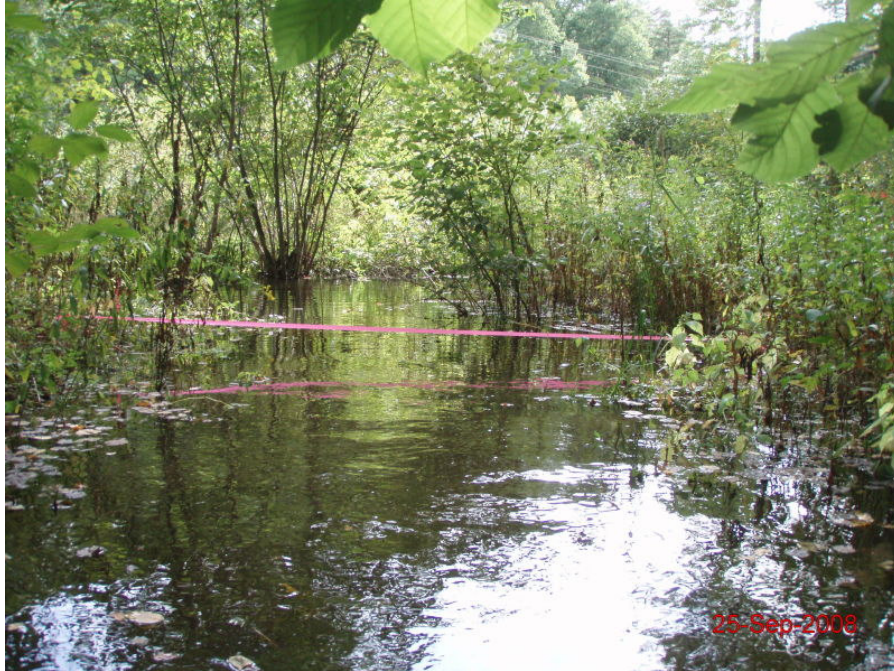
Reach II – Cross Section #3 – Riffle
Looking Downstream
Monitoring Year 6 – September 25, 2008

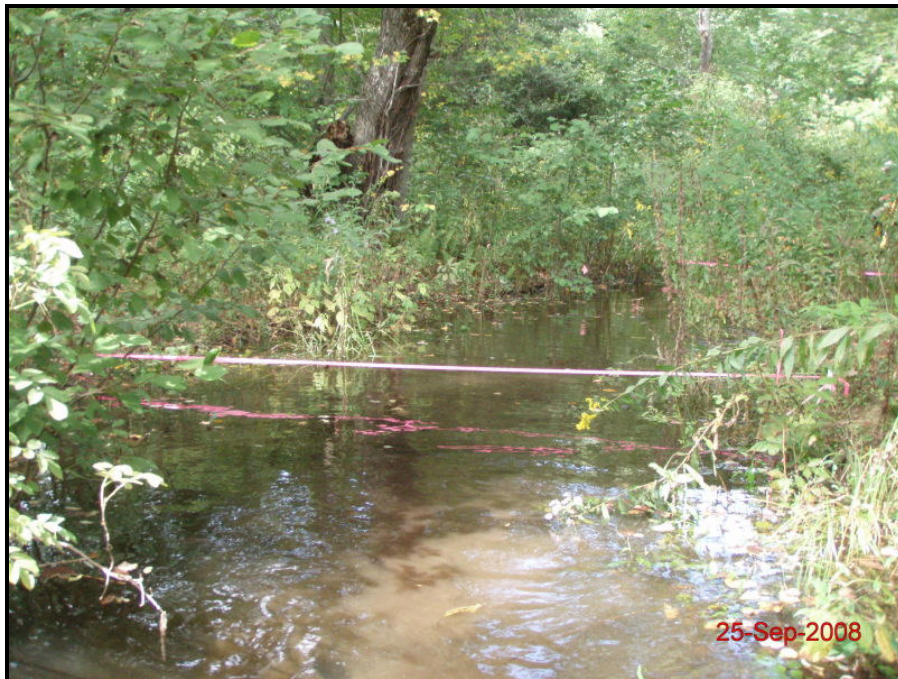
Reach II – Cross Section #3 – Riffle
Looking Upstream
Monitoring Year 6 – September 25, 2008

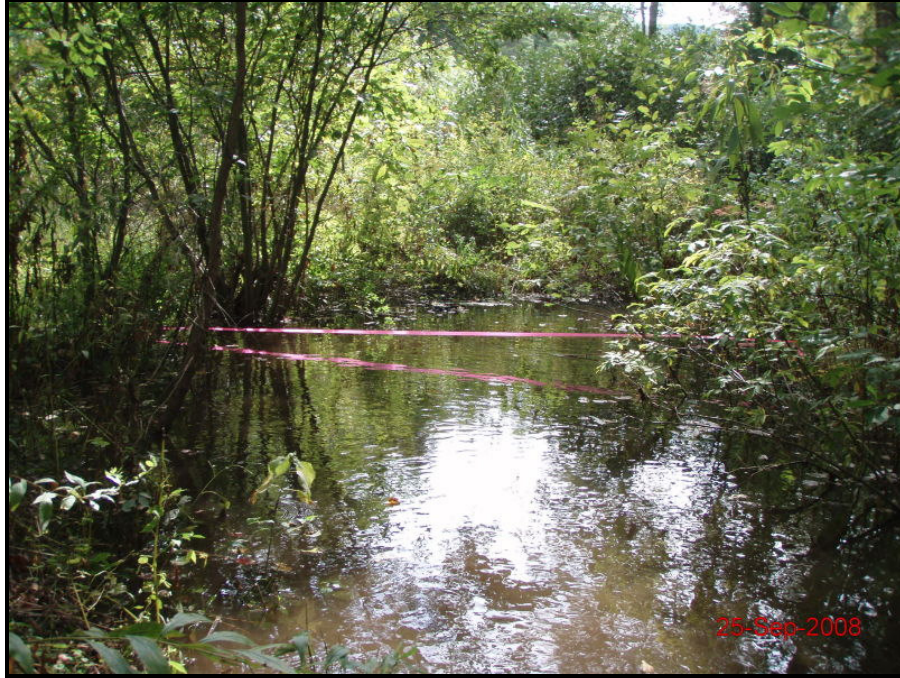
Reach II – Cross Section #4 – Pool
Looking Downstream
Monitoring Year 6 – September 25, 2008
