MONITORING YEAR 2 ANNUAL REPORT Final

UNDERWOOD MITIGATION SITE

Chatham County, NC
DENR Contract 003268
NCEP Project Number 94641

Data Collection Period: June 2014-November 2014
Draft Submission Date: December 1, 2014
Final Submission Date: January 9, 2014

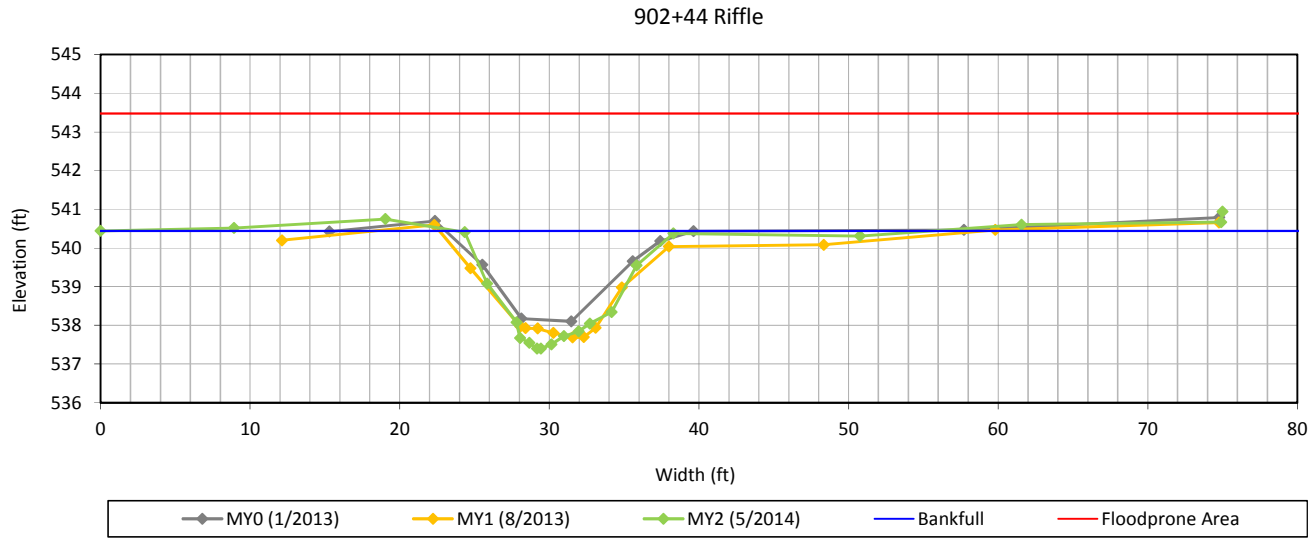
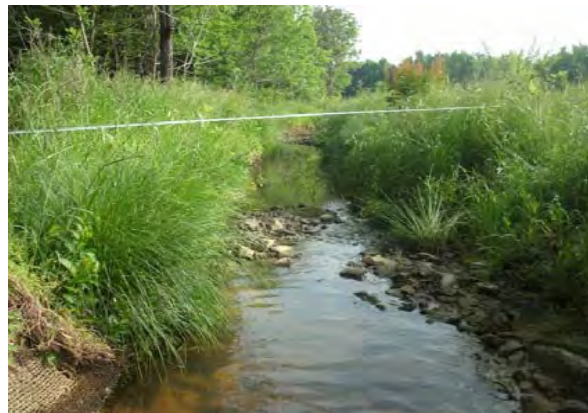
Cross Section 16 - SF4a

¹Number of riffles and pools are determined based on the as-built survey along Restoration and Enhancement Level I reaches. Approximately 533 LF of the stream bed has downcut along SF4A and riffles and pools shifted have shifted downstream. Although these conditions were not intended in the design, the stream has maintained a stable bedform with riffles and pools at a lower elevation.

With the exception of SF4A, all streams within the Site are stable and functioning as designed. Degradation observed on SF4A will be monitored for indications of long term instability. A maintenance plan will be prepared after MY-3 if conditions continue to degrade. The average stem density for the Site is on track to meeting the MY-5 success criteria; however, some individual vegetation plots did not meet the MY-3 success criteria as noted in the Integrated Current Condition Plan View. With the exception of UT2, there have been multiple documented bankfull events with the crest gage recordings along UT1, SF2, SF3, SF4, and SF4A since construction completion. The MY-5 stream hydrology attainment requirement has been partially met for the Site at this time. With the exception of one gage, the MY-2 hydrology success criteria has been met.

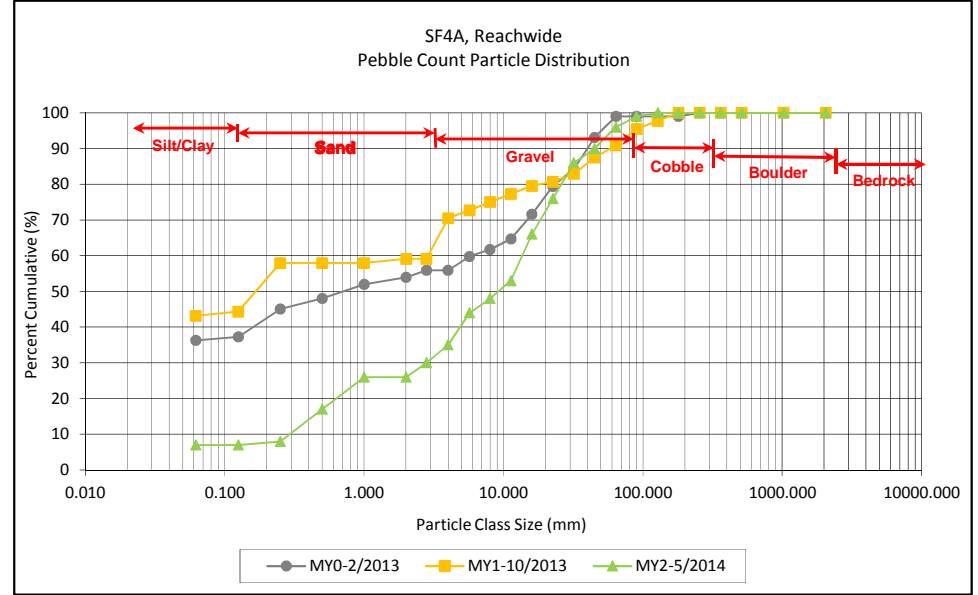
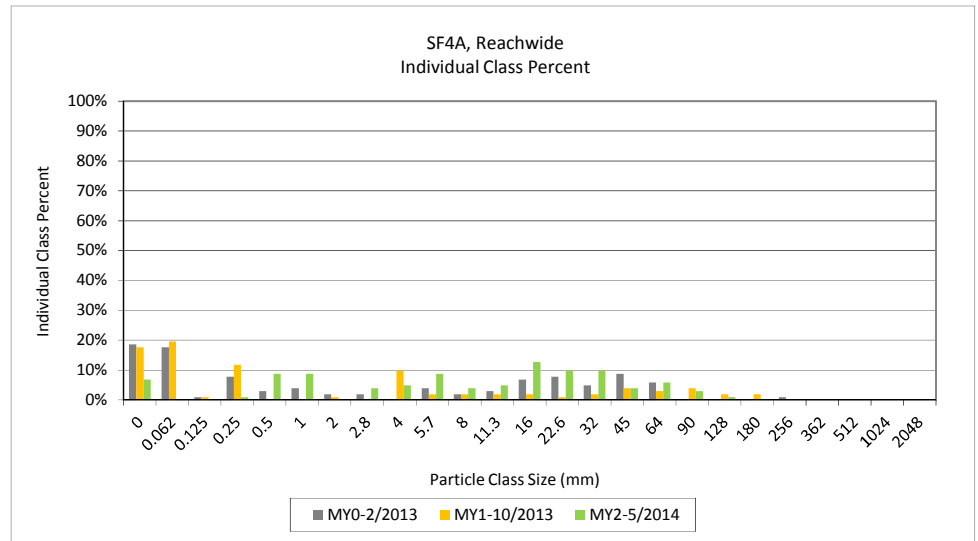
Reachwide and Cross-Section Pebble Count Plots
 Underwood Mitigation Site (NCEP Project No. 94641)
 Lindley Site; SF4A, Reachwide
 Monitoring Year 2

Reachwide	
Channel materials (mm)	
D ₁₆ =	0.93
D ₃₅ =	5.60
D ₅₀ =	12.8
D ₈₄ =	42.0
D ₉₅ =	85.0
D ₁₀₀ =	180.0
