MONITORING YEAR 3 ANNUAL REPORT Final

UNDERWOOD MITIGATION SITE

Chatham County, NC
NCDEQ Contract 003268
DMS Project Number 94641

Data Collection Period: June 2015- October 2015
Draft Submission Date: December 1, 2015
Final Submission Date: December 14, 2015

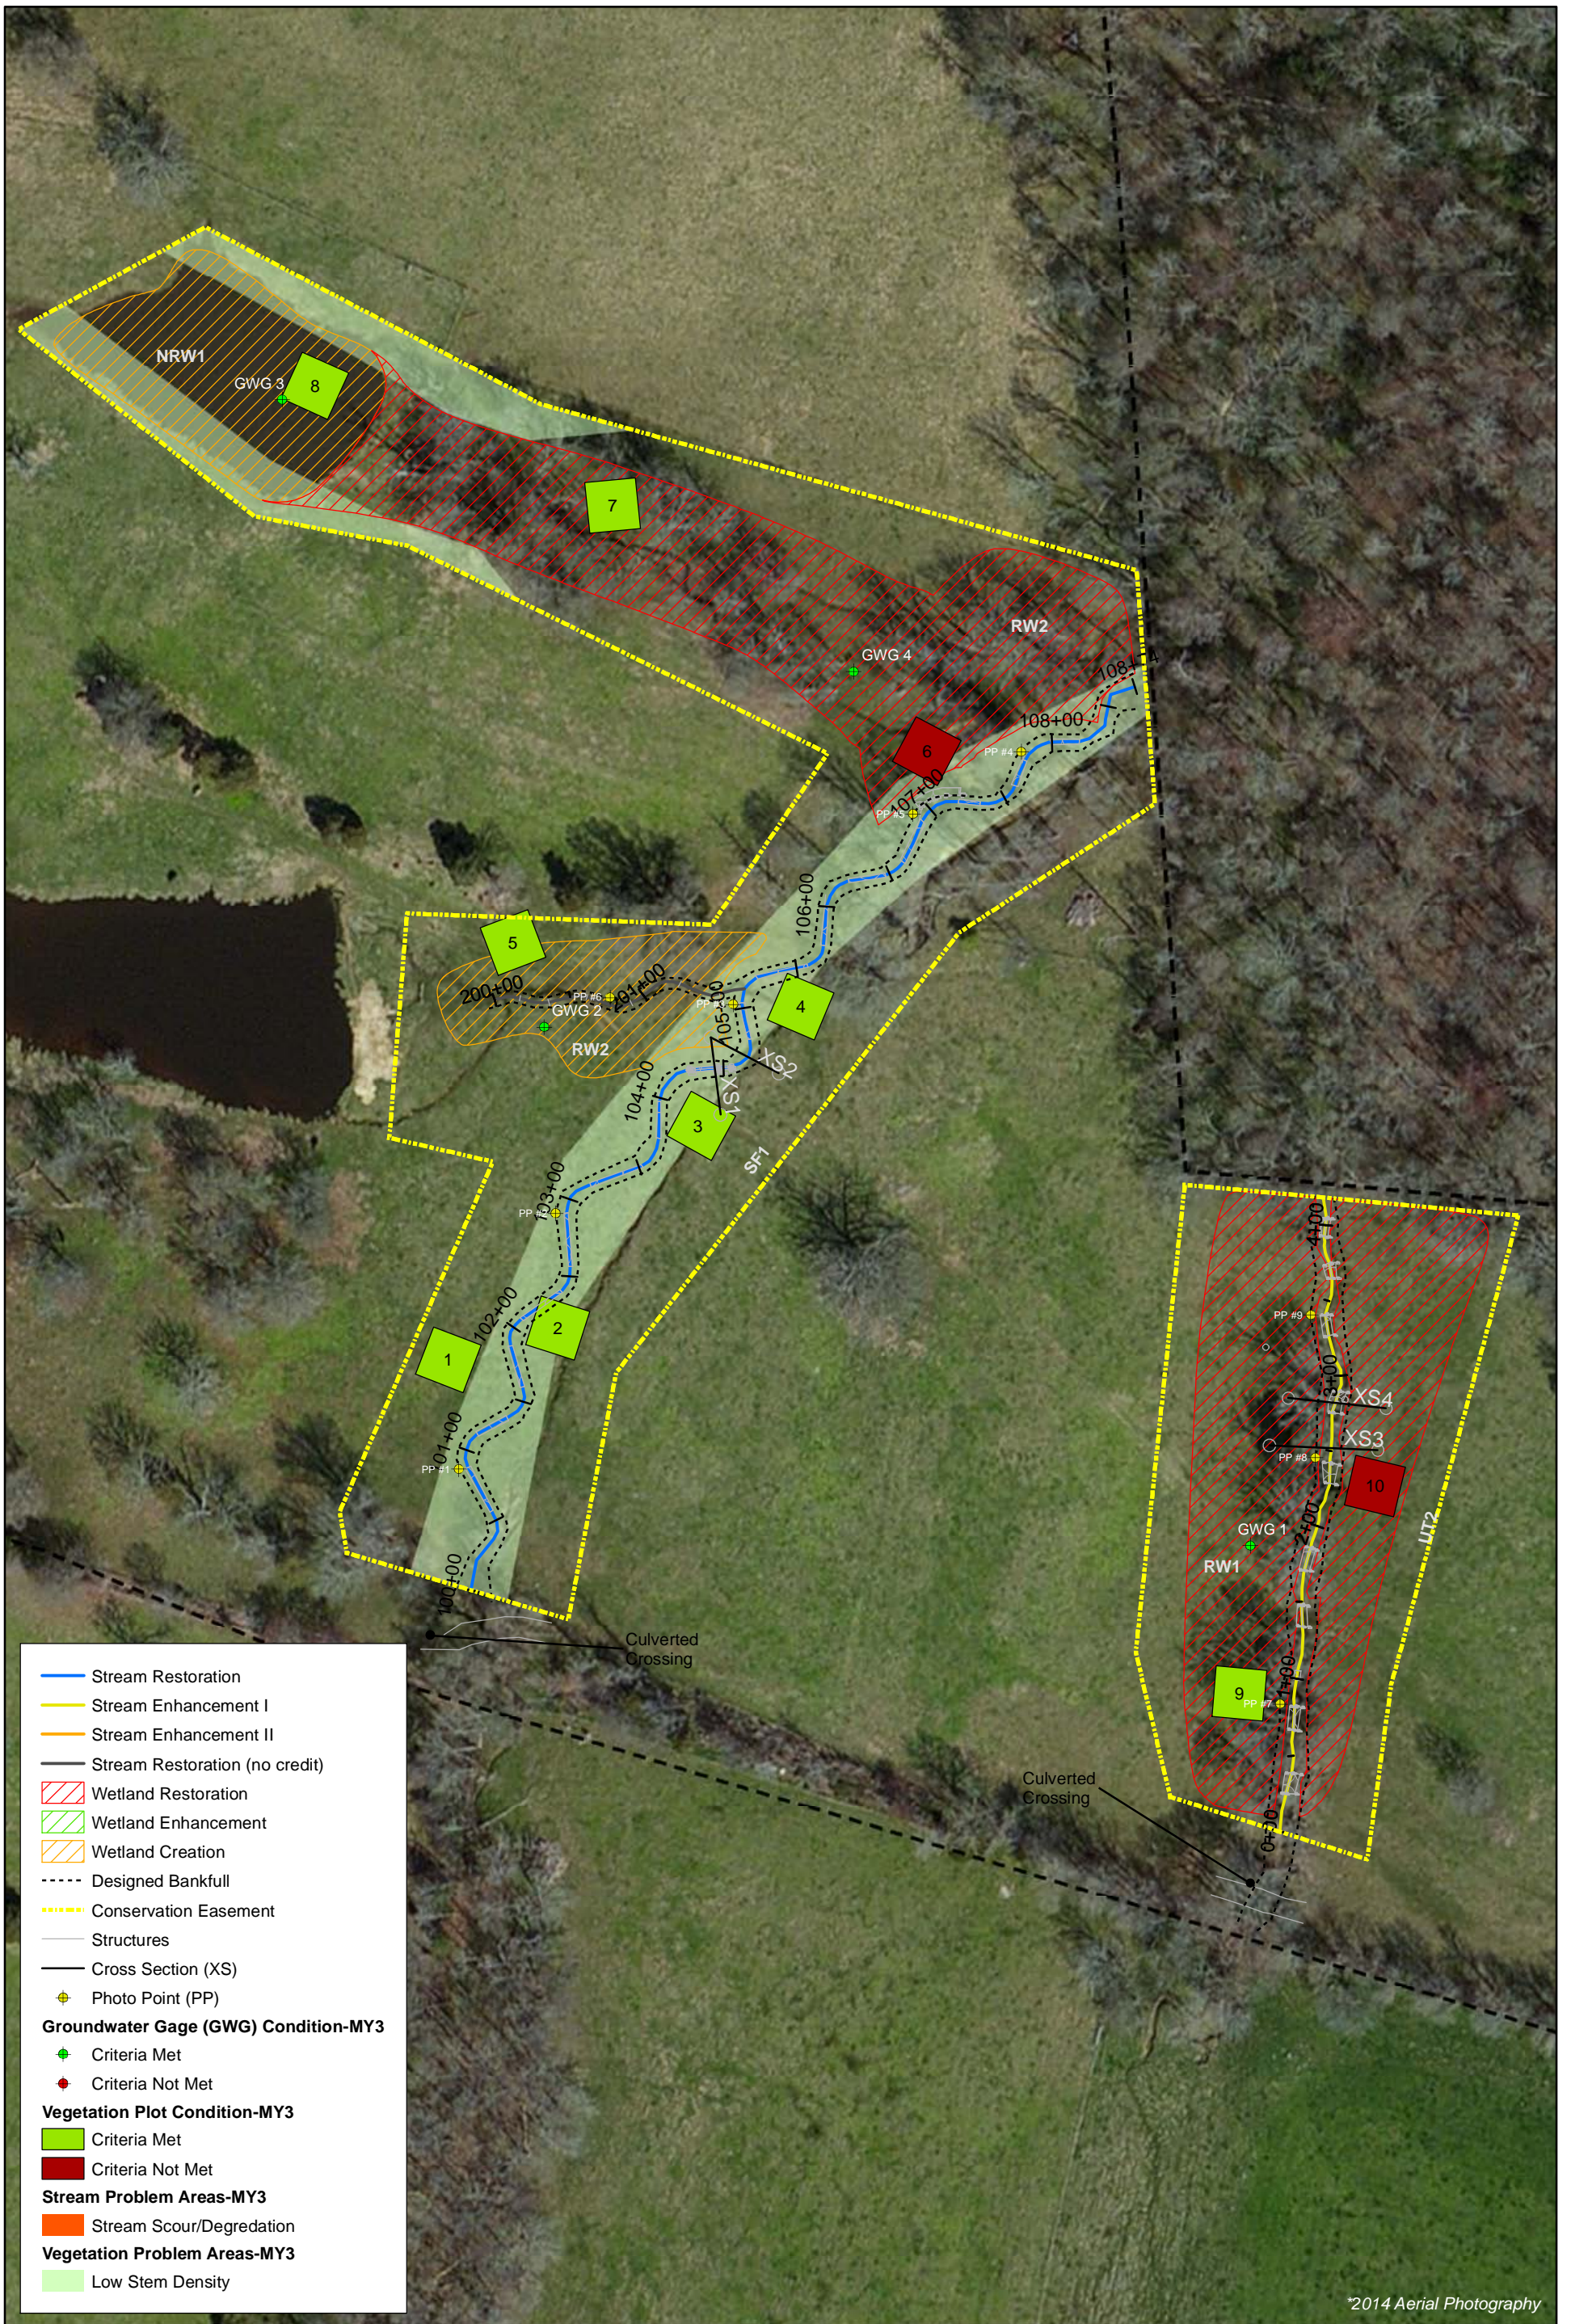
Figure 3.1 Integrated Current Condition Plan View
(Sheet 1 of 3)

During MY3 a few isolated areas were observed to have low tree densities. These areas are shown on the CCPV maps (Figures 3.0-3.3). These areas will be supplemented with additional trees during the beginning of MY4. Some of these areas were graded down several feet during construction and are believed to have poor soil conditions due to the removal of the nutrient rich top soil. Soil samples will be taken in these graded areas and appropriate actions, such as lime or fertilizer application, will be taken to help improve soil growing conditions. Also, most of these areas have limited herbaceous cover growing on them. A native grass seed mix will be applied to these areas to create a well-established herbaceous ground cover.

As described in section 1.2.2 above, supplemental tree planting will be performed in the areas shown to have low stem density on Figures 3.0-3.3. Also, a native grass seed mix will be applied to areas with limited herbaceous cover.

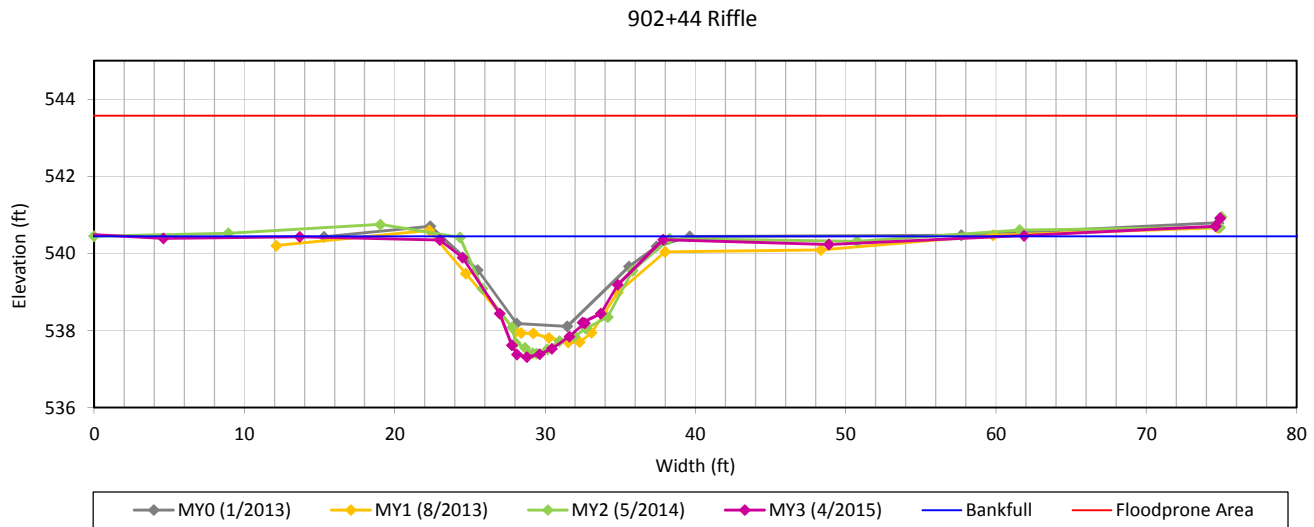
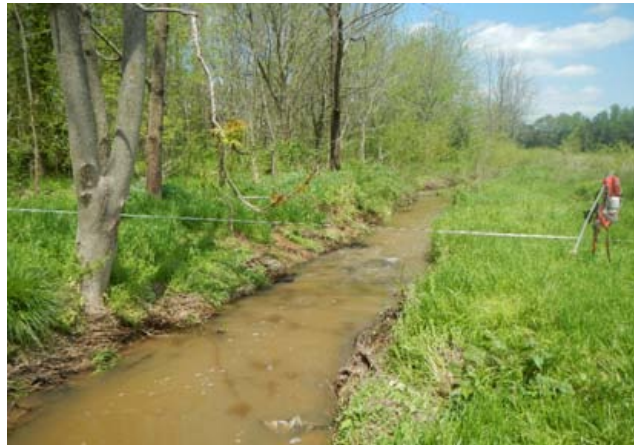
Cross Section 16 - SF4A

¹Number of riffles and pools are determined based on the as-built survey along Restoration and Enhancement Level I reaches. Approximately 533 LF of the stream bed has downcut along SF4A and riffles and pools have shifted downstream. Although these conditions were not intended in the design, the stream has maintained a stable bedform with riffles and pools at a lower elevation.

All streams, except SF4A, on the Site are stable and functioning as designed. SF4A will have repair work performed during the beginning of MY4 to stabilize its bed and banks. The average planted stem density for the Site is on track to meeting the MY5 success criteria; however, seven individual vegetation plots out of 42 did not meet the MY3 success criteria as noted in the Integrated Current Condition Plan View. When volunteer stems are counted in these seven plots, all but one meet MY5 success criteria. Supplemental tree planting will be performed in a few areas. With the exception of UT2, there have been multiple documented bankfull events with the crest gage recordings along UT1, SF1, SF3, SF4, and SF4A since MY0. The MY5 stream hydrology attainment requirement has been partially met for the Site at this time. All groundwater gages met hydrology success criteria during MY3.
