MONITORING YEAR 4 ANNUAL REPORT

UNDERWOOD MITIGATION SITE

Chatham County, NC
NCDEQ Contract 003268
DMS Project Number 94641

Data Collection Period: May 2016- November 2016
Draft Submission Date: December 1, 2016
Final Submission Date: January 11, 2017

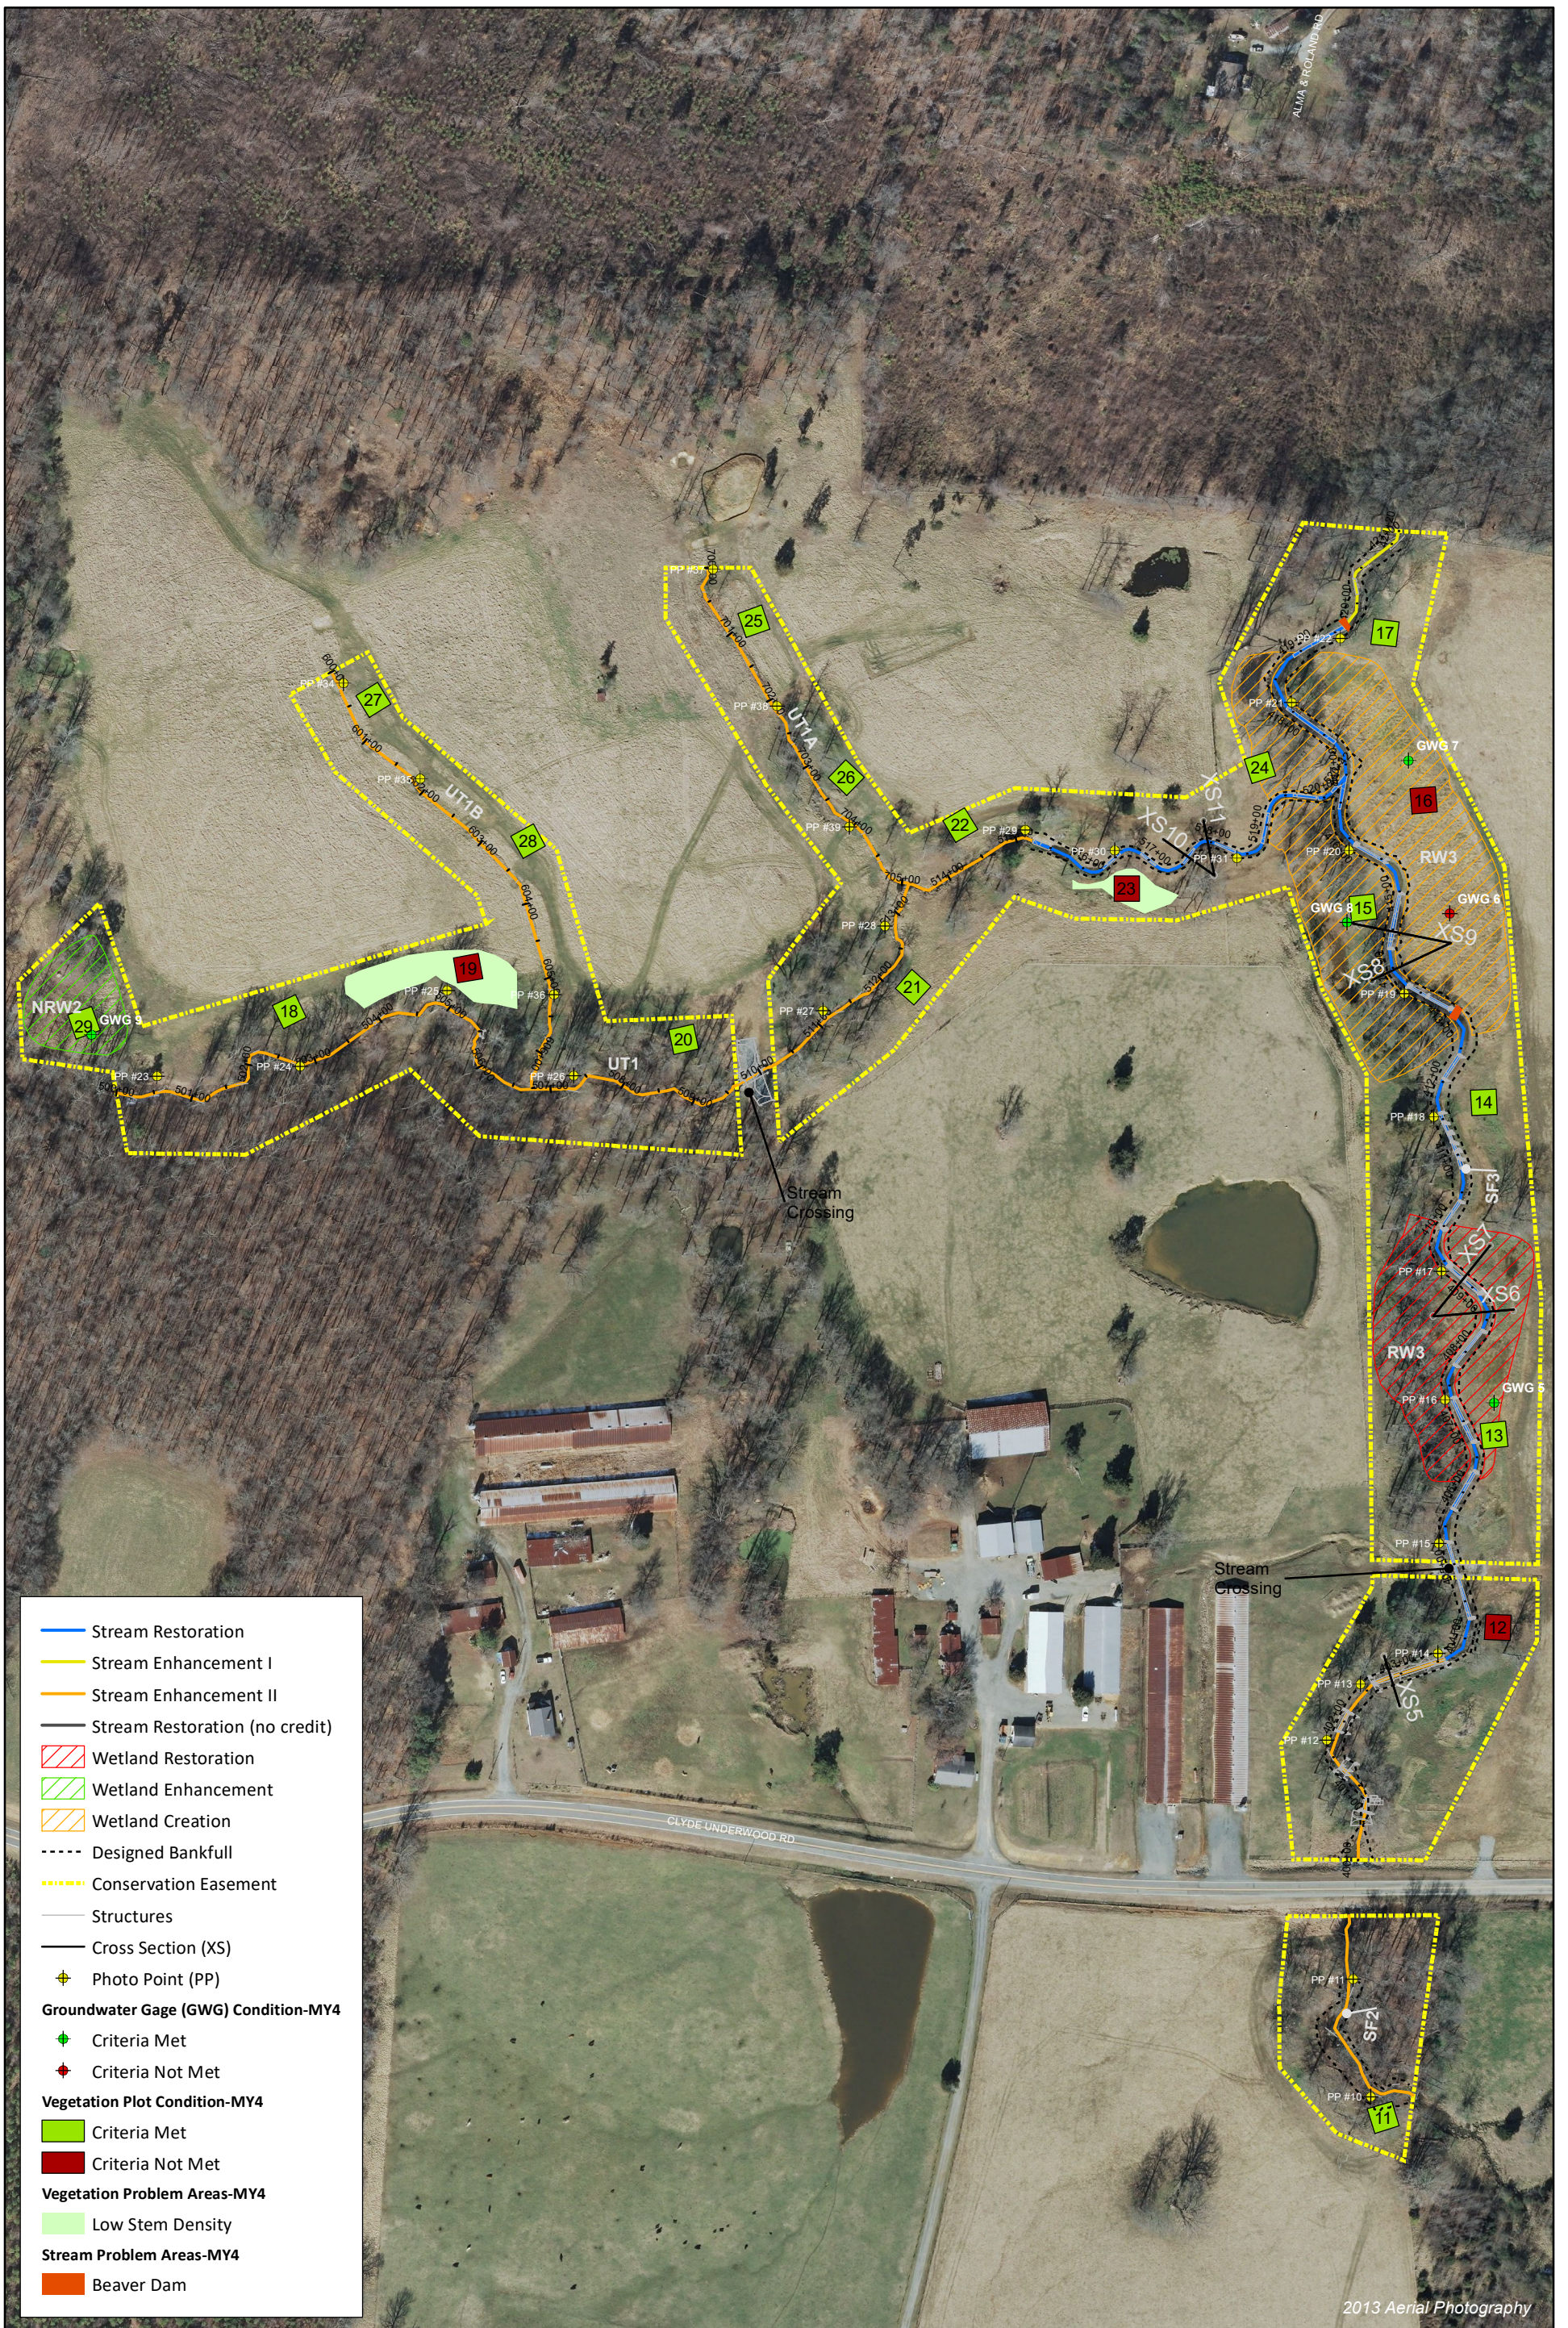
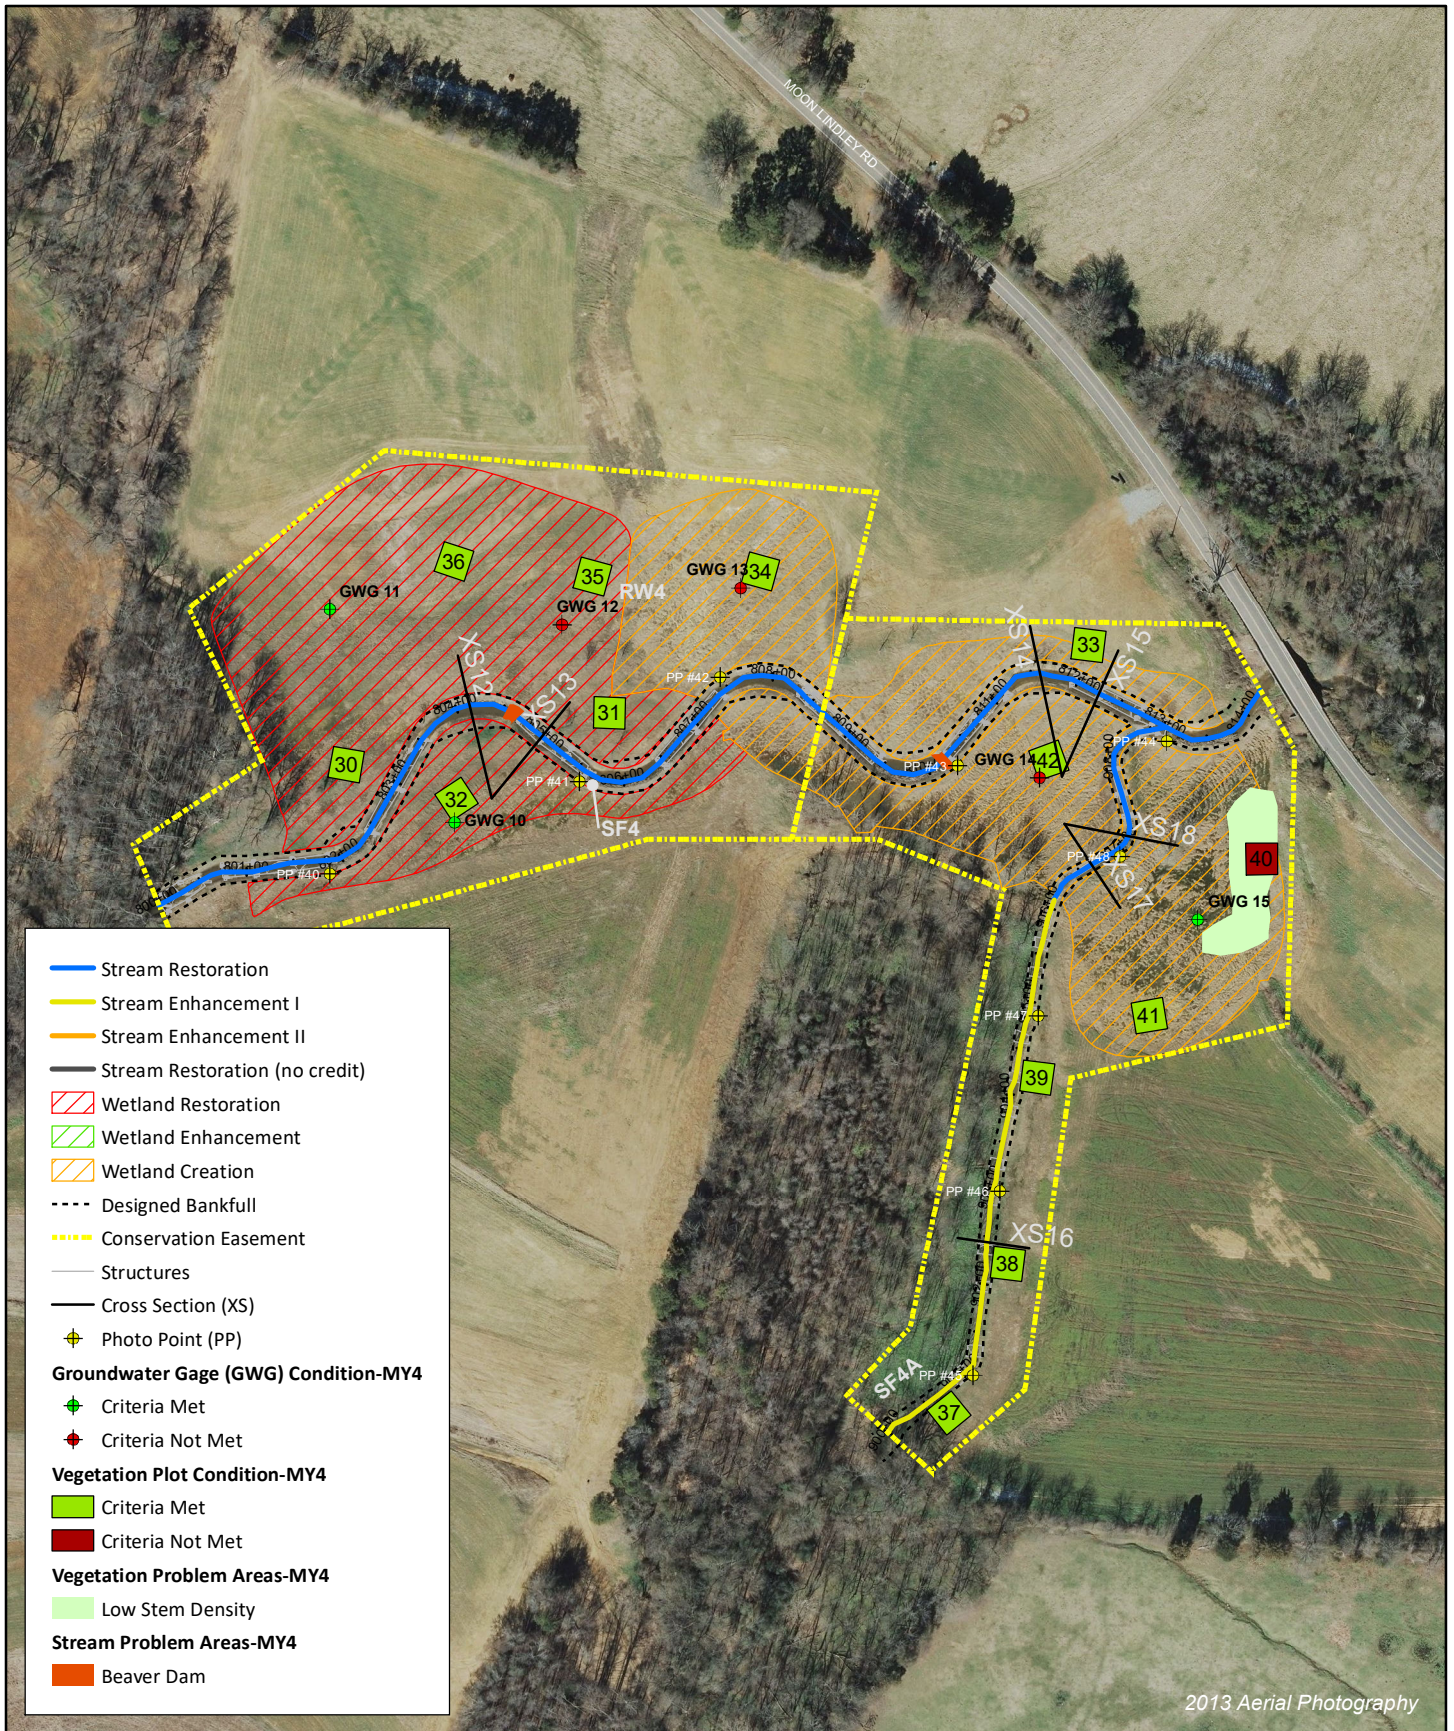
Figure 3.3 Integrated Current Condition Plan View (Sheet 3 of 3)

During MY4 a few isolated areas were observed to have low tree densities. These areas are shown on the CCPV maps (Figures 3.0-3.3 in Appendix 2). Vegetation plots 19, and 23 did not meet the MY4 success criteria as noted above in section 1.2.1. Plot 19 is in a shaded area dominated by mature trees, and plot 23 is in a wet area which has resulted in poor growth of planted stems. Isolated areas with low tree densities will be monitored during subsequent monitoring years.

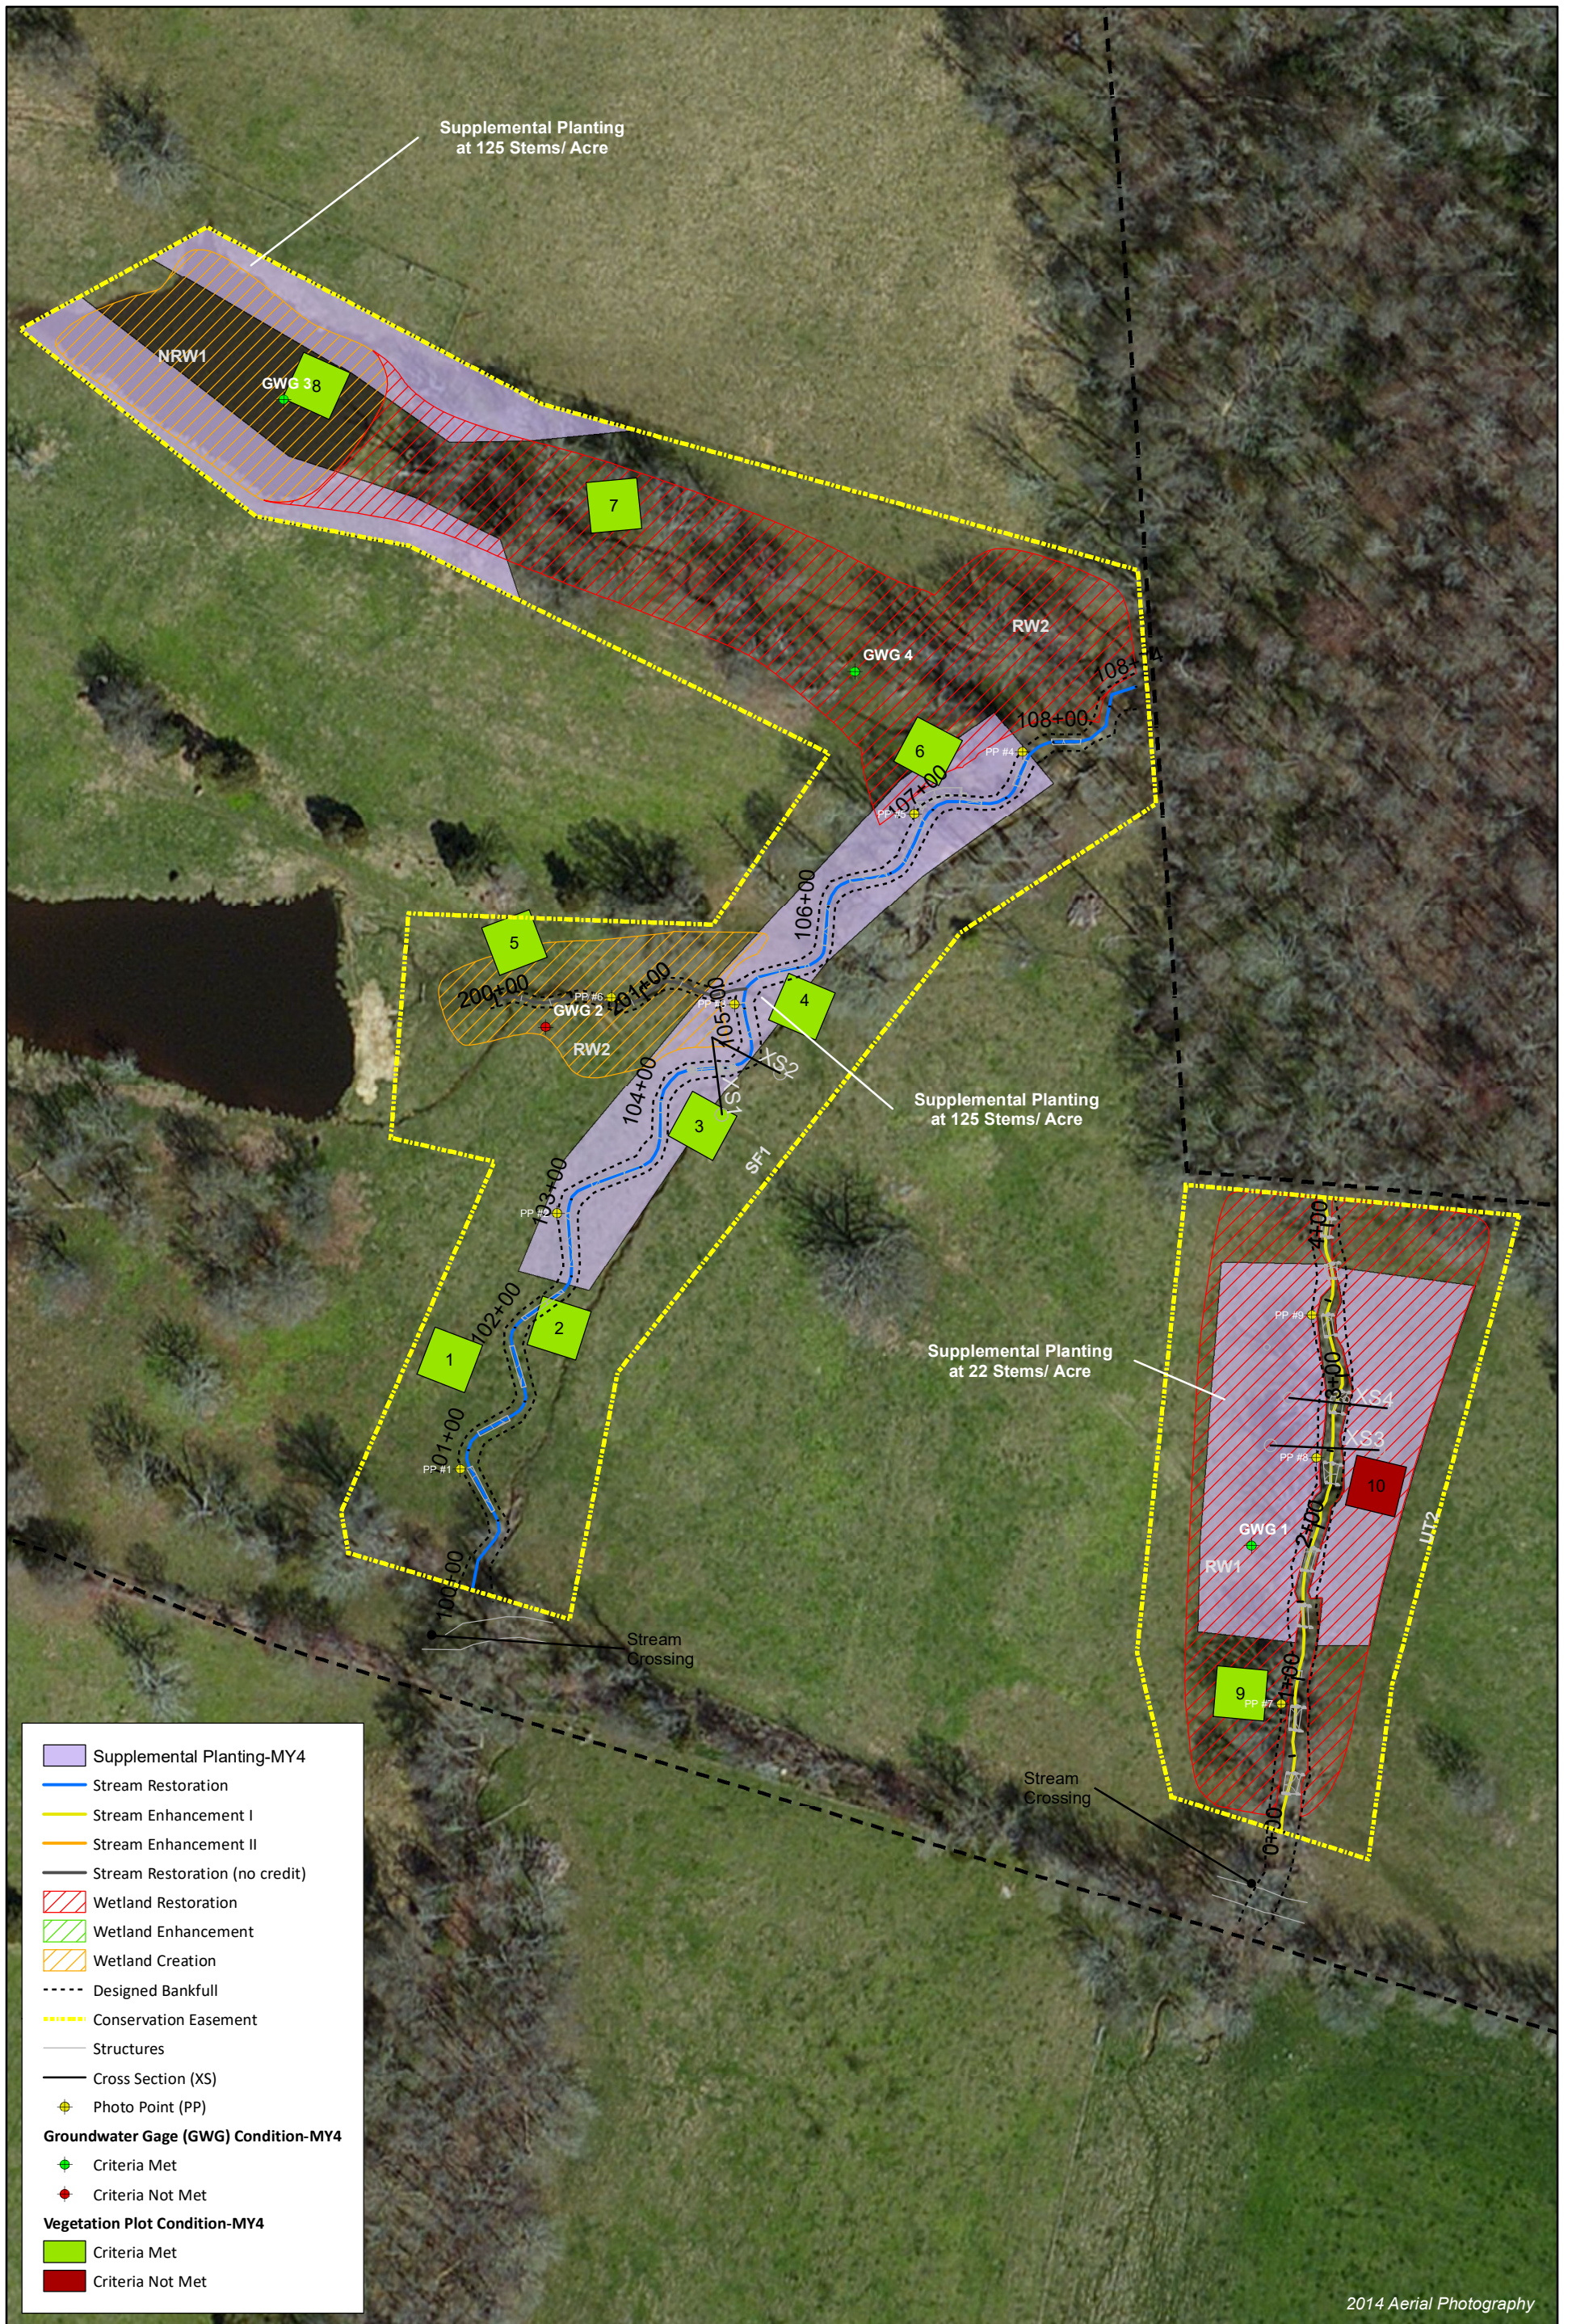
Figure 4.1 Supplemental Planting
 (Sheet 1 of 3)
 Underwood Mitigation Site - Harris Site
 DMS Project No. 94641
 Monitoring Year 4 - 2016
 Chatham County, NC

Early in MY4, supplemental planting was performed in low stem density areas along SF1, UT1, UT1B, and SF4 in areas shown to have low stem densities during MY3 (Figures 4.1-4.3 in Appendix 2). The MY4 vegetative survey was completed in June 2016. The 2016 annual vegetation monitoring resulted in an

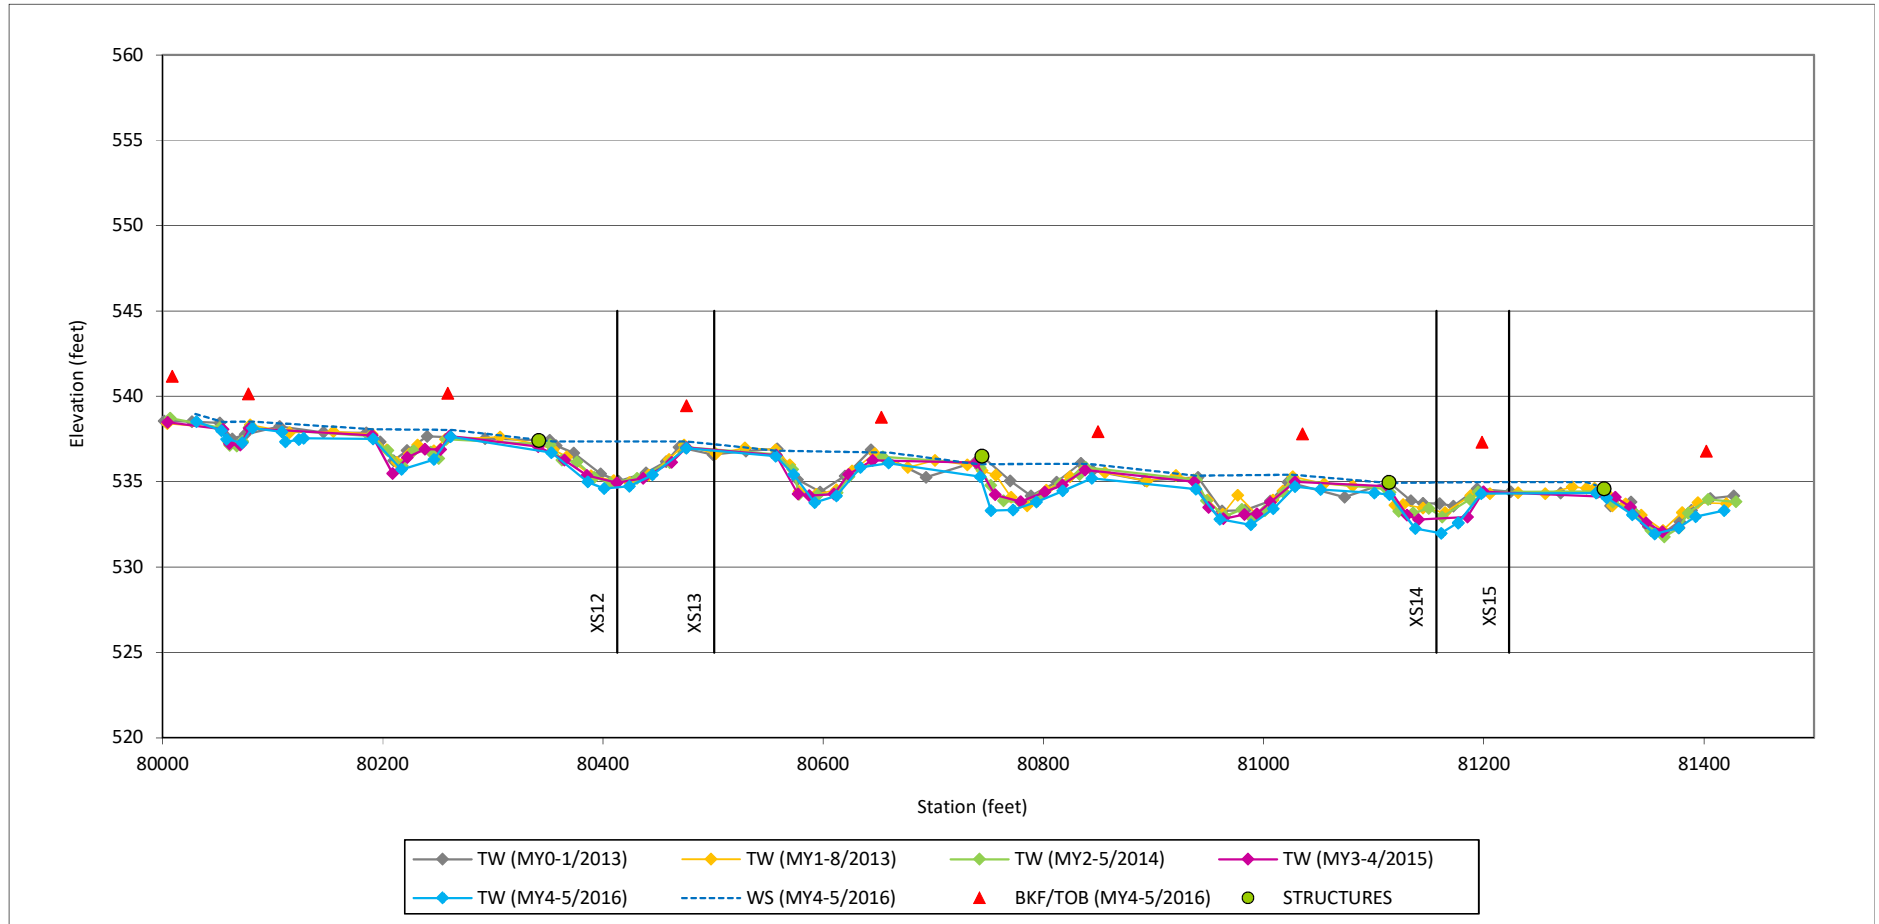
Lindley Site; SF4

¹Number of riffles and pools are determined based on the as-built survey along Restoration and Enhancement Level I reaches. Approximately 533 LF of the stream bed has downcut along SF4A and riffles and pools have shifted downstream. Although these conditions were not intended in the design, the stream has maintained a stable bedform with riffles and pools at a lower elevation.

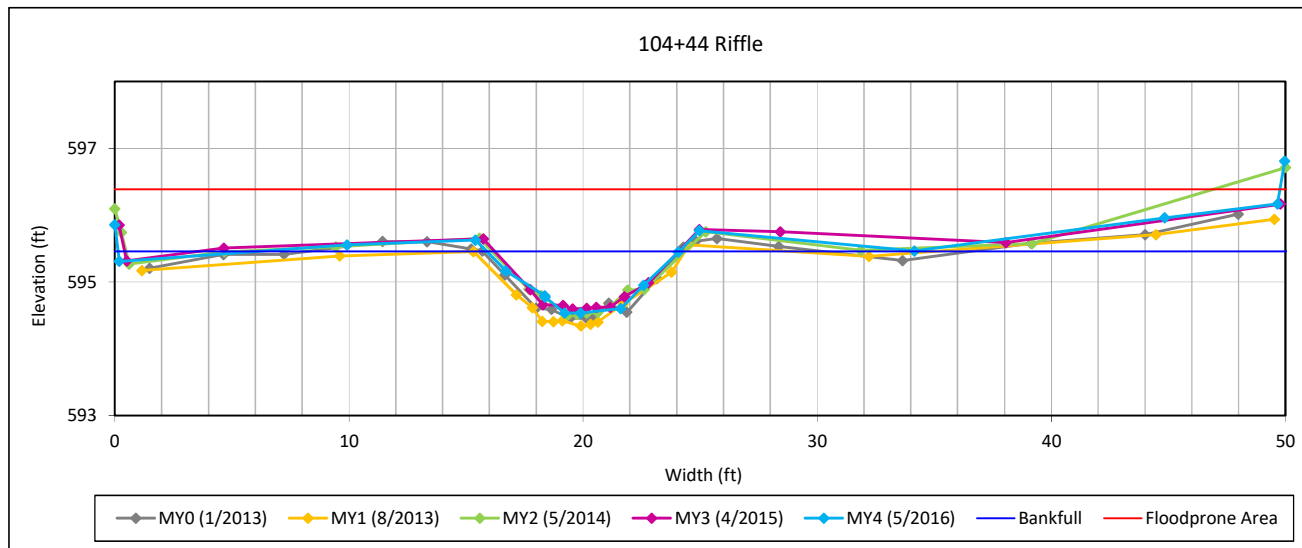
Cross Section 1 - SF1

4.8	x-section area (ft.sq.)
8.2	width (ft)
0.6	mean depth (ft)
0.9	max depth (ft)
8.5	wetted perimeter (ft)
0.6	hyd radi (ft)
14.1	width-depth ratio
50.0	W flood prone area (ft)
6.1	entrenchment ratio
1.0	low bank height ratio

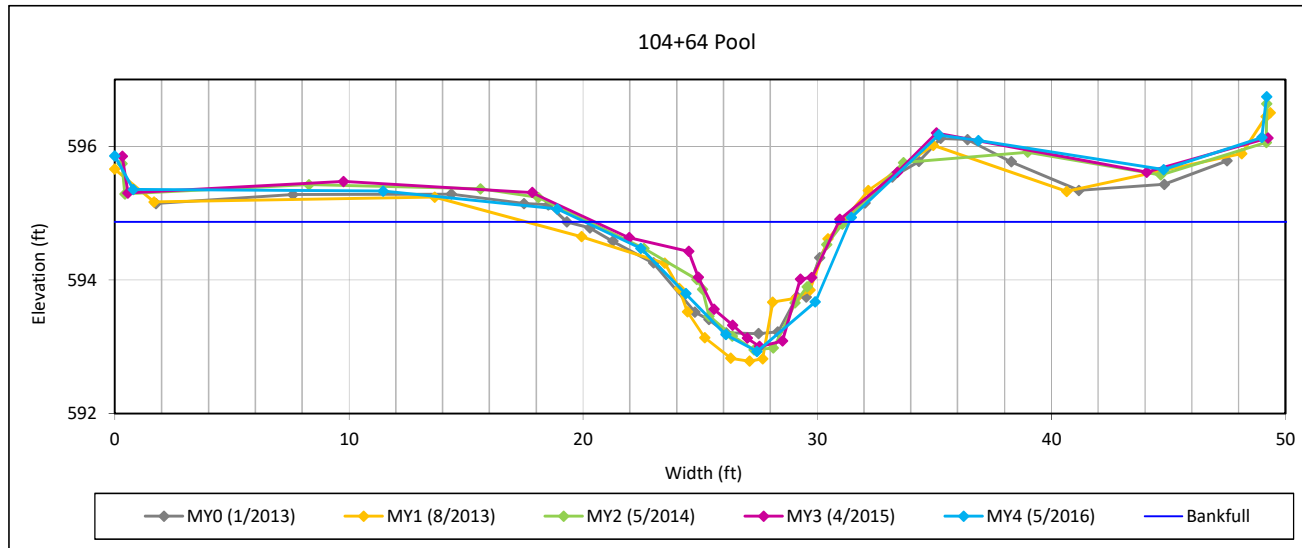
Cross Section 2 - SF1

11.4	x-section area (ft.sq.)
11.3	width (ft)
1.0	mean depth (ft)
1.9	max depth (ft)
12.1	wetted perimeter (ft)
0.9	hyd radi (ft)
11.2	width-depth ratio

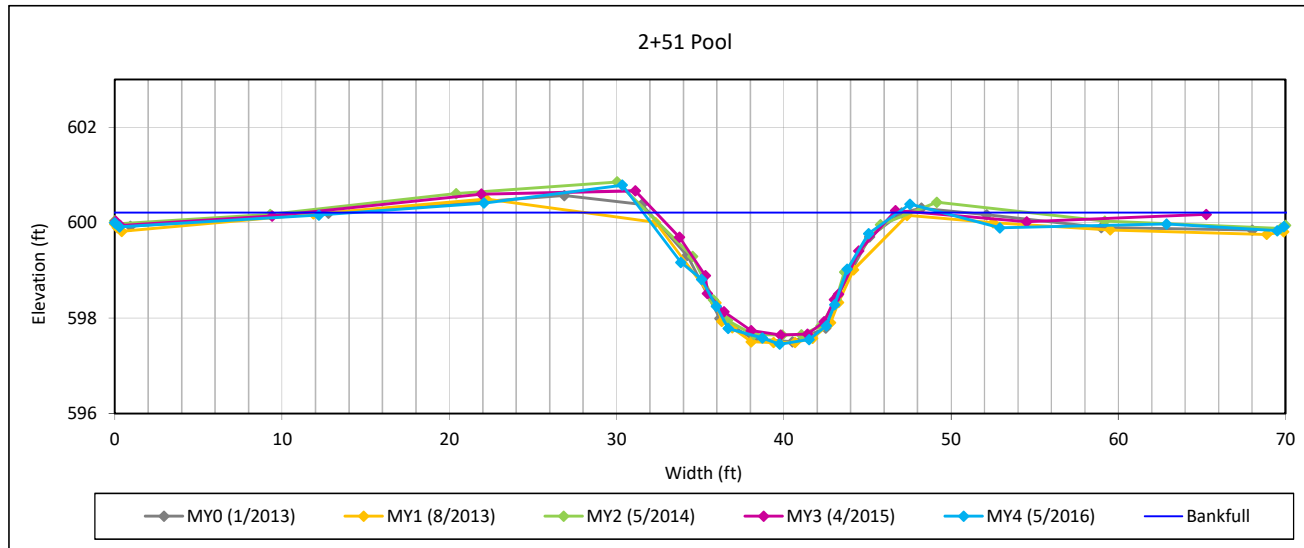
Cross Section 3 - UT2

24.7	x-section area (ft.sq.)
15.2	width (ft)
1.6	mean depth (ft)
2.8	max depth (ft)
16.6	wetted perimeter (ft)
1.5	hyd radi (ft)
9.4	width-depth ratio

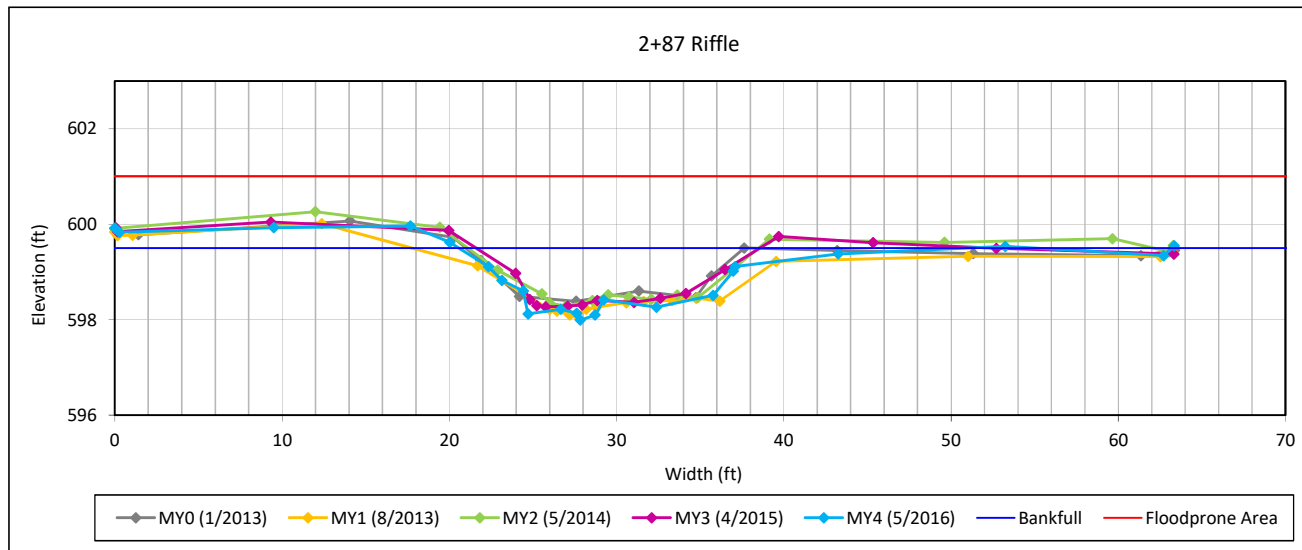
Cross Section 4 - UT2

16.6	x-section area (ft.sq.)
16.5	width (ft)
1.0	mean depth (ft)
1.5	max depth (ft)
17.2	wetted perimeter (ft)
1.0	hyd radi (ft)
16.5	width-depth ratio
200.0	W flood prone area (ft)
12.1	entrenchment ratio
1.0	low bank height ratio

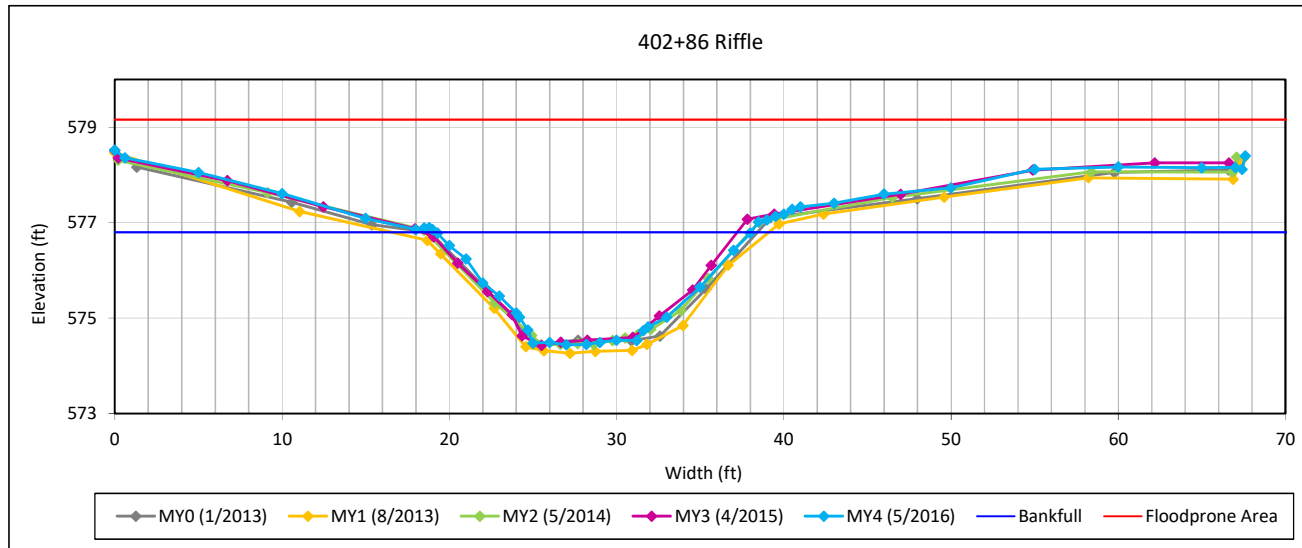
Cross Section 5 - SF3

28.6	x-section area (ft.sq.)
18.8	width (ft)
1.5	mean depth (ft)
2.4	max depth (ft)
19.7	wetted perimeter (ft)
1.4	hyd radi (ft)
12.4	width-depth ratio
100.0	W flood prone area (ft)
5.3	entrenchment ratio
1.0	low bank height ratio
