# MONITORING YEAR 5 ANNUAL REPORT

## UNDERWOOD MITIGATION SITE

Chatham County, NC  
NCDEQ Contract 003268  
DMS Project Number 94641

Data Collection Period: March 2017 - November 2017  
Draft Submission Date: December 5, 2017  
Final Submission Date: January 5, 2018

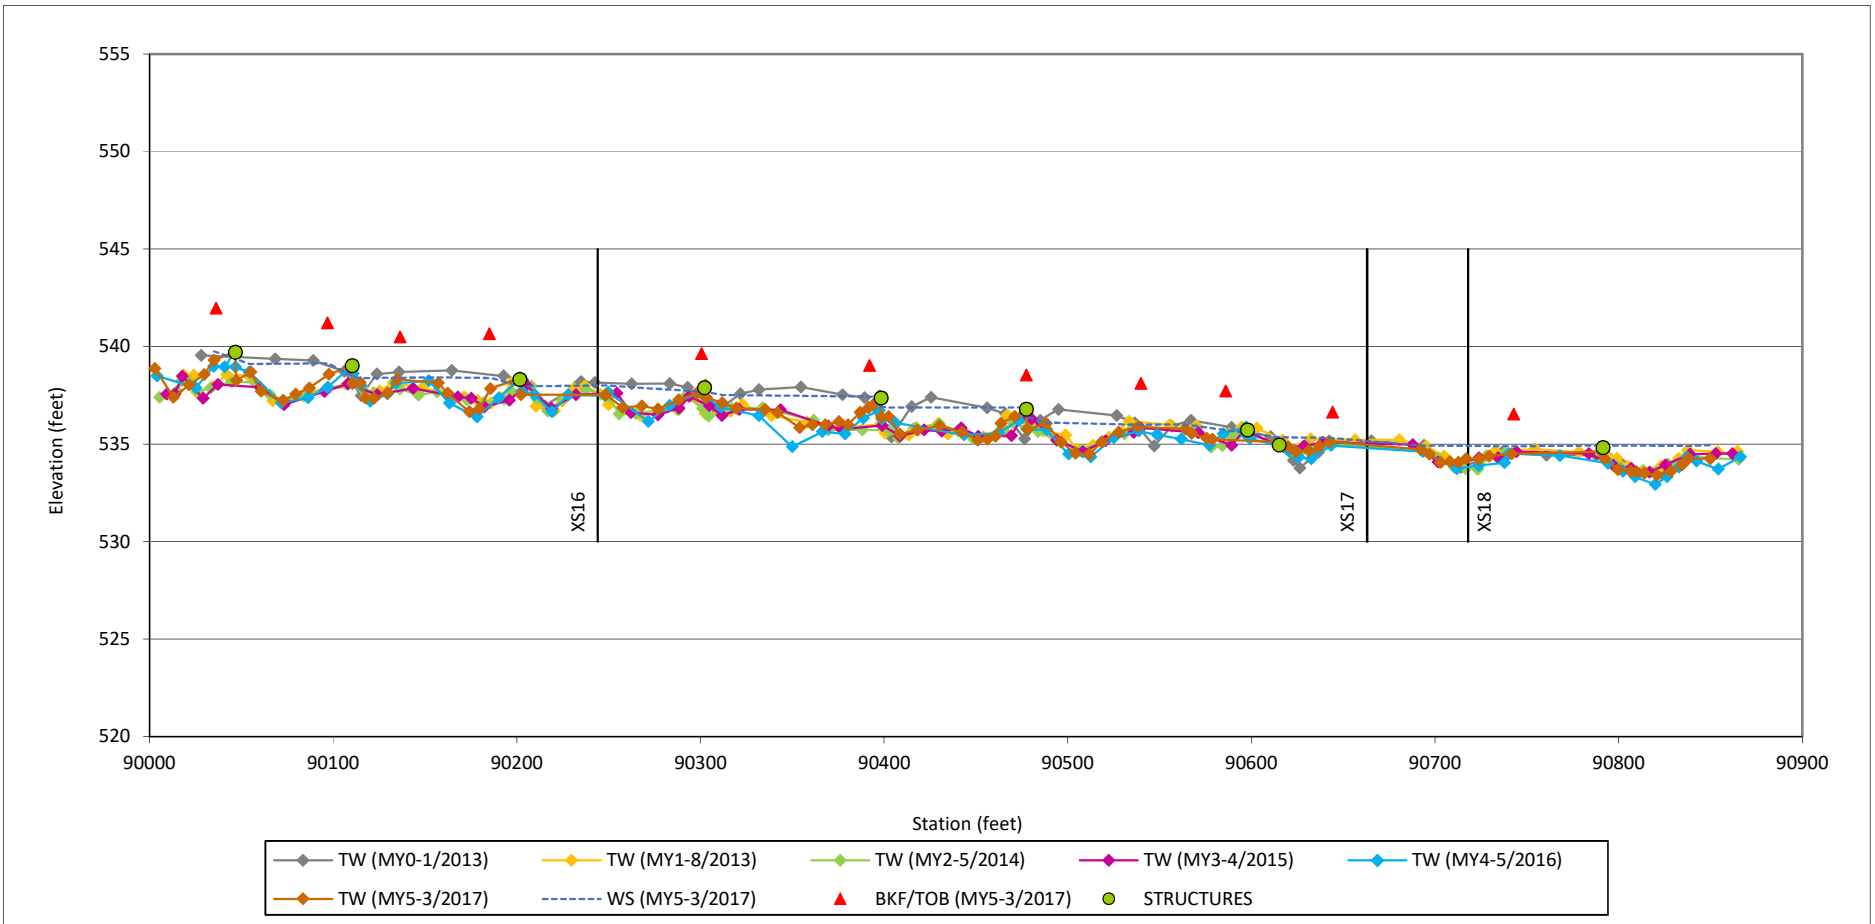
### Lindley Site; SF4A

<sup>1</sup>Number of riffles and pools are determined based on the as-built survey along Restoration and Enhancement Level I reaches. Approximately 533 LF of the stream bed has downcut along SF4A and riffles and pools have shifted downstream. Although these conditions were not intended in the design, the stream has maintained a stable bedform with riffles and pools at a lower elevation.

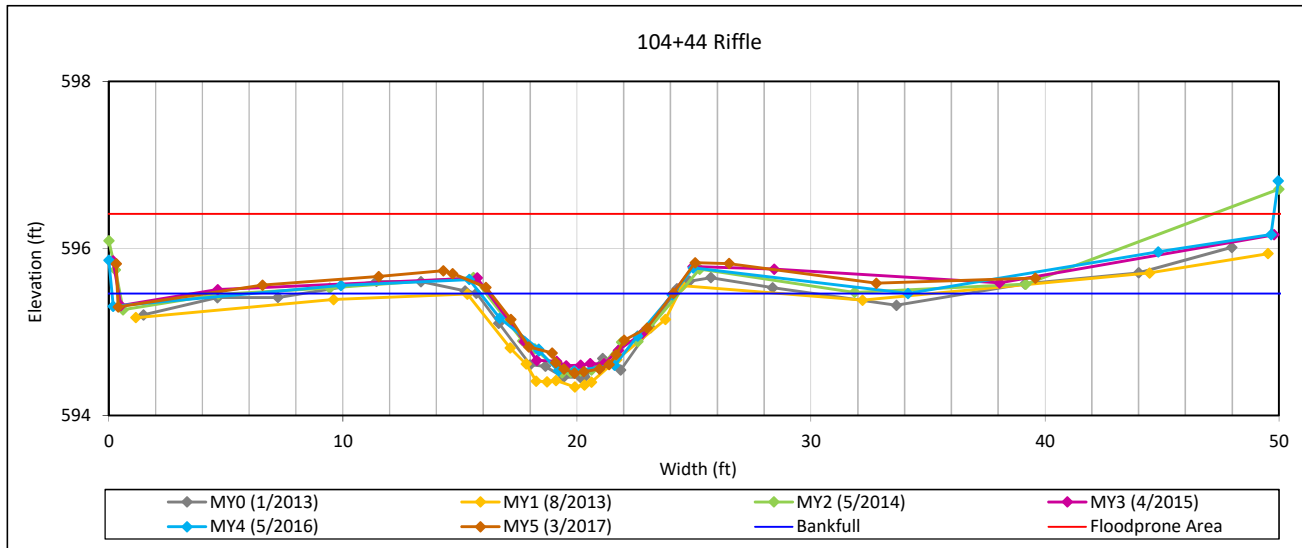
#### Cross Section 1 - SF1

4.5	x-section area (ft.sq.)
7.8	width (ft)
0.6	mean depth (ft)
1.0	max depth (ft)
8.1	wetted perimeter (ft)
0.6	hyd radi (ft)
13.4	width-depth ratio
50.0	W flood prone area (ft)
6.4	entrenchment ratio
1.0	low bank height ratio

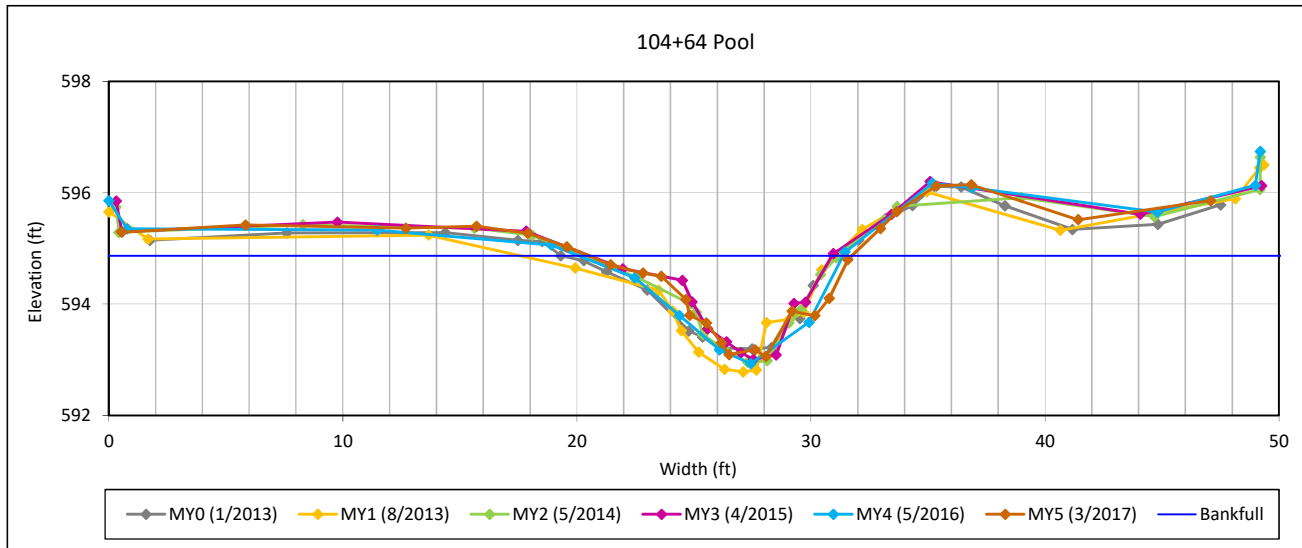
#### Cross Section 2 - SF1

9.9	x-section area (ft.sq.)
11.2	width (ft)
0.9	mean depth (ft)
1.8	max depth (ft)
12.3	wetted perimeter (ft)
0.8	hyd radi (ft)
12.8	width-depth ratio

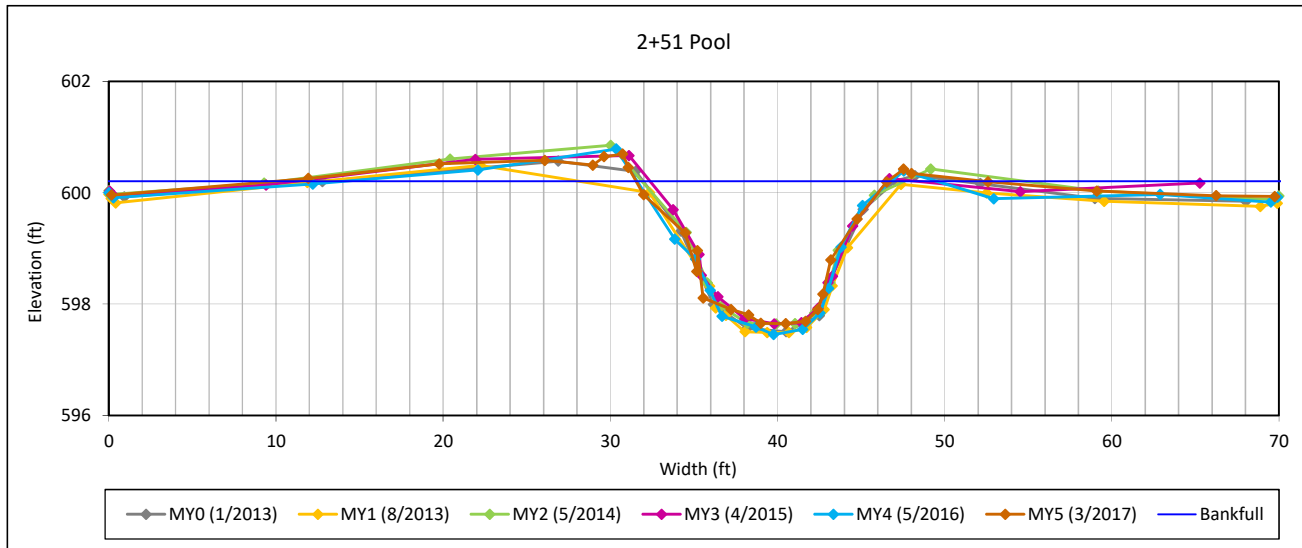
### Cross Section 3 - UT2

23.3	x-section area (ft.sq.)
15.0	width (ft)
1.6	mean depth (ft)
2.6	max depth (ft)
17.2	wetted perimeter (ft)
1.4	hyd radi (ft)
9.7	width-depth ratio

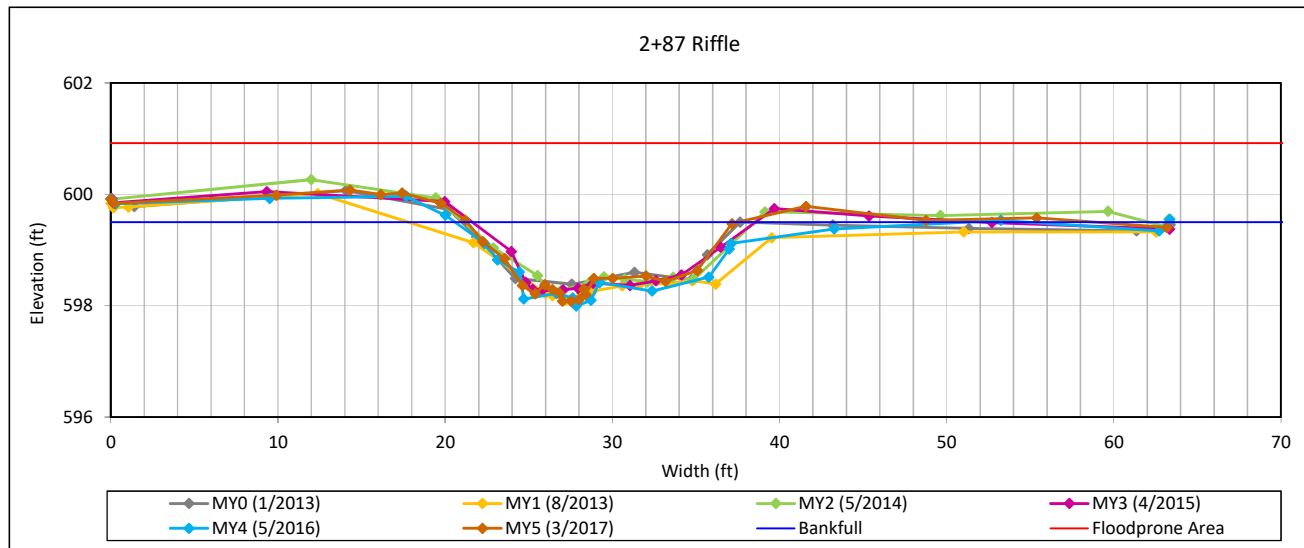
### Cross Section 4 - UT2

14.2	x-section area (ft.sq.)
15.9	width (ft)
0.9	mean depth (ft)
1.4	max depth (ft)
16.5	wetted perimeter (ft)
0.9	hyd radi (ft)
17.7	width-depth ratio
200.0	W flood prone area (ft)
12.6	entrenchment ratio
1.0	low bank height ratio

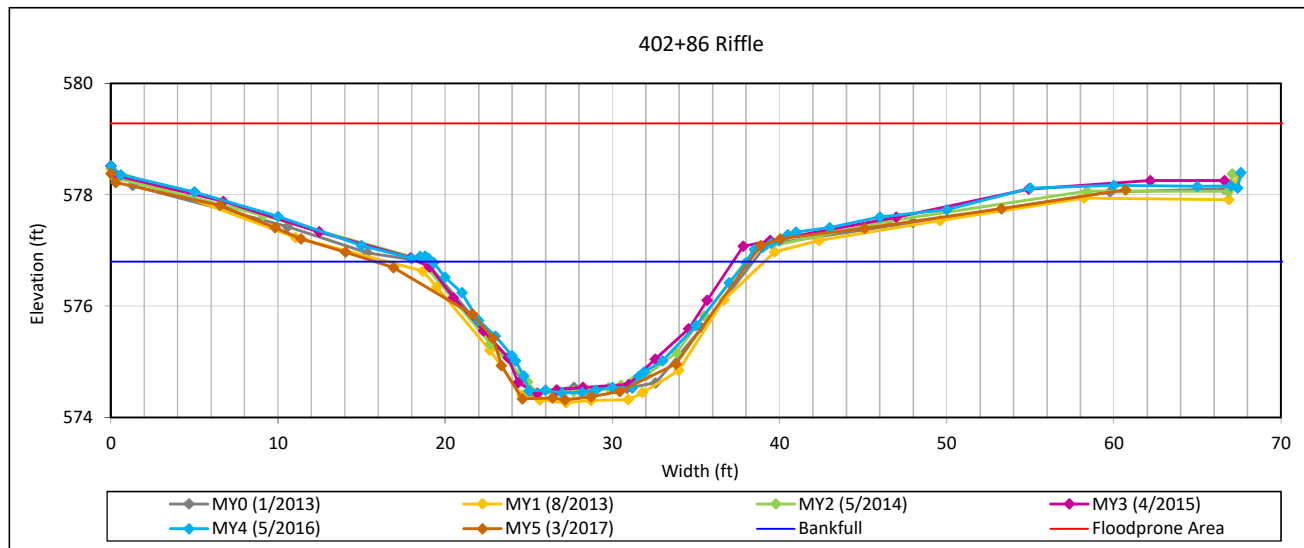
### Cross Section 5 - SF3

32.7	x-section area (ft.sq.)
21.3	width (ft)
1.5	mean depth (ft)
2.5	max depth (ft)
22.2	wetted perimeter (ft)
1.5	hyd radi (ft)
13.9	width-depth ratio
100.0	W flood prone area (ft)
4.7	entrenchment ratio
1.0	low bank height ratio

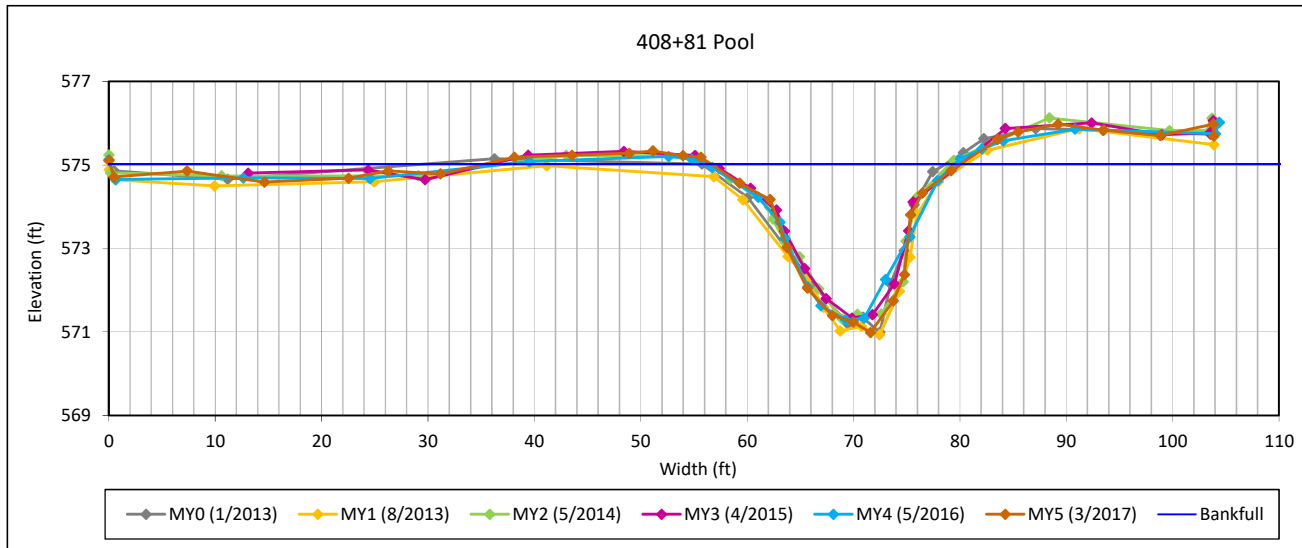
### Cross Section 6 - SF3

45.2	x-section area (ft.sq.)
23.5	width (ft)
1.9	mean depth (ft)
4.0	max depth (ft)
25.7	wetted perimeter (ft)
1.8	hyd radi (ft)
12.2	width-depth ratio

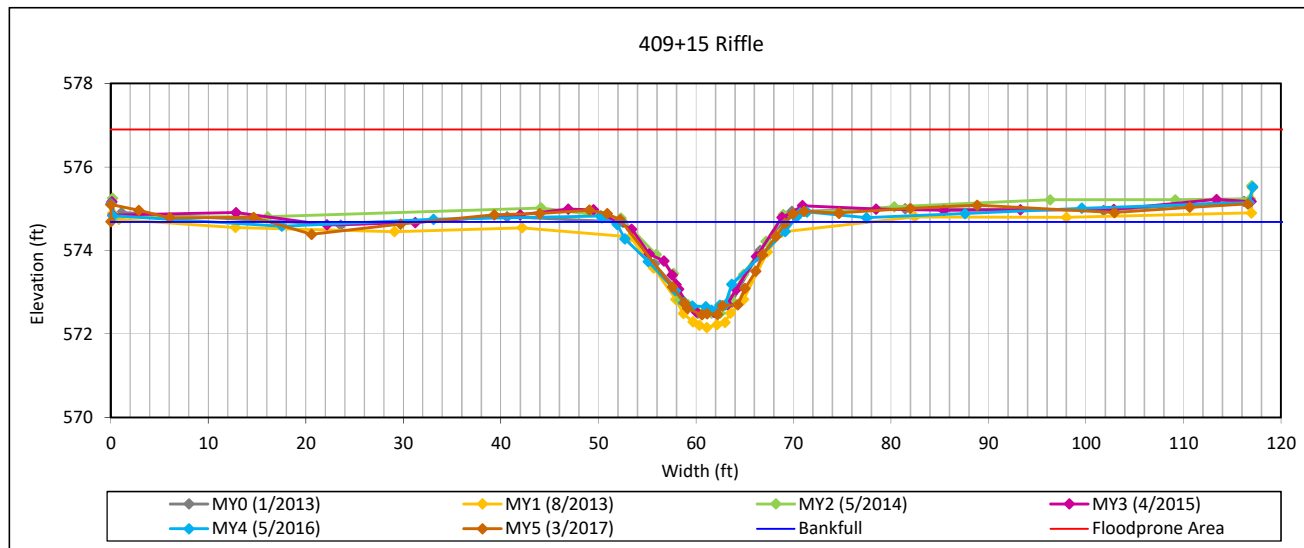
### Cross Section 7 - SF3

22.2	x-section area (ft.sq.)
16.9	width (ft)
1.3	mean depth (ft)
2.2	max depth (ft)
17.6	wetted perimeter (ft)
1.3	hyd radi (ft)
12.8	width-depth ratio
200.0	W flood prone area (ft)
11.9	entrenchment ratio
1.0	low bank height ratio
