Upper Silver Creek Restoration Project Year 1 Monitoring Report

NCDMS Project ID Number – 94645

Submission Date: April 2016

Report Prepared and Submitted by Michael Baker Engineering, Inc.
797 Haywood Road, Suite 201
Asheville, NC 28806

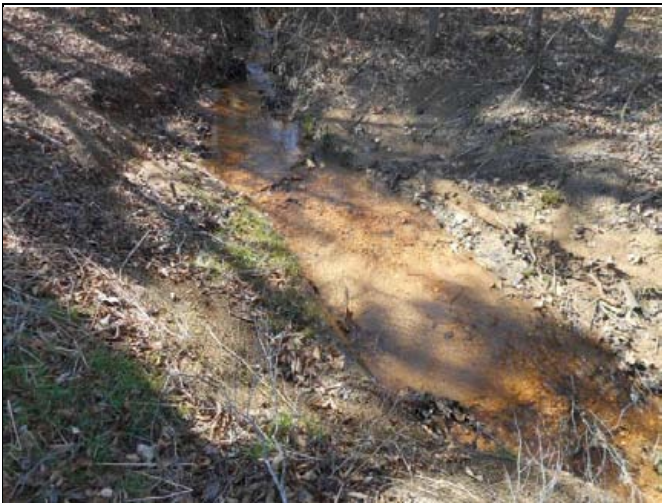
Photo 46. UT3 Photo Point 7 – Station 3+60
(February 2, 2016) upstream to structure.

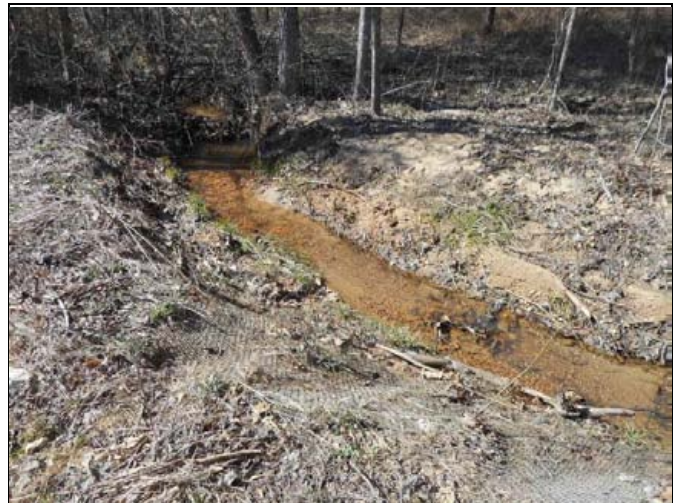
Photo 47. UT3 Photo Point 8 – Station 2+70
(February 2, 2016) upstream to structure.

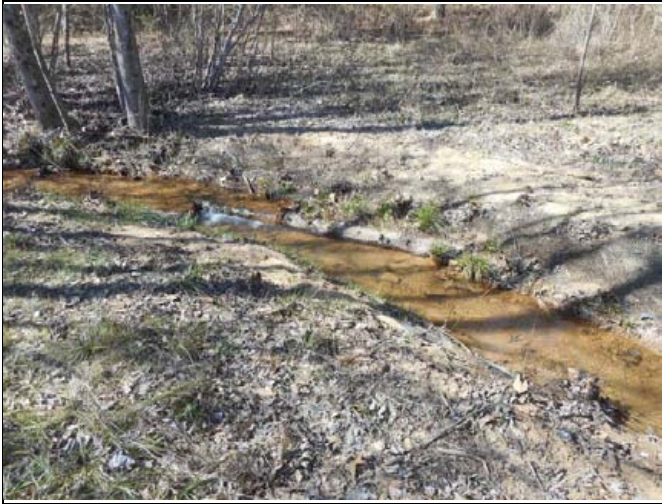
Photo 48. UT3 Photo Point 9 – Station 1+90
(February 2, 2016) upstream to structure.

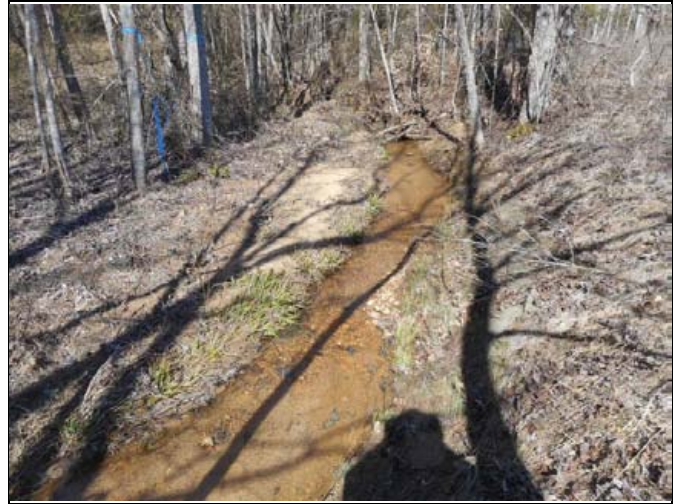
Photo 49. UT3 Photo Point 10 – Station 0+60
(February 2, 2016) downstream to structure.

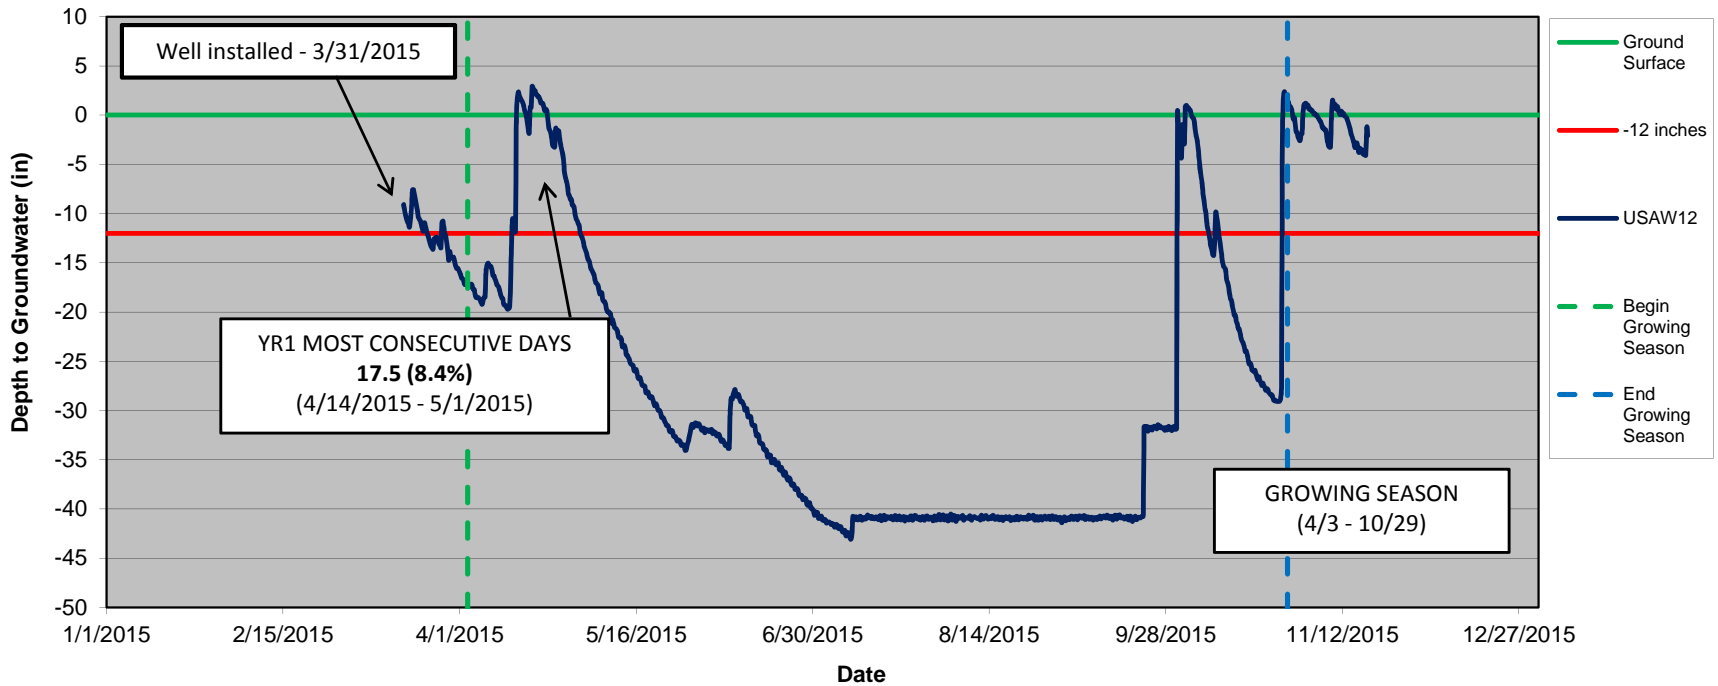
Upper Silver Creek Wetland Restoration Well (USAW12)

Gauge	Success Criteria Achieved/Max Consecutive Days During Growing Season (Percentage)				
	Monitoring Year 1 (2015)	Monitoring Year 2 (2016)	Monitoring Year 3 (2017)	Monitoring Year 4 (2018)	Monitoring Year 5 (2019)
USAW1	Yes/36.5 days (17.5 %)				
USAW2	No/21.8 days (10.5 %)				
USAW3	No/20.3 days (9.7 %)				
USAW4	No/5.5 days (2.6 %)				
USAW5	Yes/80.5 days (38.7 %)				
USAW6	No/19.5 days (9.4 %)				
USAW7	Yes/74.5 days (35.8 %)				
USAW8	No/2.5 days (1.2 %)				
USAW9	Yes/35.5 days (17.1 %)				
USAW10	No/19.8 days (9.5 %)				
USAW11	No/18.5 days (8.9 %)				
USAW12	No/17.5 days (8.4 %)
