Subject: Response to DMS comments on the Year 3 Monitoring Report Review for the Upper Silver Creek Stream and Wetland Restoration Project; Catawba River Basin - CU# 03050101; Burke County, North Carolina; NCEEP Project # 94645; Contract No. 003270

Burke County, North Carolina
NCDMS Project ID Number – 94645

Figure 2 - Overview
Current Conditions Plan View
Monitoring Year 3
Upper Silver Creek Site

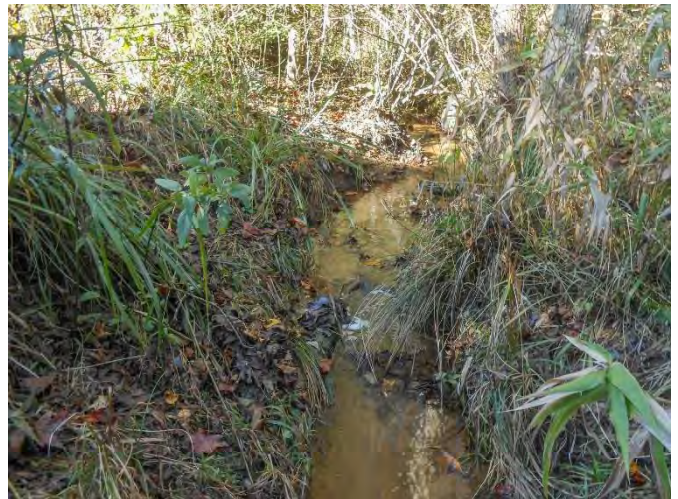
Photo 47. UT3 Photo Point 8 – Station 2+70
(October 18, 2017) upstream to structure.

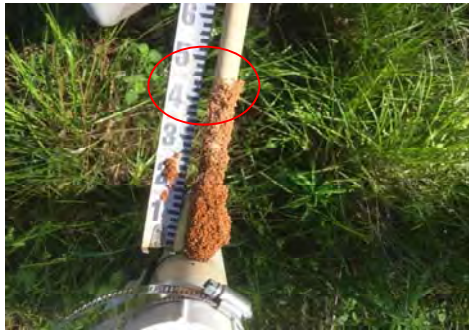
Photo 1. Silver Creek mainstem crest gauge staff showing cork deposition in red circle at 0.45' above the bottom of the staff, which is at the bankfull elevation. (5/2/2017)

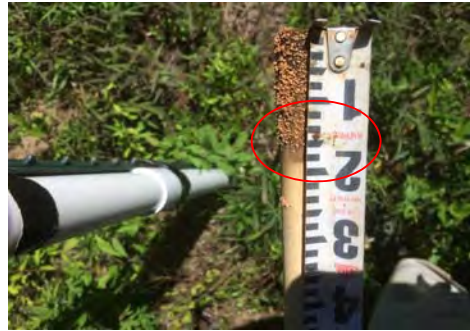
Photo 2. UT3 crest gauge staff showing cork deposition in red circle at 0.25' above the bottom of the staff, which is at the bankfull elevation (5/2/2017).

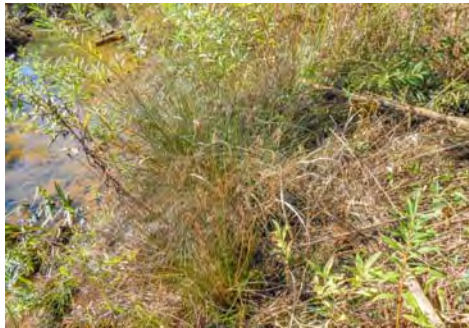
Photo 3. Silver Creek stream bank showing accumulated debris of wrack line and bent over vegetation well above bankfull. Verifies crest gauge measurement. (11/1/2017)

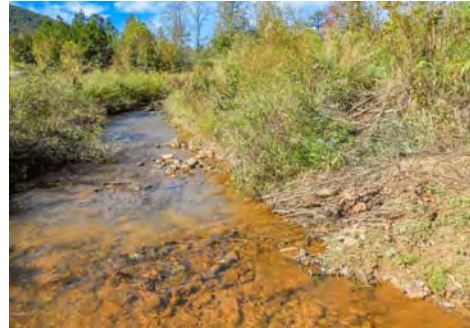
Photo 4. Silver Creek stream bank showing accumulated debris of wrack line and bent over vegetation well above bankfull. Verifies crest gauge measurements (11/1/2017).

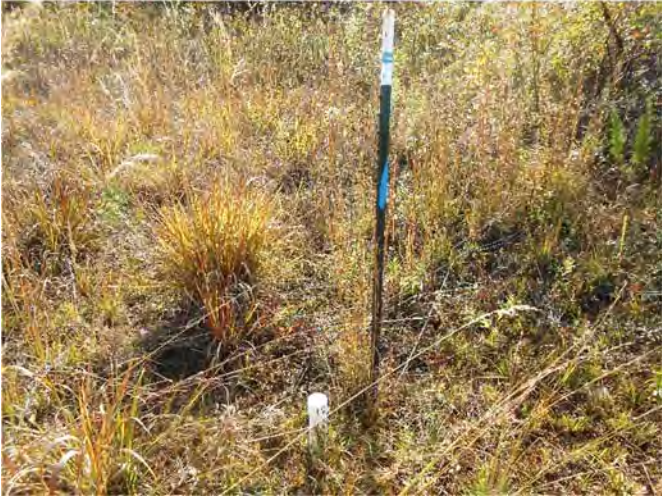
Photo 13. Wetland Photo Point – W13 added between time of baseline and MY1 survey, (April 1, 2015)
