Subject: Response to DMS comments on the Year 5 Monitoring Report Review for the Upper Silver Creek Stream and Wetland Restoration Project; Catawba River Basin - CU# 03050101; Burke County, North Carolina; NCEEP Project # 94645; Contract No. 003270

Figure 2 - Overview
Current Conditions Plan View
Monitoring Year 5
Upper Silver Creek Site

**Figure 4. Vegetation Monitoring Plot Photos
Upper Silver Creek - DMS Project #94645**

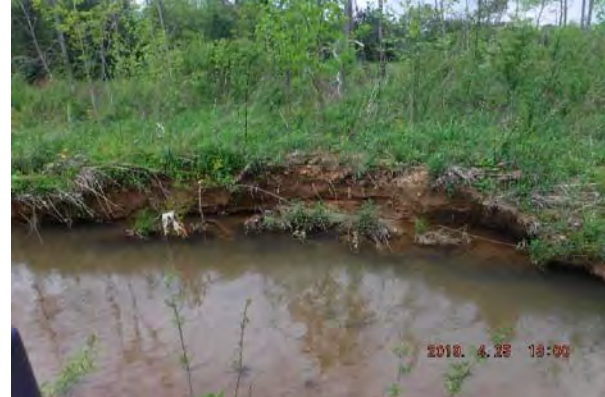
Table 8a. Stream Problem Areas			
Upper Silver Creek Mitigation Project, NCDMS Project No. 94645			
Sink Hole Creek and Uts			
Feature Issue	Station No.	Suspected Cause	Photo Number
J-hook Arm Piping.	23+00	Loss of back fill and fabric that seals the arm. This problem area was first noted in MY3 and has continued during MY5. While not fully functioning as a vane it is providing good habitat, is turning water to the thalweg and is stable.	Photo #1
Bank Erosion	6 + 50	Bank erosion along outside of menader bend. Not completely stable but significantly better than first noted in MY3 and gradually revegetating.	Photo #2 & #3

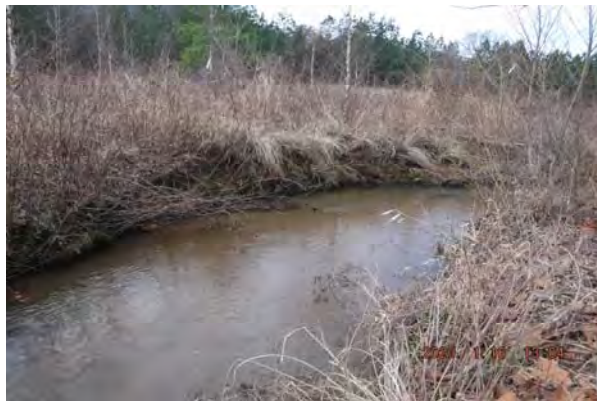
Photo #2: April of 2019.

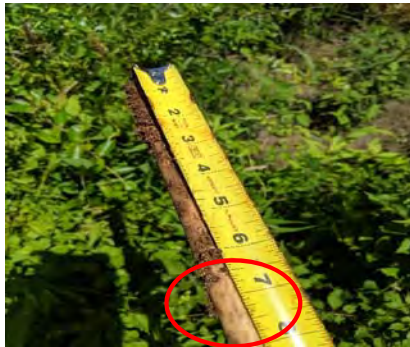
Photo 1. Silver Creek mainstem crest gauge staff showing cork deposition in red circle at 7.25" above the bottom of the staff, which is at the bankfull elevation (6/11/2019)

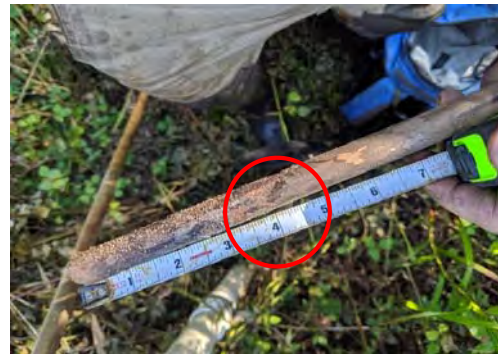
Photo 2. Silver Creek mainstem crest gauge staff showing cork deposition in red circle at 4.25" above the bottom of the staff, which is at the bankfull elevation (9/4/2019)

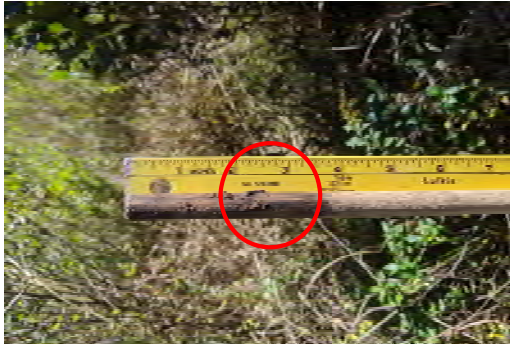
² Crest gauge along UT3 was impacted by an ant hill and did not record all bankfull events. The crest gauge was cleaned out repeatedly and refilled with cork in 2019 but the ant hill was rebuilt from cork from the crest gauge, so the events documented on 6/11/2019 and 9/4/2019 at the mainstem gauge, were not recorded on this gauge.

Photo 3. UT3 crest gauge staff showing cork deposition in red circle at 2.5" above the bottom of the staff, which is at the bankfull elevation (10/17/2019)
