**Baseline Monitoring Document
and
As-built (MY0) Baseline Report**

**Upper South Hominy Mitigation Site,
South Hominy Creek, French Broad River Basin,
Buncombe County, North Carolina**

EEP Project Number: 92632
Contract Number: D06082; Task Order: 08 FB05-1b-d

Data Collected: November 2011-February 2012
Submitted: 30 April 2013

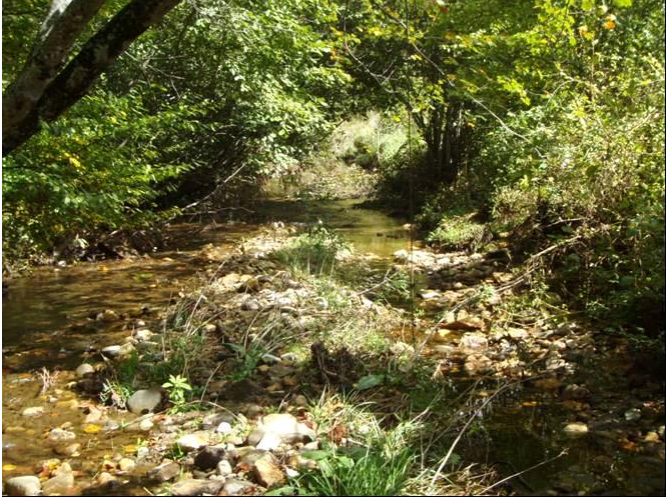
Photo Station 1

Mid channel bar, sta. 0+50, facing downstream, pre-construction. 30 September 2008.

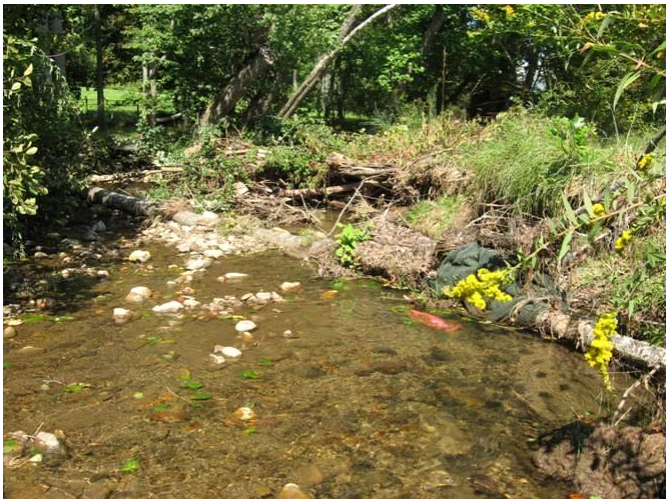
Photo Station 2

Channel blockage, sta.2+50, facing downstream, pre-construction, 30 September 2008.

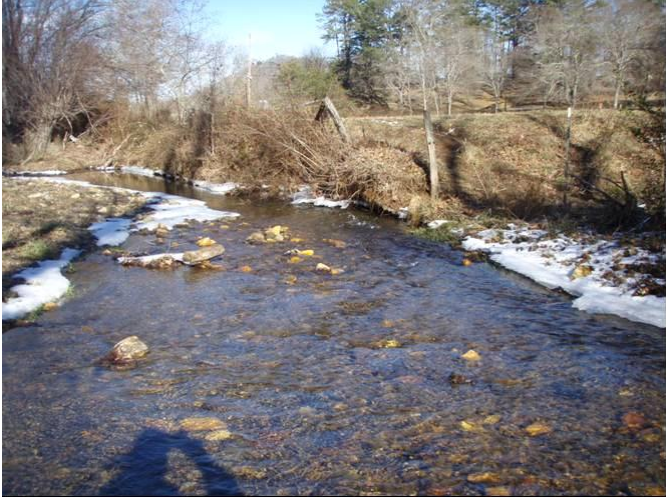
Photo Station 14

Outside meander bend bank stress, sta. 7+25 to 8+00, facing downstream, 22 January 2009.

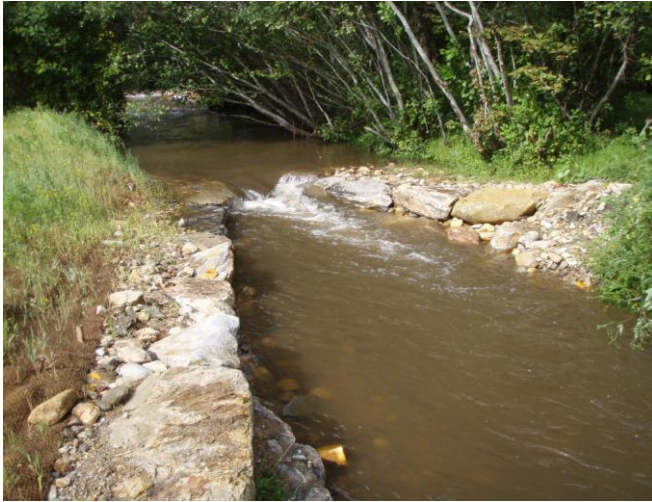
Problem Area 1

Stream Problem Areas Upper South Hominy (EEP project number 92632)			
Feature/Issue	Reach / Station	Suspected Cause	Photo Number
Aggradation/Bar Formation	Mainstem 1 - 2+25 to 2+75	flood event	Figure B.6, PA3
	Mainstem 2 – 9+00 to 9+50	flood event	Figure B.6, PA4
Bank Scour	Mainstem 1 – 1+75 to 2+25	flood event	Figure B.6, PA2
Engineered structures	Mainstem 1 - 1+50	flood event	Figure B.6, PA1

Rock vane after construction, sta. 1+50, facing upstream, 5 September 2011.

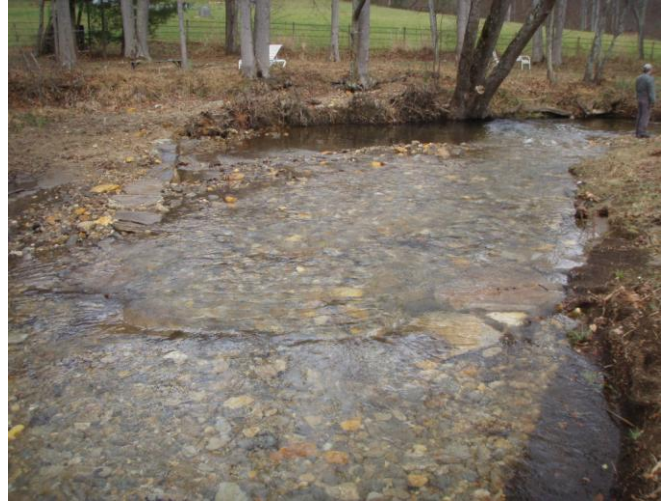
Aggradation and bar formation in meander below J-hook after flood event, 5 December 2012.

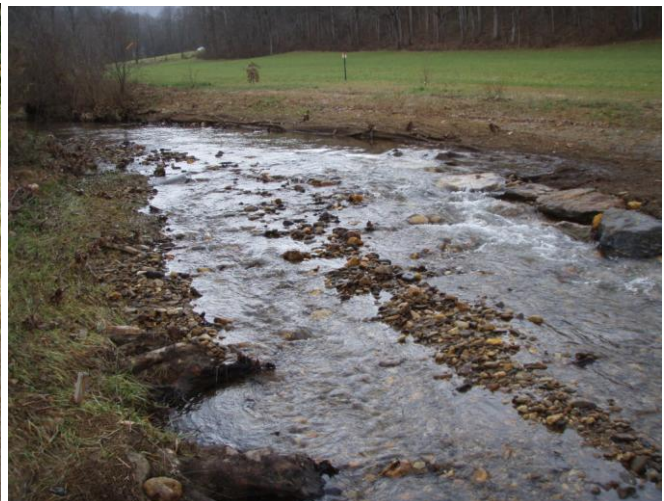
Aggradation and bar formation in below J-hook after flood event, 5 December 2012.
