# Monitoring Year 1 Report

## Upper South Hominy Mitigation Site, South Hominy Creek, French Broad River Basin, Buncombe County, North Carolina

EEP Project Number: 92632  
Contract Number: D06082; Task Order: 08 FB05-1b-d

Data Collected: October 2012-November 2012  
Submitted: 7 February 2014

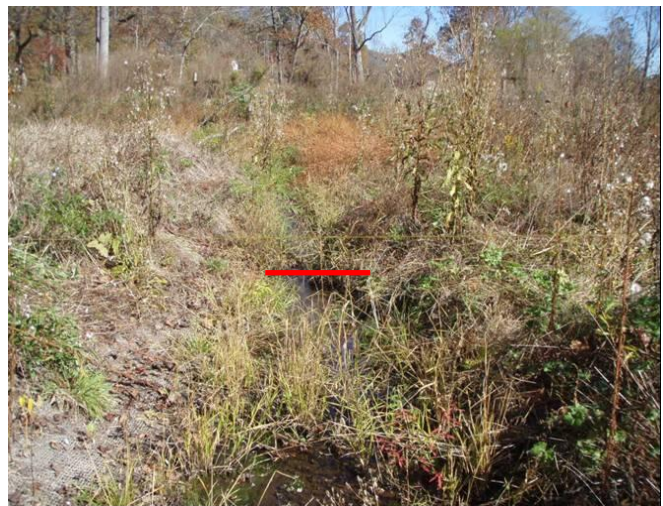
Cross-section 1, UT2 facing downstream, 24 October 2012, MY1.

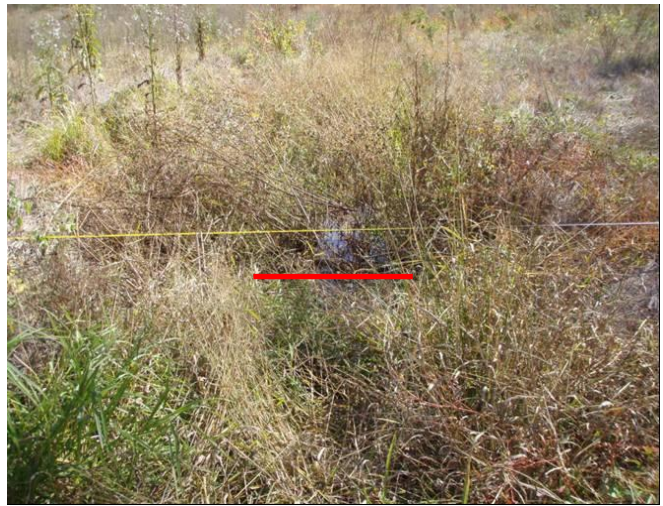
Cross-section 1, UT3 facing downstream, 24 October 2012, MY1.

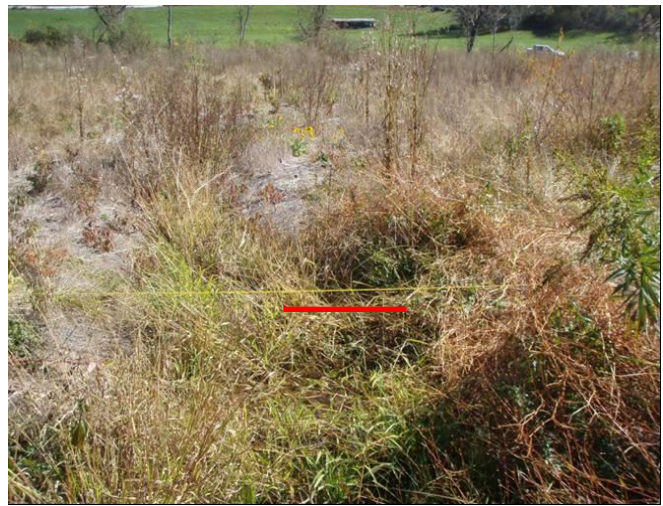
Cross-section 2, UT3 facing downstream, 24 October 2012, MY1.

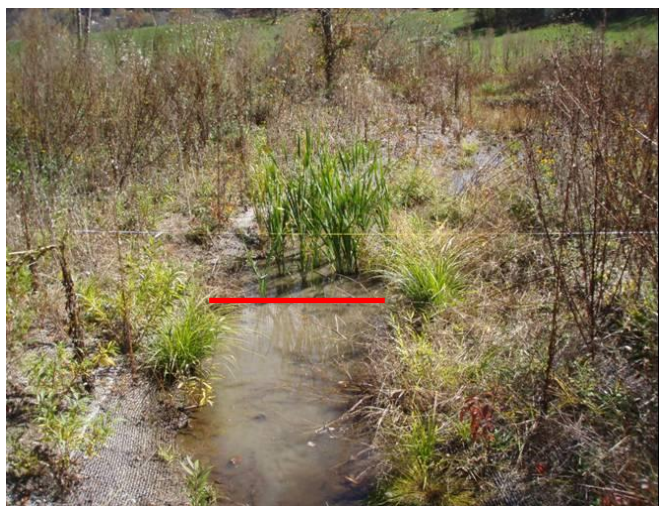
Cross-section 3, UT3 facing downstream, 24 October 2012, MY1.

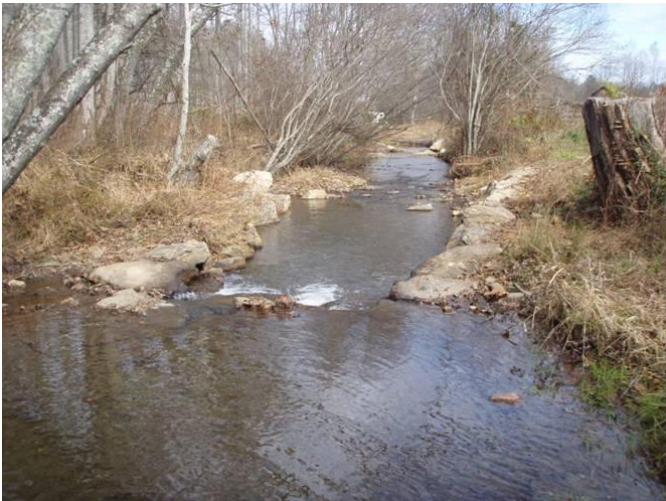
Cross vane, sta. 0+50, facing downstream, 20 November 2012.

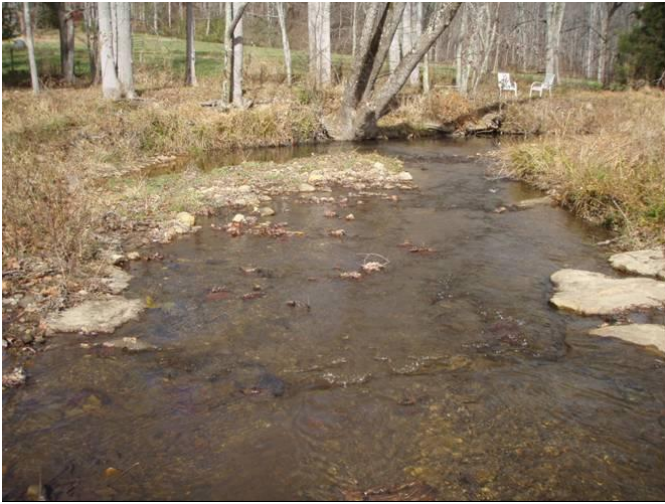
J-hook, sta. 2+50, facing downstream, 20 November 2012.

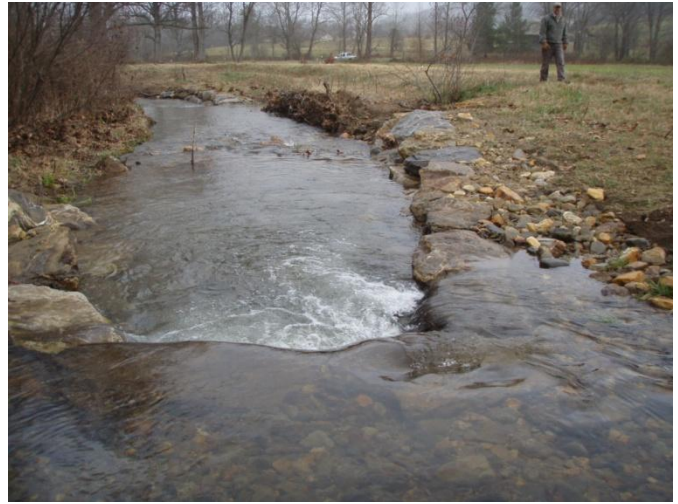
J-hook, sta. 5+00, facing downstream, 5 December 2011.

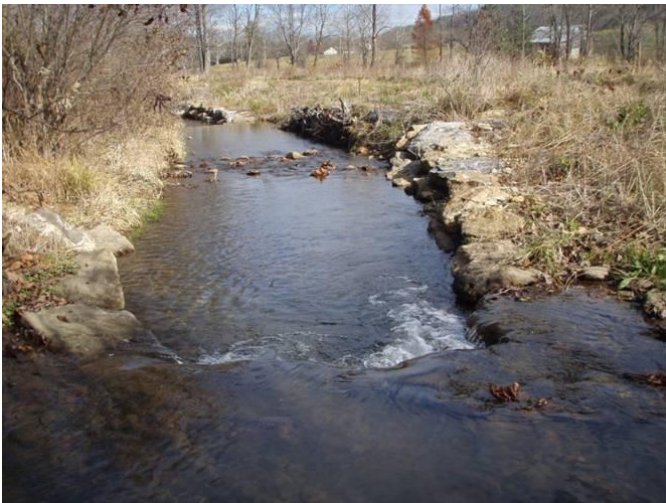
J-hook, sta. 5+00, facing downstream, 20 November 2012.

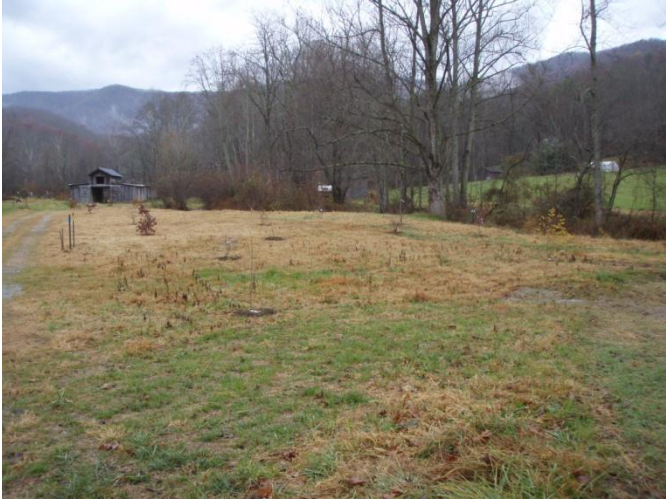
Photo Station 4

Sta. 6+50 to 8+00, right bank facing upstream, 5 December 2011.

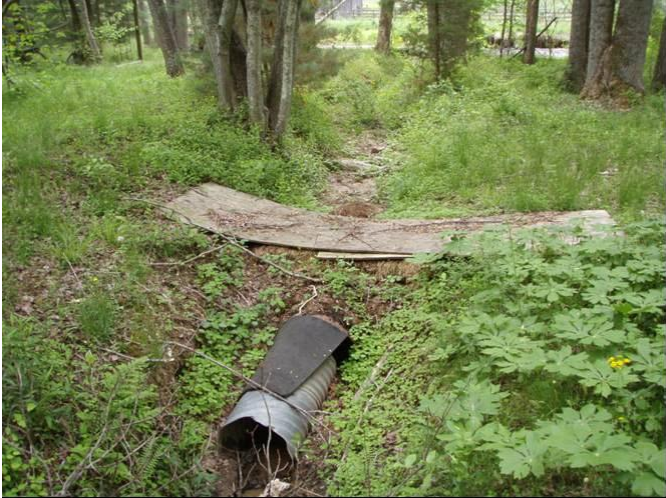
Photo Station 6

UT1 facing downstream, pre-construction 28 July 2009.

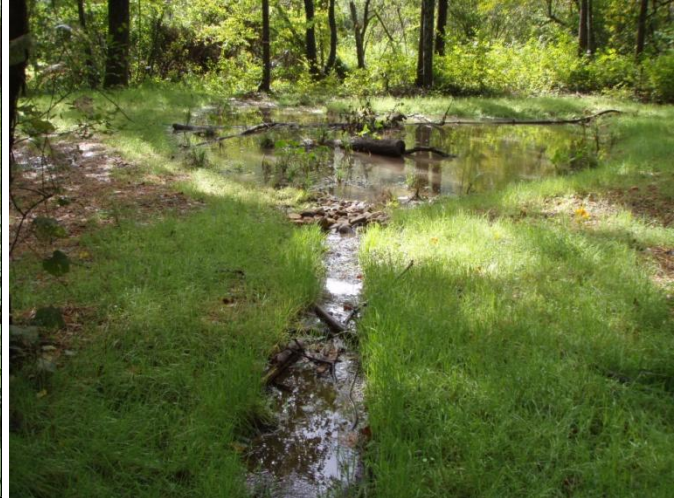
UT1 Priority I channel construction, above vernal pond, 5 September 2011.

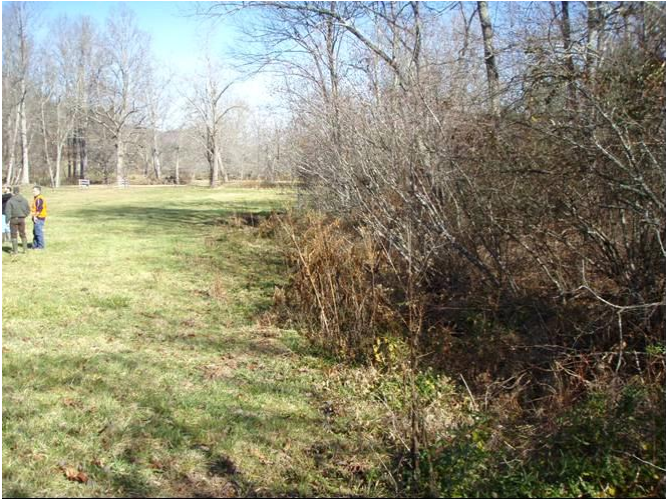
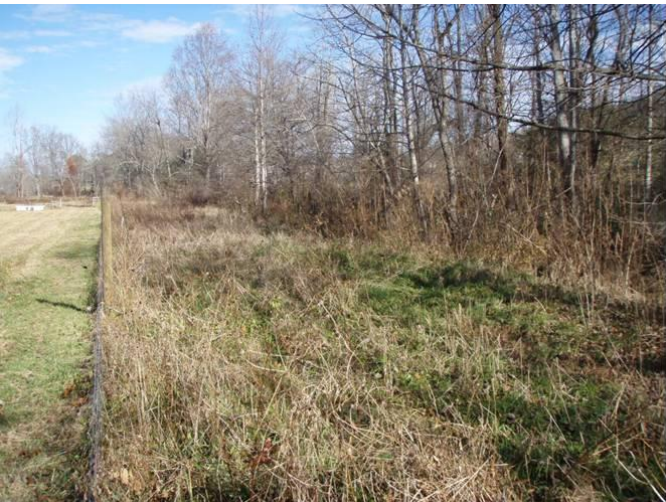
Photo Station 7

UT2 facing downstream, pre-construction, 30 November 2007.

UT2 facing downstream, post invasive removal, 5 December 2011.

UT2 facing downstream, post invasive removal, 20 November 2012.

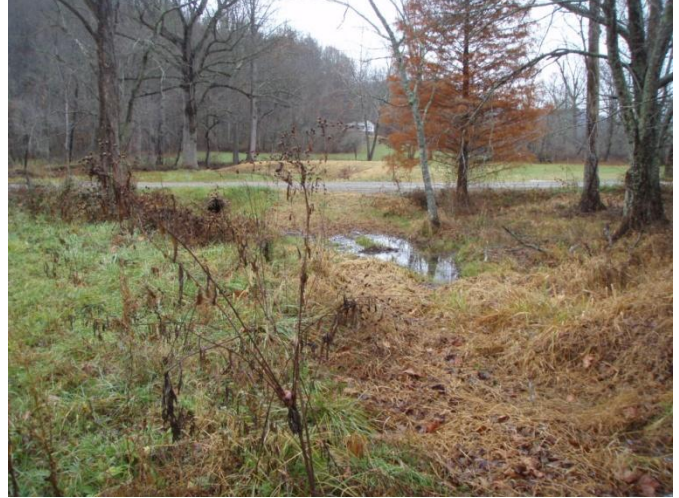
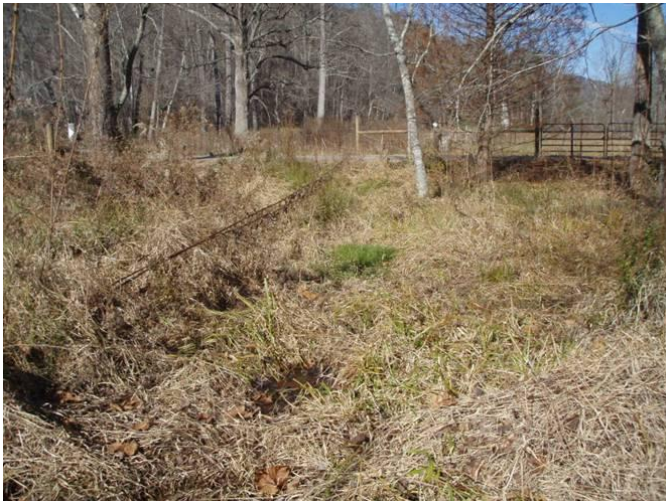
Photo Station 8

UT2 routed from original channel to a road ditch, pre-construction, 30 November 2007.

UT2 re-connected under Canterfield Lane to abandoned channel, sta. 0+00 to 0+50, 5 December 2011.

UT2 re-connected under Canterfield Lane to abandoned channel, sta. 0+00 to 0+50, 20 November 2012.

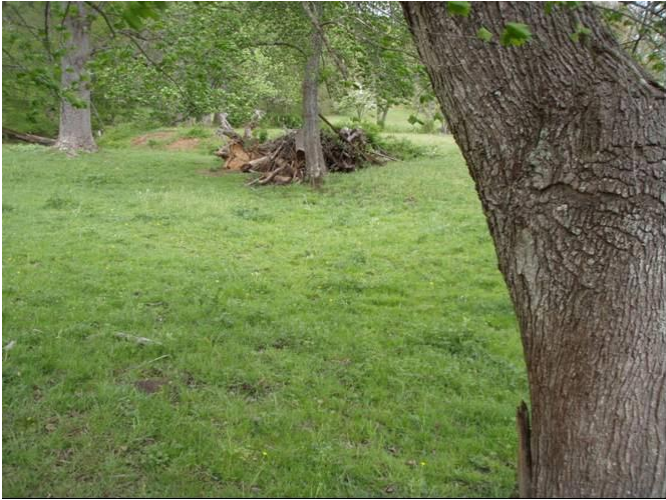
Photo Station 9

Upper portion of the UT2 abandoned channel east of Canterfield Lane, 26 April 2010.

UT2 restored portion, east of Canterfield Lane, 5 September 2011.

UT2 restored portion, east of Canterfield Lane, 20 November 2012.

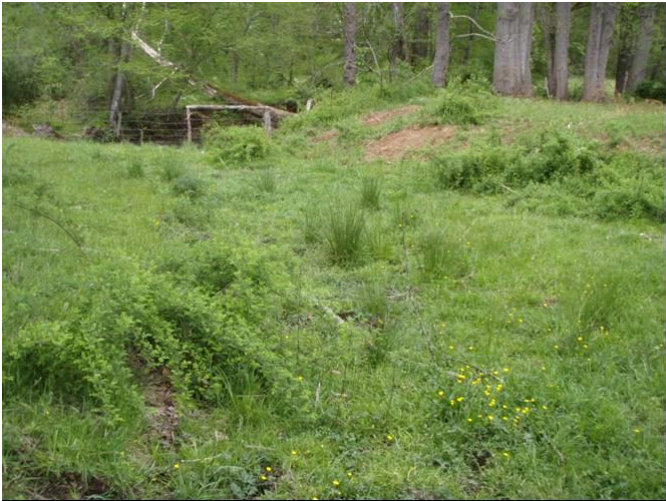
Photo Station 10

Lower portion of UT2 abandoned channel at confluence with SHC, Pre-construction, facing downstream, 26 April 2010.

Lower portion of UT2 at confluence with SHC, facing upstream, 5 September 2011.

Lower portion of UT2 at confluence with SHC, facing downstream, 20 November 2012.

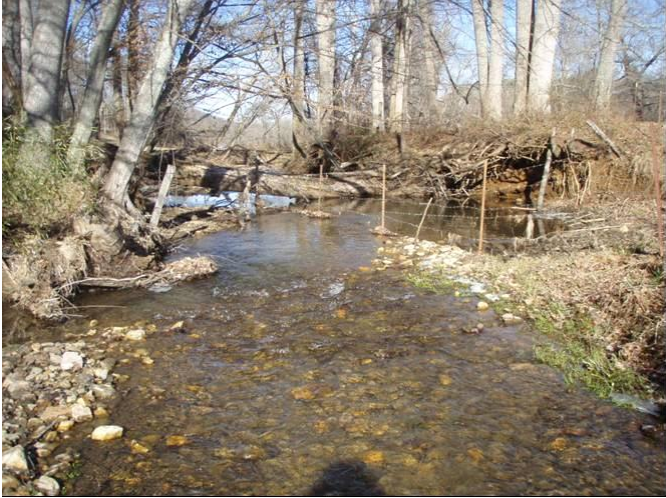
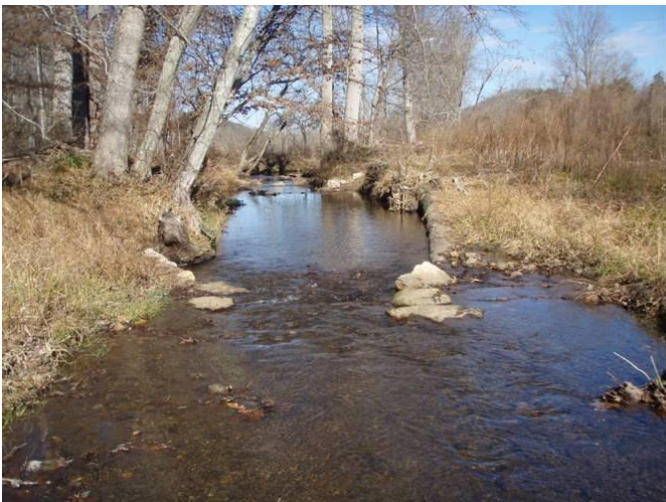
Photo Staton 11

Livestock access right bank, sta. 1+00 to 1+50, facing downstream.  
22 January 2009.

Log vane sta. 1+00 to 1+50, facing downstream

Log vane sta. 1+00 to 1+50, facing downstream, 20 November 2012.

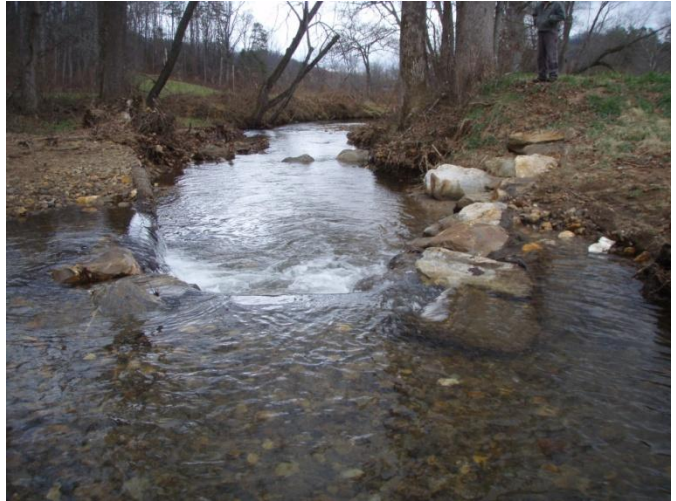
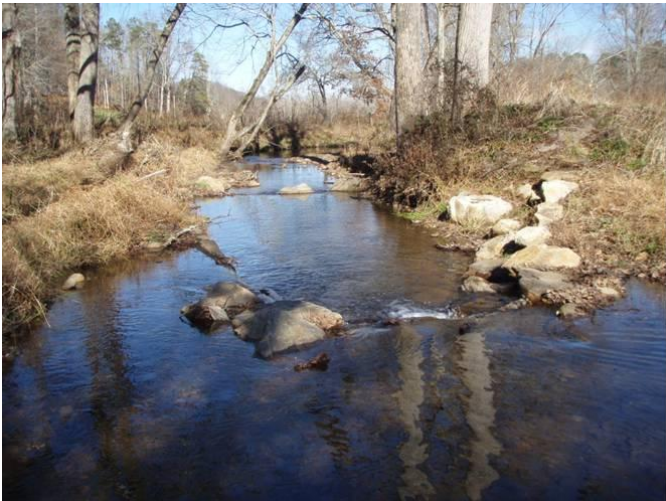
Photo Station 12

Mid channel aggradation, sta. 1+50 to 2+50, facing downstream.  
22 January 2009.

Log vane at sta. 1+50 to 2+50, facing downstream,  
5 December 2011.

Log vane sta. 1+50 to 2+50, facing downstream, 20 November 2012.

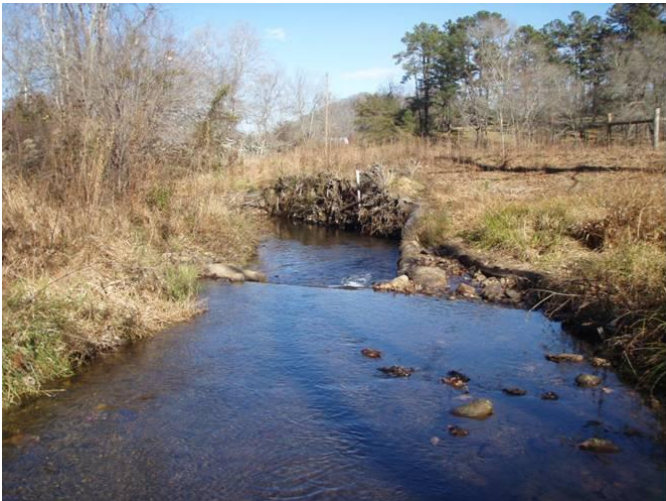
Photo Station 14

Outside meander bend bank stress, sta. 7+25 to 8+00, facing downstream, 22 January 2009.

Log vane, root wad, and bank shaping, sta. 7+25 to 8+00, 22 September 2011.

Log vane, root wad, and bank shaping, sta. 7+25 to 8+00, 20 November 2012.

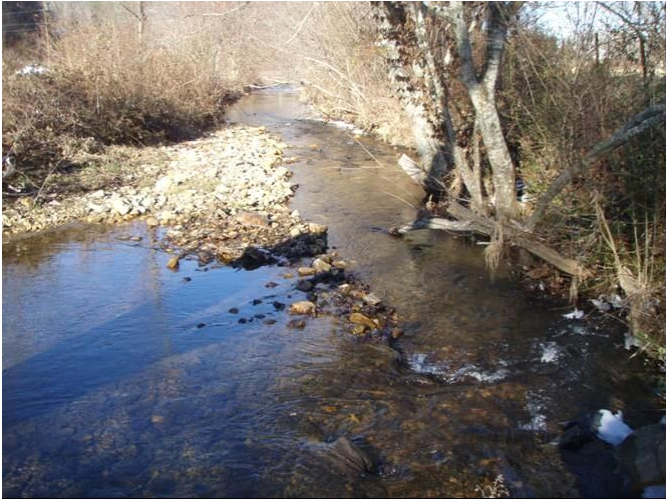
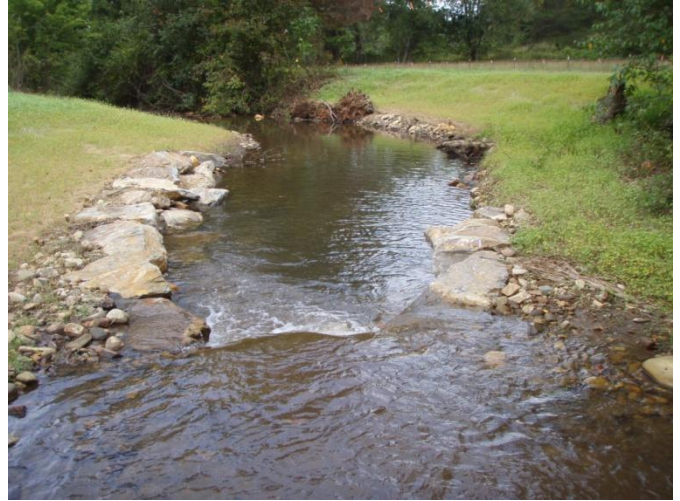
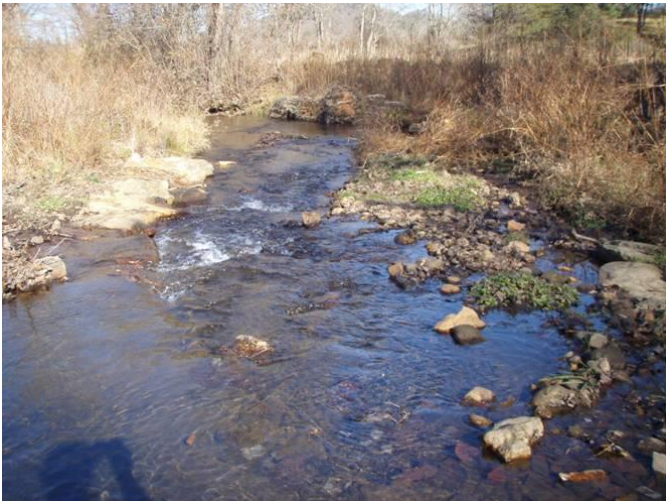
Photo Station 15

Bed aggradation and transverse bar, sta. 9+50 to 10+00, facing downstream, 22 January 2009.

Bank sloping and J-hook, sta. 9+25 to 10+00, 22 September 2011.

Bank sloping and J-hook, sta. 9+25 to 10+00, 14 June 2012.

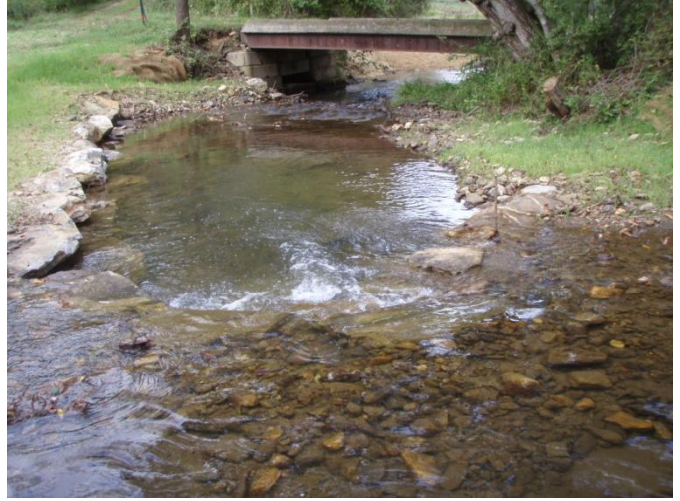
Photo Station 17

Driveway bridge at lower end of Bura/Roberson properties, sta. 12+50, facing downstream, 22 January 2009.

J-hook sta. 12+75, lower end of Bura/Roberson properties, 22 September 2011.

J-hook sta. 12+75, lower end of Bura/Roberson properties, 20 November 2012.

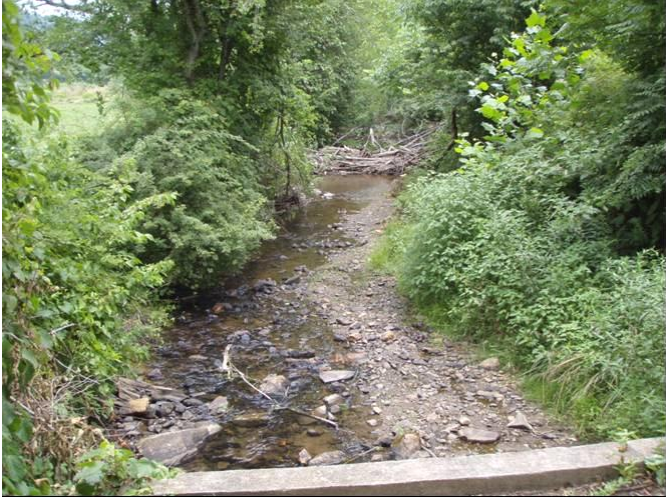
Photo Station 18

J-hook proposed, sta. 0+50, facing downstream, 25 July 2008, pre-construction.

Bank shaping, log vane, and riffle construction, sta. 0+25, 22 September 2011.

Bank shaping, log vane, and riffle construction, sta. 0+25, 20 November 2012.

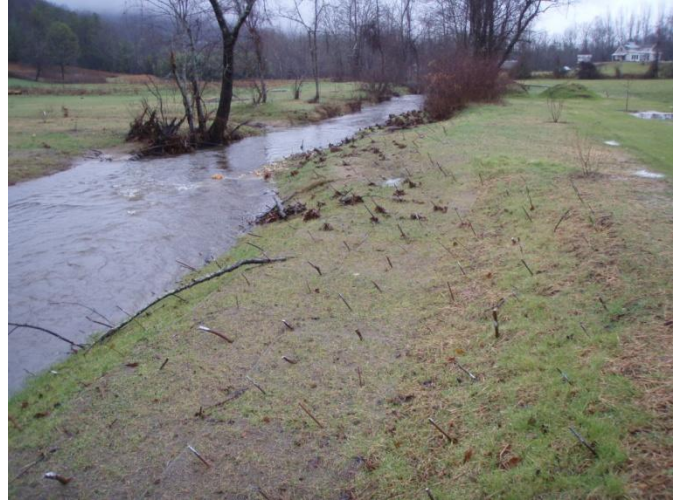
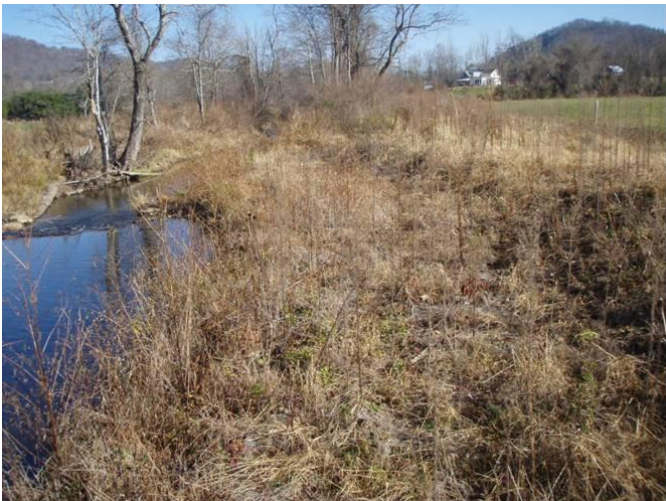
Photo Station 19

In-stream structures proposed to enhance habitat features, sta. 2+00 to 3+50, facing downstream, 25 July 2008.

Log vane, root wads, and bank shaping, sta. 2+25 to 3+50, facing downstream, 7 December 2011.

Log vane, root wads, and bank shaping, sta. 2+25 to 3+50, facing Downstream, 20 November 2012.

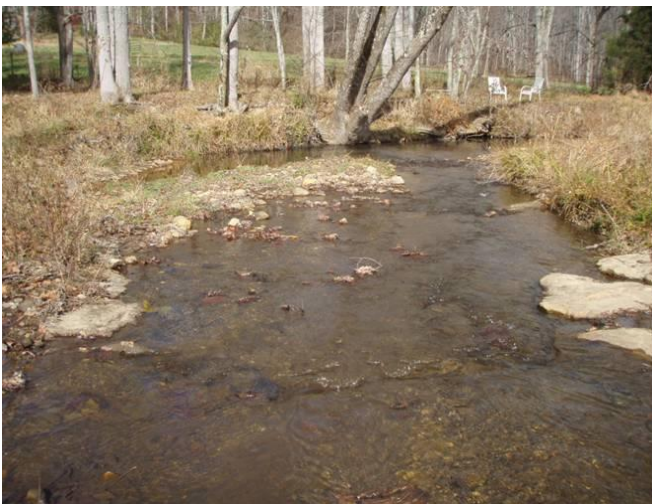
Aggradation and bar formation in meander below J-hook, sta. 2+50, facing downstream, 20 November 2012.

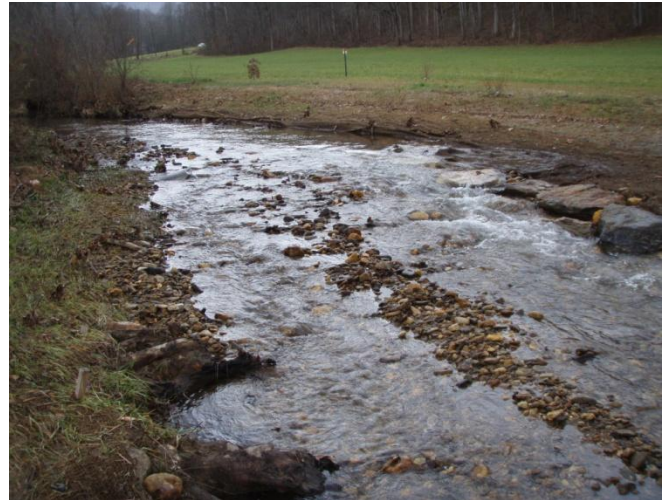
Aggradation and bar formation below J-hook, sta. 9+25 to 9+50, after flood event, facing upstream, 5 December 2011.

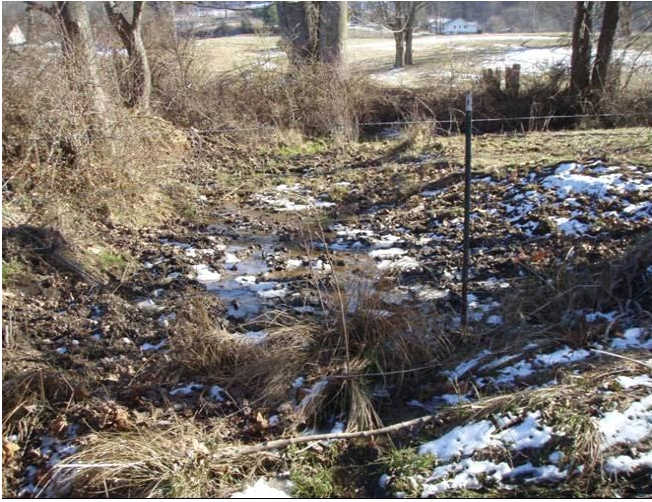
Lower portion of Wetland D, livestock impacts, facing upstream, 2009.
