Monitoring Year 2 Report

Upper South Hominy Mitigation Site, South Hominy Creek, French Broad River Basin, Buncombe County, North Carolina

EEP Project Number: 92632
Contract Number: D06082; Task Order: 08 FB05-1b-d

Data Collected: October 2013-November 2013
Submitted: 30 May 2014

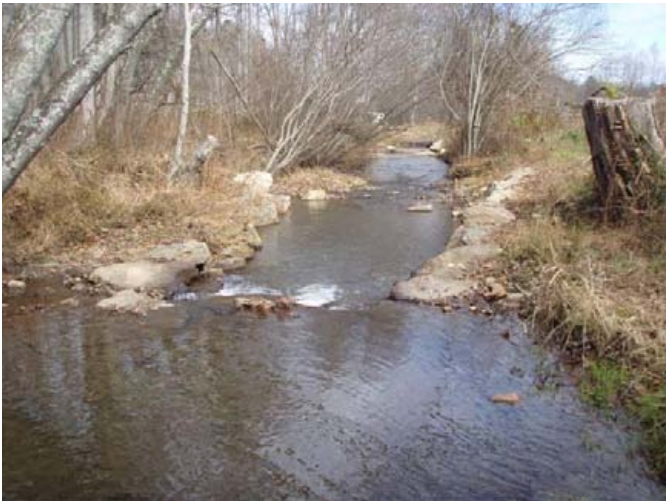
Cross vane, sta. 0+50, facing downstream, 20 November 2012.

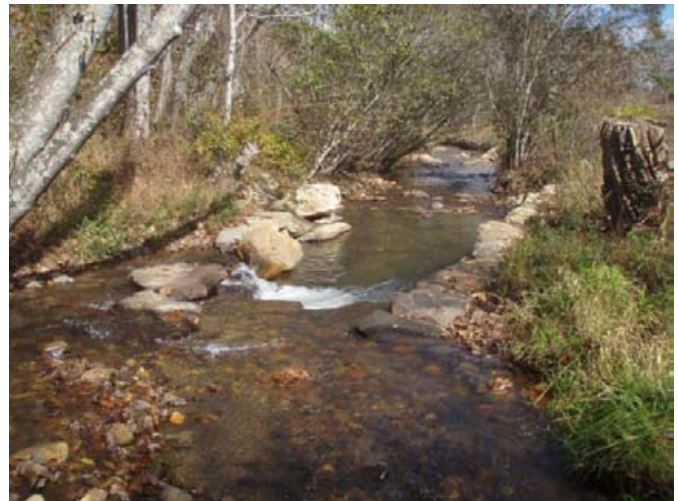
Cross vane, sta. 0+50, facing downstream, 29 October 2013.

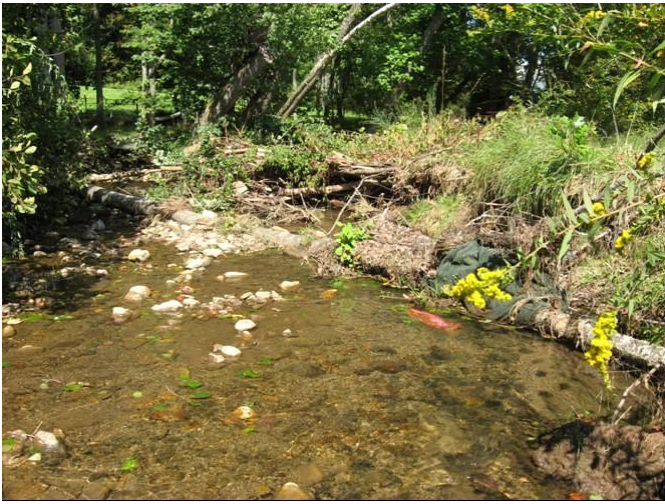
Photo Station 2

Channel blockage, sta.2+50, facing downstream, pre-construction, 30 September 2008.

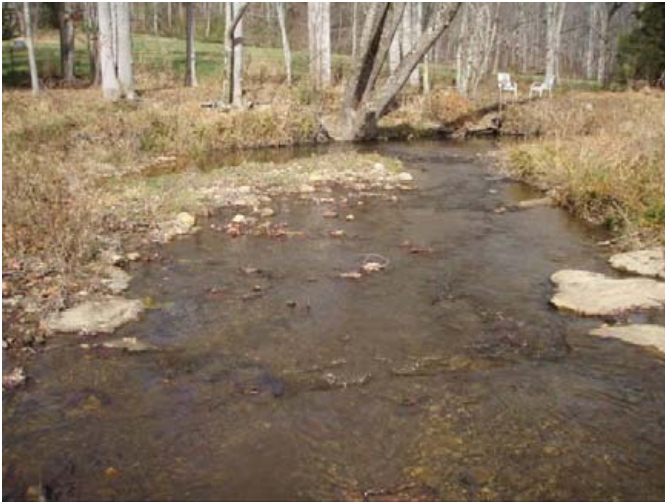
J-hook, sta. 2+50, facing downstream, 20 November 2012.

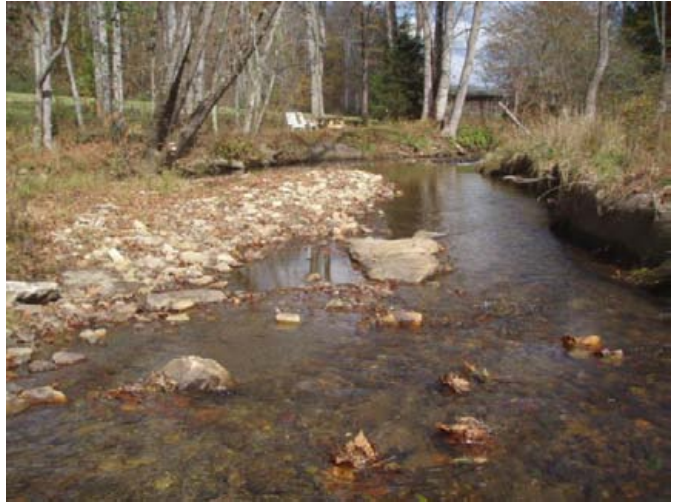
J-hook, sta. 2+50, facing downstream, 29 October 2013.

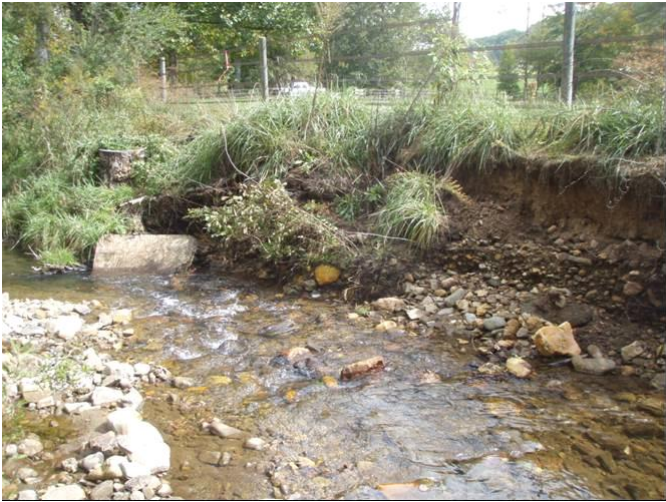
Photo Station 3

Right bank erosion, sta. 5+50, pre-construction, 30 September 2008.

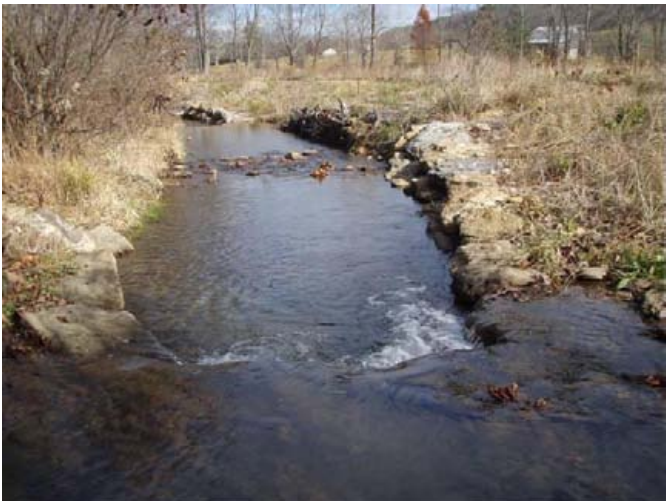
J-hook, sta. 5+00, facing downstream, 20 November 2012.

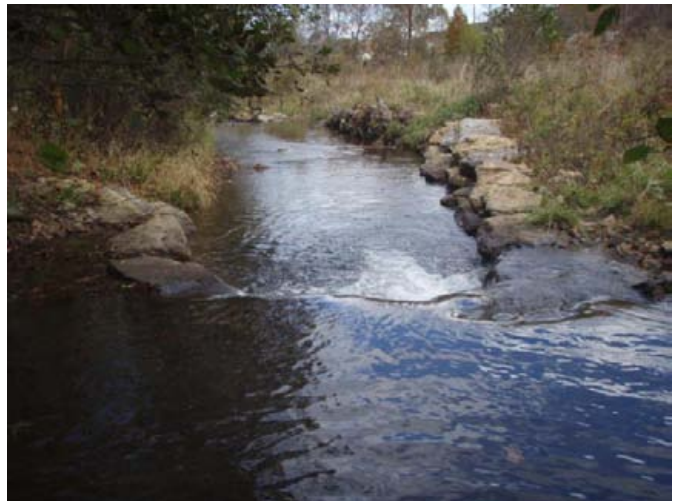
J-hook, sta. 5+00, facing downstream, 29 October 2013.

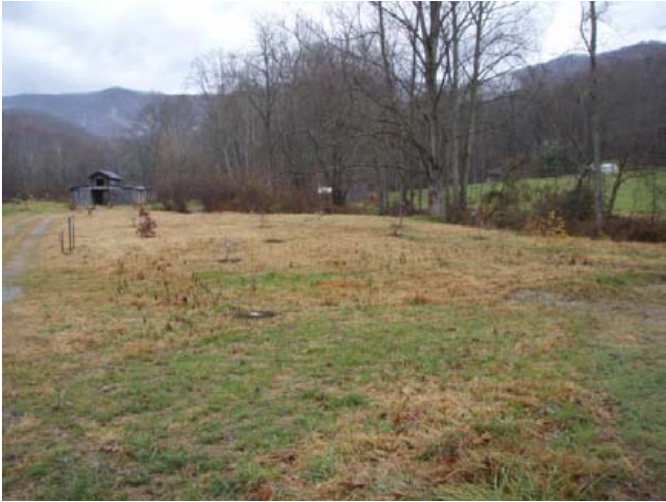
Photo Station 4

Sta. 6+50 to 8+00, right bank facing upstream, 5 December 2011.
2012.

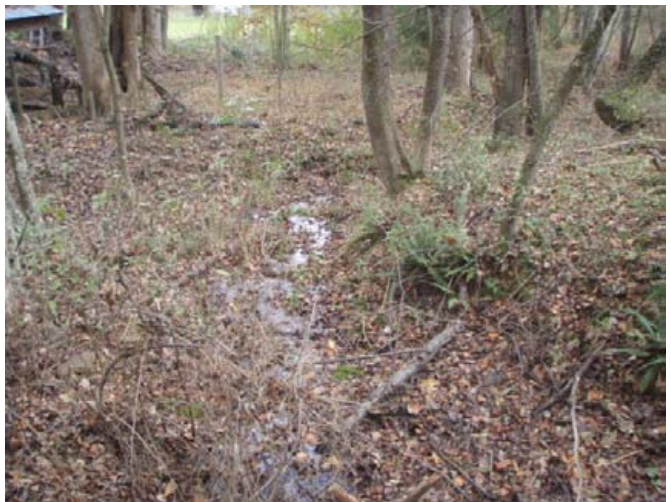
UT1 facing downstream, adjacent to small barn, 29 October 2013.

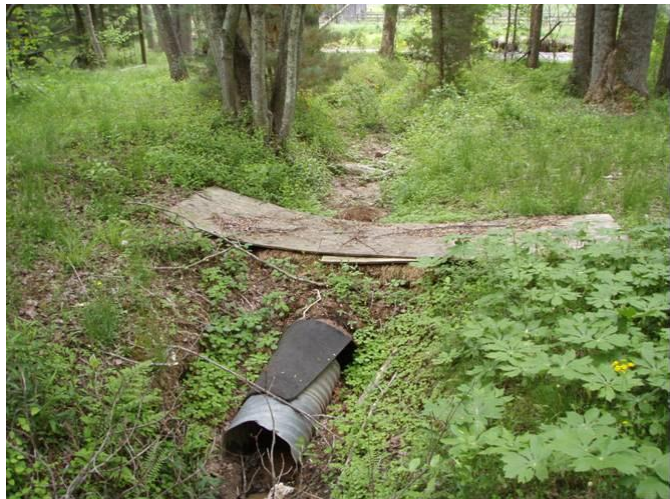
Photo Station 6

UT1 facing downstream, pre-construction 28 July 2009.

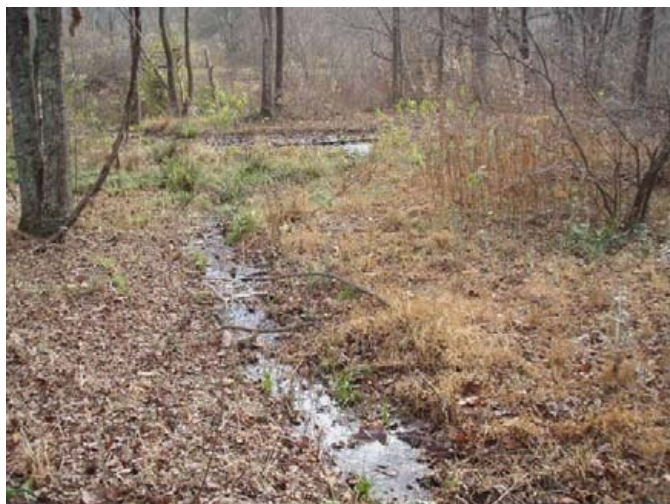
UT1 Priority I construction, above vernal pond, 20 November 2012.

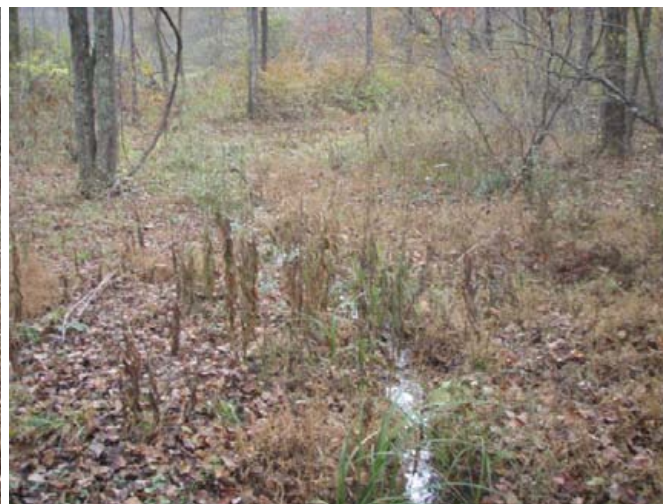
UT1 Priority I construction, above vernal pond, 29 October 2013.

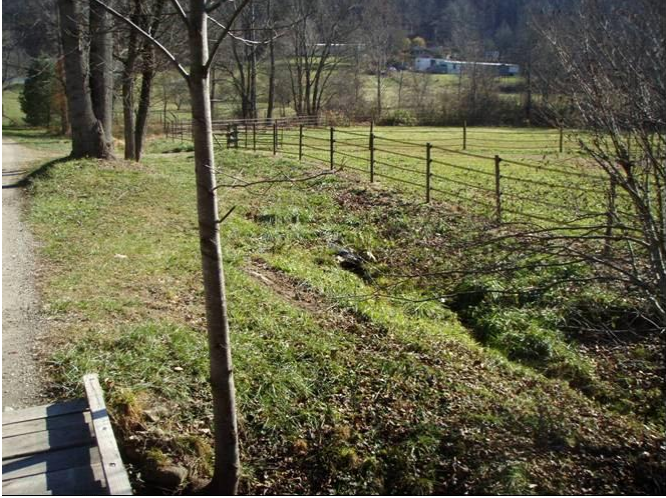
Photo Station 8

UT2 routed from original channel to a road ditch, pre-construction, 30 November 2007.

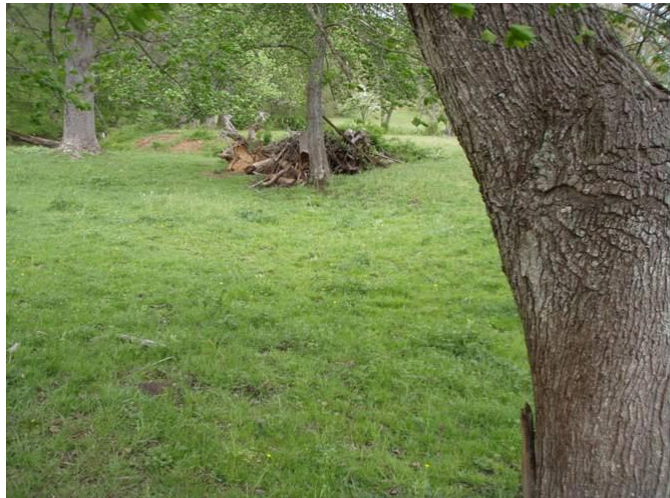
Photo Station 9

Abandoned UT2 channel east of Canterfield Lane, 26 April 2010.

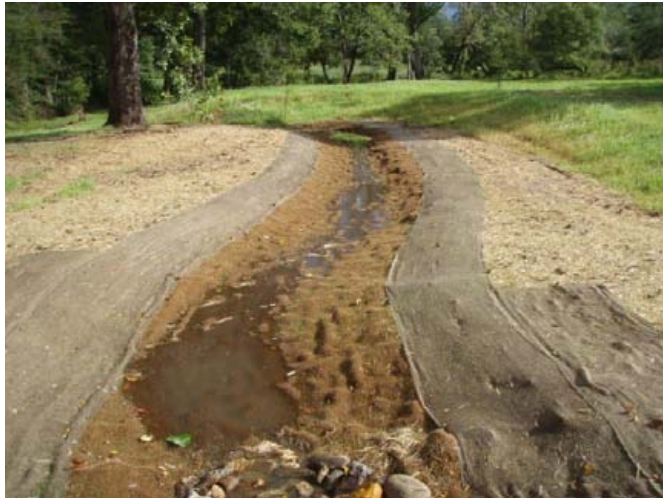
UT2 restored portion, east of Canterfield Lane, 5 September 2011.

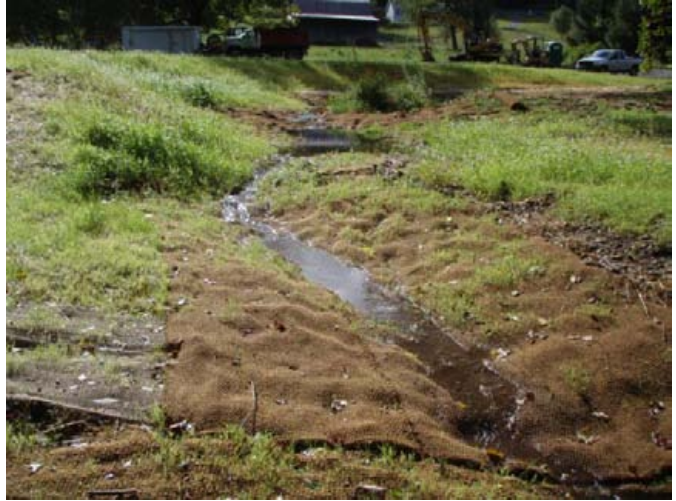
Lower portion of UT2 at confluence with SHC, facing upstream, 5 September 2011.

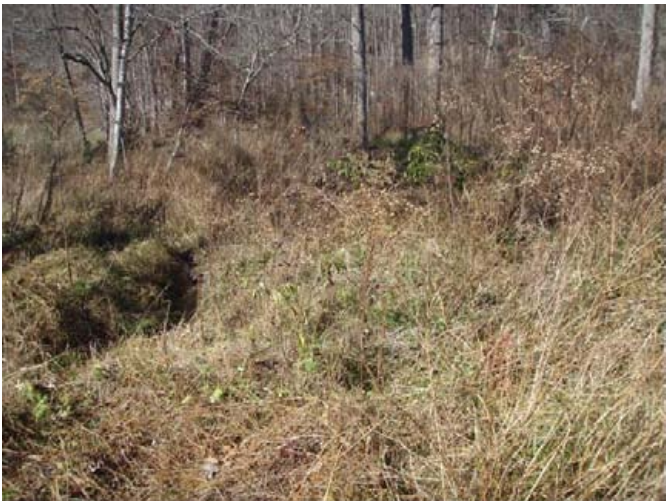
Lower portion of UT2 at confluence with SHC, facing downstream, 20 November 2012.

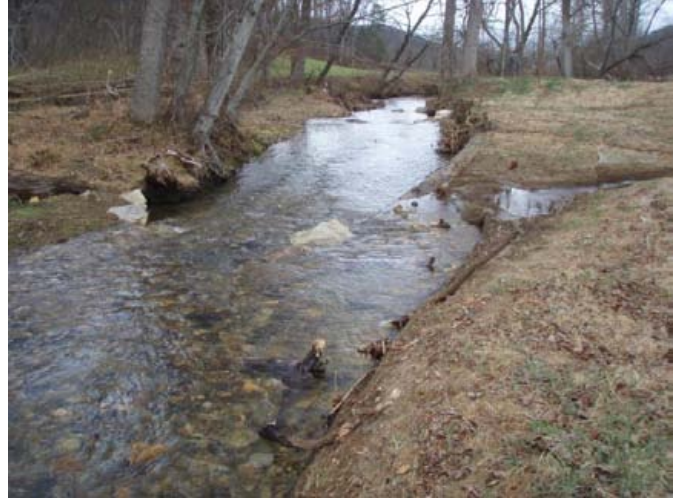
Log vane sta. 1+00 to 1+50, facing downstream

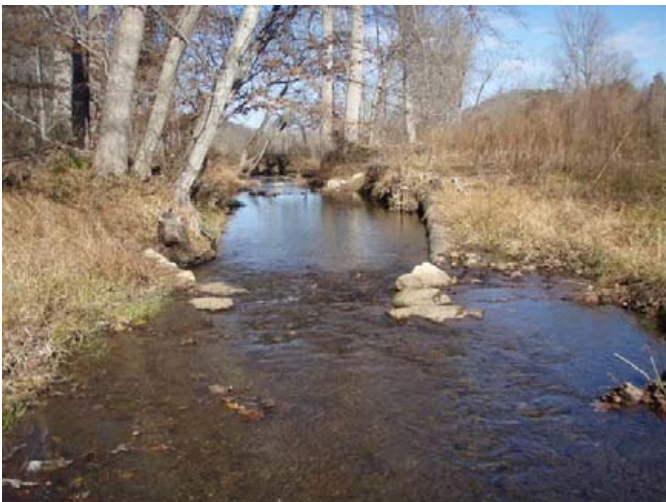
Log vane sta. 1+00 to 1+50, facing downstream, 20 November 2012.

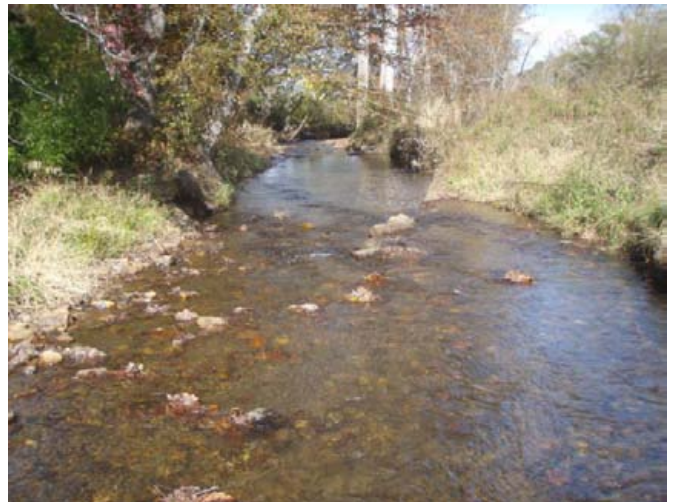
Log vane sta. 1+00 to 1+50, facing downstream, 29 October 2013.

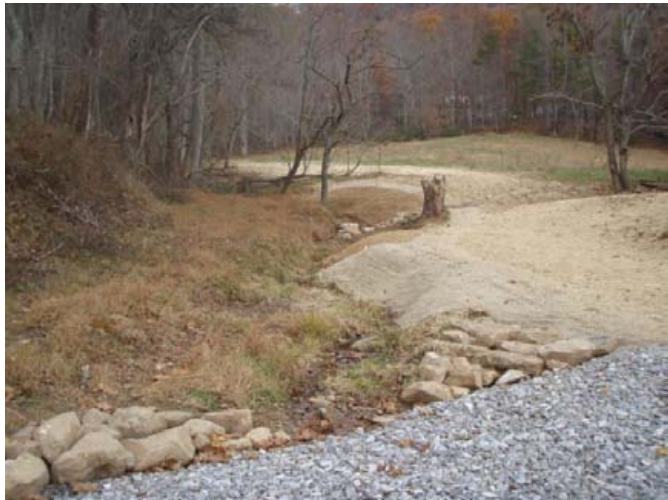
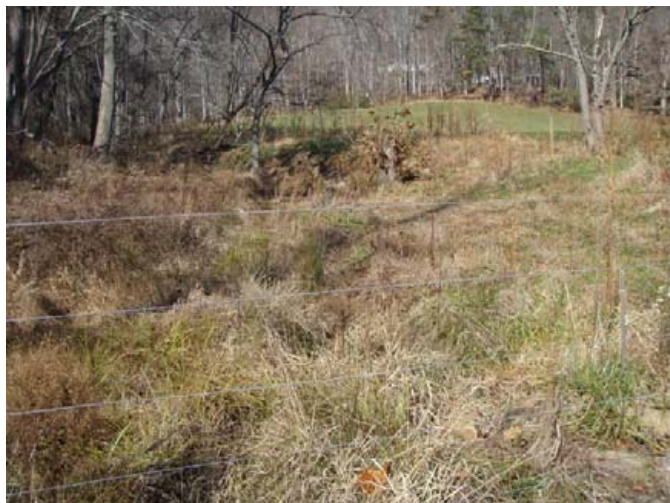
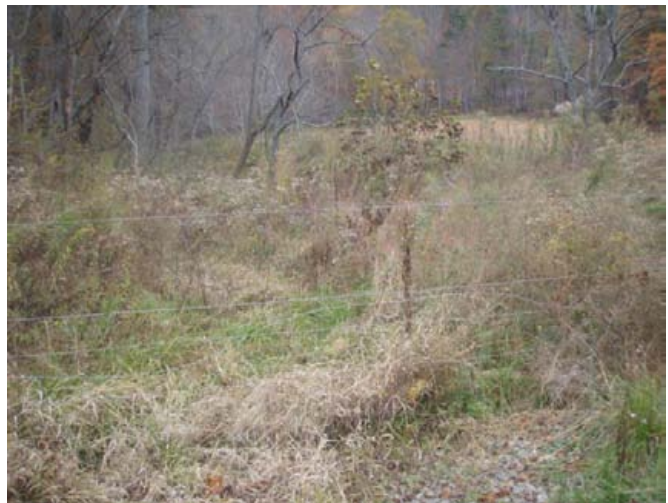
Photo Station 24

UT3 above ford, channel incision, facing downstream, 25 July 2008.

UT3 above ford, invasive removal, cattle exclusion, and bank shaping, facing upstream, 9 November 2011.

UT3 above ford, invasive removal, cattle exclusion, and bank shaping, facing upstream, 20 November 2012.

UT3 above ford, invasive removal, cattle exclusion, and bank shaping, facing upstream, 29 October 2013.

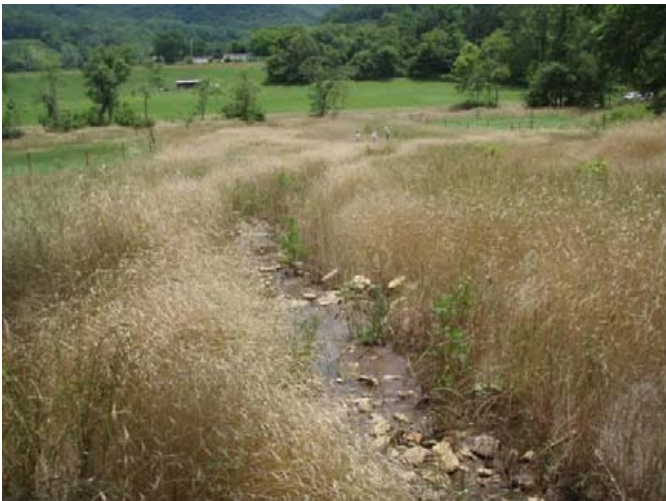
Photo Station 25

UT3 below ford, severe entrenchment and head cutting, 25 July 2008.

UT3 below ford, Priority I channel restoration, facing downstream, sta. 0+00, 15 November 2011.

UT3 below ford, Priority I channel restoration, facing downstream, sta. 0+00, 14 June 2012.

UT3 below ford, Priority I channel restoration, facing downstream, sta. 0+00, 29 October 2013.

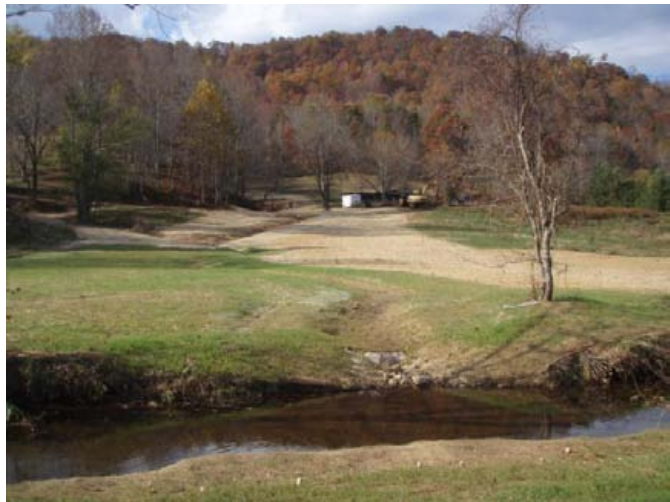
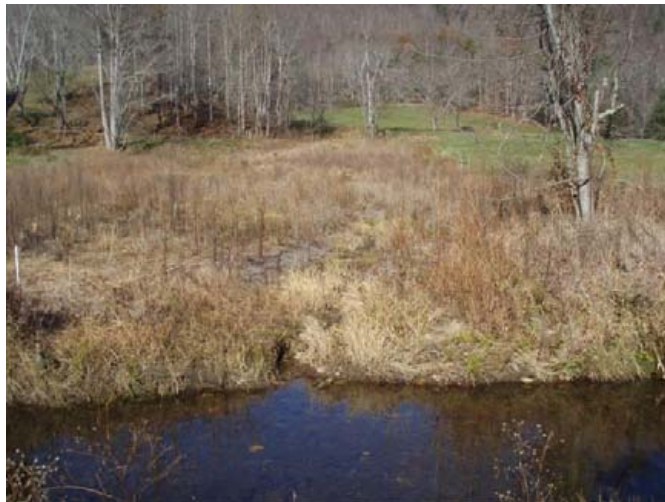
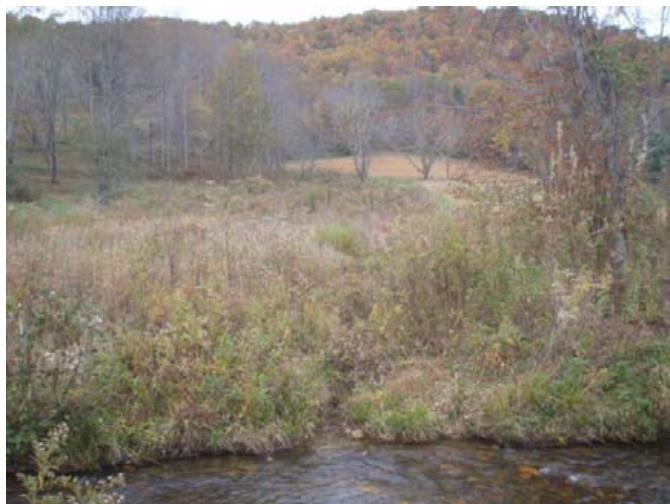
Photo Station 26

UT3 lower at confluence with SHC, Priority I restoration, facing upstream, 15 November 2011.

UT3 lower at confluence with SHC, Priority I restoration, facing upstream, 20 November 2012.

UT3 lower at confluence with SHC, Priority I restoration, facing upstream, 29 October 2013.

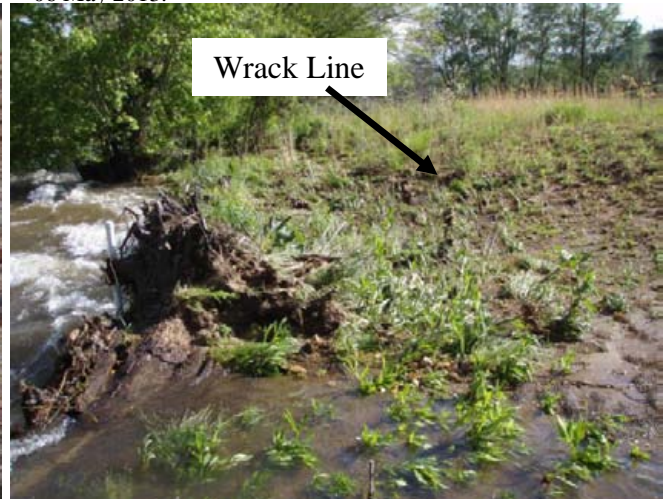
Photo 5 bankfull event on SHC, Roberson property, sta. 8+00 06 May 2013

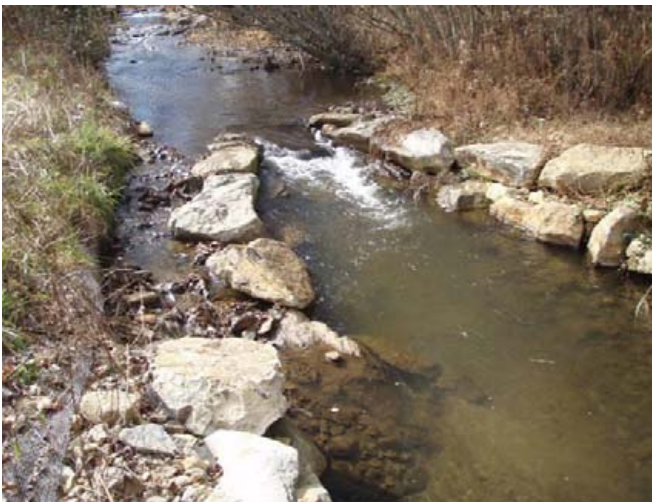
Problem Area 1

Rock vane after construction, sta. 1+50, facing upstream, 5 September 2011.

Rock vane, sta. 1+50, facing upstream, 20 November 2012.

Rock vane, sta. 1+50, facing upstream, 29 October 2013.

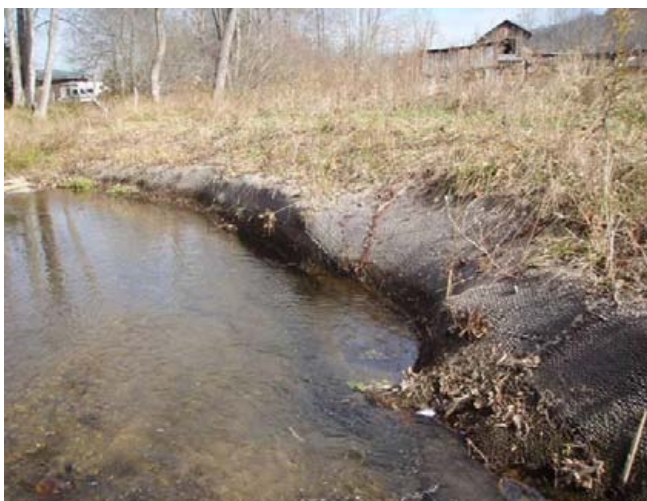
Problem Area 2

Right channel bank in stable condition, sta. 2+00, facing upstream, 5 September 2011.

Right channel bank instability, sta. 1+75 to 2+25, facing downstream, 20 November 2012.

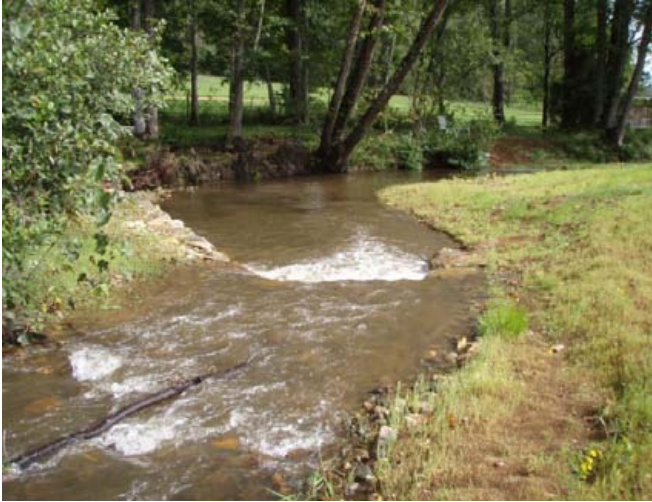
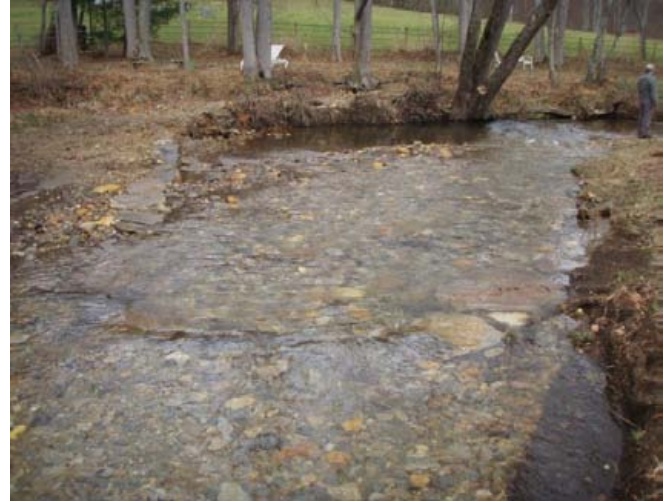
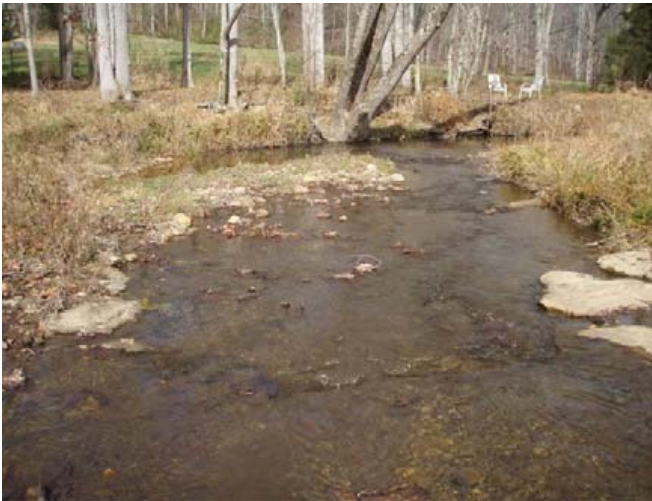
Problem Area 3

Stream Problem Areas			
Upper South Hominy (EEP project number 92632)			
Feature/Issue	Reach / Station	Suspected Cause/Date	Photo Number
Aggradation/Bar Formation	Mainstem 1 - 2+25 to 2+75	flood event / 28 Nov 2011	Figure B.6, PA3
	Mainstem 1 - 4+00 to 4+50	flood event / 5 May 2013	Figure B.6, PA8
	Mainstem 2 - 9+00 to 9+50	flood event / 28 Nov 2011	Figure B.6, PA4
	Mainstem 2 - 12+25 to 12+75	flood event / 5 May 2013	Figure B.6, PA7
Bank Scour & Erosion	Mainstem 1 - 1+75 to 2+25	flood event / 28 Nov 2011	Figure B.6, PA2
	Mainstem 1 - 2+25 to 2+50	flood event / 28 Nov 2013	Figure B.6, PA3
	Mainstem 1 - 6+25 to 6+50	flood event / 5 May 2013	Figure B.6, PA6
	Mainstem 2 - 12+25 to 12+75	flood event / 5 May 2013	Figure B.6, PA7
	Mainstem 3 - 0+00 to 0+20	Flood event / 5 May 2013	Figure B.6, PA9
Engineered Structures	Mainstem 1 - 1+50	flood event / 28 Nov 2011	Figure B.6, PA1
	Mainstem 1 - 0+50	Flood event / 5 May 2013	Figure B.6, PA5

J-hook and meander post construction, sta. 2+50, facing downstream, 5 September 2011.

Aggradation and bar formation in meander below J-hook after flood event, sta. 2+50, facing downstream, 5 December 2011.

Aggradation and bar formation in meander below J-hook, sta. 2+50, facing downstream, 20 November 2012.

Aggradation and thalweg movement following 5 May 2013 flood, sta. 2+50, facing downstream, 29 October 2013.

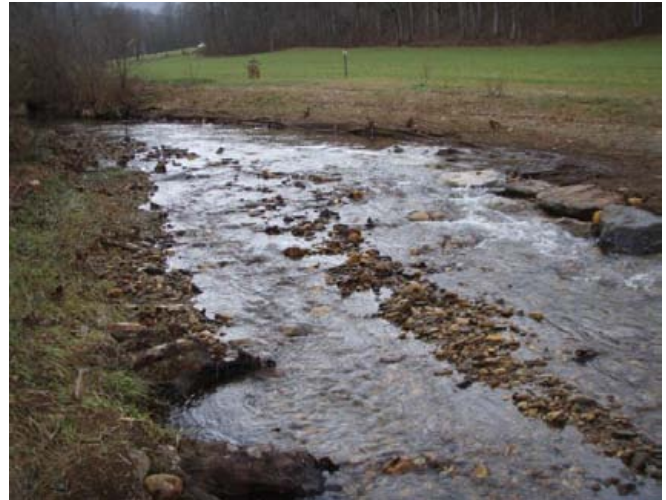
Problem Area 4

J-hook vane after construction, sta. 9+25, facing upstream, 5 September 2011.

Aggradation and bar formation below J-hook, sta. 9+25 to 9+50, after flood event, facing upstream, 5 December 2011.

Inner berm formation below J-hook, sta. 9+25 to 9+50, following 5 May 2013 flood event, facing upstream, 18 July 2013.

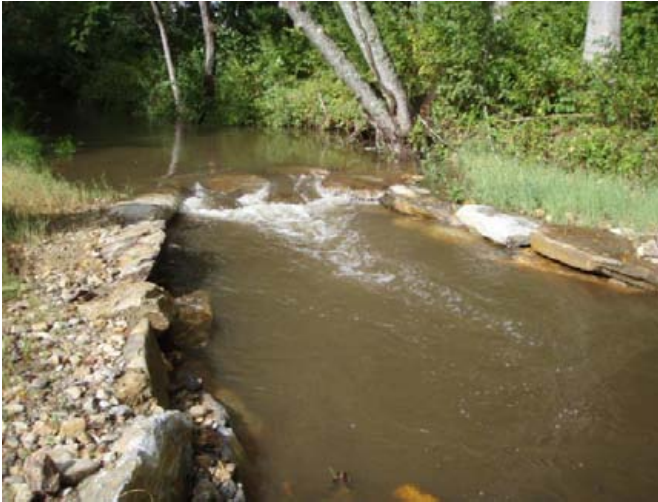
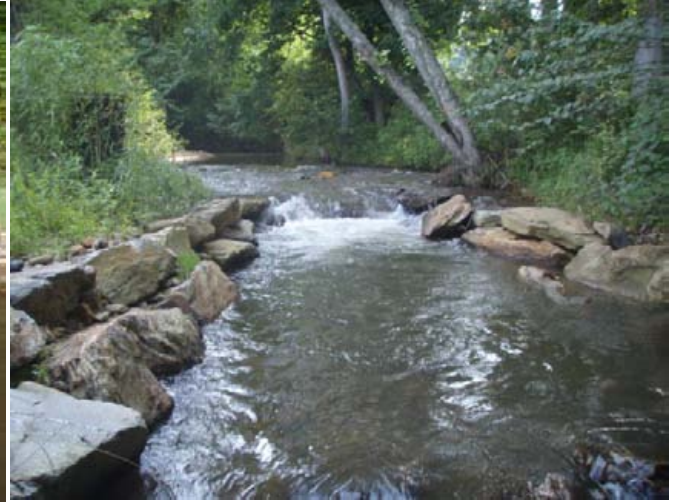
Problem Area 5

Cross vane after construction, facing upstream, sta. 0+50
14 Aug 2011.

Cross vane after 5 May 2013 flood event, facing upstream,
sta. 0+50, 18 July 2013.

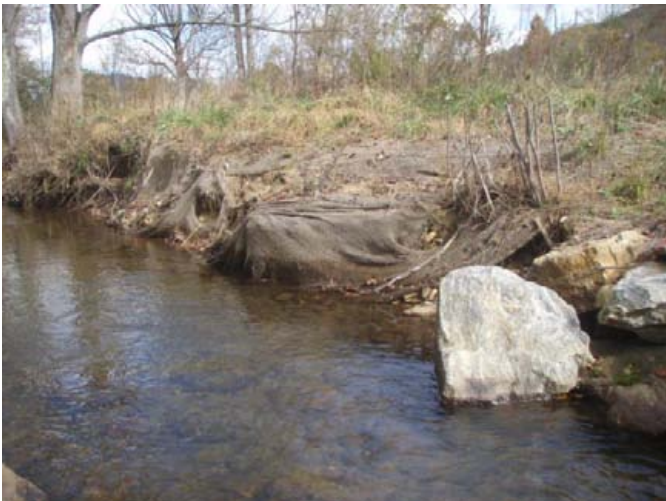
Problem Area 6

Right bank scour and erosion, sta. 6+25, facing downstream, occurred during the 5 May 2013 flood event, 29 October 2013.

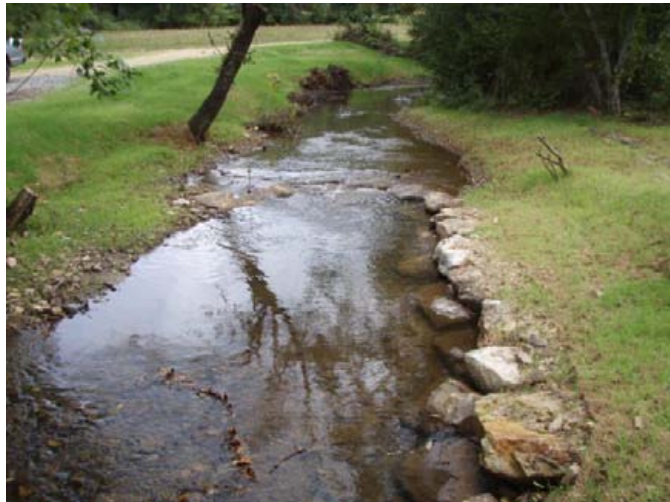
Problem Area 7

J-hook, sta. 12+75, after construction, facing upstream, 22 Sept 2011.

J-hook after 28 Nov 2011 flood event, aggradation in pool below J-hook, 5 December 2011.

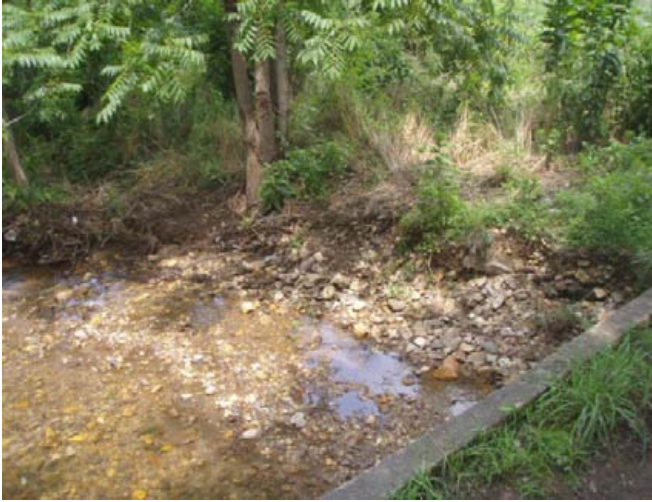
Problem Area 9

Right bank scour during 5 May 2013 flood event, sta. 0+00 to 0+20, facing downstream, 18 July 2013.
