Monitoring Year 3 Report

Upper South Hominy Mitigation Site, South Hominy Creek, French Broad River Basin, Buncombe County, North Carolina

EEP Project Number: 92632
Contract Number: D06082; Task Order: 08 FB05-1b-d

Data Collected: October 2014-November 2014
Submitted: February 2015

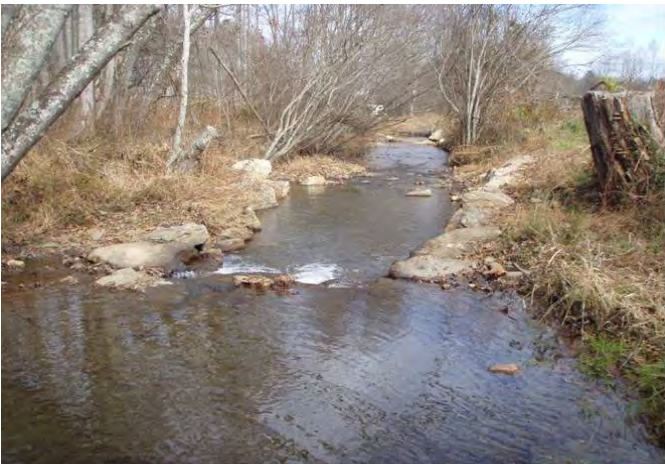
Cross vane, sta. 0+50, facing downstream, 20 November 2012.

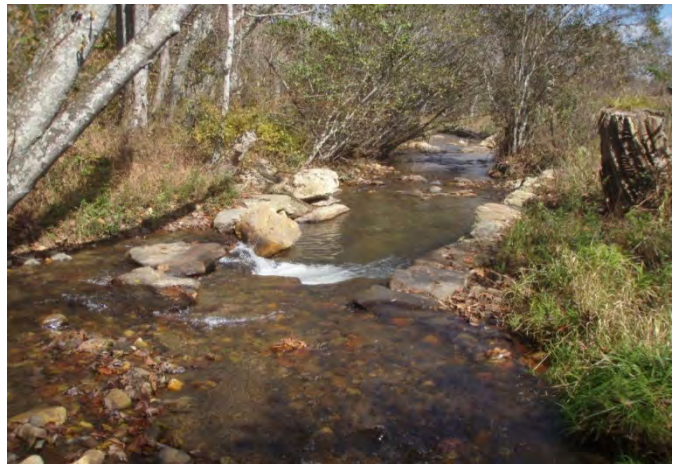
Cross vane, sta. 0+50, facing downstream, 29 October 2013.

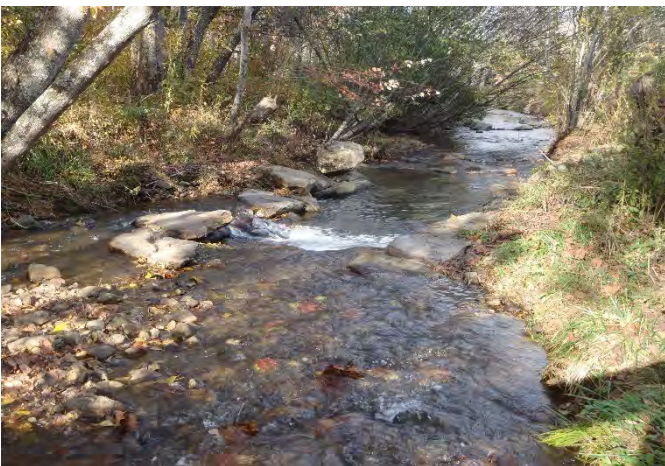
Cross vane, sta. 0+50, facing downstream, 12 November 2014.

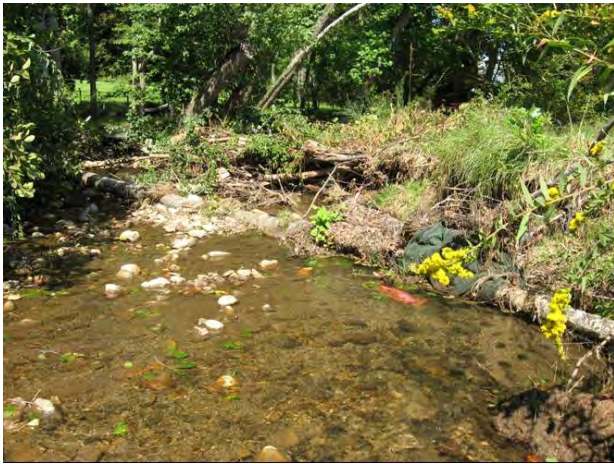
Photo Station 2

Channel blockage, sta.2+50, facing downstream, pre-construction, 30 September 2008.

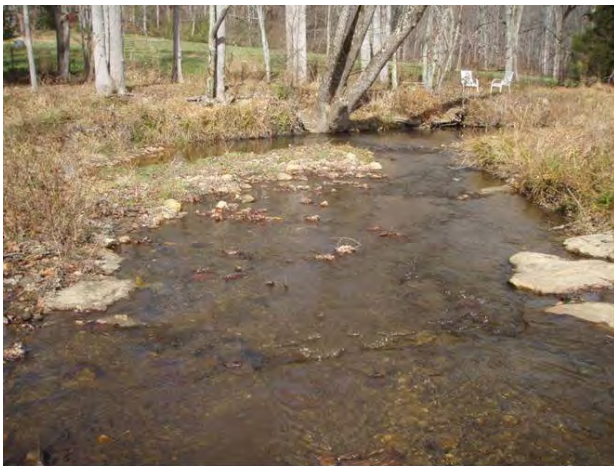
J-hook, sta. 2+50, facing downstream, 20 November 2012.

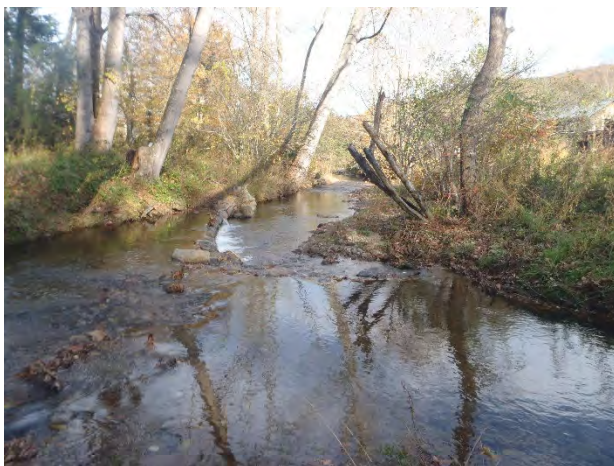
J-hook, sta. 2+50, facing downstream, 12 November 2014.

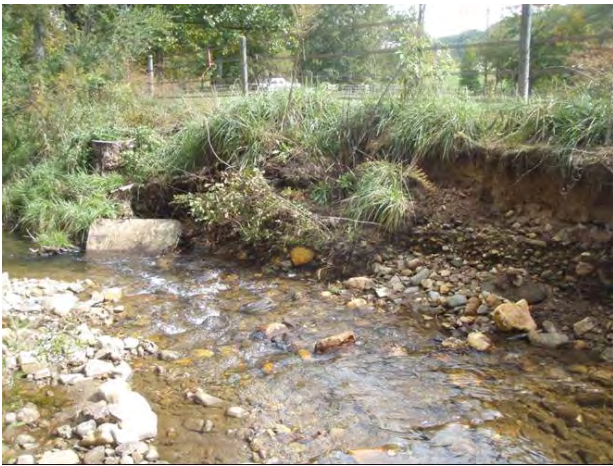
Photo Station 3

Right bank erosion, sta. 5+50, pre-construction, 30 September 2008.

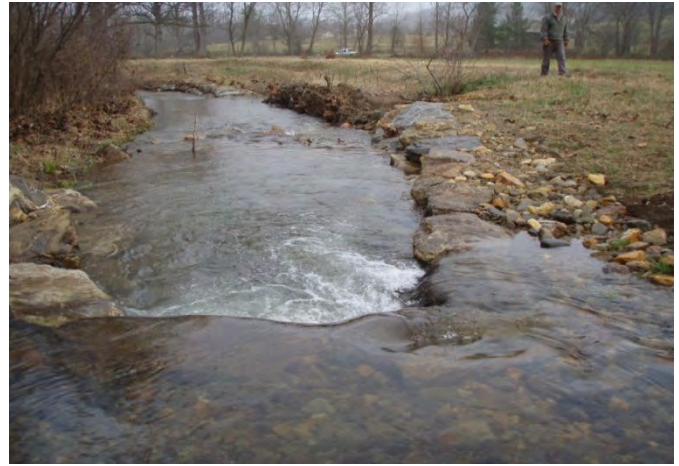
J-hook, sta. 5+00, facing downstream, 5 December 2011.

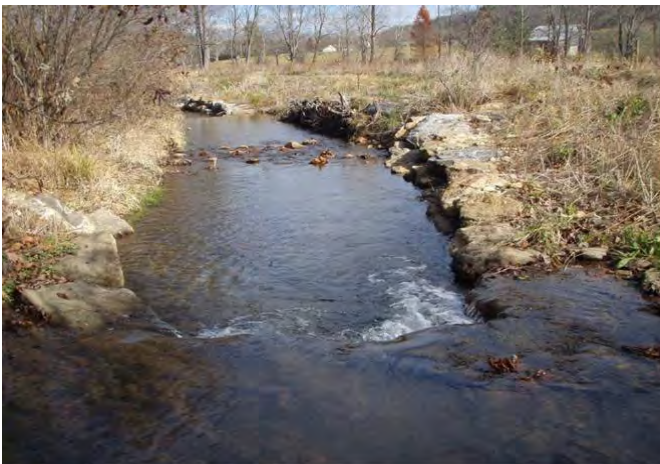
J-hook, sta. 5+00, facing downstream, 20 November 2012.

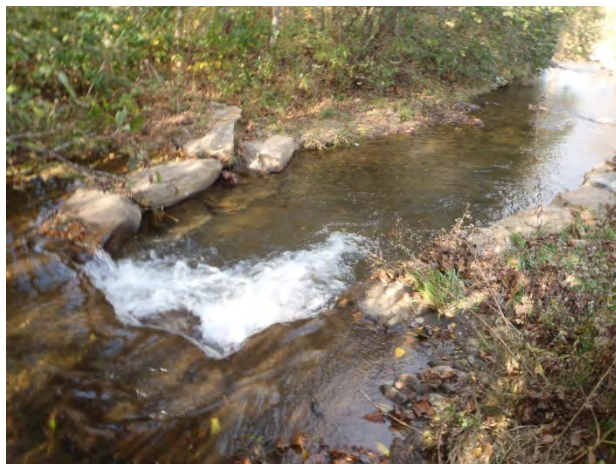
J-hook, sta. 5+00, facing downstream, 12 November 2014.

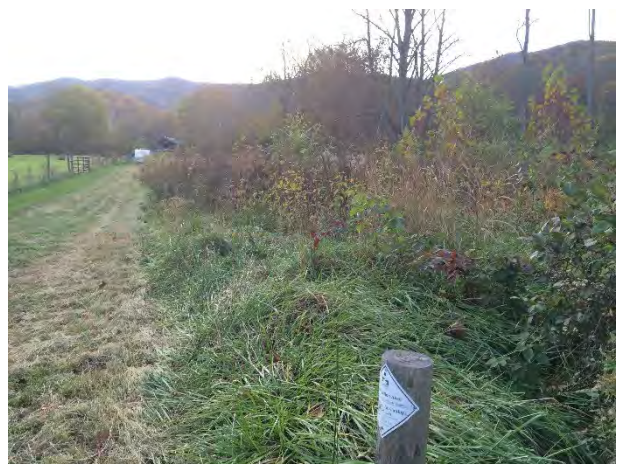
Sta. 6+50 to 8+00, right bank facing upstream, 12 Nov 2014.

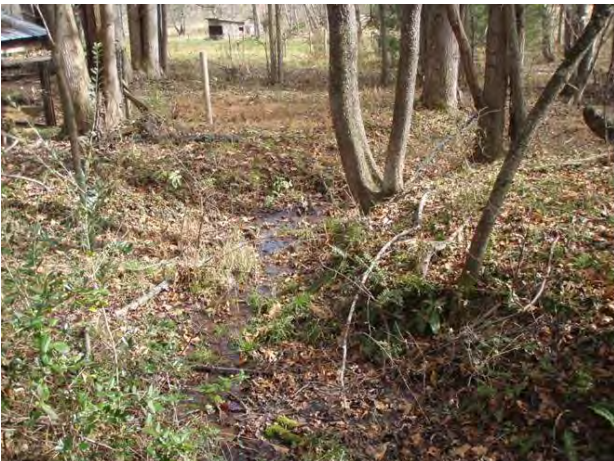
UT1 facing downstream, adjacent to small barn, 20 Nov 2012

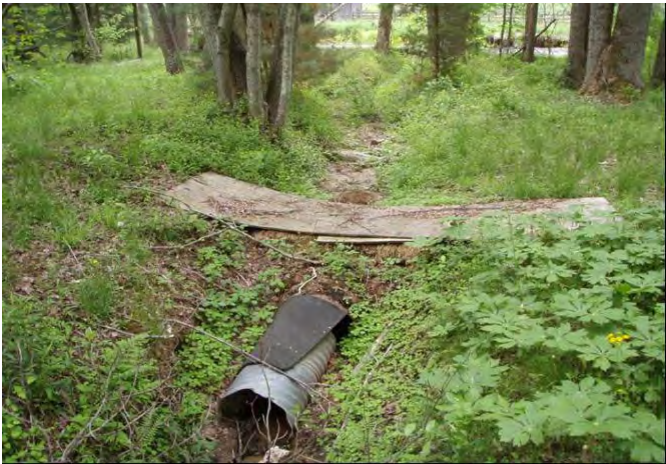
Photo Station 6

UT1 facing downstream, pre-construction 28 July 2009.

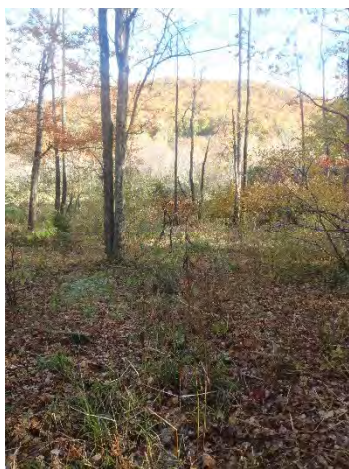
UT1 Priority I construction, above vernal pond, 12 Nov 2014.

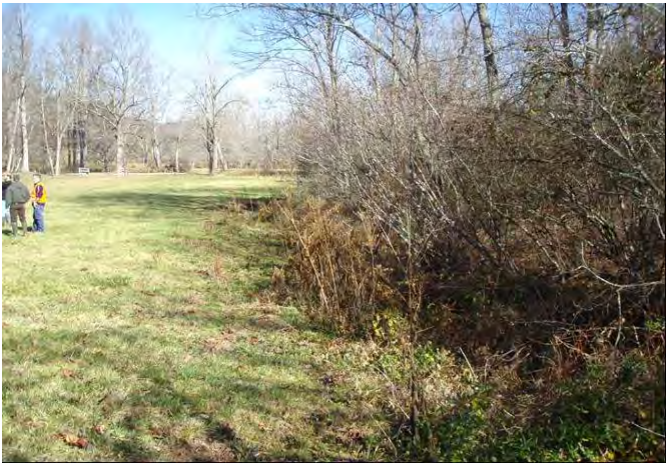
Photo Station 7

UT2 facing downstream, pre-construction, 30 November 2007.

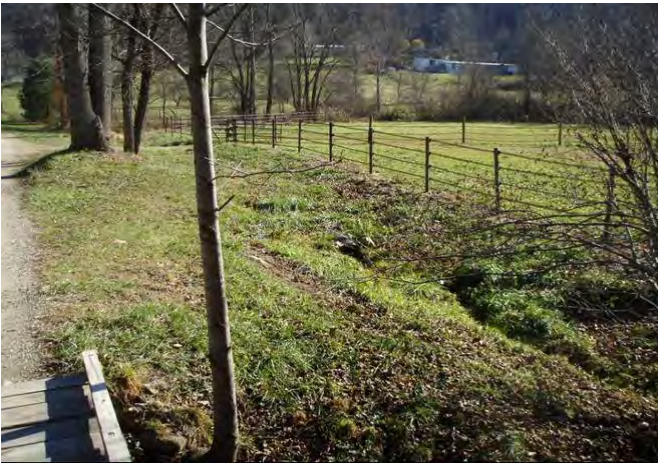
Photo Station 8

UT2 routed from original channel to a road ditch, pre-construction, 30 November 2007.

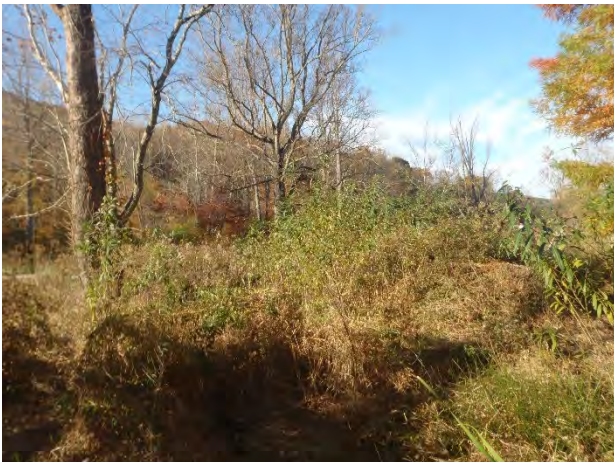
UT2 re-connected under Canterfield Lane to abandoned channel, sta. 0+00 to 0+50, 12 Nov 2014.

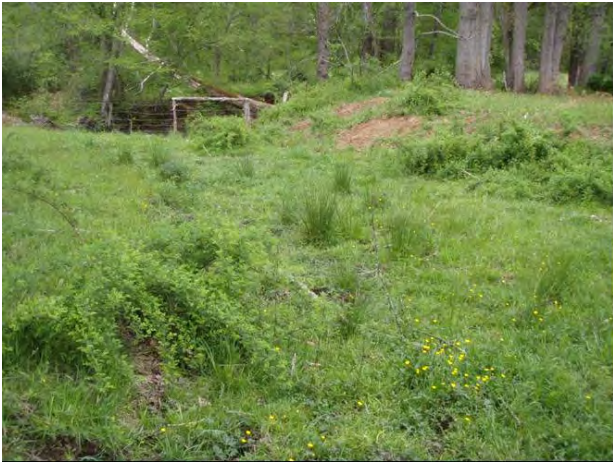
Photo Station 10

Lower portion of UT2 abandoned channel at confluence with SHC, Pre-construction, facing downstream, 26 April 2010.

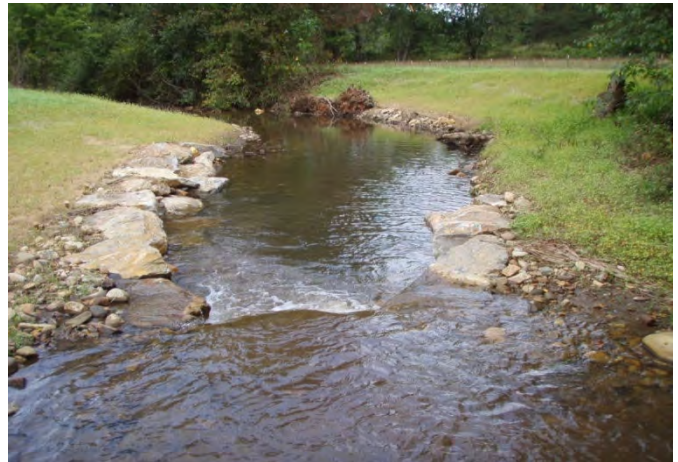
Bank sloping and J-hook, sta. 9+25 to 10+00, 22 September 2011.

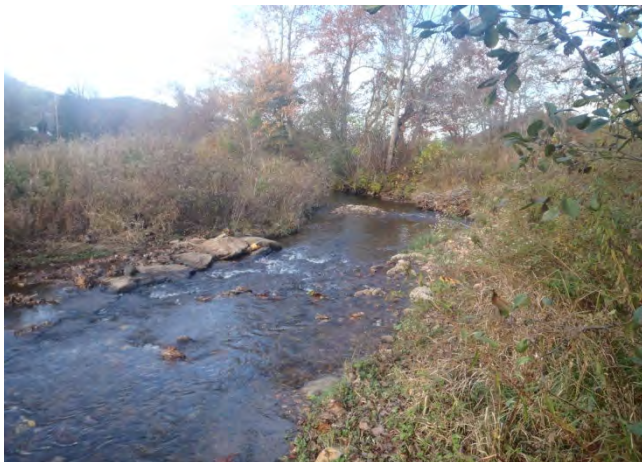
Bank sloping and J-hook, sta. 9+25 to 10+00, 12 Nov 2014.

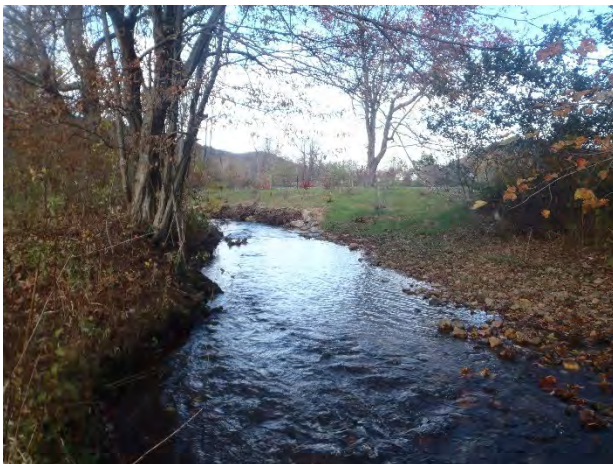
Bank shaping, root wads, and toe-wood, sta. 11+50 to 12+00, facing downstream, 12 Nov 2014.

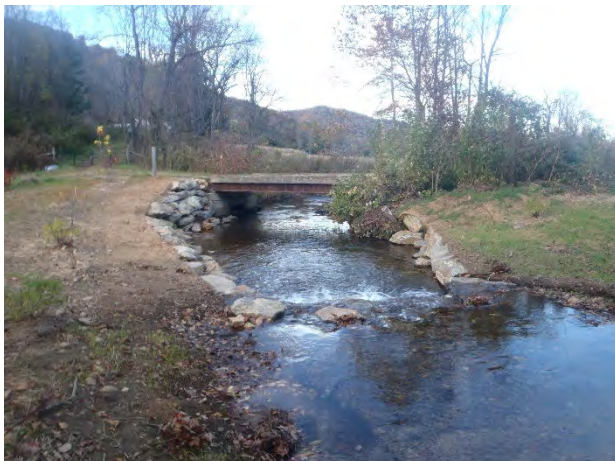
J-hook sta. 12+75, lower end of Bura/Roberson properties, 12 Nov 2014.

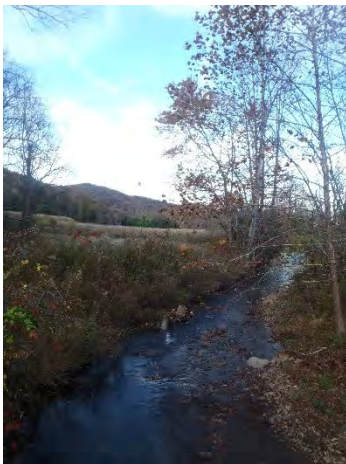
Bank shaping, log vane, and riffle construction, sta. 0+25, 12 Nov 2014.

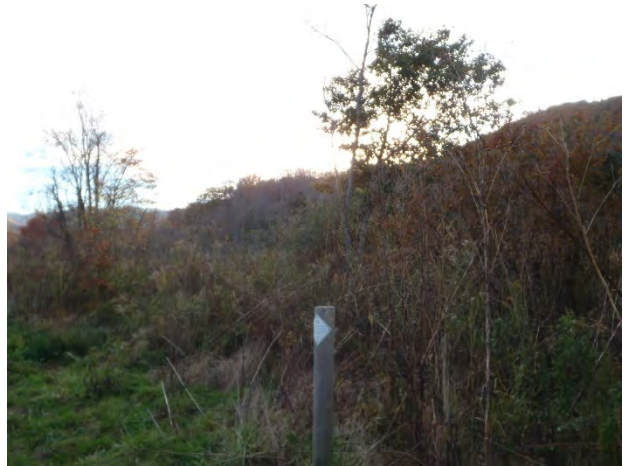
Left bank of Davis property, sta. 7+37, lower project boundary, facing upstream, 12 Nov 2014.

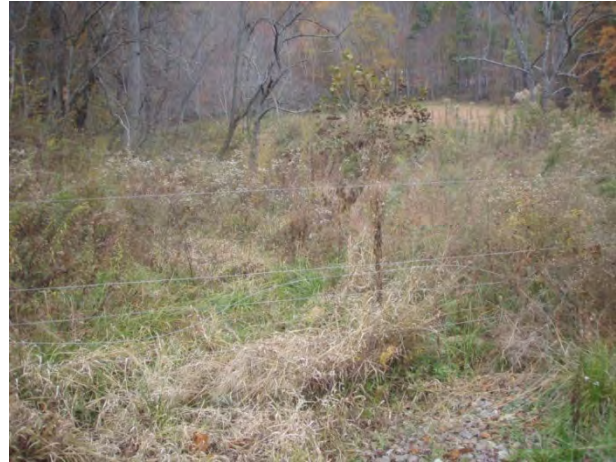
UT3 above ford, invasive removal, cattle exclusion, and bank shaping, facing upstream, 29 October 2013.

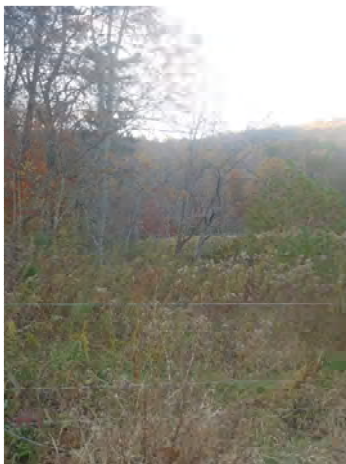
UT3 above ford, invasive removal, cattle exclusion, and bank shaping, facing upstream, 12 Nov 2014.

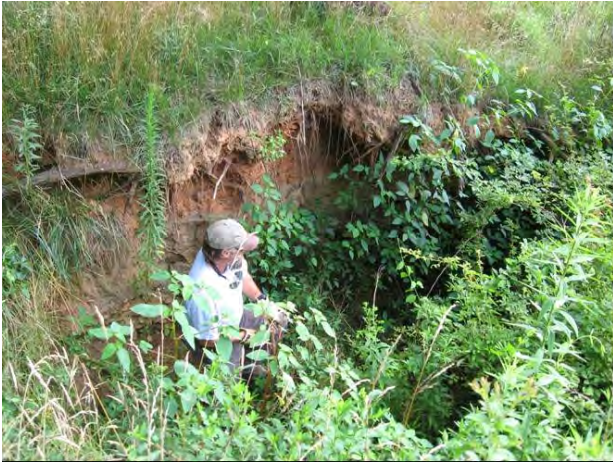
Photo Station 25

UT3 below ford, severe entrenchment and head cutting, 25 July 2008.

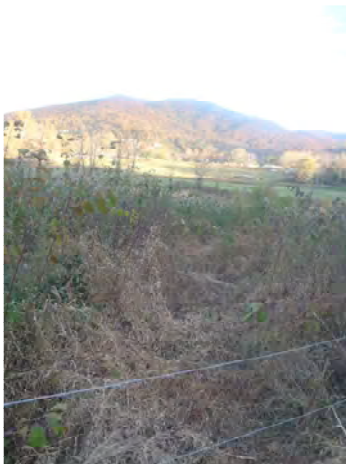
UT3 below ford, Priority I channel restoration, facing downstream, sta. 0+00, 12 Nov 2014.

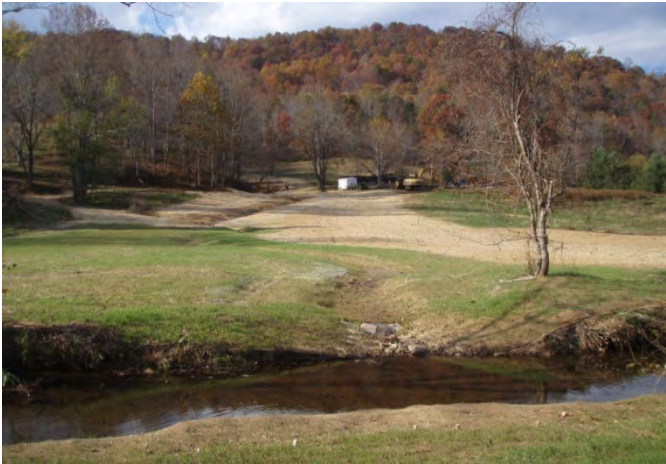
Photo Station 26

UT3 lower at confluence with SHC, Priority I restoration, facing upstream, 15 November 2011.

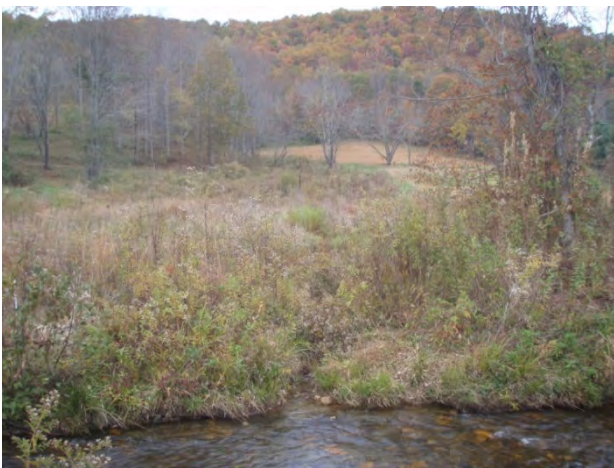
UT3 lower at confluence with SHC, Priority I restoration, facing upstream, 29 October 2013.

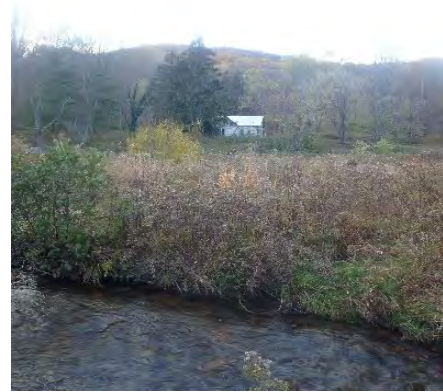
UT3 lower at confluence with SHC, Priority I restoration, facing upstream, 12 Nov 2014.

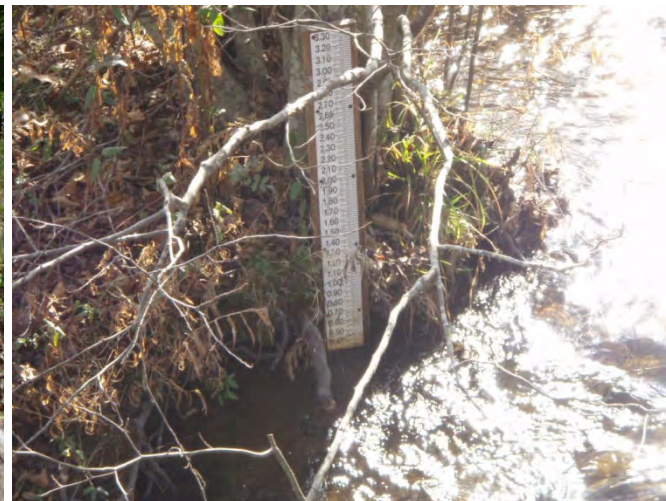
Stream gage plate, sta. 8+00, Mainstem 1 reach

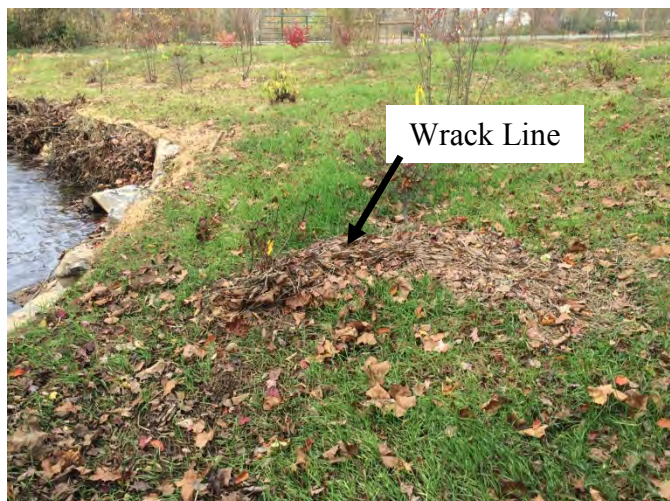
Photo 7 bankfull event on SHC, right bank Robertson property,
approximately sta.12+00 facing downstream on 28 October 2014.

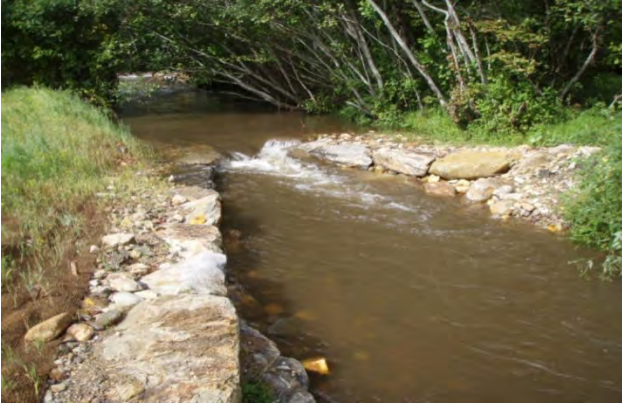
Problem Area 1

Rock vane after construction, sta. 1+50, facing upstream, 5 September 2011.

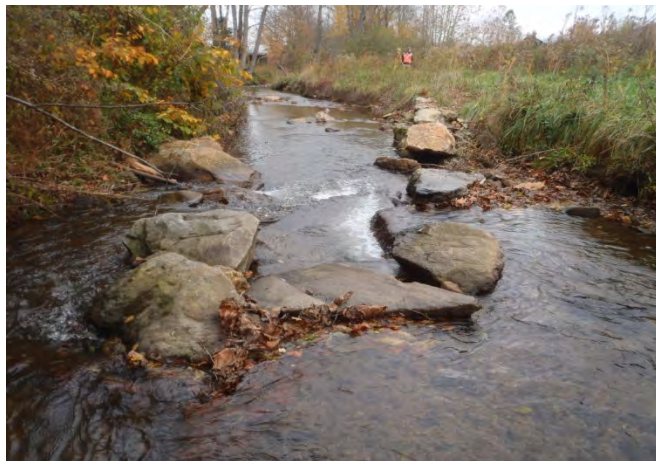
Rock vane, sta 1+50 facing downstream 28, October 2014

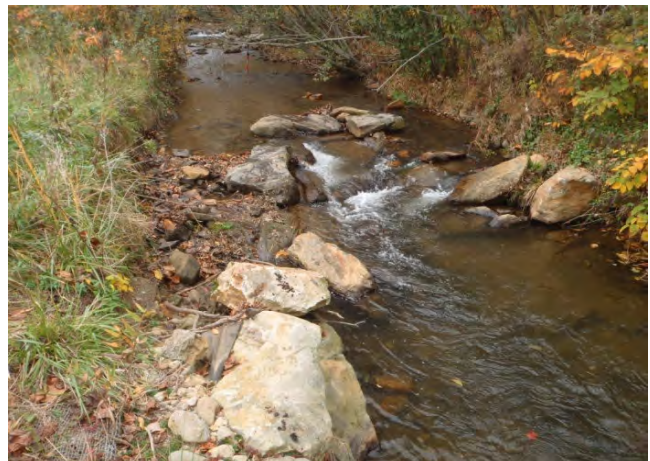
Rock vane, sta 1+50 facing upstream, 28, October 2014

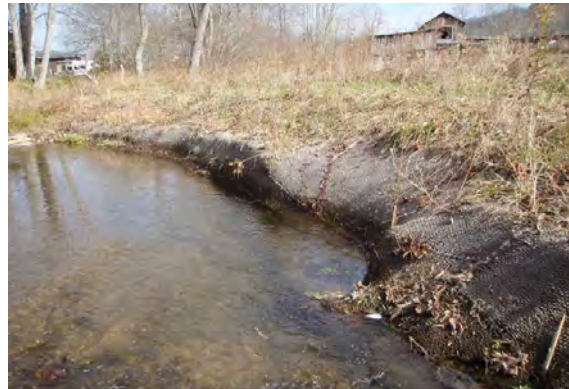
Right channel bank instability, sta. 1+75 to 2+25, facing downstream, 20 November 2012.

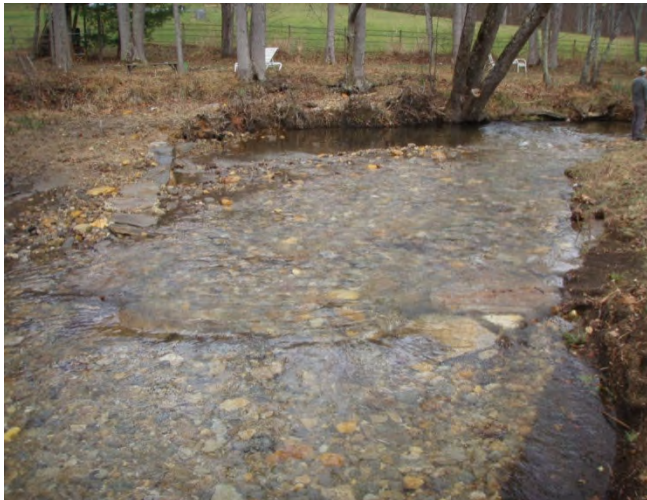
Aggradation and bar formation in meander below J-hook after flood event, sta. 2+50, facing downstream, 5 December 2011.

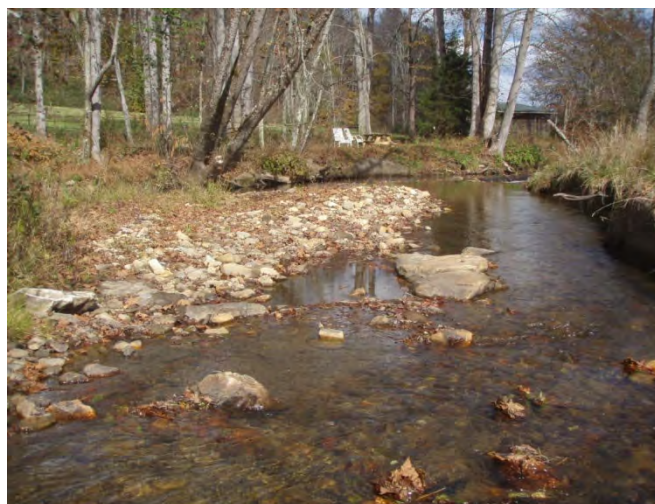
Aggradation and thalweg movement following 5 May 2013 flood, sta. 2+50, facing downstream, 29 October 2013.

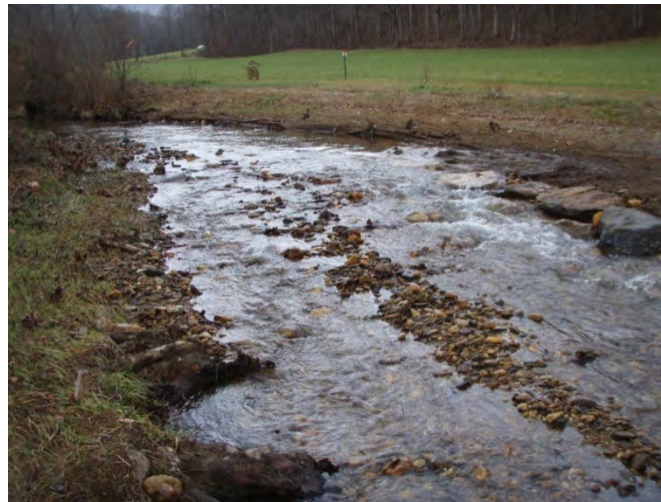
Aggradation and bar formation below J-hook, sta. 9+25 to 9+50, after flood event, facing upstream, 5 December 2011.

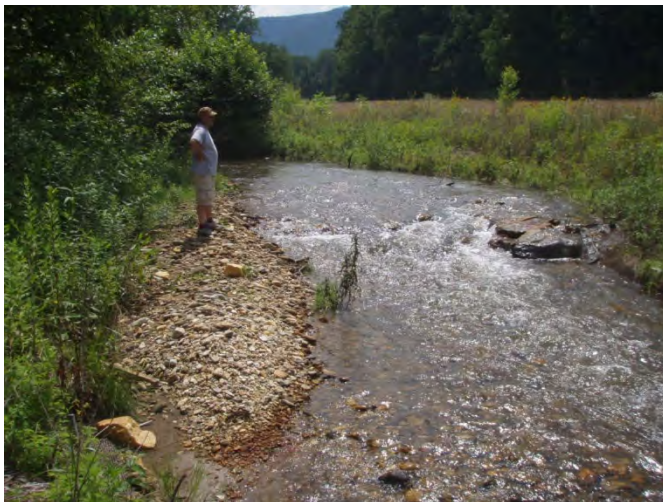
Inner berm formation below J-hook, sta. 9+25 to 9+50, following 5 May 2013 flood event, facing upstream, 18 July 2013.

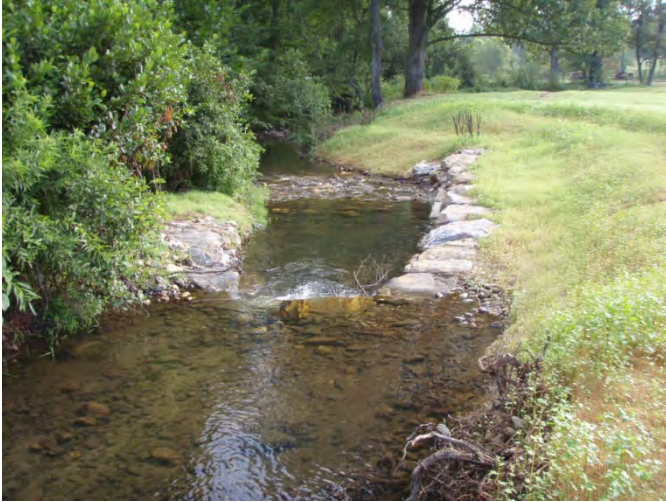
Problem Area 6

J-hook vane after construction, sta. 5+75, facing downstream, 14 August 2011.

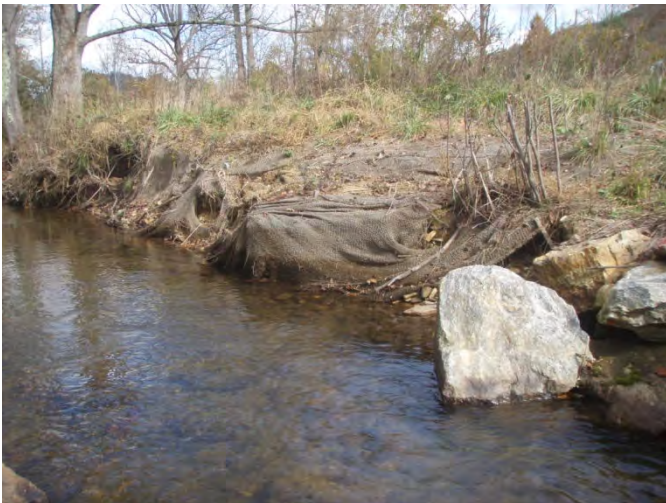
Right bank scour and erosion, sta. 6+25, facing downstream, occurred during the 5 May 2013 flood event, 29 October 2013.

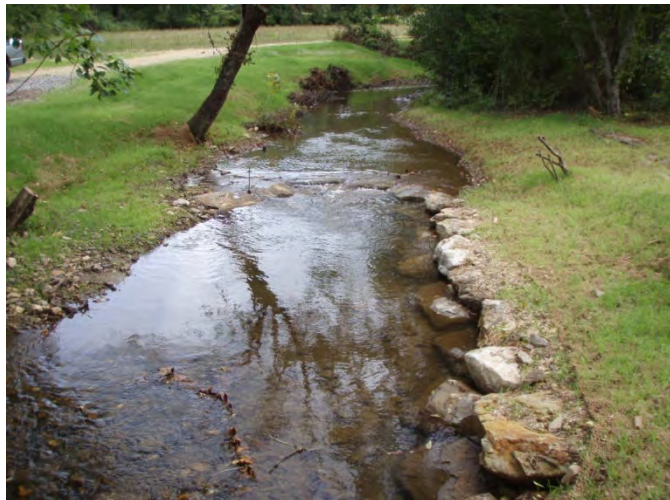
Problem Area 7

J-hook, sta. 12+75, after construction, facing upstream, 22 Sept 2011.

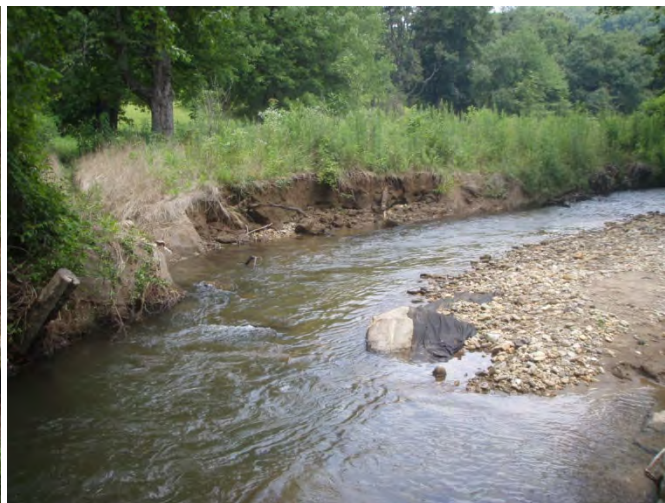
Right bank scour and erosion during 5 May 2013 flood event, facing upstream, sta. 12+50, 18 July 2013.

PA-7 station 12+75 facing upstream was repaired and is no longer considered a problem 28 October 2014

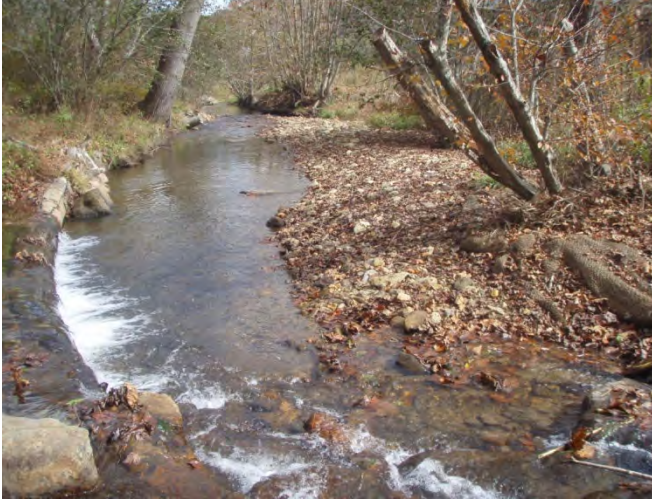
Problem Area 8

Aggradation below J-hook, sta. 4+00 to 4+50, following 5 May 2013 flood event, facing downstream, 29 October 2013.

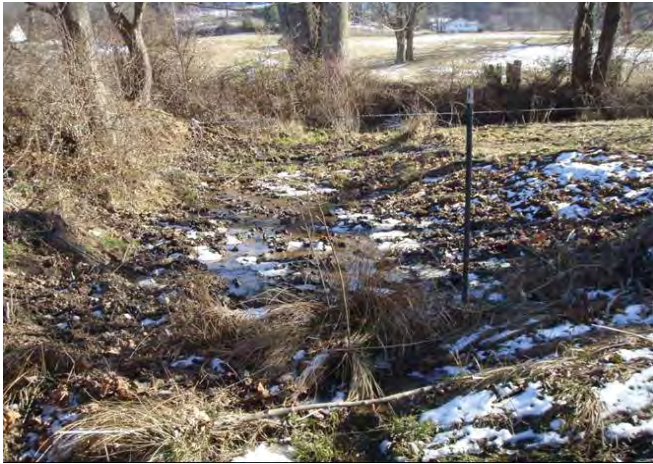
Lower portion of Wetland D, livestock impacts, facing upstream, 2009.
