Monitoring Year 4 (2015) Report

Upper South Hominy Mitigation Site, South Hominy Creek, French Broad River Basin, Buncombe County, North Carolina

DMS Project Number: 92632
Contract Number: D06082; Task Order: 08 FB05-1b-d

Data Collected: April - November 2015
Submitted: December 2015

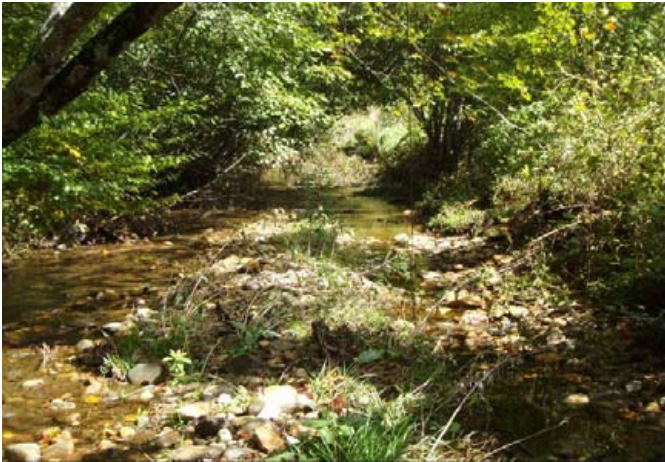
Photo Station 1

Mid channel bar, sta. 0+50, facing downstream, pre-construction.
 30 September 2008.

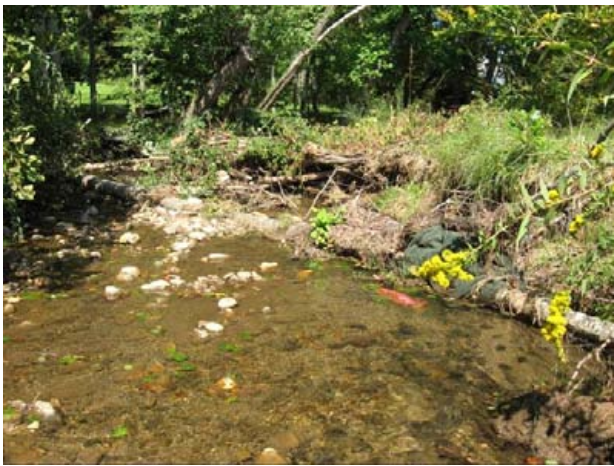
Photo Station 2

Channel blockage, sta.2+50, facing downstream, pre-construction, 30 September 2008.

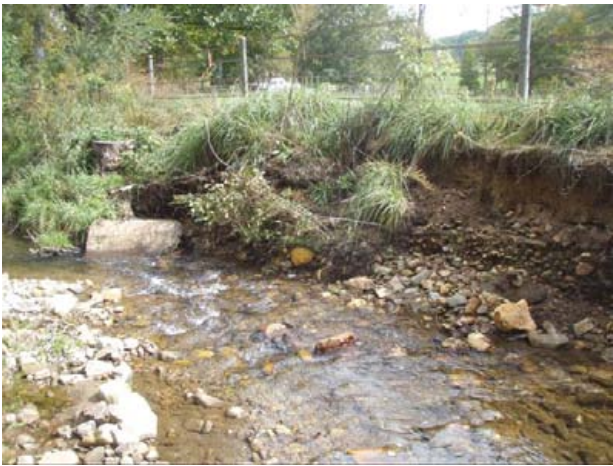
Photo Station 3

Right bank erosion, sta. 5+50, pre-construction, 30 September 2008.

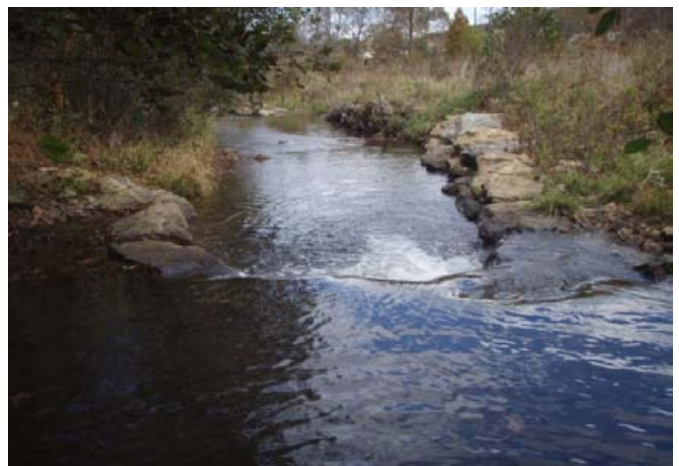
J-hook, sta. 5+00, facing downstream, 29 October 2013.

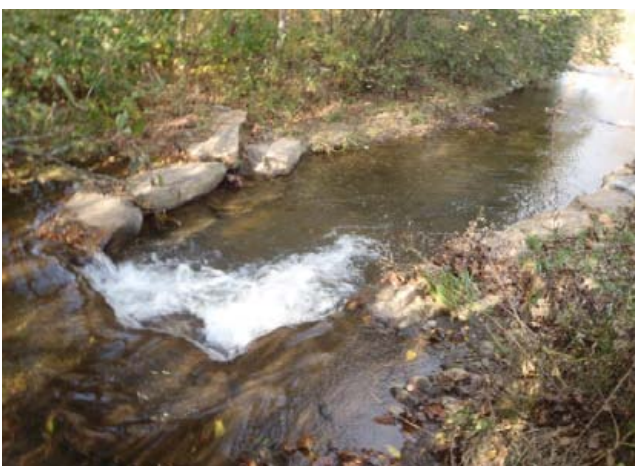
J-hook, sta. 5+00, facing downstream, 12 November 2014.

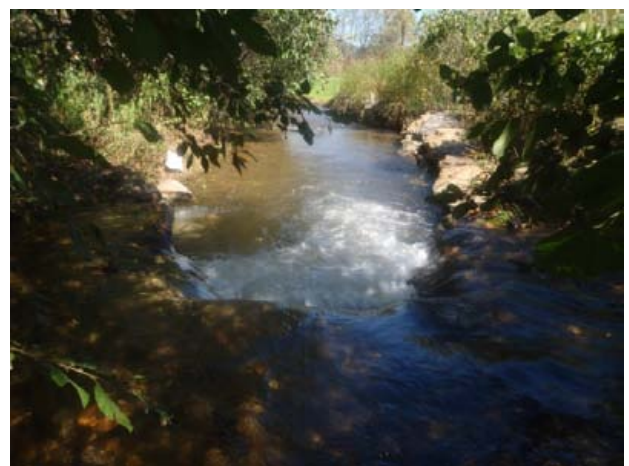
J-hook, sta. 5+00, facing downstream, 14 October 2015.

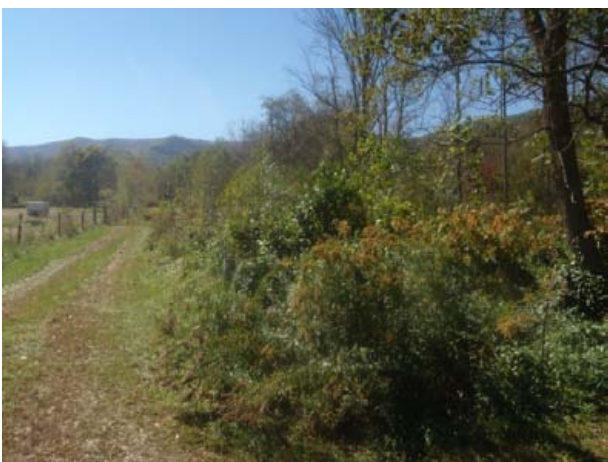
Sta. 6+50 to 8+00, right bank facing upstream, 14 October 2015.

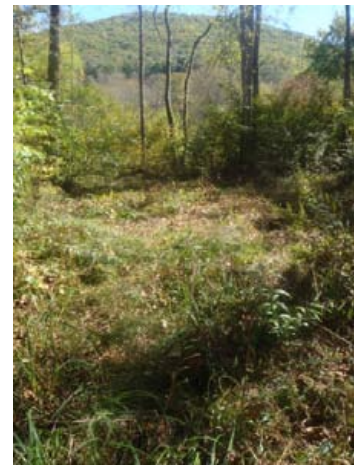
UT1 Priority I construction, above vernal pond, 14 October 2015.

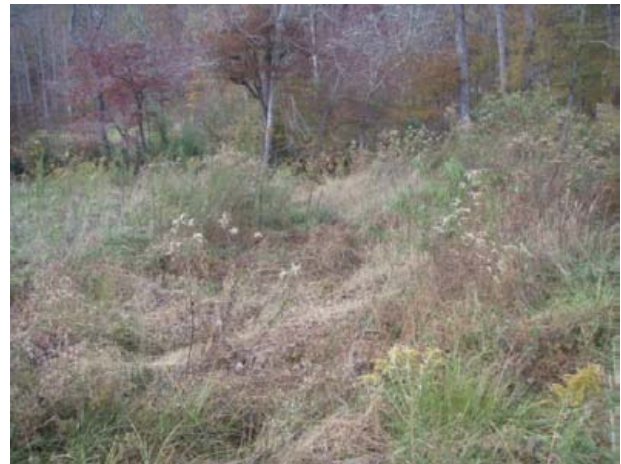
Lower portion of UT2, facing downstream, 29 October 2013.

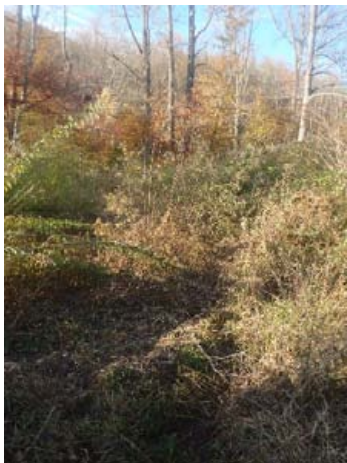
Lower portion of UT2, facing downstream, 12 Nov 2014.

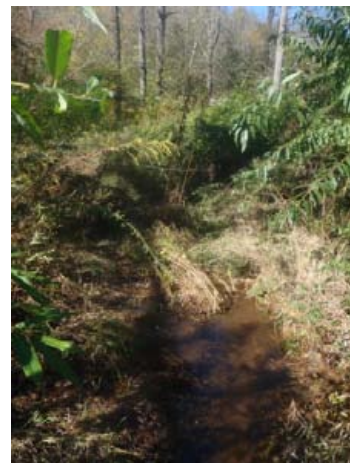
Lower portion of UT2, facing downstream, 14 October 2015.

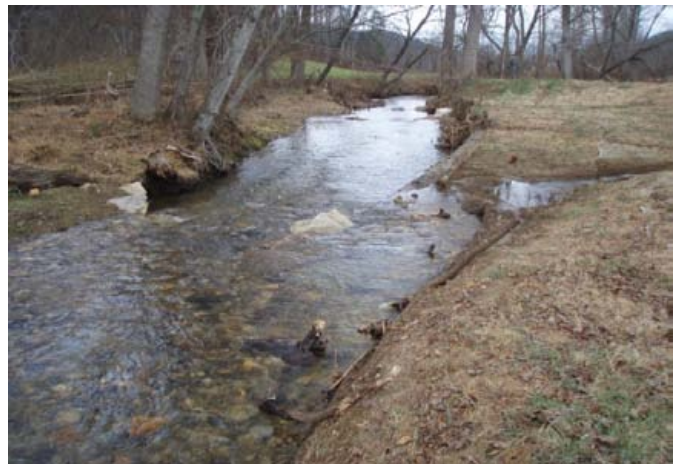
Log vane sta. 1+00 to 1+50, facing downstream

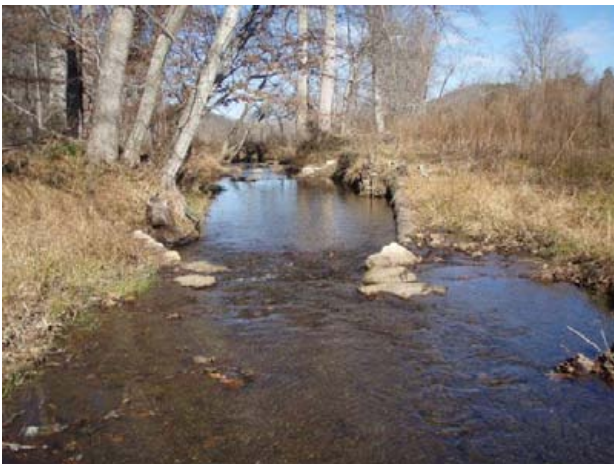
Log vane sta. 1+00 to 1+50, facing downstream, 20 November 2012.

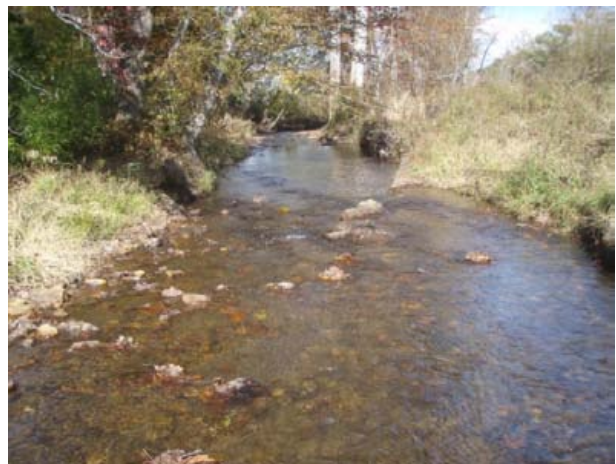
Log vane sta. 1+00 to 1+50, facing downstream, 29 October 2013.

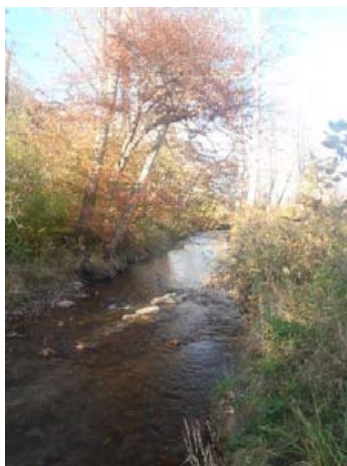
Log vane sta. 1+00 to 1+50, facing downstream, 12 Nov 2014.

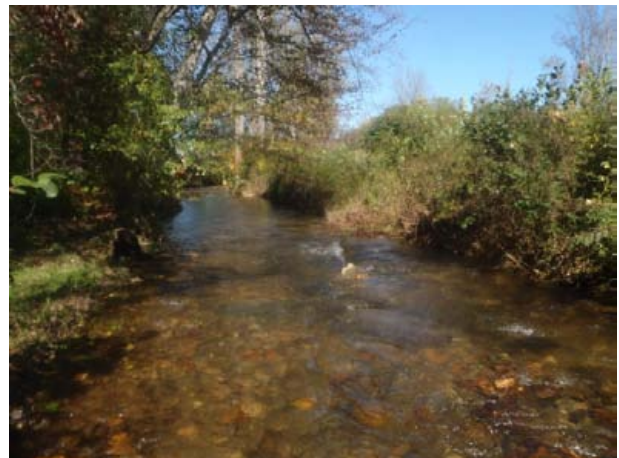
Log vane sta. 1+00 to 1+50, facing downstream, 14 October 2015.

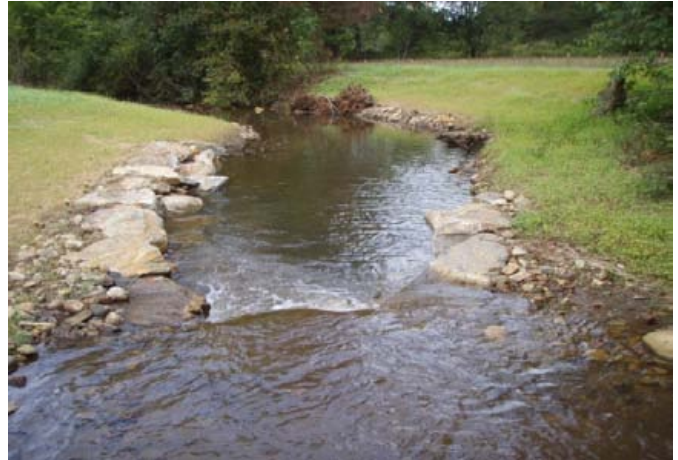
Bank sloping and J-hook, sta. 9+25 to 10+00, 22 September 2011.

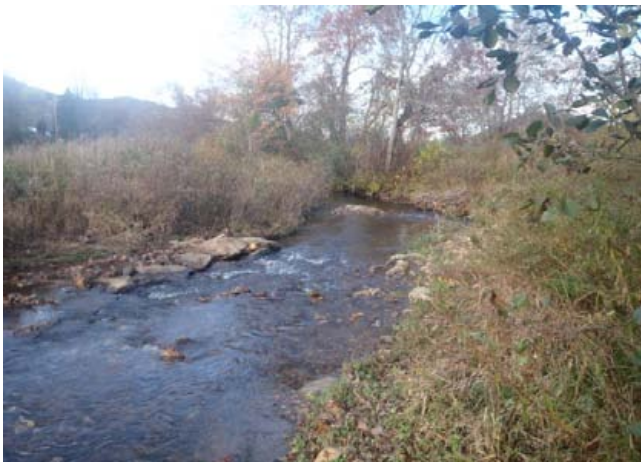
Bank sloping and J-hook, sta. 9+25 to 10+00, 12 Nov 2014.

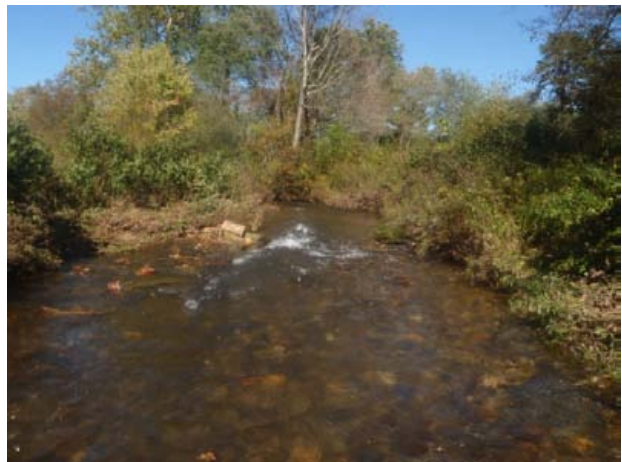
Bank sloping and J-hook, sta. 9+25 to 10+00, 12 Nov 2014.

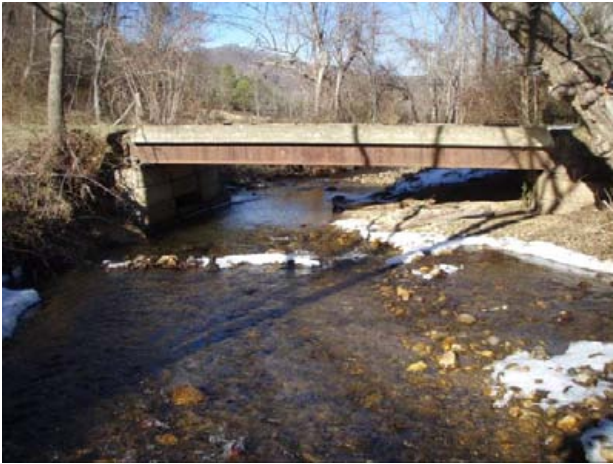
Driveway bridge at lower end of Bura/Roberson properties, sta. 12+50, facing downstream, 22 January 2009.

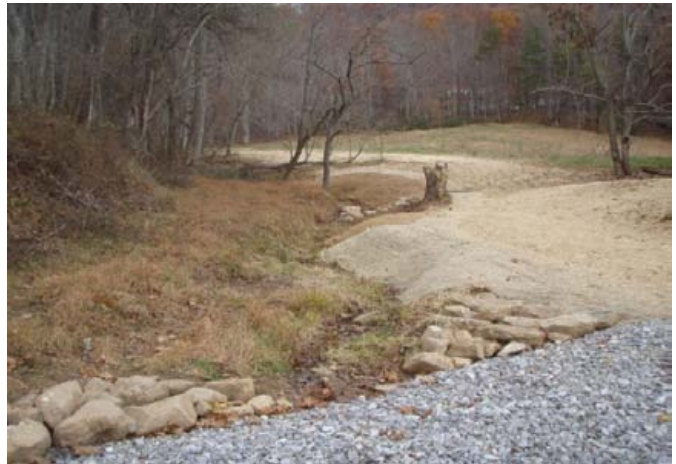
UT3 above ford, invasive removal, cattle exclusion, and bank shaping, facing upstream, 9 November 2011.

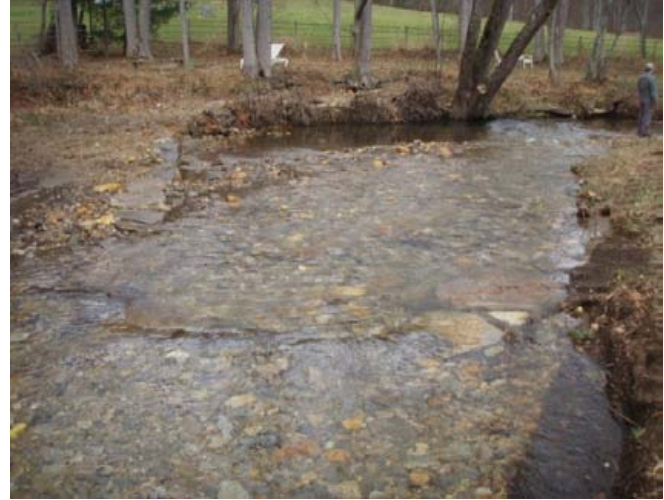
Aggradation and bar formation in meander below J-hook after flood event, sta. 2+50, facing downstream, 5 December 2011.

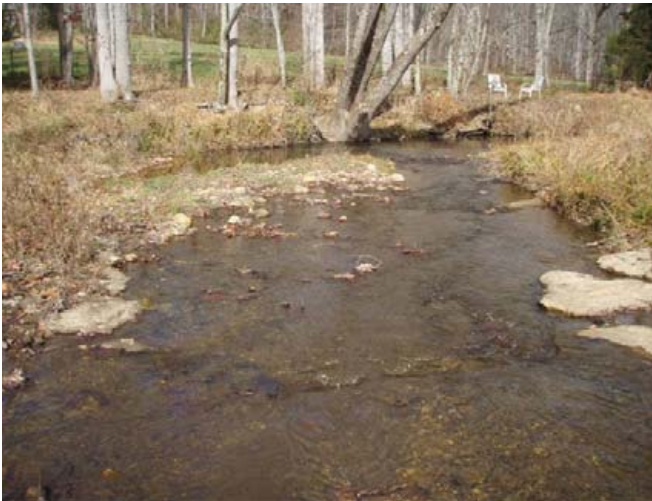
Aggradation and bar formation in meander below J-hook, sta. 2+50, facing downstream, 20 November 2012.

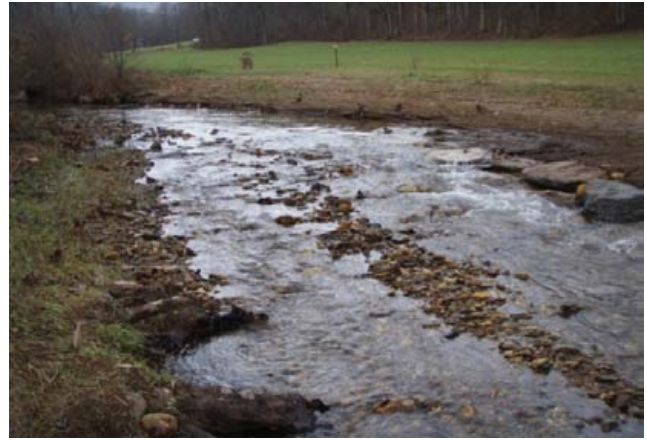
Aggradation and bar formation below J-hook, sta. 9+25 to 9+50, after flood event, facing upstream, 5 December 2011.

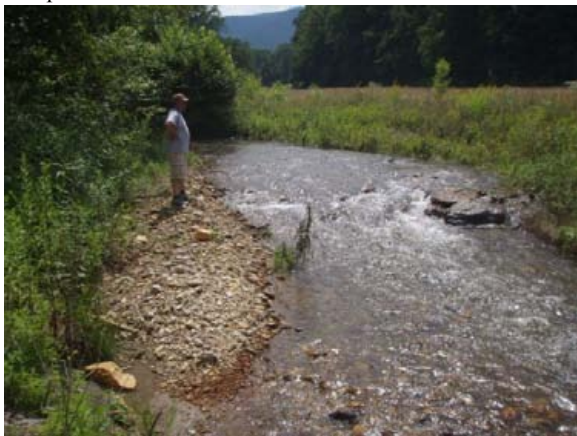
Inner berm formation below J-hook, sta. 9+25 to 9+50, following 5 May 2013 flood event, facing upstream, 18 July 2013.

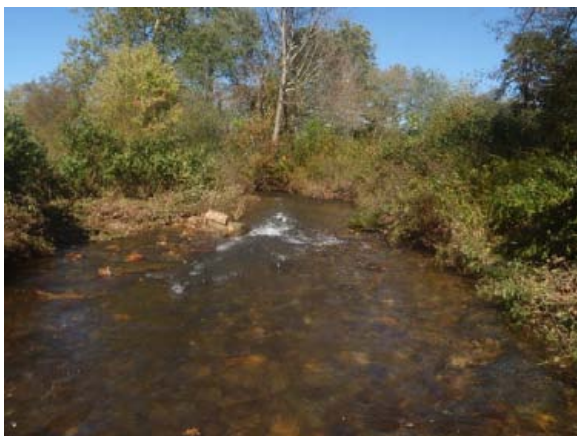
Aggradation and bar formation below J-hook, sta. 9+25 to 9+50, following 5 May 2013 flood event, facing downstream, 14 October 2015.

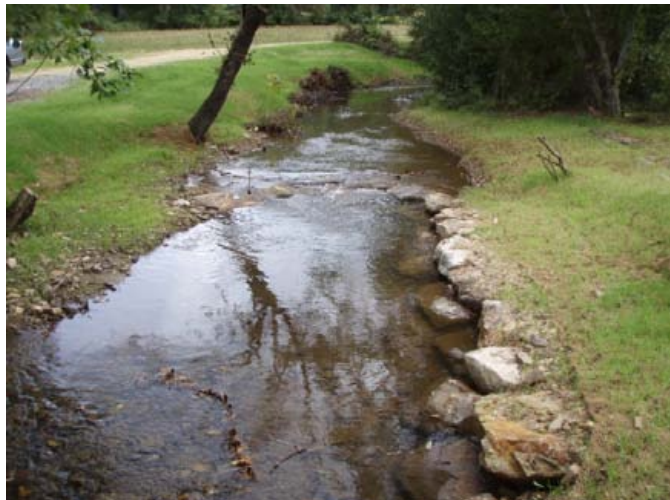
Problem Area 7

J-hook, sta. 12+75, after construction, facing upstream, 22 Sept 2011.

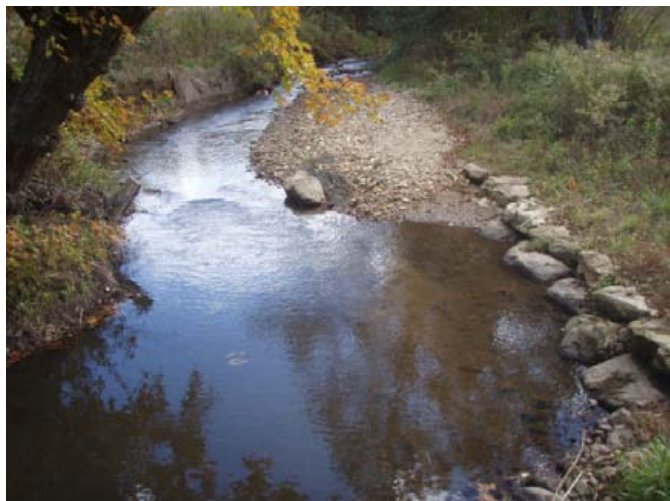
J-hook after 5 May 2013 flood event, aggradation above J-hook and scour pool below, 29 October 2013.

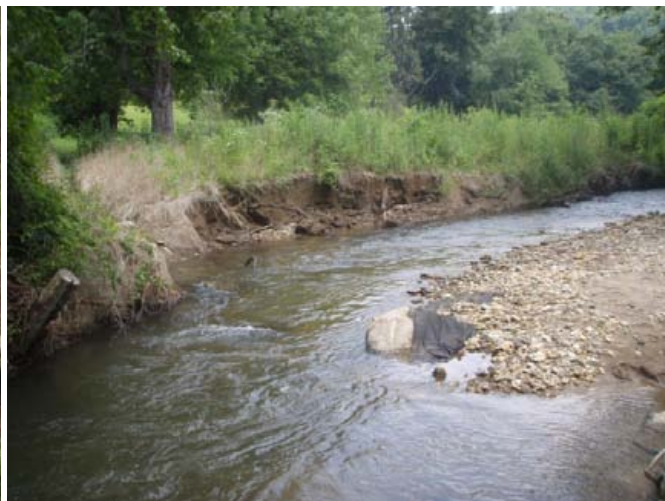
Right bank scour and erosion during 5 May 2013 flood event, facing upstream, sta. 12+50, 18 July 2013.

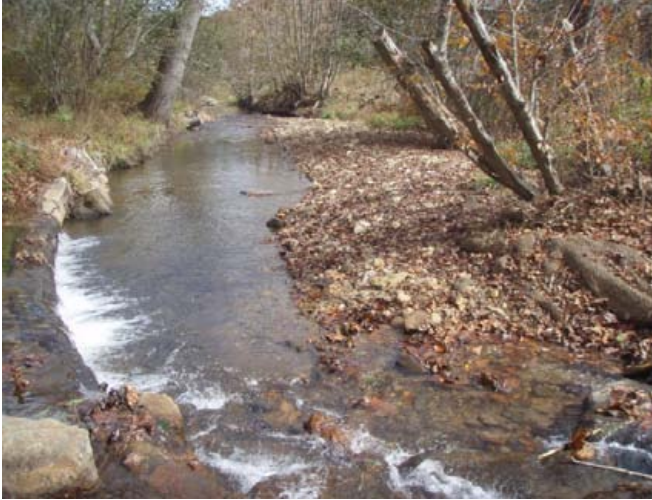
Problem Area 8

Aggradation below J-hook, sta. 4+00 to 4+50, following 5 May 2013 flood event, facing downstream, 29 October 2013.

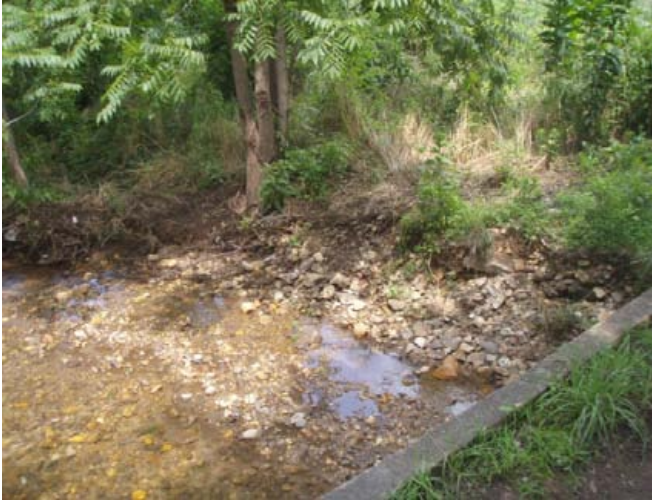
Problem Area 9

Right bank scour during 5 May 2013 flood event, sta. 0+00 to 0+20, facing downstream, 18 July 2013.

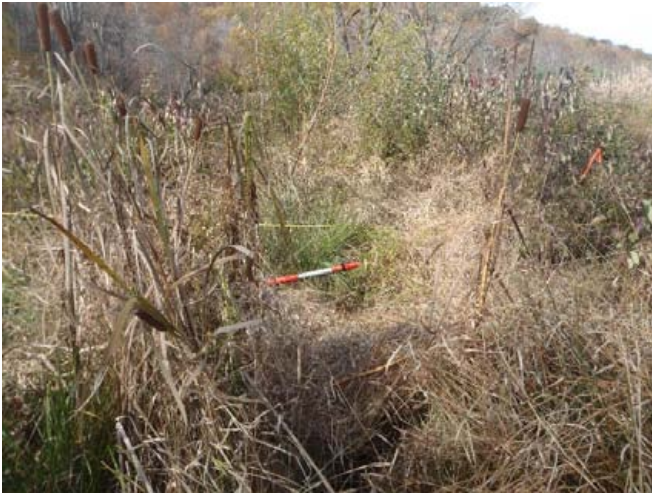
Problem Area 10

Aggradation due to low flow velocity and dense herbaceous vegetation, sta. 0+00 to 2+00 UT-3 Upper Davis Reach, facing upstream, 28 October 2014.

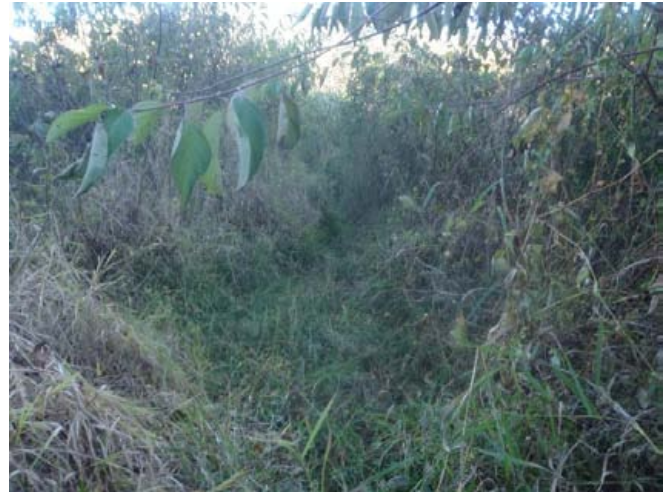
Aggradation due to low flow velocity and dense herbaceous vegetation, sta. 0+00 to 2+00 UT-3 Upper Davis Reach, facing downstream, 15 October 2015.

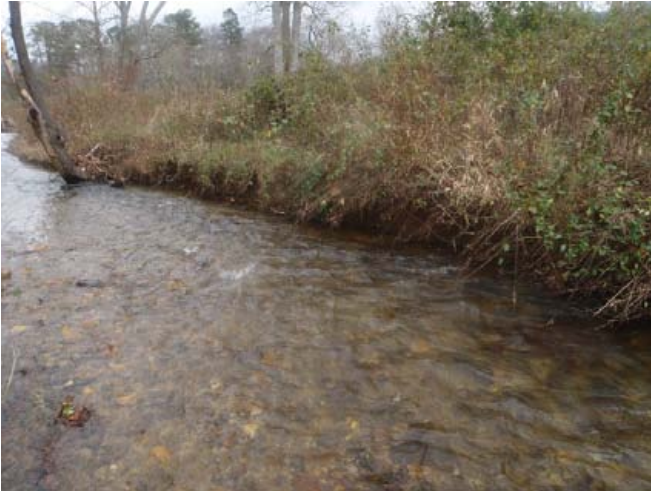
Problem Area 11

Right bank erosion due to high flow events, sta. 5+05 to 6+10 facing downstream, 17 November 2015.

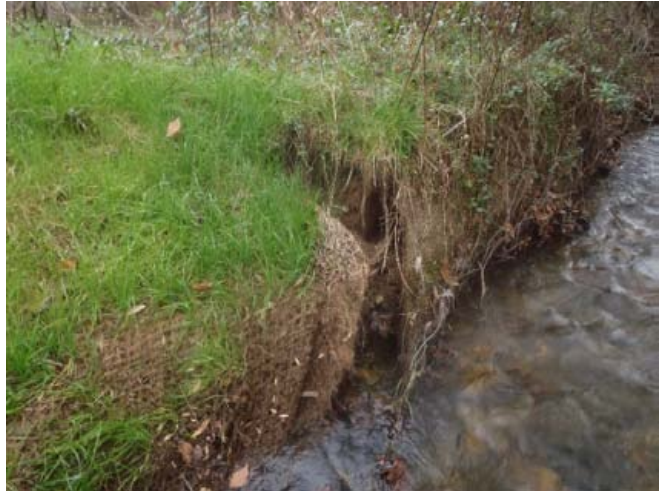
Right bank erosion due to high flow events, sta. 5+05 to 6+10 facing upstream, 17 November 2015
