UT to Magness Creek Mitigation Project

Year 1 (2023) Monitoring Report FINAL

Cleveland County, North Carolina

DMS Project ID No. 100081

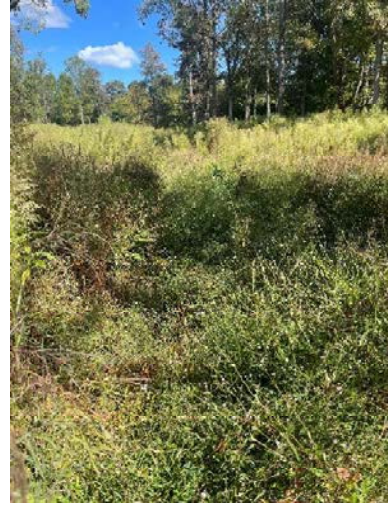
PP-10: Reach 1A, Upstream, Station 18+50. October 2, 2023

General: As discussed in the MY0 IRT comments, the IRT would like a condition update and additional photos at Photo Point 10 where there was a reported mid-channel bar (see IRT comments (E. Davis) for further detail).

RESPONSE: The mid-channel bar was repaired by hand using shovels to fill in one side of the split channel. A photo of the repair is shown in Appendix B, Monitoring Gauges and Additional Photographs, Page 2. The photo was taken on December 6, 2023 and at that time the repair appeared to be intact, with the channel maintaining a single thread.

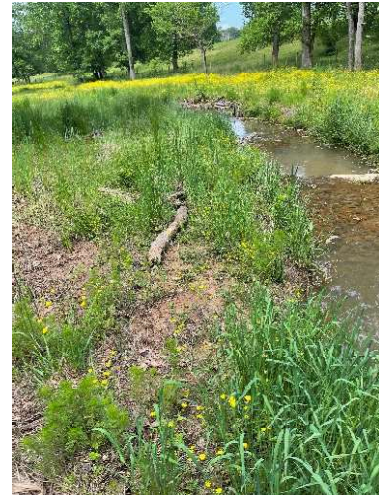
Overbank evidence. Debris in upper Reach 1B floodplain (Photo taken May 11, 2023)

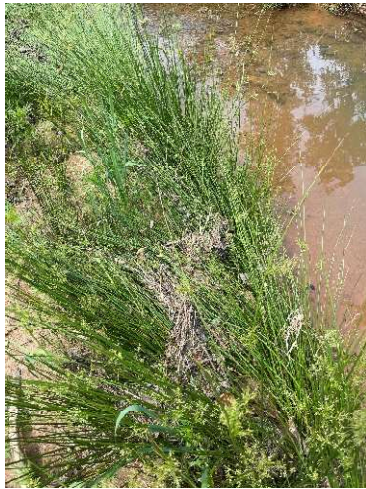
Overbank evidence. Debris in lower Reach 1A floodplain. (Photo taken May 11, 2023)

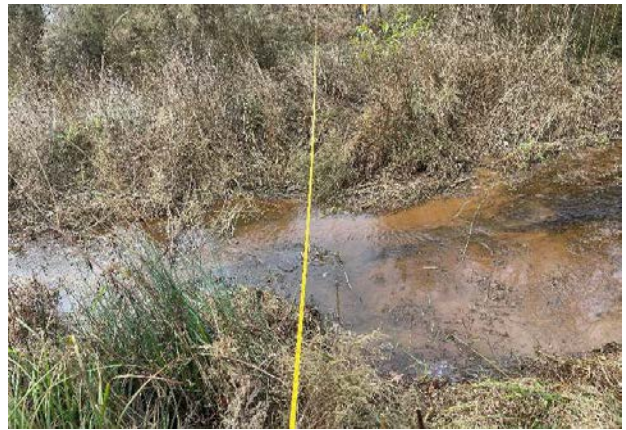
Looking at the Right Bank

Feature	Stream Type	BKF Area	BKF Width	BKF Depth	Max BKF Depth	W/D	BH Ratio	ER	BKF Elev	LTOB Elev
Riffle	C4	12.4	13.6	0.9	1.4	15.0	1.1	2.5	871.86	872.00

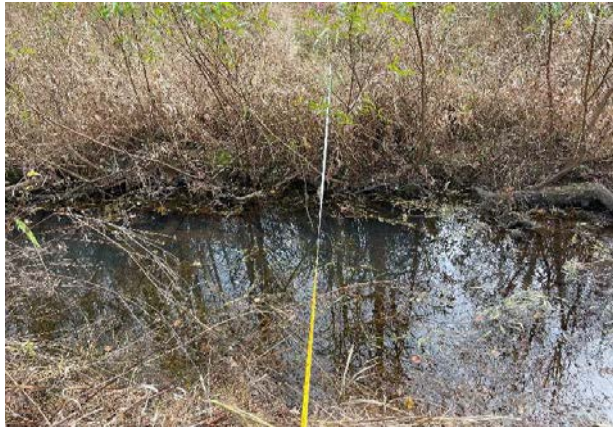
Looking at the Left Bank

Feature	Stream Type	BKF Area	BKF Width	BKF Depth	Max BKF Depth	W/D	BH Ratio	ER	BKF Elev	LTOB Elev
Pool	C4	21.6	17.7	1.2	2.9	14.5	--	--	869.61	869.56

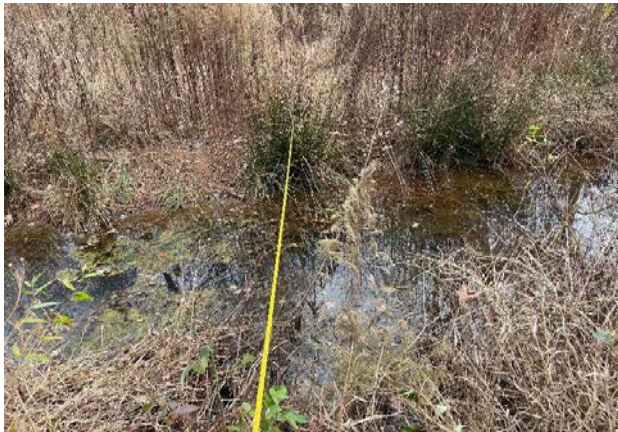
Looking at the Left Bank

Feature	Stream Type	BKF Area	BKF Width	BKF Depth	Max BKF Depth	W/D	BH Ratio	ER	BKF Elev	LTOB Elev
Pool	C4	30.2	15.4	2.0	3.3	7.8	--	--	865.67	865.67

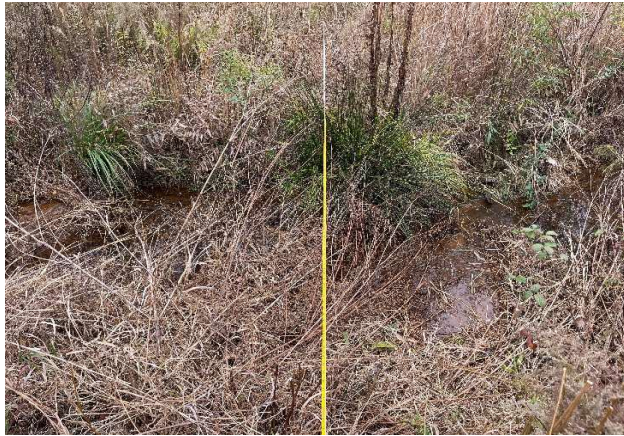
Looking at the Left Bank

Feature	Stream Type	BKF Area	BKF Width	BKF Depth	Max BKF Depth	W/D	BH Ratio	ER	BKF Elev	LTOB Elev
Riffle	C4	10.3	10.3	1.0	1.6	10.3	1.0	4.0	863.58	863.71

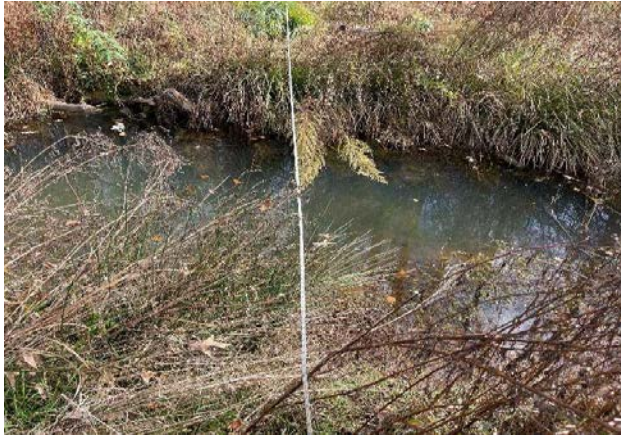
Looking at the Left Bank

Feature	Stream Type	BKF Area	BKF Width	BKF Depth	Max BKF Depth	W/D	BH Ratio	ER	BKF Elev	LTOB Elev
Pool	C4	33.2	24.5	1.4	4.0	18.1	--	--	857.17	856.90

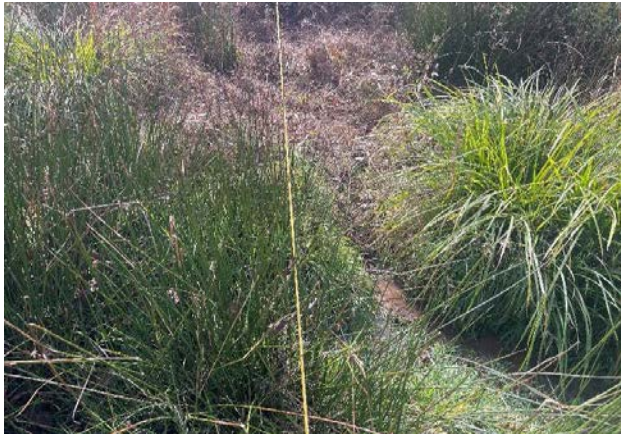
Looking at the Left Bank

Feature	Stream Type	BKF Area	BKF Width	BKF Depth	Max BKF Depth	W/D	BH Ratio	ER	BKF Elev	LTOB Elev
Pool	B4	5.8	8.1	0.7	1.2	11.4	--	--	856.97	856.94
