**FINAL**  
**ANNUAL MONITORING REPORT**  
**YEAR 4 (2015)**  
**UT TO BALD STREAM/WETLAND RESTORATION SITE**  
**YANCEY COUNTY, NORTH CAROLINA**  
**(DMS Project No. 92596, Contract No. 4997)**  
**Construction Completed December 2011**

December 2015

Prepared by:  
Axiom Environmental, Inc.  
218 Snow Avenue  
Raleigh, North Carolina 27603

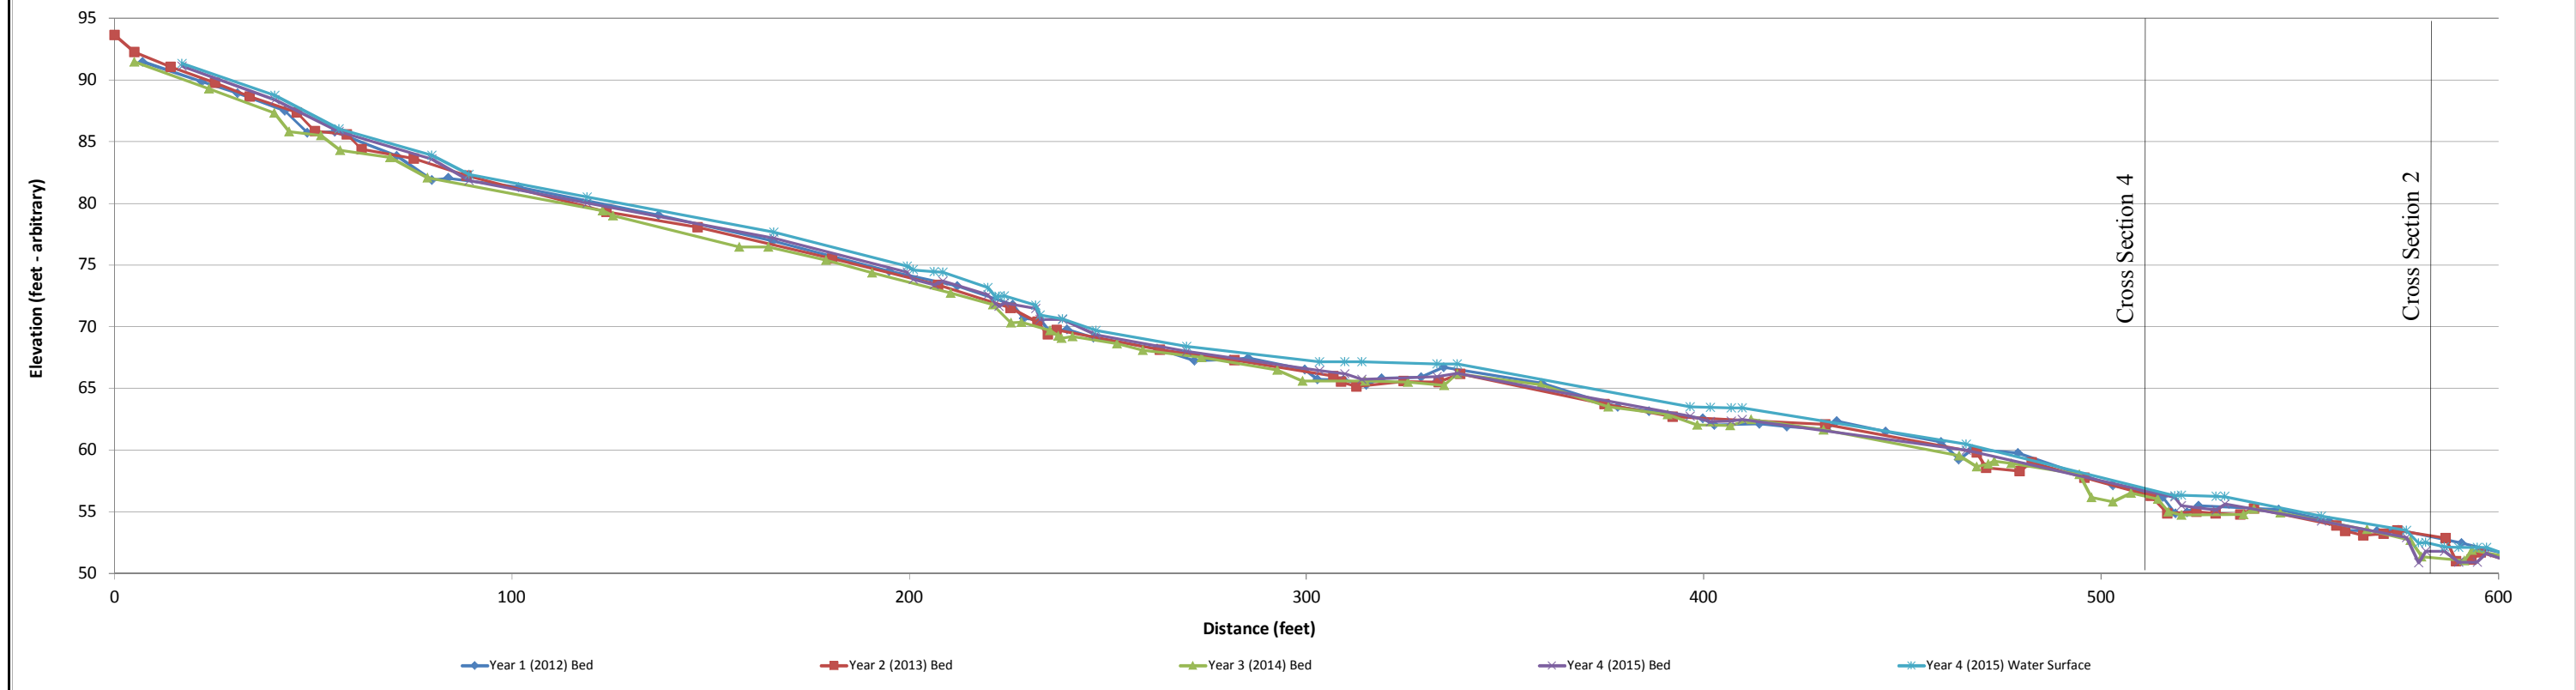
UT to Bald Creek Year 4 (2015) Profile - Mainstem, Station 00+00 to 06+00

2012	2013	2014	2015	2016
Avg. Water Surface Slope	0.0558	0.0540	0.0556	0.0542	
Riffle Length	37	35	27	34	
Avg. Riffle Slope	0.0509	0.0609	0.0715	0.0630	
Pool Length	13	12	17	11	
Pool to Pool Spacing	40	38	38	44

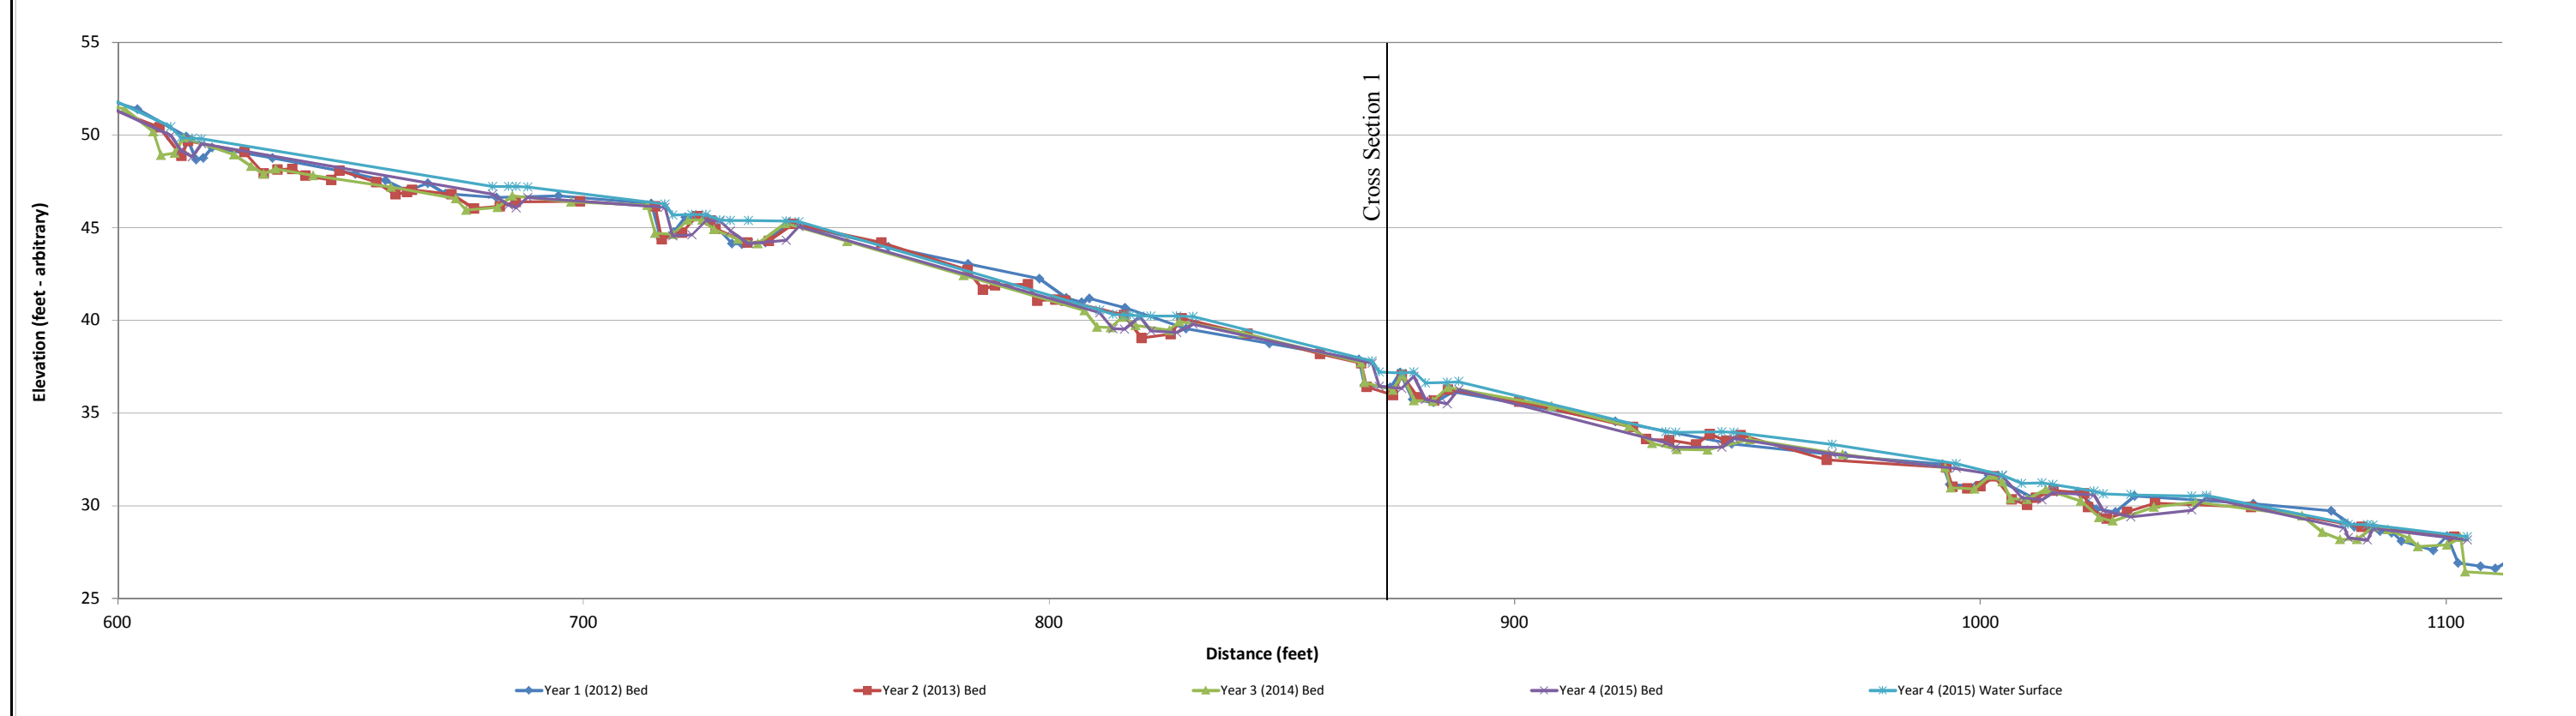
UT to Bald Creek Year 4 (2015) Profile - Mainstem, Station 06+00 to 11+12

2012	2013	2014	2015	2016
Avg. Water Surface Slope	0.0558	0.0540	0.0556	0.0542	
Riffle Length	37	35	27	34	
Avg. Riffle Slope	0.0509	0.0609	0.0715	0.0630	
Pool Length	13	12	17	11	
Pool to Pool Spacing	40	38	38	44

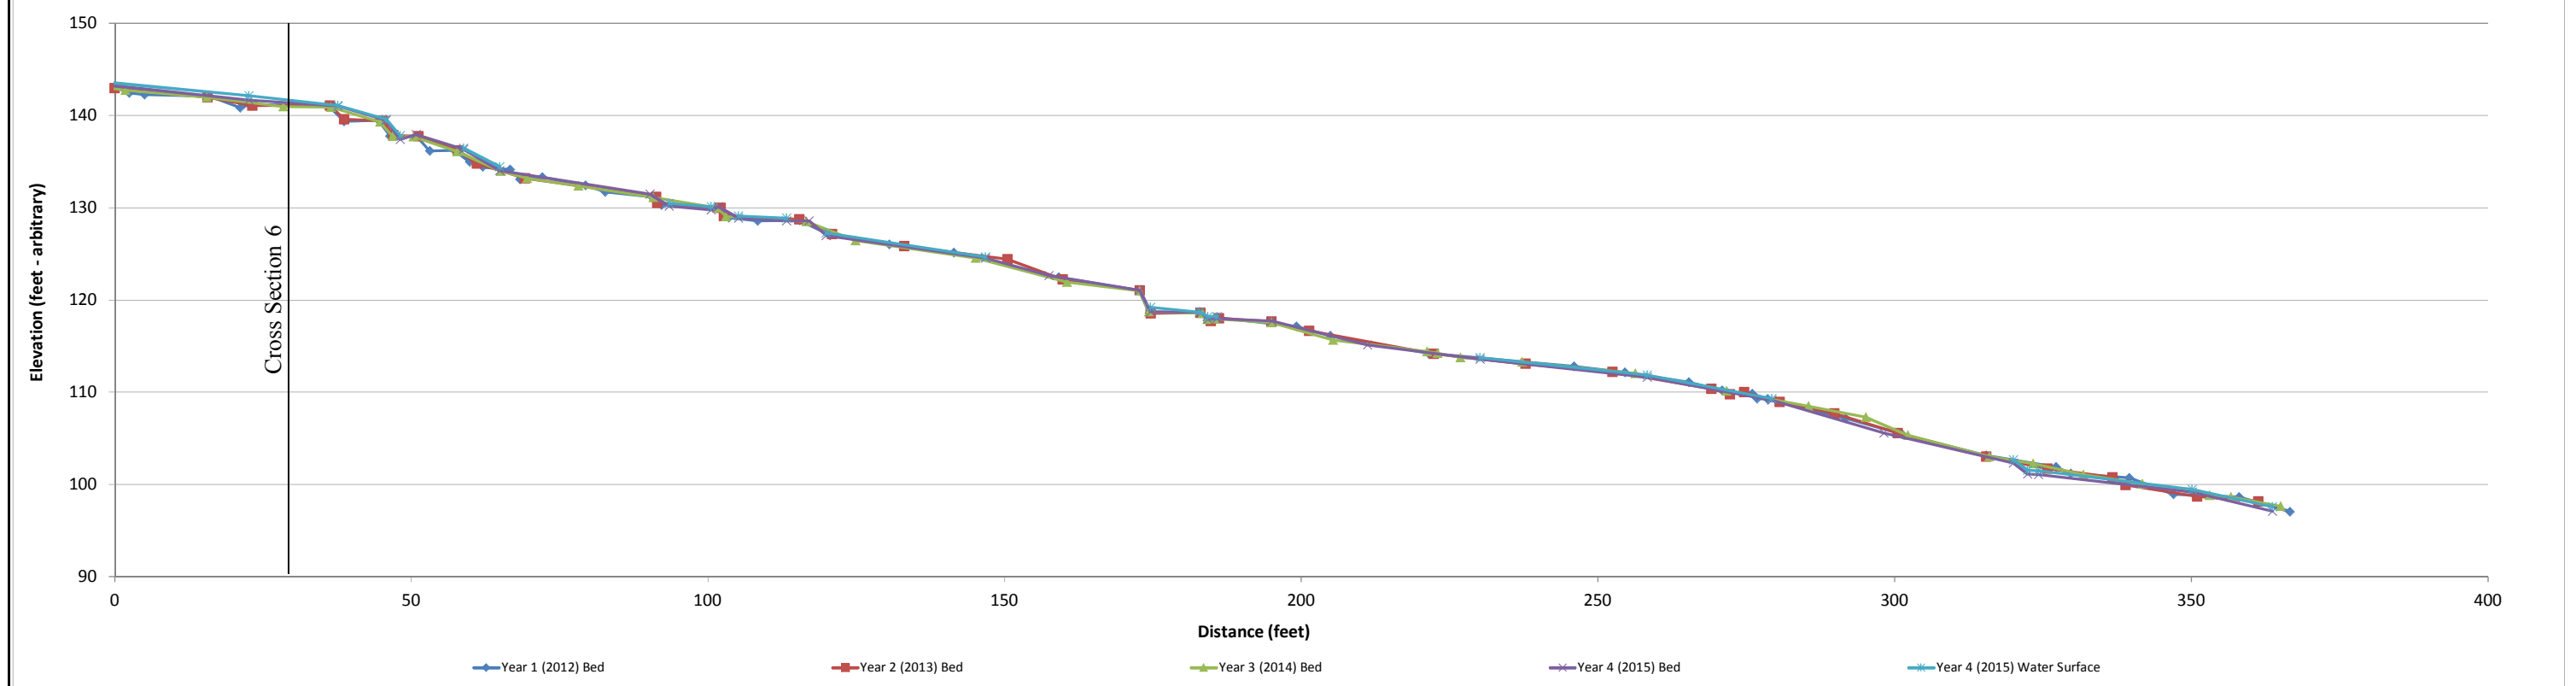
UT to Bald Creek Year 4 (2015) Profile - Mainstem Upstream, Station 00+00 to 04+00

2012	2013	2014	2015	2016
Avg. Water Surface Slope	0.1301	0.1313	0.1315	0.1324	
Riffle Length	16	43	75	42	
Avg. Riffle Slope	0.0750	0.0846	0.0953	0.0927	
Pool Length	5	2	6	4	
Pool to Pool Spacing	14	46	102	59

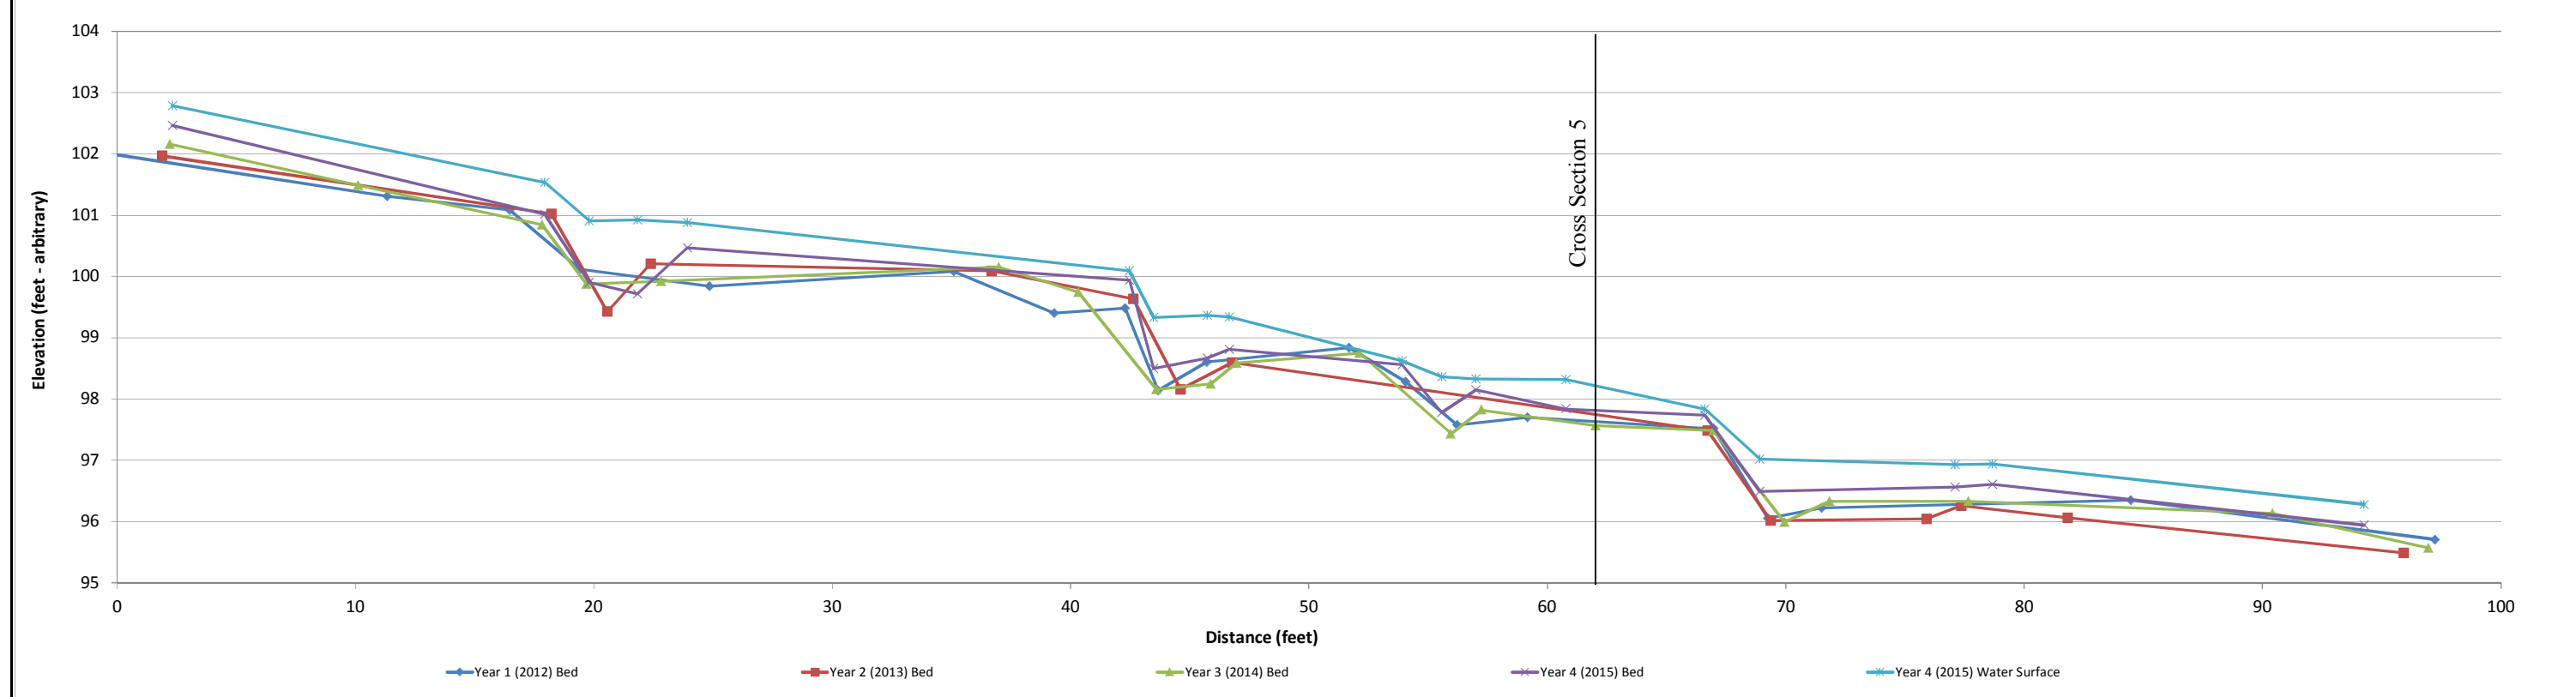
UT to Bald Creek Year 4 (2015) Profile - Tributary 1, Station 00+00 to 01+00

Avg. Water Surface Slope	2012	2013	2014	2015	2016
Riffle Length	0.0674	0.0782	0.0679	0.0766	
Avg. Riffle Slope	7	19	14	13	
Pool Length	0.0418	0.0777	0.0391	0.0631	
Pool to Pool Spacing	6	6	6	6	
	13	24	19	19

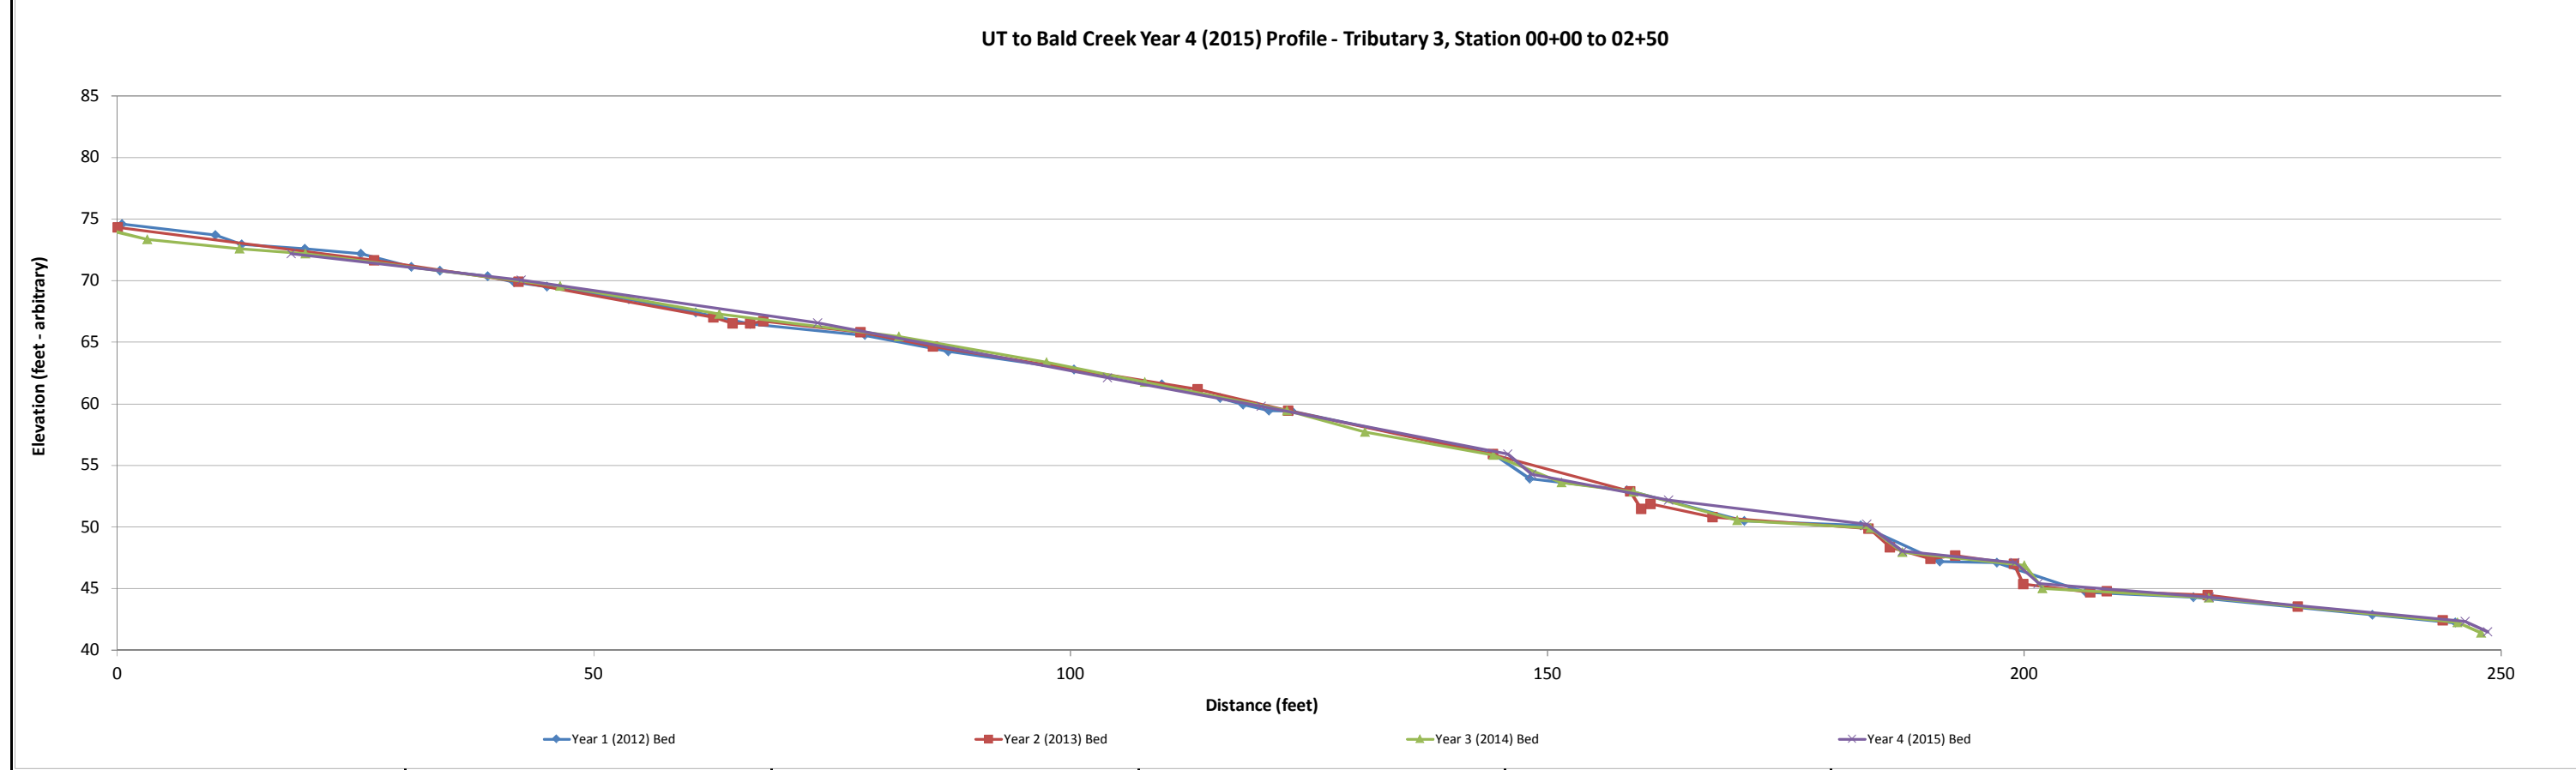
Project Name	UT to Bald Creek - Profile
Reach	Tributary 3 Station 00+00 - 02+50
Feature	Profile
Date	10/12/15
Crew	Perkinson, Jernigan

2012	2013	2014	2015	2016
Avg. Water Surface Slope	NA*	NA*	NA*	NA*	
Riffle Length	25	44	33	19	
Avg. Riffle Slope	NA*	NA*	NA*	NA*	
Pool Length	18	7	10	16	
Pool to Pool Spacing	28	45	25	25

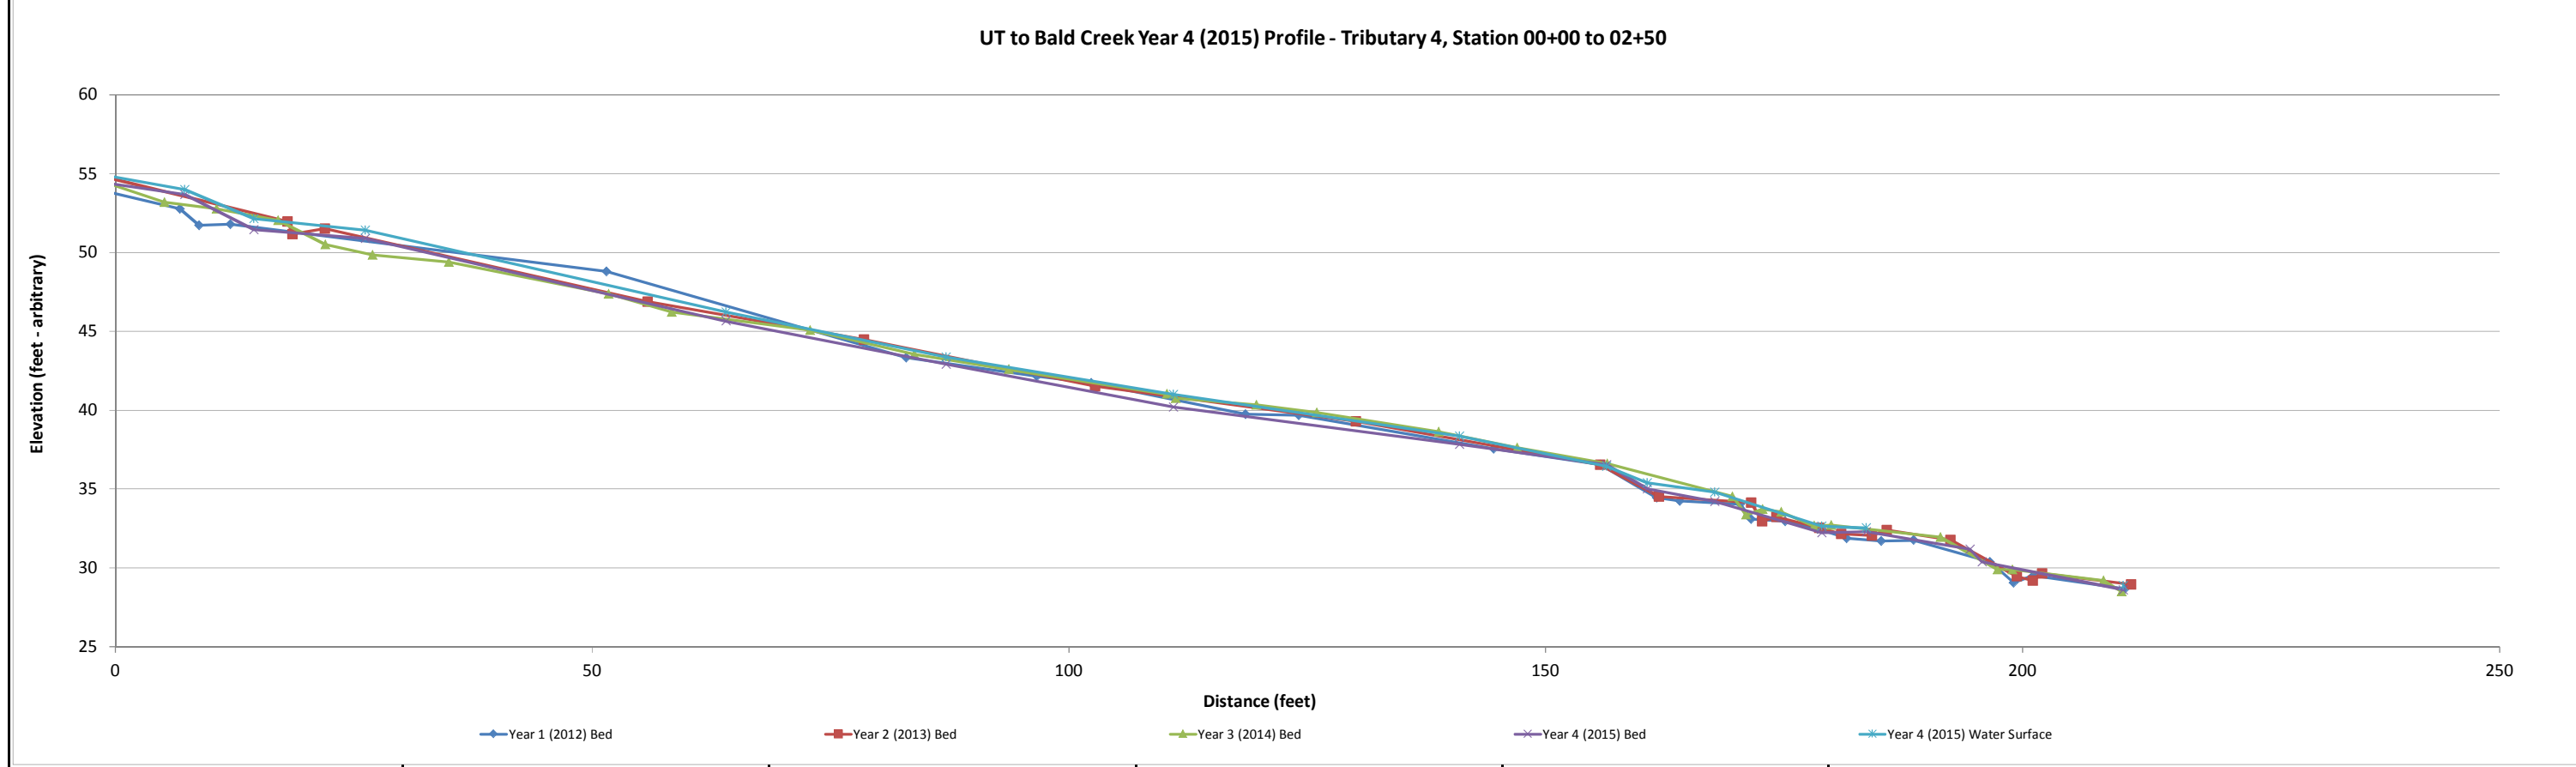
Project Name	UT to Bald Creek - Profile
Reach	Tributary 4 Station 00+00 - 02+50
Feature	Profile
Date	10/12/15
Crew	Perkinson, Jernigan

Avg. Water Surface Slope	2012	2013	2014	2015	2016
Riffle Length	0.0074	0.1228	0.1147	0.1229	
Avg. Riffle Slope	23	22	11	24	
Pool Length	0.0118	0.1118	0.0814	0.1008	
Pool to Pool Spacing	34	6	5	7	
	57	13	13	21
