**UT to Barnes Creek
Stream and Wetland Restoration Project
Project No. 397
2009 Monitoring Report: Year 4 of 5**

November 2009 (Revised May 2010)

Prepared by: Jordan, Jones & Goulding
9101 Southern Pine Blvd., Suite 160
Charlotte, NC 28273

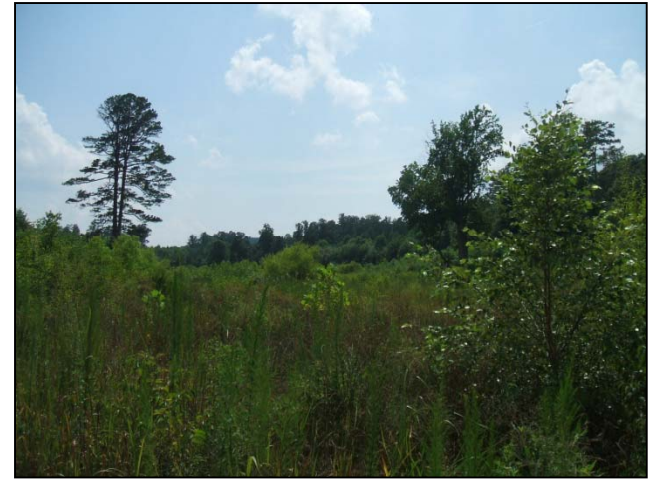
E-2 View West (8/2009)
