Cane Creek (EEP #69) Stream Restoration Site

2010 Annual Monitoring Report (Year 4 of 5)

**Alamance County, North Carolina
EEP Project No. 69
Design Firm: Stantec Consulting Services, Inc.**

April 2011

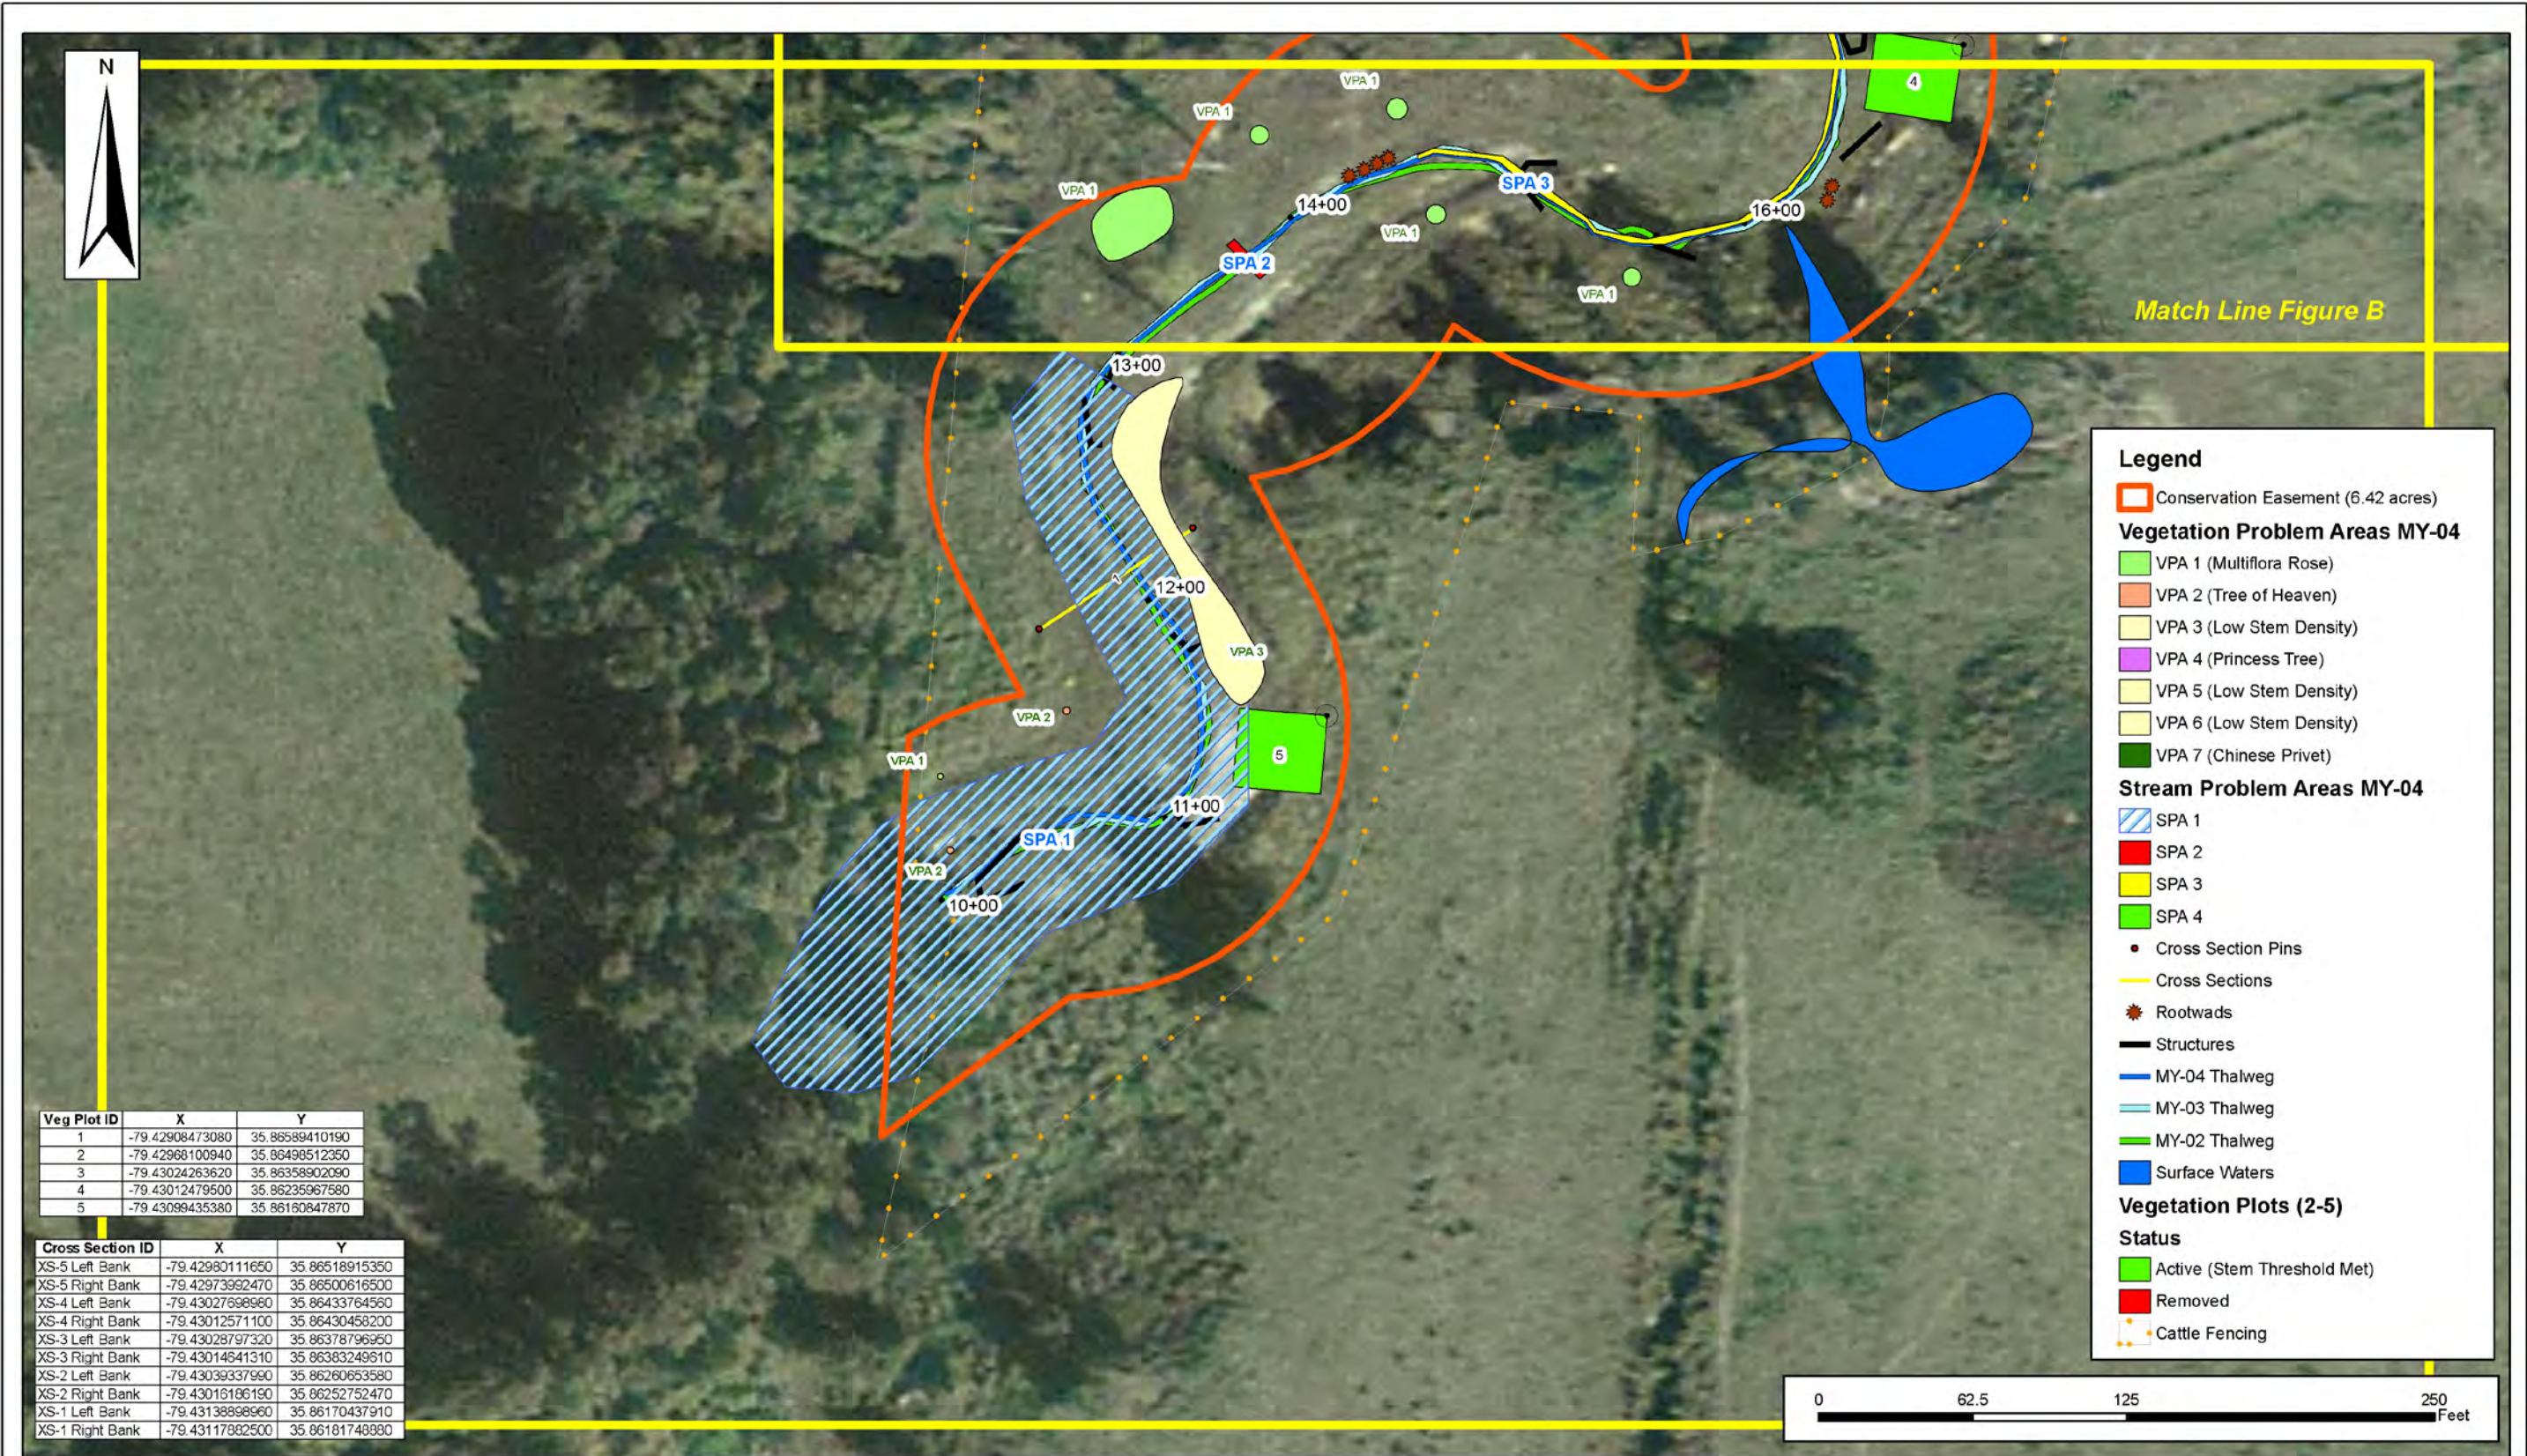
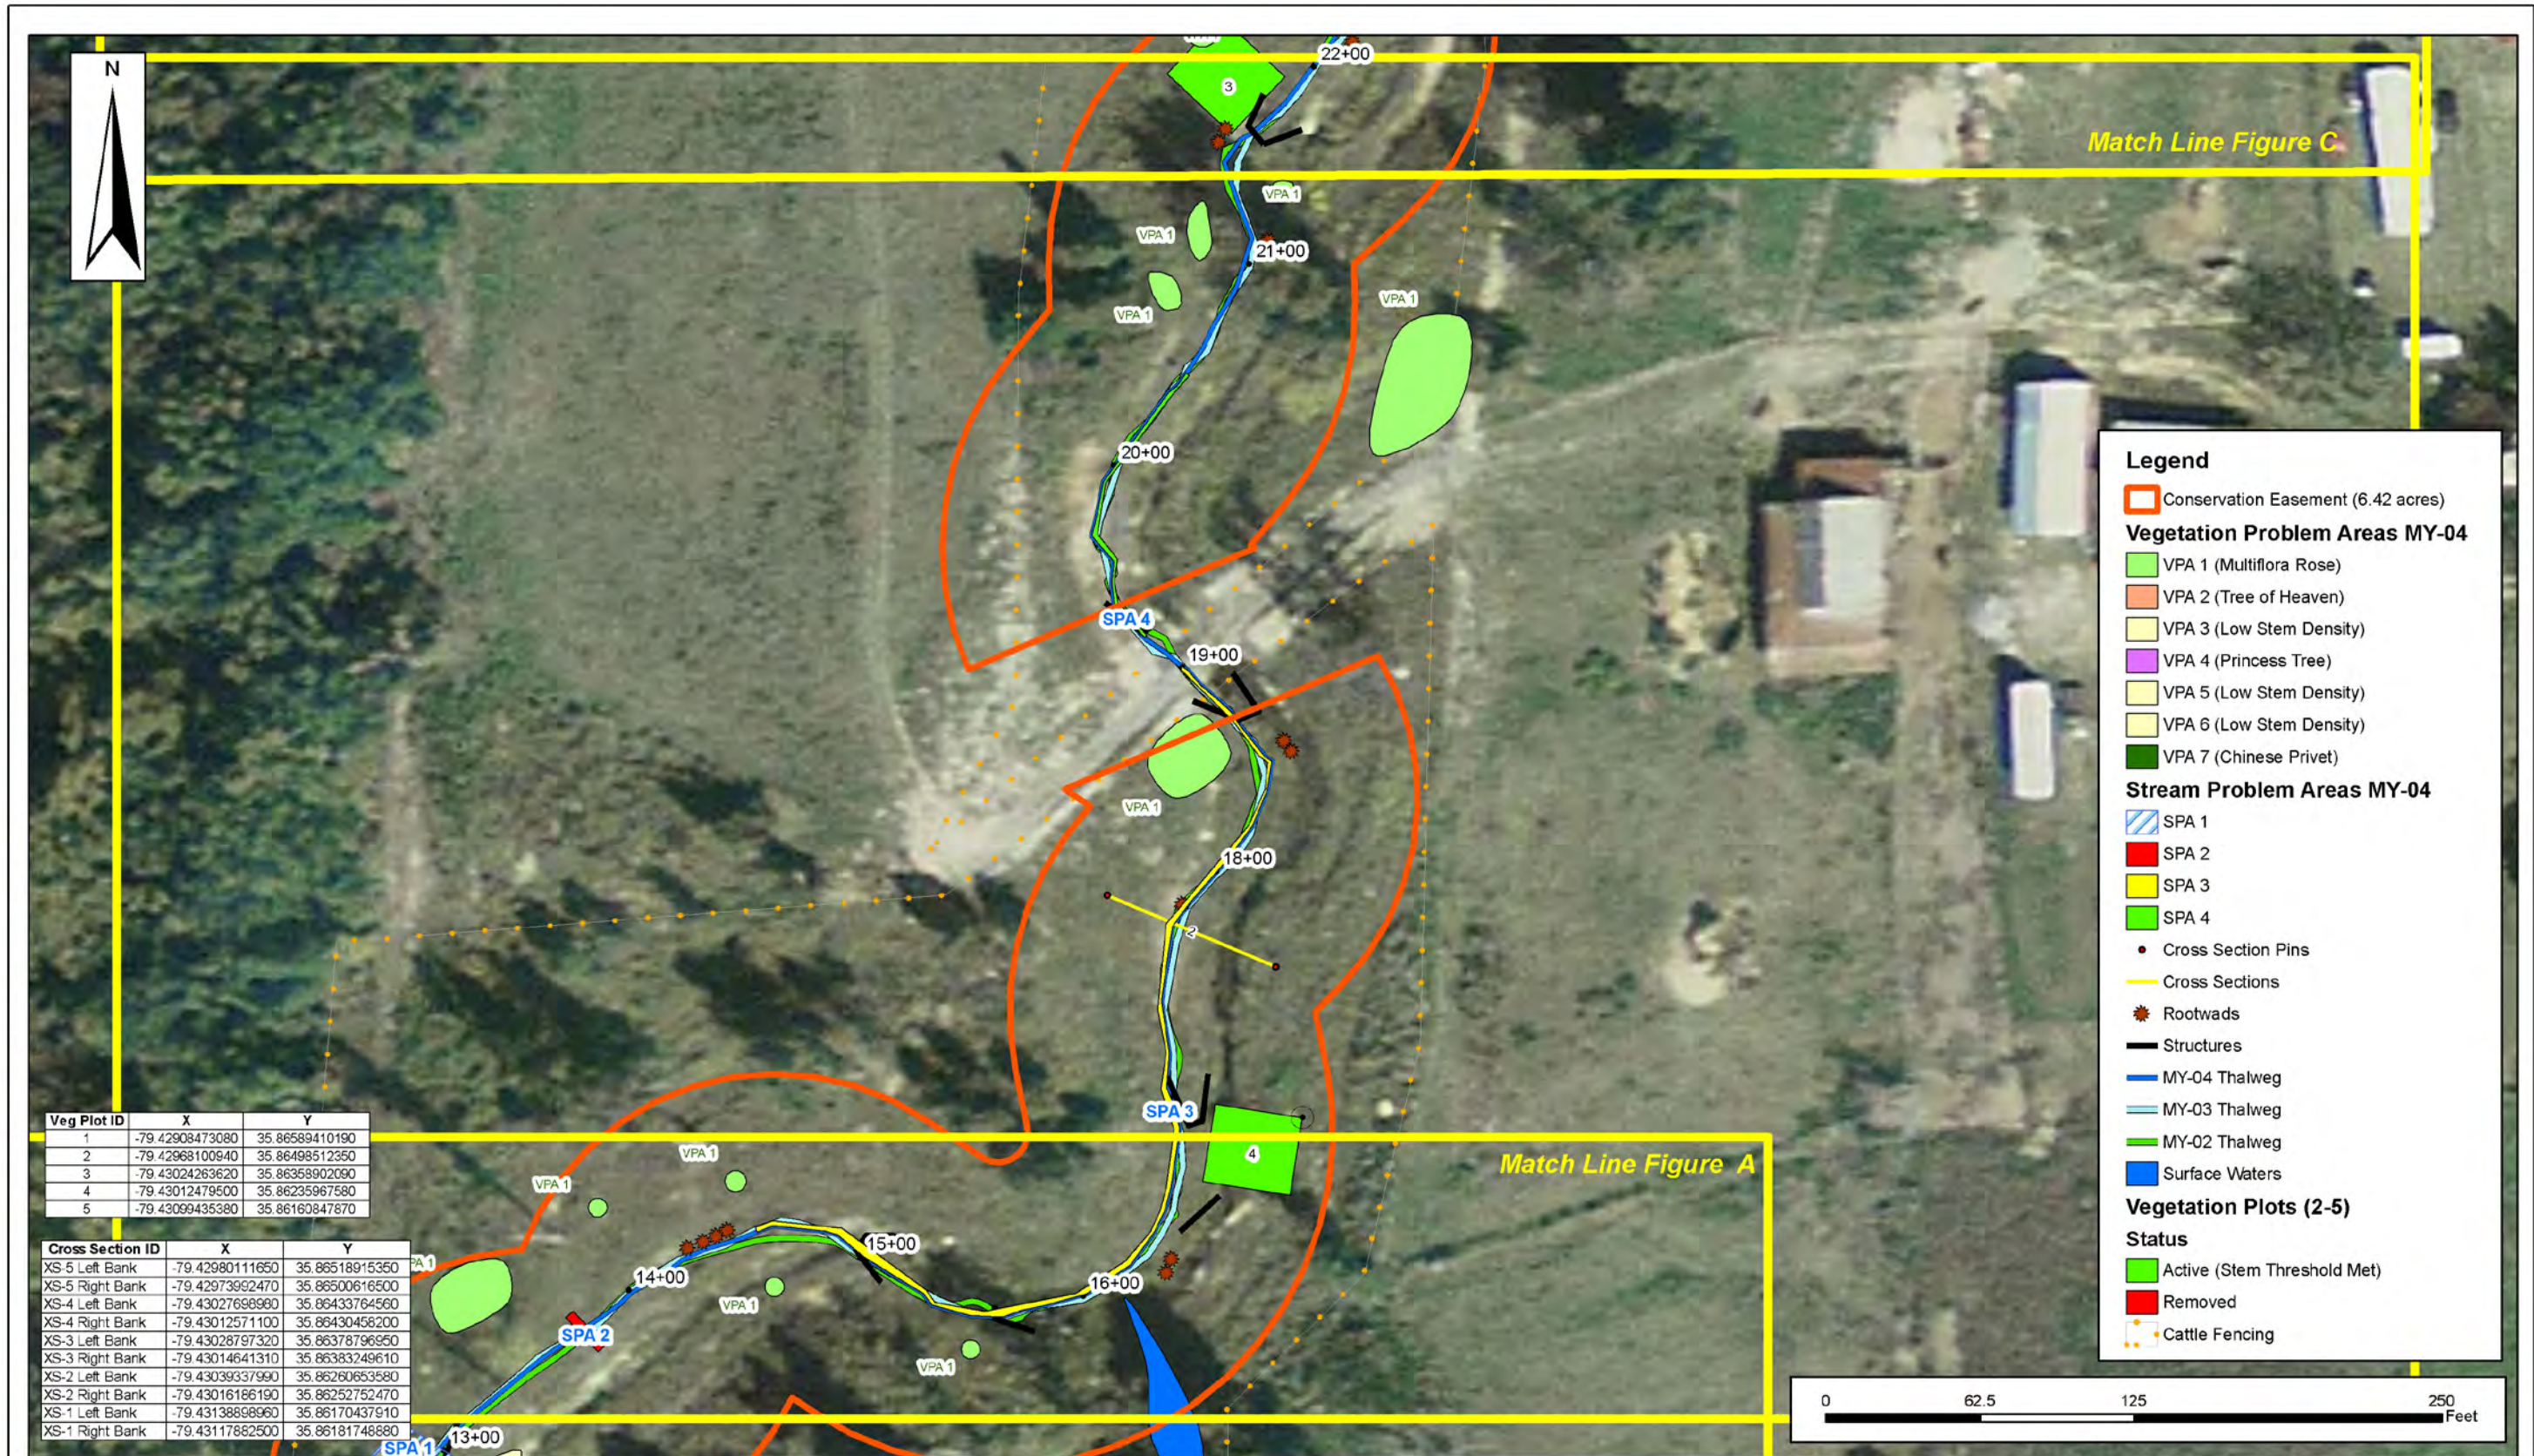
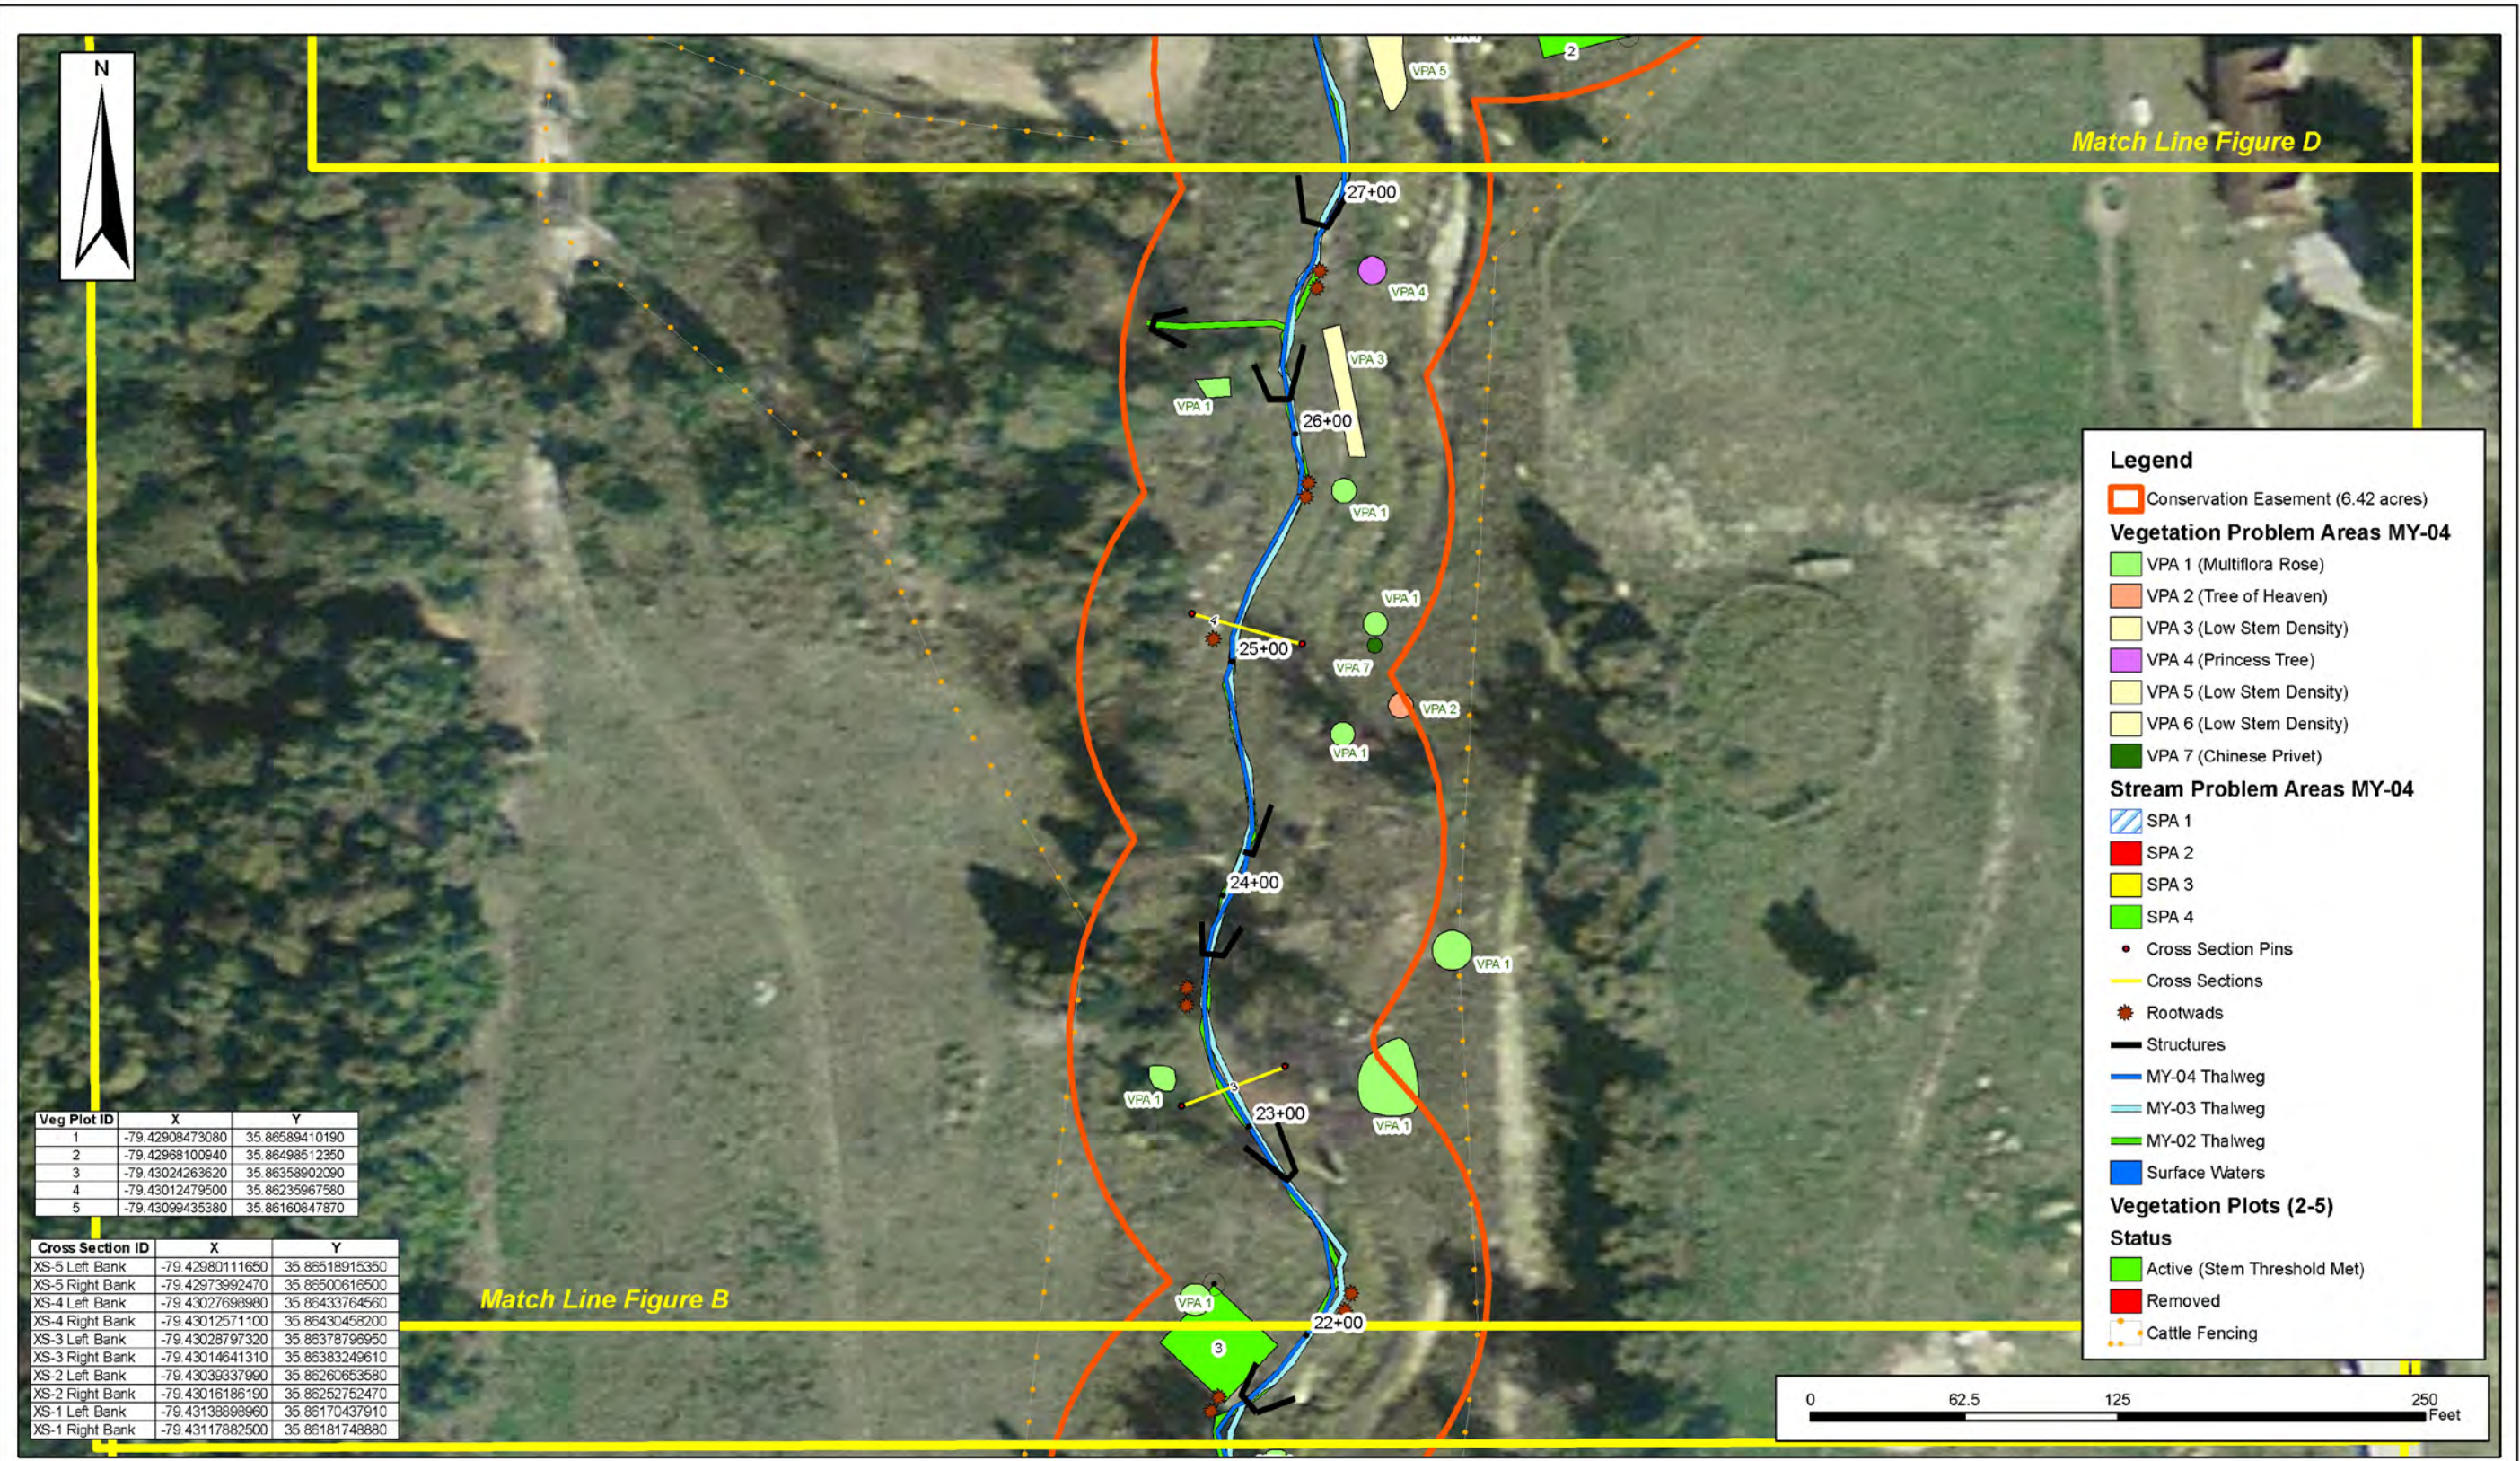
Cane Creek Stream Restoration Site
Current Conditions Plan View
 Alamance County, North Carolina

The vegetation problem areas are mainly composed of a few bare benches with low stem densities, easement encroachment by beavers, and invasive exotics. Beavers encroached into the upper reach and built three dams: a large one at station 13+00 and two smaller ones at stations 13+75 and 22+50. Beaver trapping was conducted by Animal and Plant Health Inspection Service (APHIS) in August of 2010.

Several location along the stream reach have obstruction causing backwater conditions; the stream crossing at station 19+10 and the remnant beaver dams at stations 13+75 (removed August 2010) and 15+50 (remnant soils). The stream crossing at station 32+50, and the remnant beaver dam at station 20+50 were not causing backwater conditions at the time of our survey due to the dry conditions.

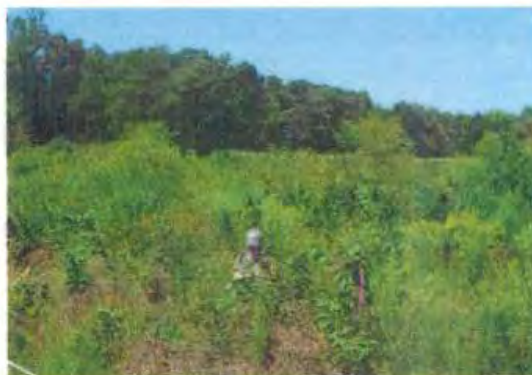
Photo 12. Plot 4 (Sept 3, 2010)

There are five vegetation plots, with only Plot 4 having identifiable planted stems with are live stakes. Four of the vegetation monitoring plots were added after the first monitoring year, therefore to err on the side of caution, stems, planted or not, were identified as natural stems. The plots were monitored using the CVS-EEP vegetation monitoring protocol, which was implemented for monitoring year (MY) -02, MY-03, and MY-04, and which will continue to be used for the remainder of the monitoring period. Vegetation Plot 1 was removed this monitoring year due to a proposed crossing which will traverse the plot. Supplemental plantings for areas with low woody stem densities will be conducted in 2011. A replacement Vegetation Plot 1 will be established for MY-05. Including Plots 2-5, there are 1,991 stems/acre; this included live stakes, planted stems, and natural/volunteer stems. All vegetation plots contain stem counts above the success criteria. The success criterion for planted woody species is 320 stems/acre after MY-03. A mortality rate of 10 percent will be allowed after MY-04 (288 stems/acre), with another 10 percent allowed after MY-05 (260 stems/acre). Natural woody stems are quantified on separate data sheets. An accurate number of planted stems/acre could not be determined since the planted stems could not be distinguished from natural stems.

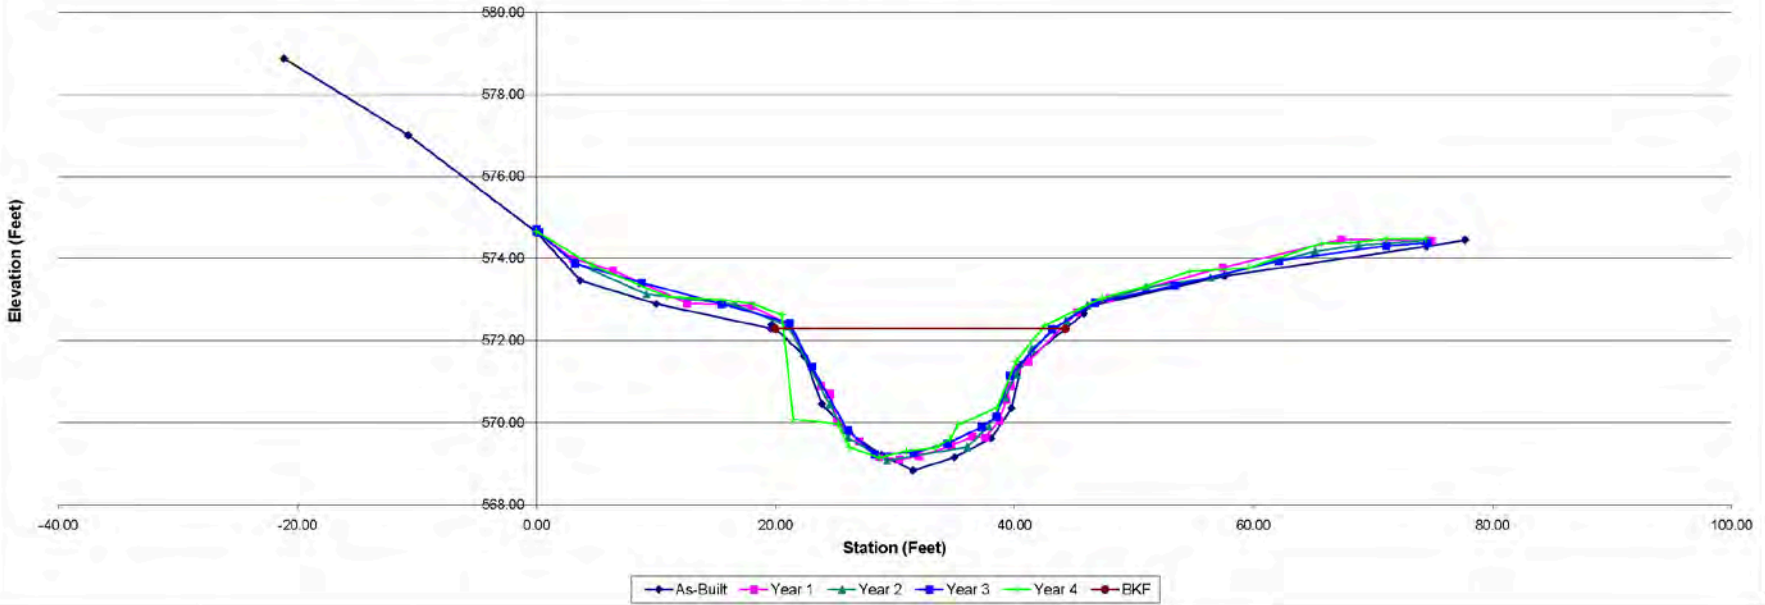
Cross Section 2 Sta 17+22 Pool

A comparison of the cross sections between MY-03 and MY-04 shows little change. Cross Section 2 shows slight bank erosion due to local disturbance caused by a dislodged tree on the bank. The stream banks in general are in good condition and the vegetation is well established at the permanent cross section locations. For MY-04, the bankfull data calculations were based on the baseline bankfull elevations. This elevation has varied in previous monitoring years. Pebble counts at riffle Cross Sections 1 and 3 show a trend towards a finer substrate due to the impoundment caused by the beaver dams. The pebble count at the riffle on Cross Section 5 continues a trend toward coarser substrate.
