**Upper UT to Cane Creek (Pickard)  
Restoration Site  
Alamance County, North Carolina  
EEP Project #395**

**MY-03 Monitoring Report**

**Upper UT to Cane Creek (Pickard)  
Restoration Site  
EEP Project #395  
Alamance County  
North Carolina**

**MY-03 Monitoring Report  
Prepared By:**

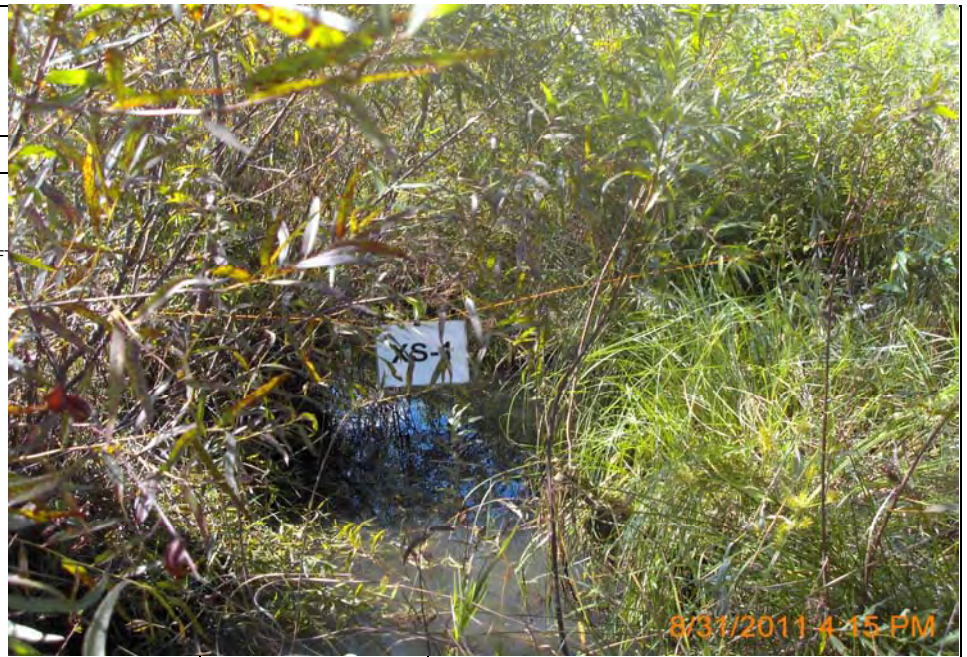
Photo of XS-1, looking in the downstream direction

Project:	UT to Cane Creek (Pickard)	Summary (bankfull)						
Cross Section:	Cross Section 1		MY0	MY1	MY2	MY3	MY4	MY5
Feature:	Pool	A (BKF)		9.0	8.8	9.4		
Station:	13+77 (Reach 1)	W (BKF)		8.1	7.8	7.5		
Date:	8/17/11	Max d		1.7	1.8	1.7		
Crew:	BW, SV, ZP	Mean d		1.1	1.1	1.3		
		W/D		N/A	N/A	5.9

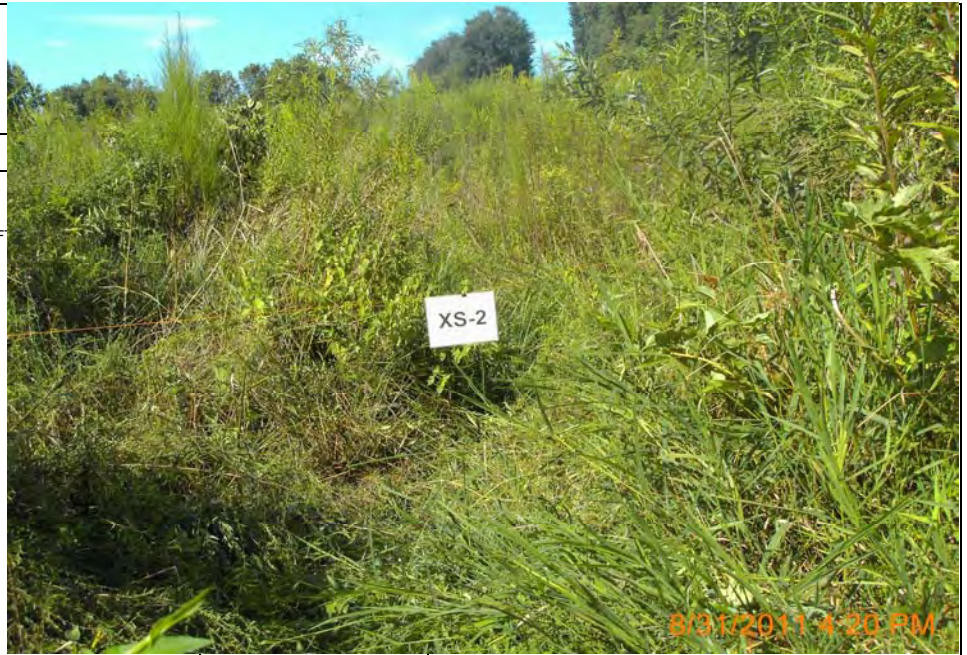
Photo of XS-2, looking in the downstream direction

Project:	UT to Cane Creek (Pickard)	Summary (bankfull)					
Cross Section:	Cross Section 2	MY0	MY1	MY2	MY3	MY4	MY5
Feature:	Riffle	A (BKF)	9.3	8.6	8.1		
Station:	17+52 Downstream of Reach 1	W (BKF)	12.4	9.7	10.8		
Date:	8/17/11	Max d	1.6	1.7	1.5		
Crew:	BW, SV, ZP	Mean d	0.8	0.9	0.8		
		W/D	16.5	10.9	14.3

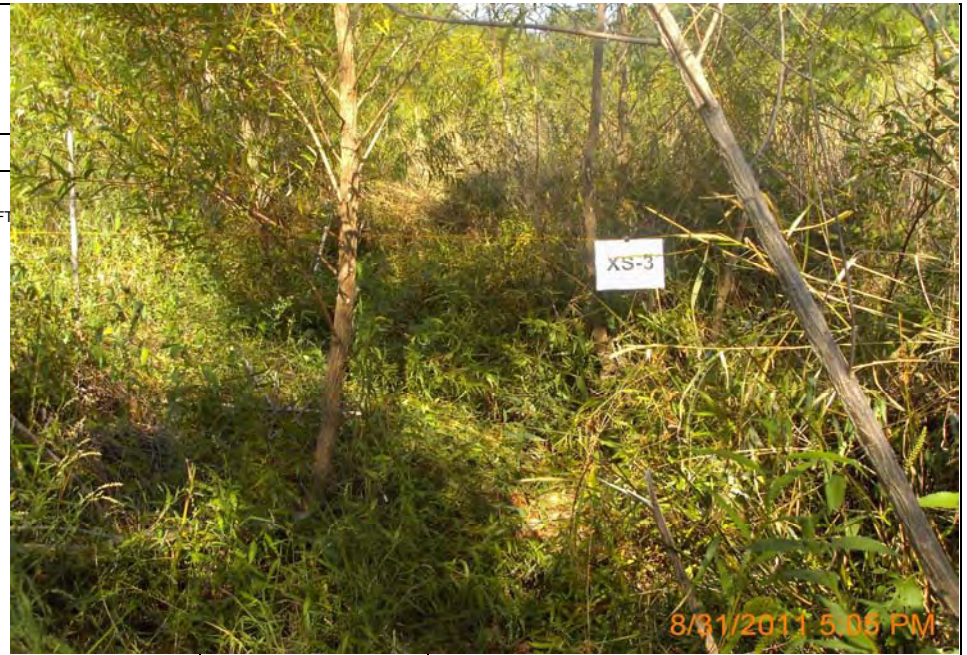
Photo of XS-3 looking in the downstream direction

Project:	UT to Cane Creek (Pickard)	Summary (bankfull)						
Cross Section:	Cross Section 3		MY0	MY1	MY2	MY3	MY4	MY5
Feature:	Pool	A (BKF)		6.1	6.9	4.1		
Station:	106+49 (Reach 2)	W (BKF)		8.2	8.2	6.6		
Date:	8/17/11	Max d		1.1	1.4	0.9		
Crew:	BW, SV, ZP	Mean d		0.7	0.8	0.6		
		W/D		N/A	N/A	10.5

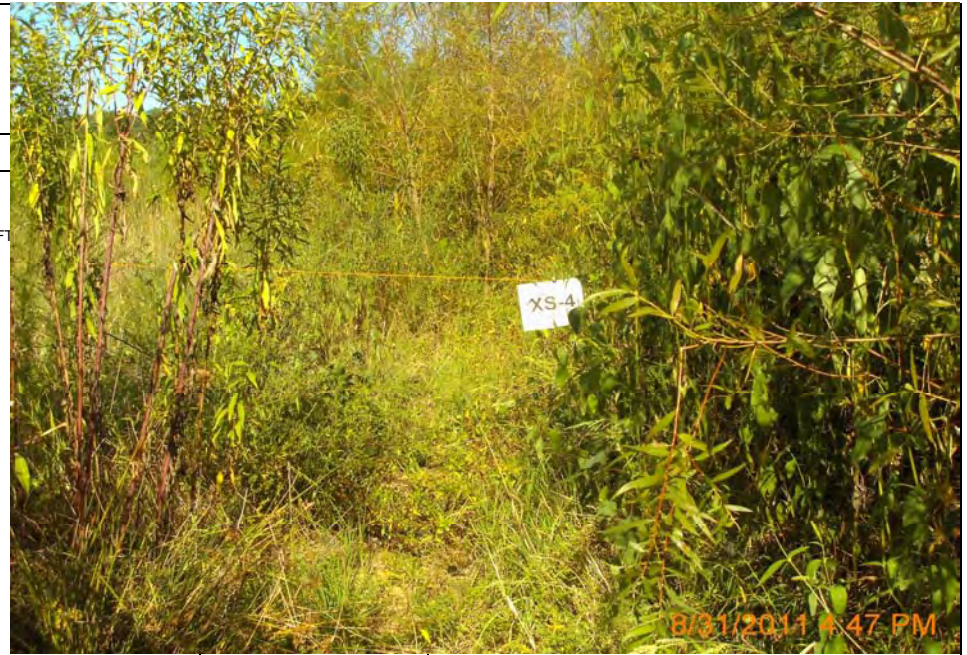
Photo of XS-4, looking in the downstream direction

Project:	UT to Cane Creek (Pickard)	Summary (bankfull)					
Cross Section:	Cross Section 4	MY0	MY1	MY2	MY3	MY4	MY5
Feature:	Riffle	A (BKF)	6.1	8.8	6.5		
Station:	102+05 Upstream of Reach 2	W (BKF)	8.6	9.8	8.6		
Date:	8/17/11	Max d	1.2	1.6	1.4		
Crew:	BW, SV, ZP	Mean d	0.7	0.9	0.8		
		W/D	12.1	11.0	11.3

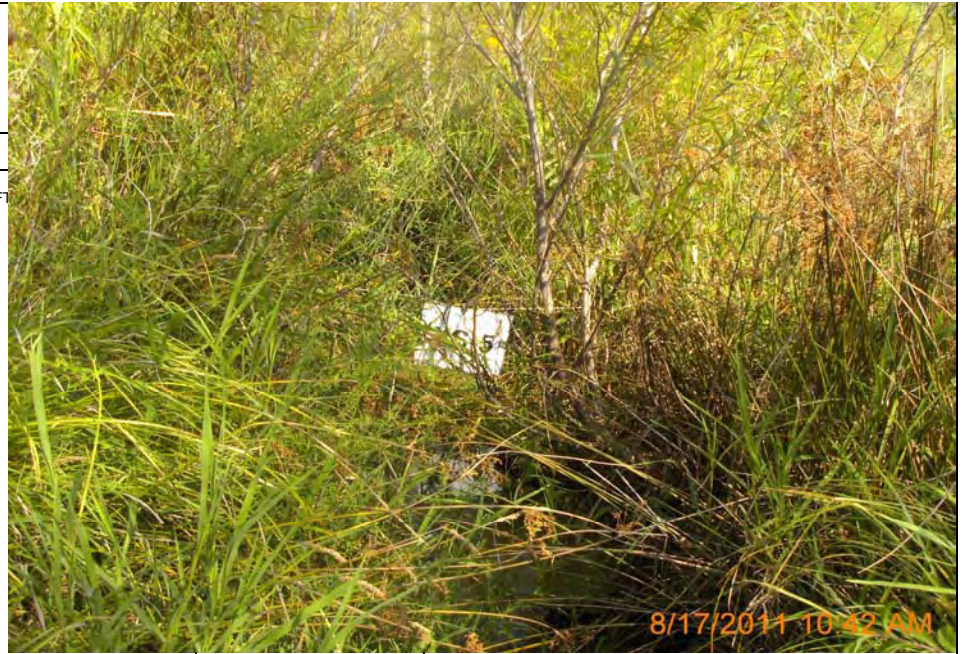
Photo of XS-5, looking in the downstream direction

Project:	UT to Cane Creek (Pickard)	Summary (bankfull)						
Cross Section:	Cross Section 5		MY0	MY1	MY2	MY3	MY4	MY5
Feature:	Pool	A (BKF)		11.1	11.1	10.7		
Station:	23+71	W (BKF)		10.8	10.4	10.0		
Date:	8/17/11	Max d		1.9	1.9	1.8		
Crew:	BW, SV, ZP	Mean d		1.0	1.1	1.1		
		W/D		N/A	N/A	9.4

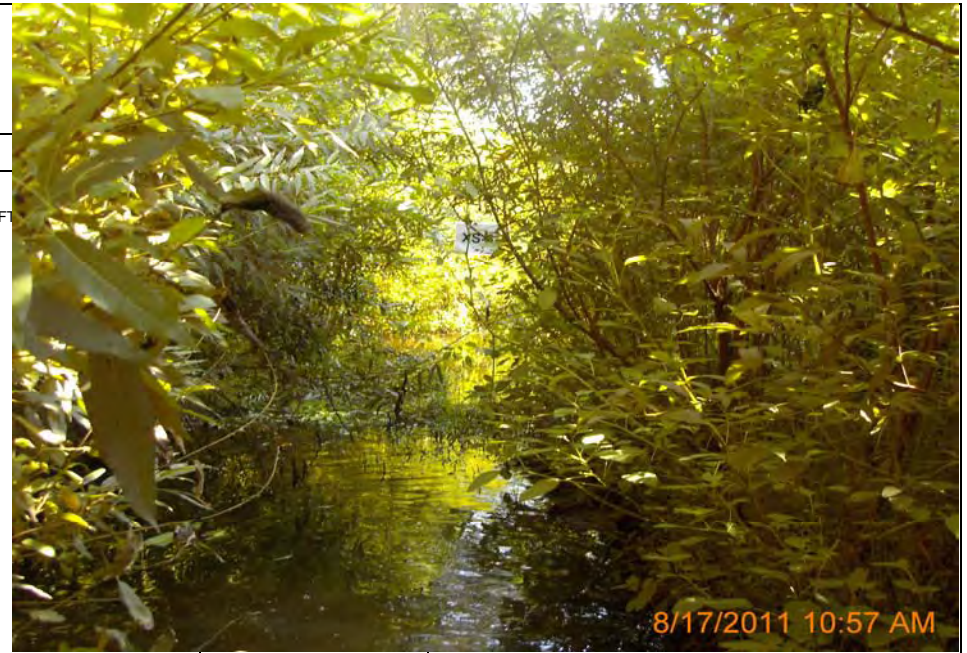
Photo of XS-6, looking in the downstream direction

Project:	UT to Cane Creek (Pickard)	Summary (bankfull)						
Cross Section:	Cross Section 6		MY0	MY1	MY2	MY3	MY4	MY5
Feature:	Riffle	A (BKF)		22.2	22.2	21.8		
Station:	29+10 Upstream of Reach 3	W (BKF)		17.8	17.8	17.8		
Date:	8/17/11	Max d		2.0	2.0	1.9		
Crew:	BW, SV, ZP	Mean d		1.2	1.2	1.2		
		W/D		14.3	14.3	14.5

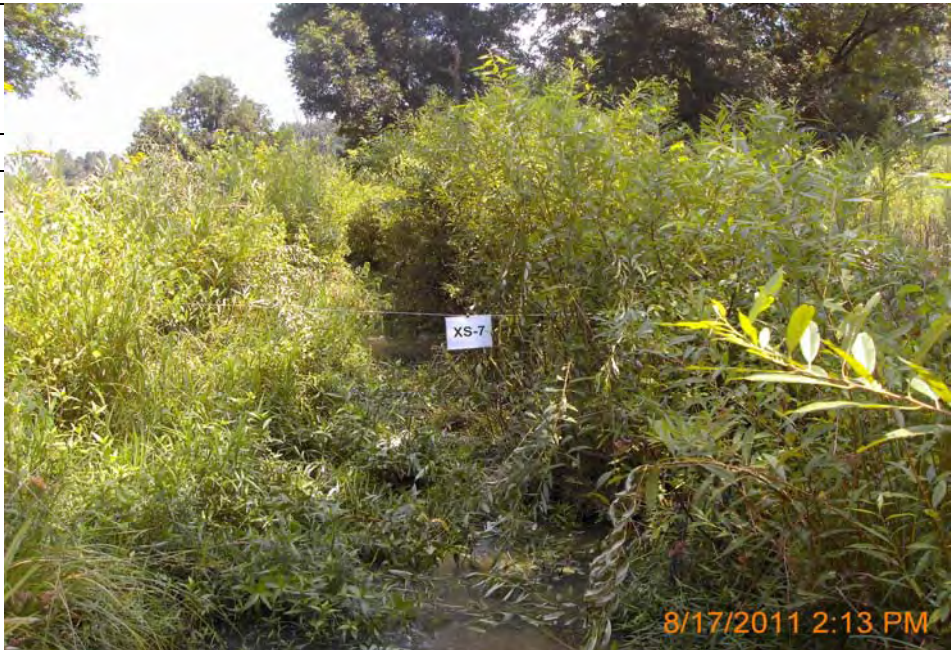
Photo of XS-7, looking in the downstream direction

Project:	UT to Cane Creek (Pickard)	Summary (bankfull)						
Cross Section:	Cross Section 7		MY0	MY1	MY2	MY3	MY4	MY5
Feature:	Riffle	A (BKF)		26.3	22.4	21.8		
Station:	32+03 (Reach 3)	W (BKF)		15.2	14.5	17.8		
Date:	8/17/11	Max d		2.5	2.2	1.9		
Crew:	BW, SV, ZP	Mean d		1.7	1.5	1.2		
		W/D		8.8	9.4	14.5

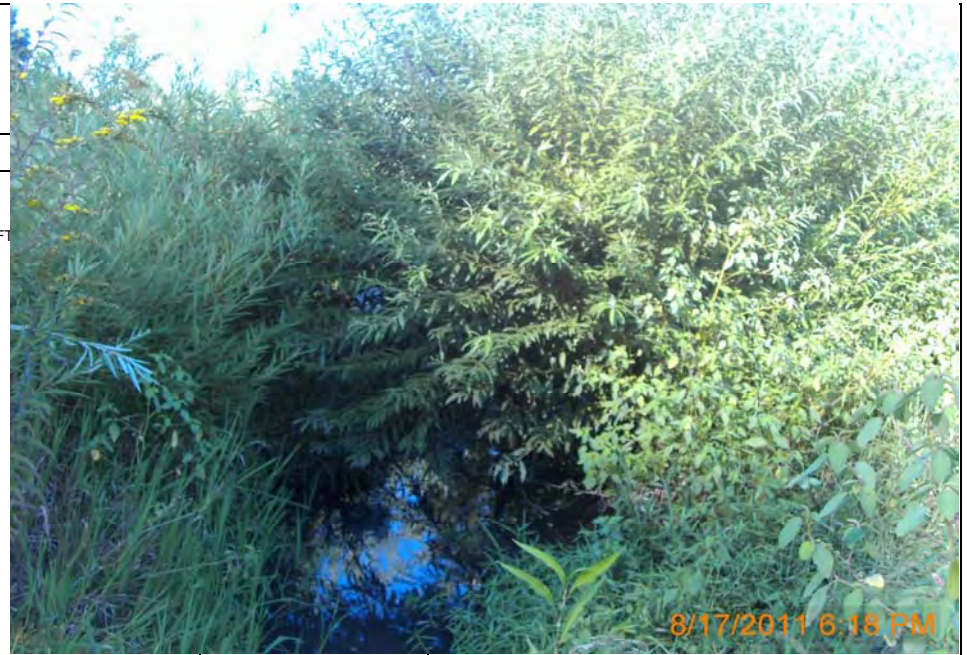
Photo of XS-8, looking in the downstream direction

Project:	UT to Cane Creek (Pickard)	Summary (bankfull)						
Cross Section:	Cross Section 8		MY0	MY1	MY2	MY3	MY4	MY5
Feature:	Riffle	A (BKF)		24.4	23.7	25.8		
Station:	36+76 Downstream of Reach 3	W (BKF)		18.3	17.6	18.0		
Date:	8/17/11	Max d		2.3	2.2	2.5		
Crew:	BW, SV, ZP	Mean d		1.3	1.3	1.4		
		W/D		13.7	13.1	12.5

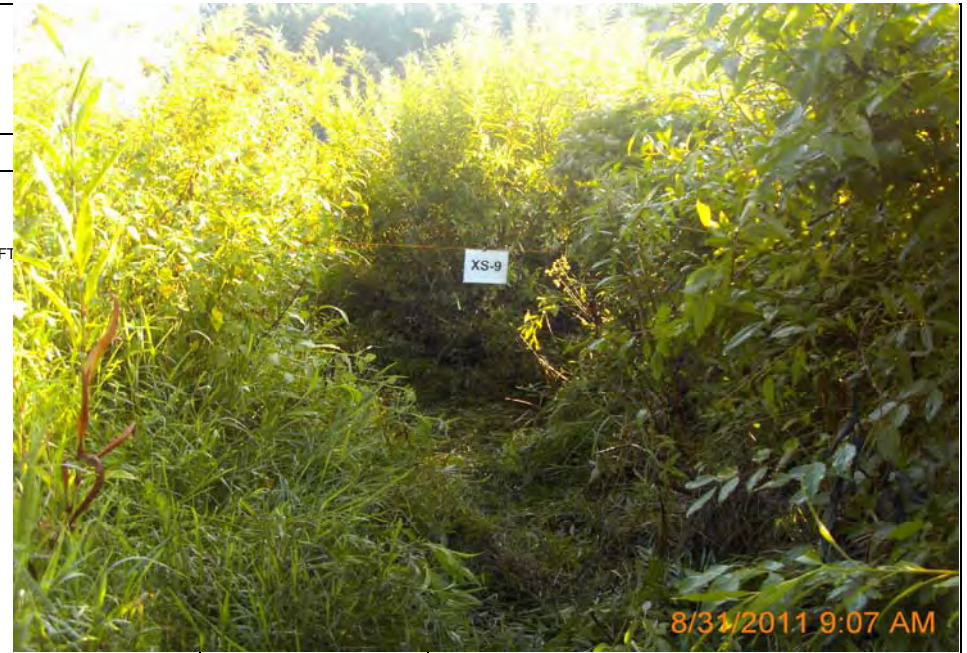
Photo of XS-9, looking in the downstream direction

Project:	UT to Cane Creek (Pickard)	Summary (bankfull)						
Cross Section:	Cross Section 9		MY0	MY1	MY2	MY3	MY4	MY5
Feature:	Pool	A (BKF)		28.4	28.5	28.4		
Station:	43+03 (Reach 4)	W (BKF)		16.8	17.7	16.8		
Date:	8/17/11	Max d		3.2	3.1	3.3		
Crew:	BW, SV, ZP	Mean d		1.7	1.6	1.7		
		W/D		N/A	N/A	9.9

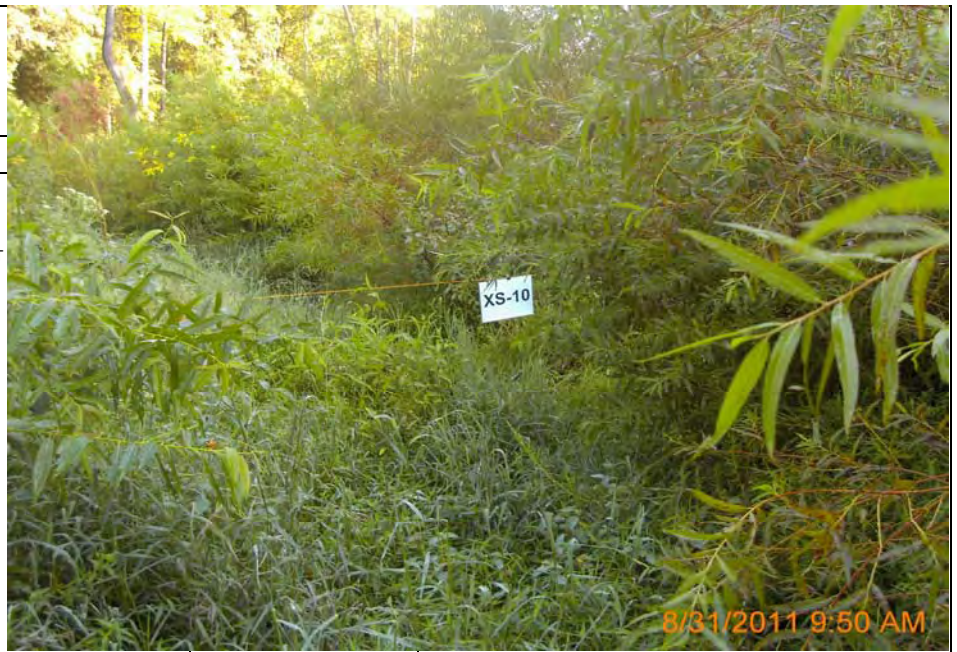
Photo of XS-10, looking in the downstream direction

Project:	UT to Cane Creek (Pickard)	Summary (bankfull)						
Cross Section:	Cross Section 10		MY0	MY1	MY2	MY3	MY4	MY5
Feature:	Riffle	A (BKF)		24.5	24.9	23.7		
Station:	48+08 B/W Reach 4 and 5	W (BKF)		20.6	21.1	20.1		
Date:	8/17/11	Max d		2.0	2.0	2.1		
Crew:	BW, SV, ZP	Mean d		1.2	1.2	1.2		
		W/D		17.3	17.9	17.1

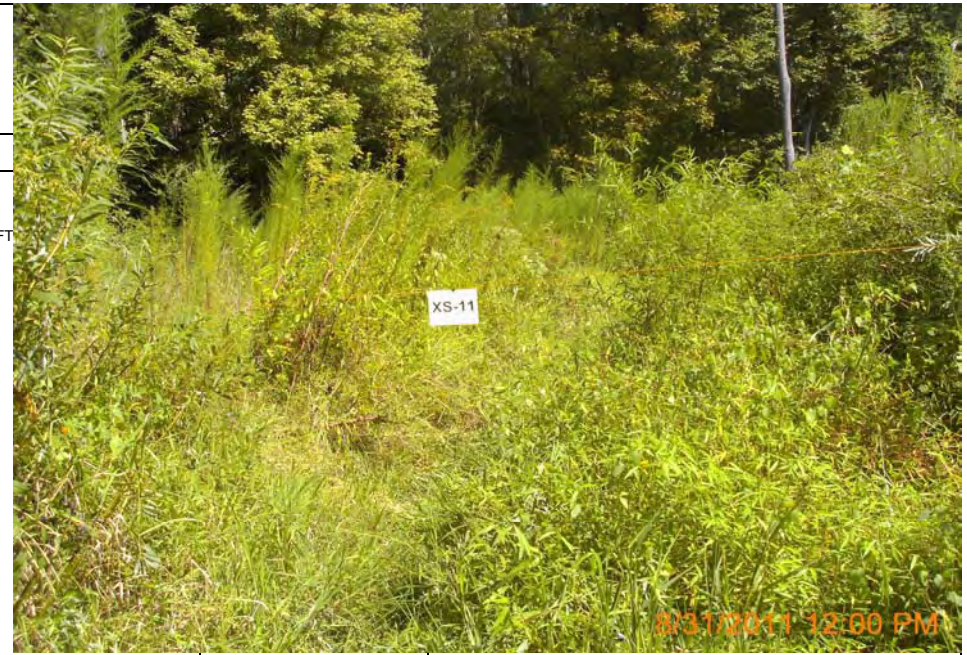
Photo of XS-11, looking in the downstream direction

Project:	UT to Cane Creek (Pickard)	Summary (bankfull)						
Cross Section:	Cross Section 11		MY0	MY1	MY2	MY3	MY4	MY5
Feature:	Riffle	A (BKF)		25.7	25.8	20.5		
Station:	52+76 (Reach 5)	W (BKF)		15.9	17.0	14.3		
Date:	8/17/11	Max d		2.4	2.5	2.6		
Crew:	BW, SV, ZP	Mean d		1.6	1.5	1.4		
		W/D		9.8	11.2	10.0

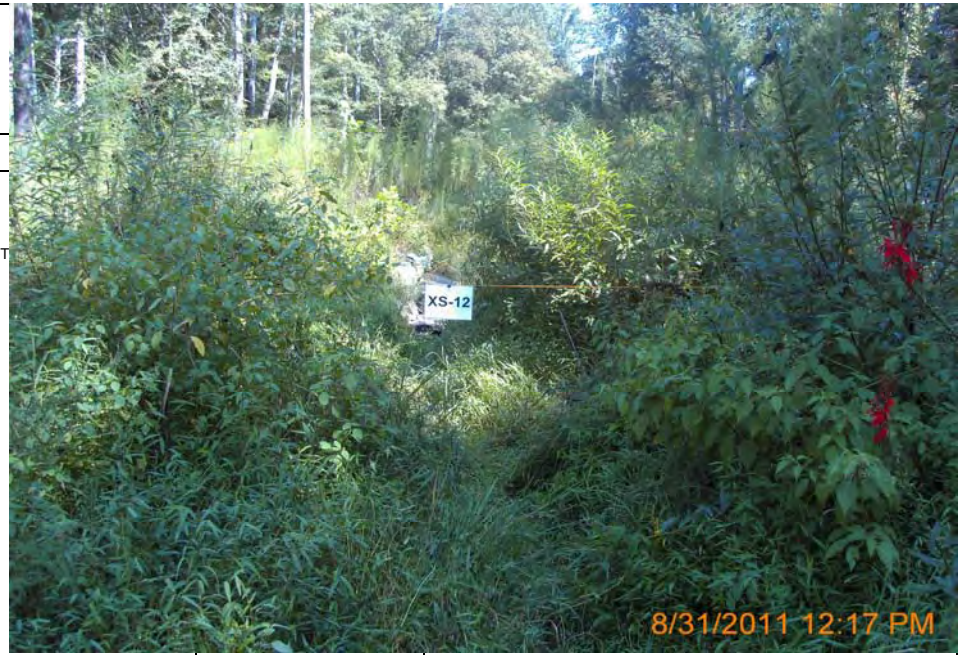
Photo of XS-12, looking in the downstream direction

Project:	UT to Cane Creek (Pickard)	Summary (bankfull)						
Cross Section:	Cross Section 12		MY0	MY1	MY2	MY3	MY4	MY5
Feature:	Riffle	A (BKF)		22.9	21.1	22.3		
Station:	56+11 Downstream of Reach 5	W (BKF)		14.5	12.4	15.5		
Date:	8/17/11	Max d		2.6	2.6	2.3		
Crew:	BW, SV, ZP	Mean d		1.6	1.7	1.4		
		W/D		9.2	7.3	10.7

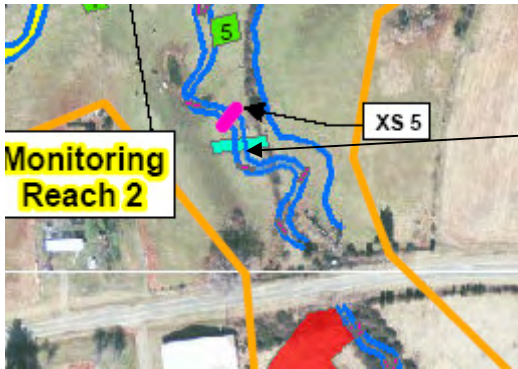
Encroachment 1: Debris blockage in stream creating backwater

Encroachment 1 –  
Upstream side of  
stream crossing

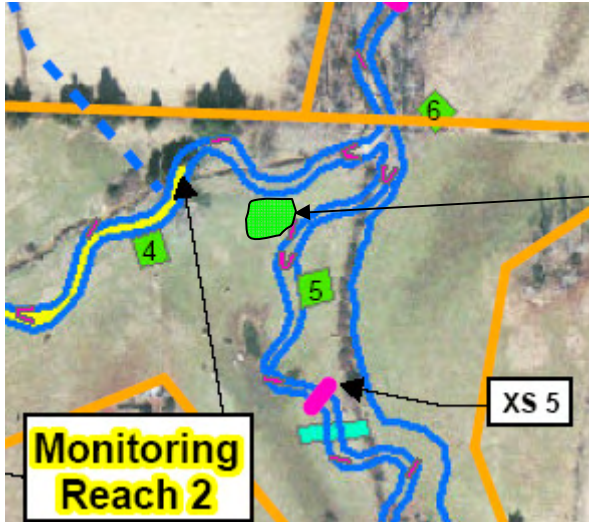
## Encroachment 2: Corn remnants used for baiting deer

Encroachment 2 –  
Corn on ground  
for deer baiting

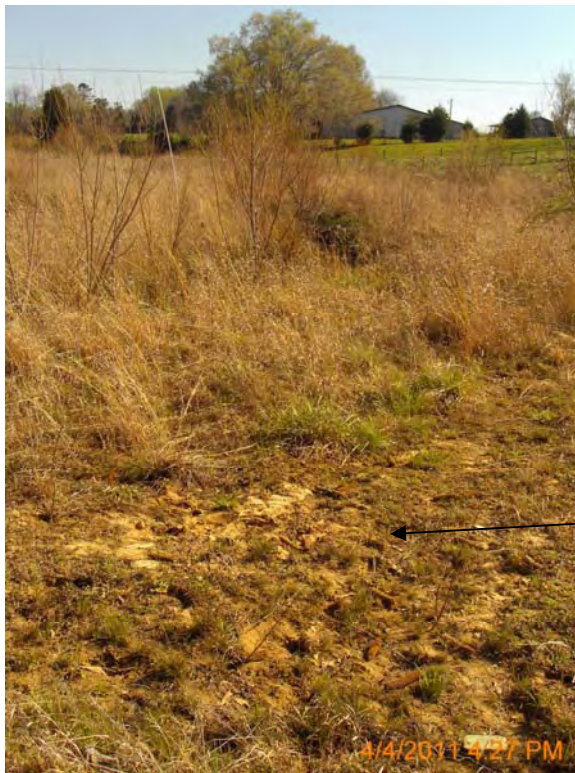
Encroachment 2 –  
Corn on ground  
for deer baiting

Photo taken on Left floodplain of main stream

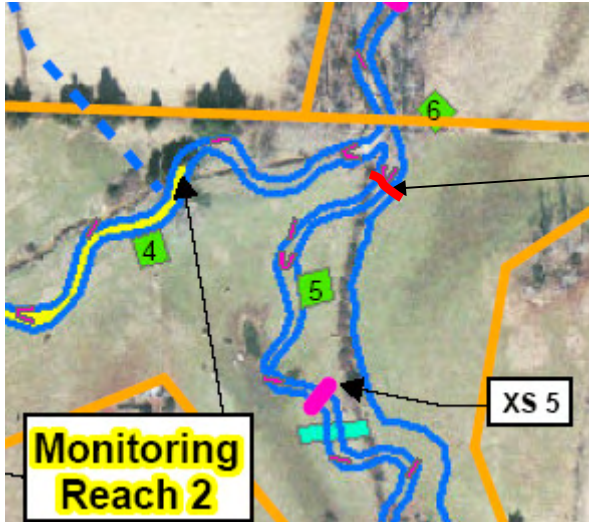
## Encroachment 3: Debris blockage in stream creating backwater

Encroachment 3 –  
Debris at sill rock  
of rock structure

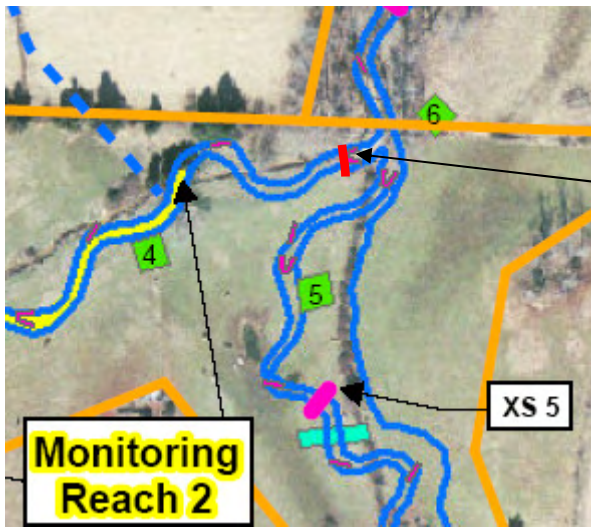
Encroachment 4: Debris blockage on Tributary creating backwater effects for approximately 200 feet upstream

Encroachment 4 –  
Debris at end of  
rock structure

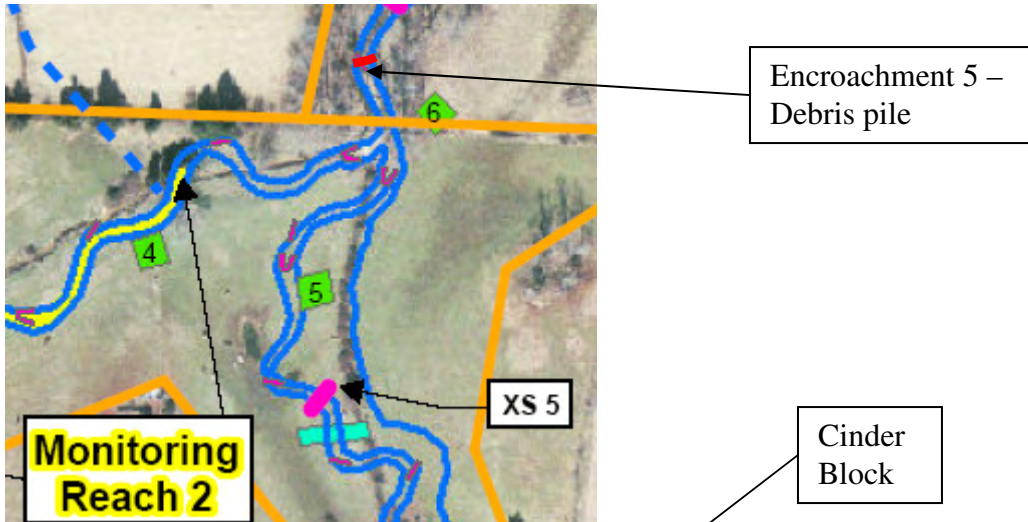
Encroachment 5: Debris pile resembling the beginning of a blockage

Photo taken from right bank looking at the log structure (note cinder block on left bank)

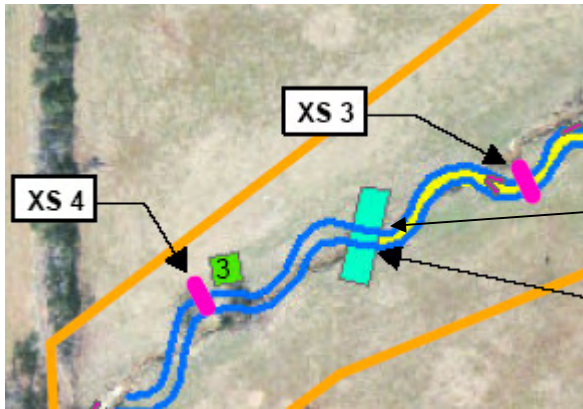
Encroachment 6: Fence hanging low at tributary (Reach 2) stream crossing allowing animal access

Encroachment 6 –  
Upstream side of  
stream crossing
