UT to Clarke Creek Stream and Wetland Restoration Site Annual Final Monitoring Report

DMS # 92500
DENR Contract # 005363
USACE Action ID # SAW-2010-00471
DWR Project # 11-0409
SCO # 09-07763-01
DLR (Land Quality) Project # MECK-2012-034

Monitoring Report Year 4 of 5
Mecklenburg County, North Carolina

UT to Clarke Creek Stream and Wetland Restoration
DMS Project #92500

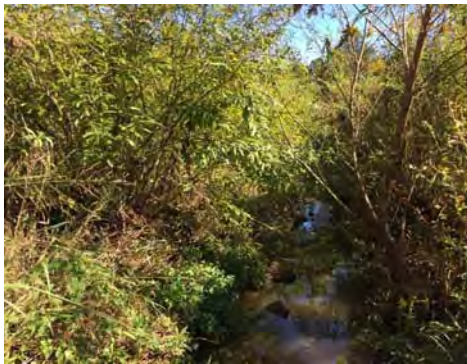
Photo 1: 10/18/17 - Wracklines on UT to Clarke Creek.

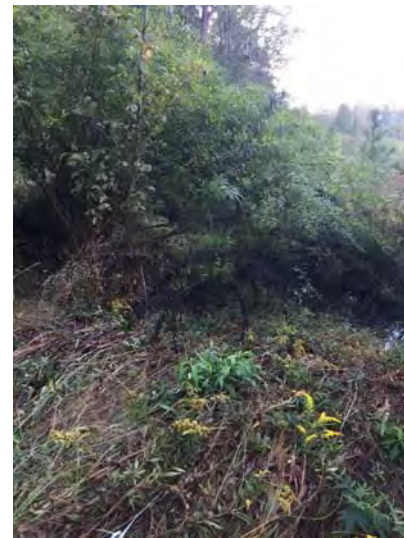
Photo 2: 10/19/17 - Wracklines on UT1.
