**UT to Clarke Creek Stream and Wetland Restoration Site  
Annual Final Monitoring Report  
FINAL**

DMS # 92500

Monitoring Report Year 5 of 5  
Mecklenburg County, North Carolina

Data Collection: October 2018  
Report Submission: February 2019

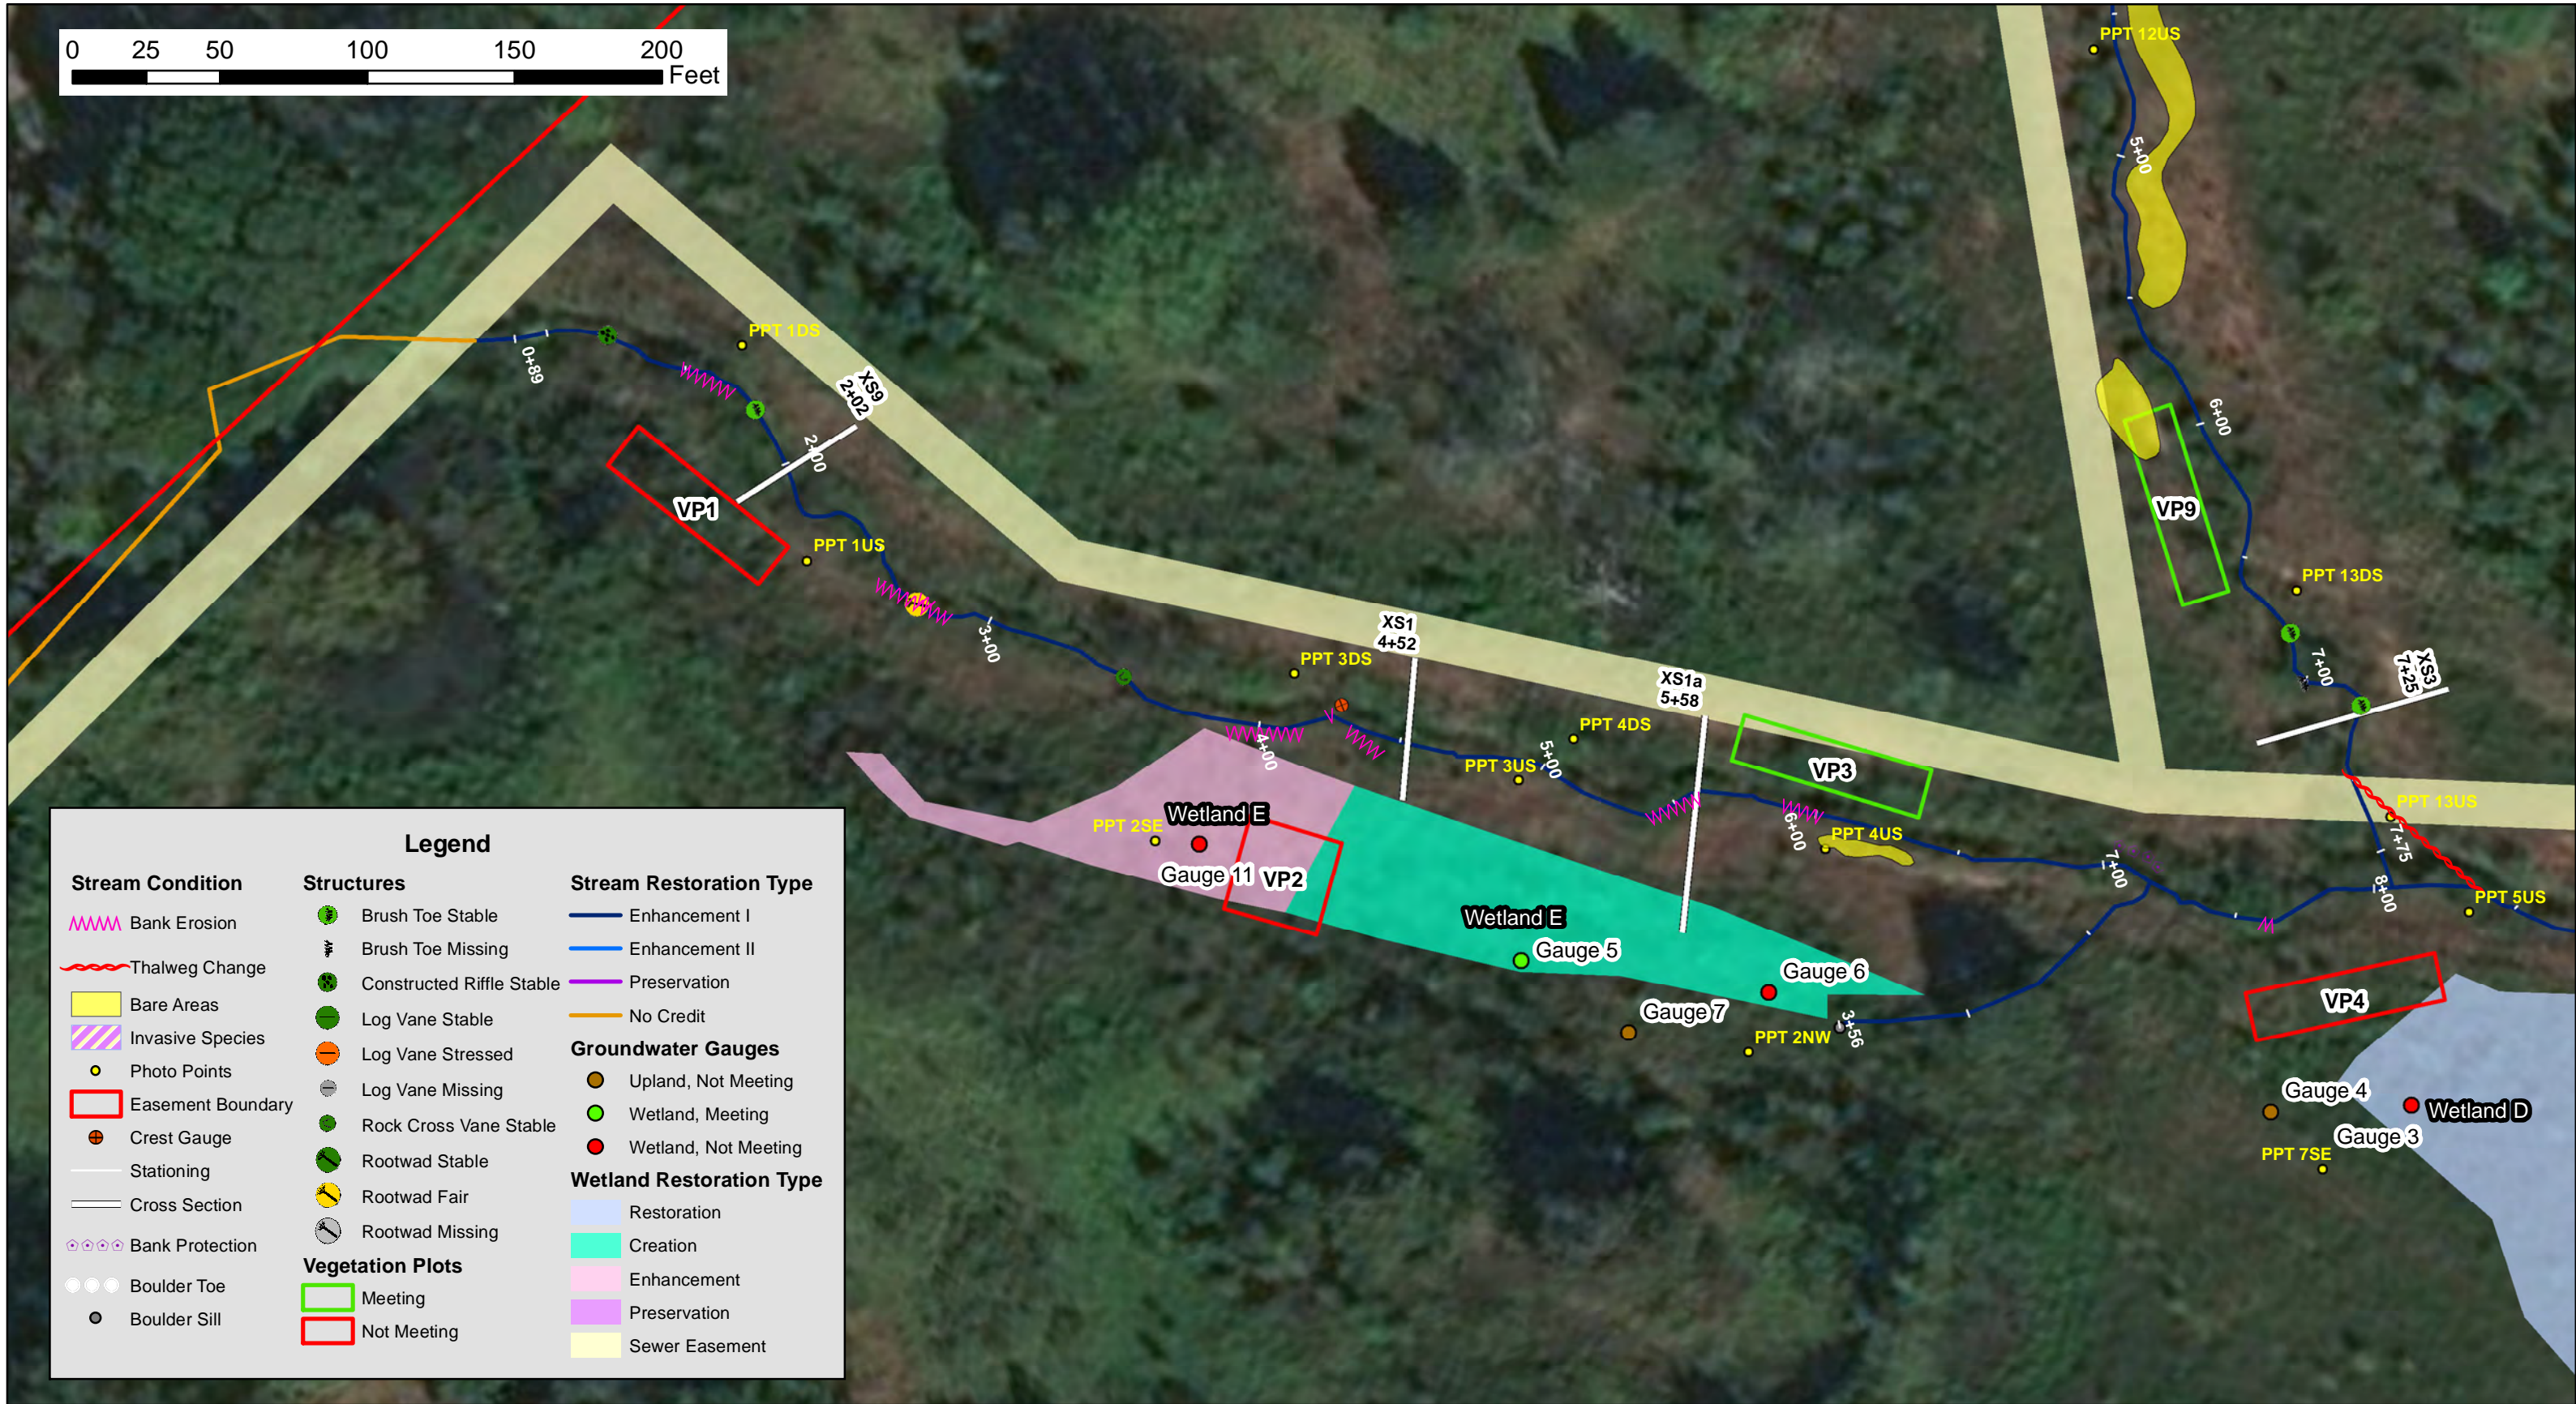
## Current Conditions Plan View - UT Clarke Creek above Confluence

During MY05 (2018), one area of sparse vegetation was observed on UT to Clarke Creek around Station 6+00. This is a depression in the floodplain that is holding water limiting the establishment of vegetation. Another small area near Sta. 11+00 is still present. These were the only areas of sparse vegetation on the floodplain observed along UT to Clarke Creek.

Minor beaver activity was noted on UT to Clarke Creek near the confluence with UT1 in the form of chewed stems and slides along the streambanks. No beaver dams were observed. The US Department of Agriculture (USDA) Animal and Plant Health Inspection Service (APHIS) visited the Site in July and October 2018, during which they trapped beaver. APHIS will continue to monitor the Site quarterly for evidence of beaver and will remove beaver and dams as necessary.

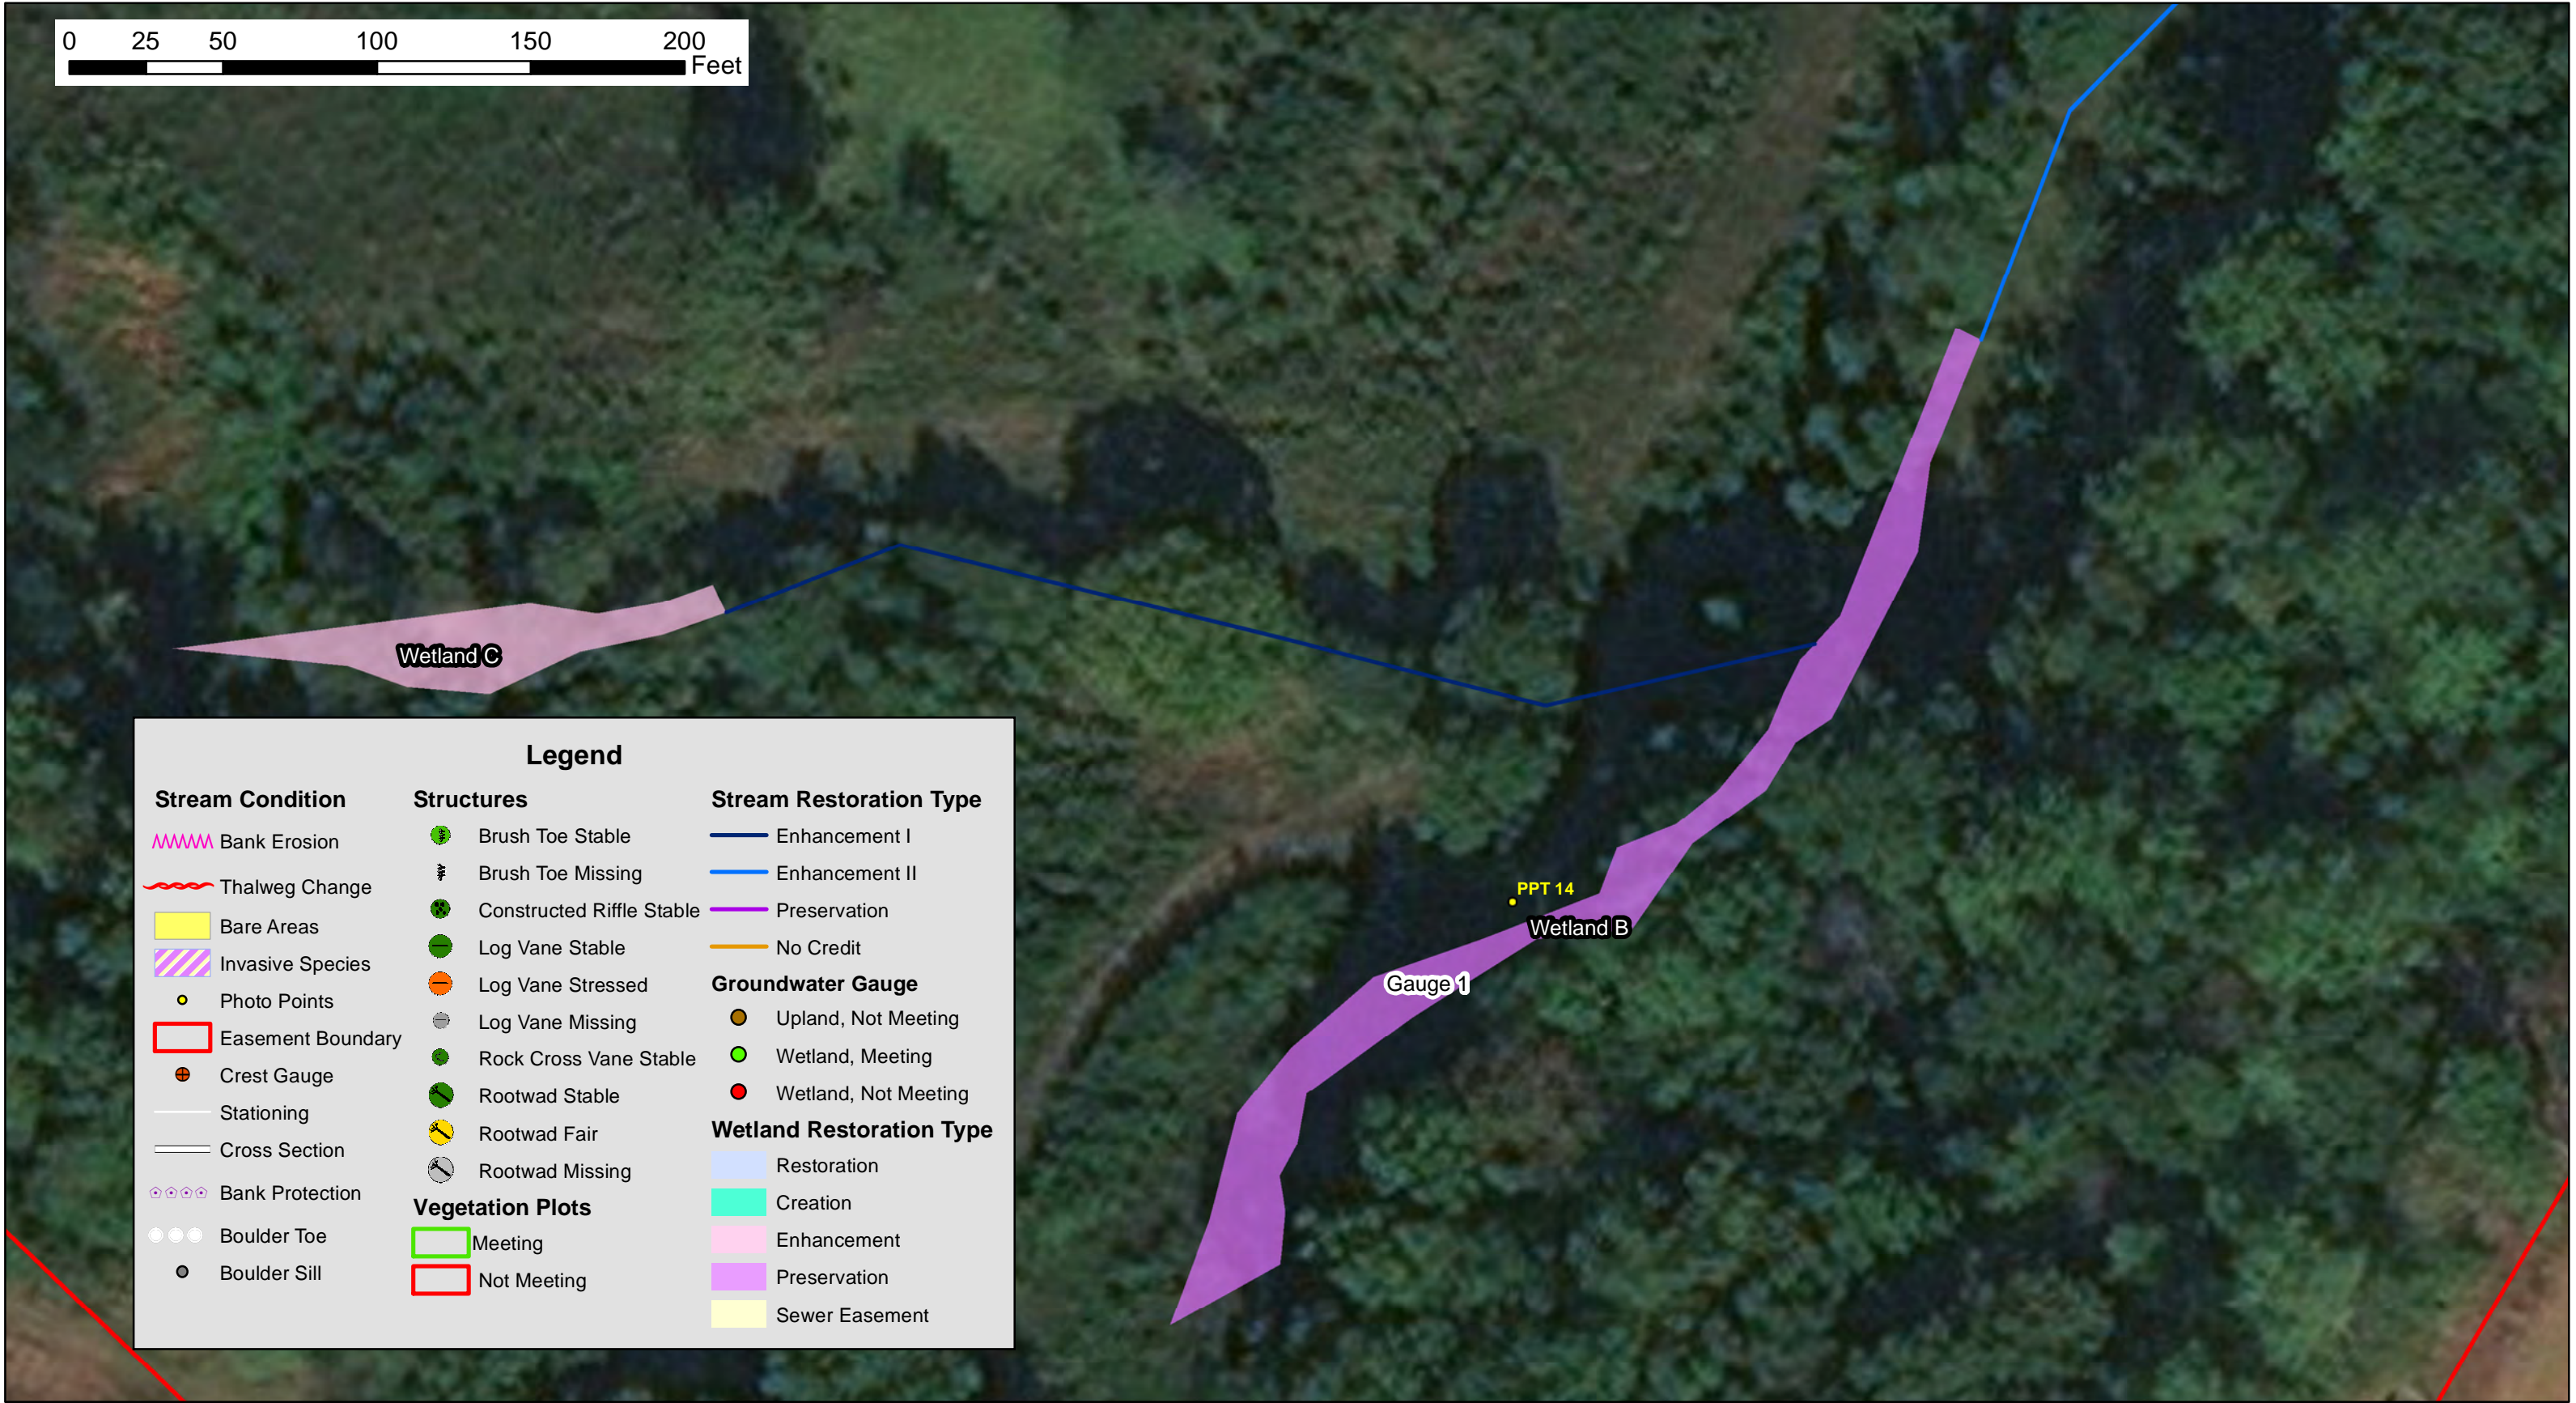
## Current Conditions Plan View - UT 4

Monitoring gauges were installed by NCDMS on UT3, UT4 and UT5 to document surface flow within the tributaries during MY05. One gauge was installed on UT3; four on UT4 and one on UT5. All gauges showed surface flow for greater than 120 consecutive days between January 2018 and October 2018. Eleven areas of minor bank erosion were observed totaling 164 feet. Ten areas on UT to Clarke Creek (154 feet) and one on UT1 (10 feet). Because the banks are so low and well vegetated, the erosion is not considered significant. It should be noted that Hurricane Florence and Hurricane Michael passed over Charlotte in 2018. Florence dropped over 3" of rain on September 16, 2018 and Michael over 2" on October 11, 2018.

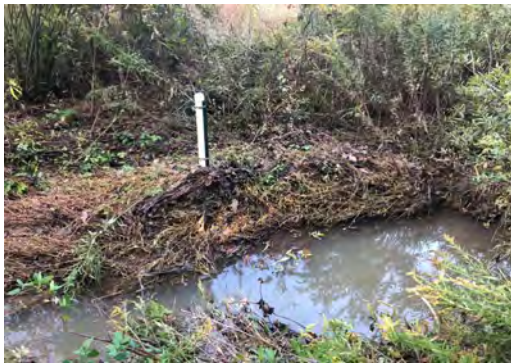
Photo 1: 10/30/18 - Wracklines on UT to Clarke Creek at crest gauge.

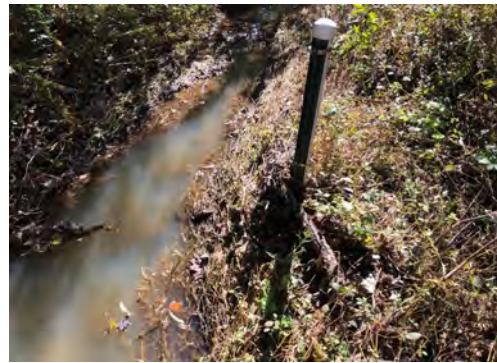
Photo 2: 10/30/18 - Wracklines on UT1 at crest gauge.
