**UT to Crooked Creek
Stream Restoration Monitoring Report
EEP Project # 434
Monitoring Year 04**

**Data Collection: 2010
Construction Completed: July 2006
Submitted: December 2010**

**Project Contact: Adam Spiller
Email: adam.spiller@kci.com
KCI Project No: 12071067C_CC10**

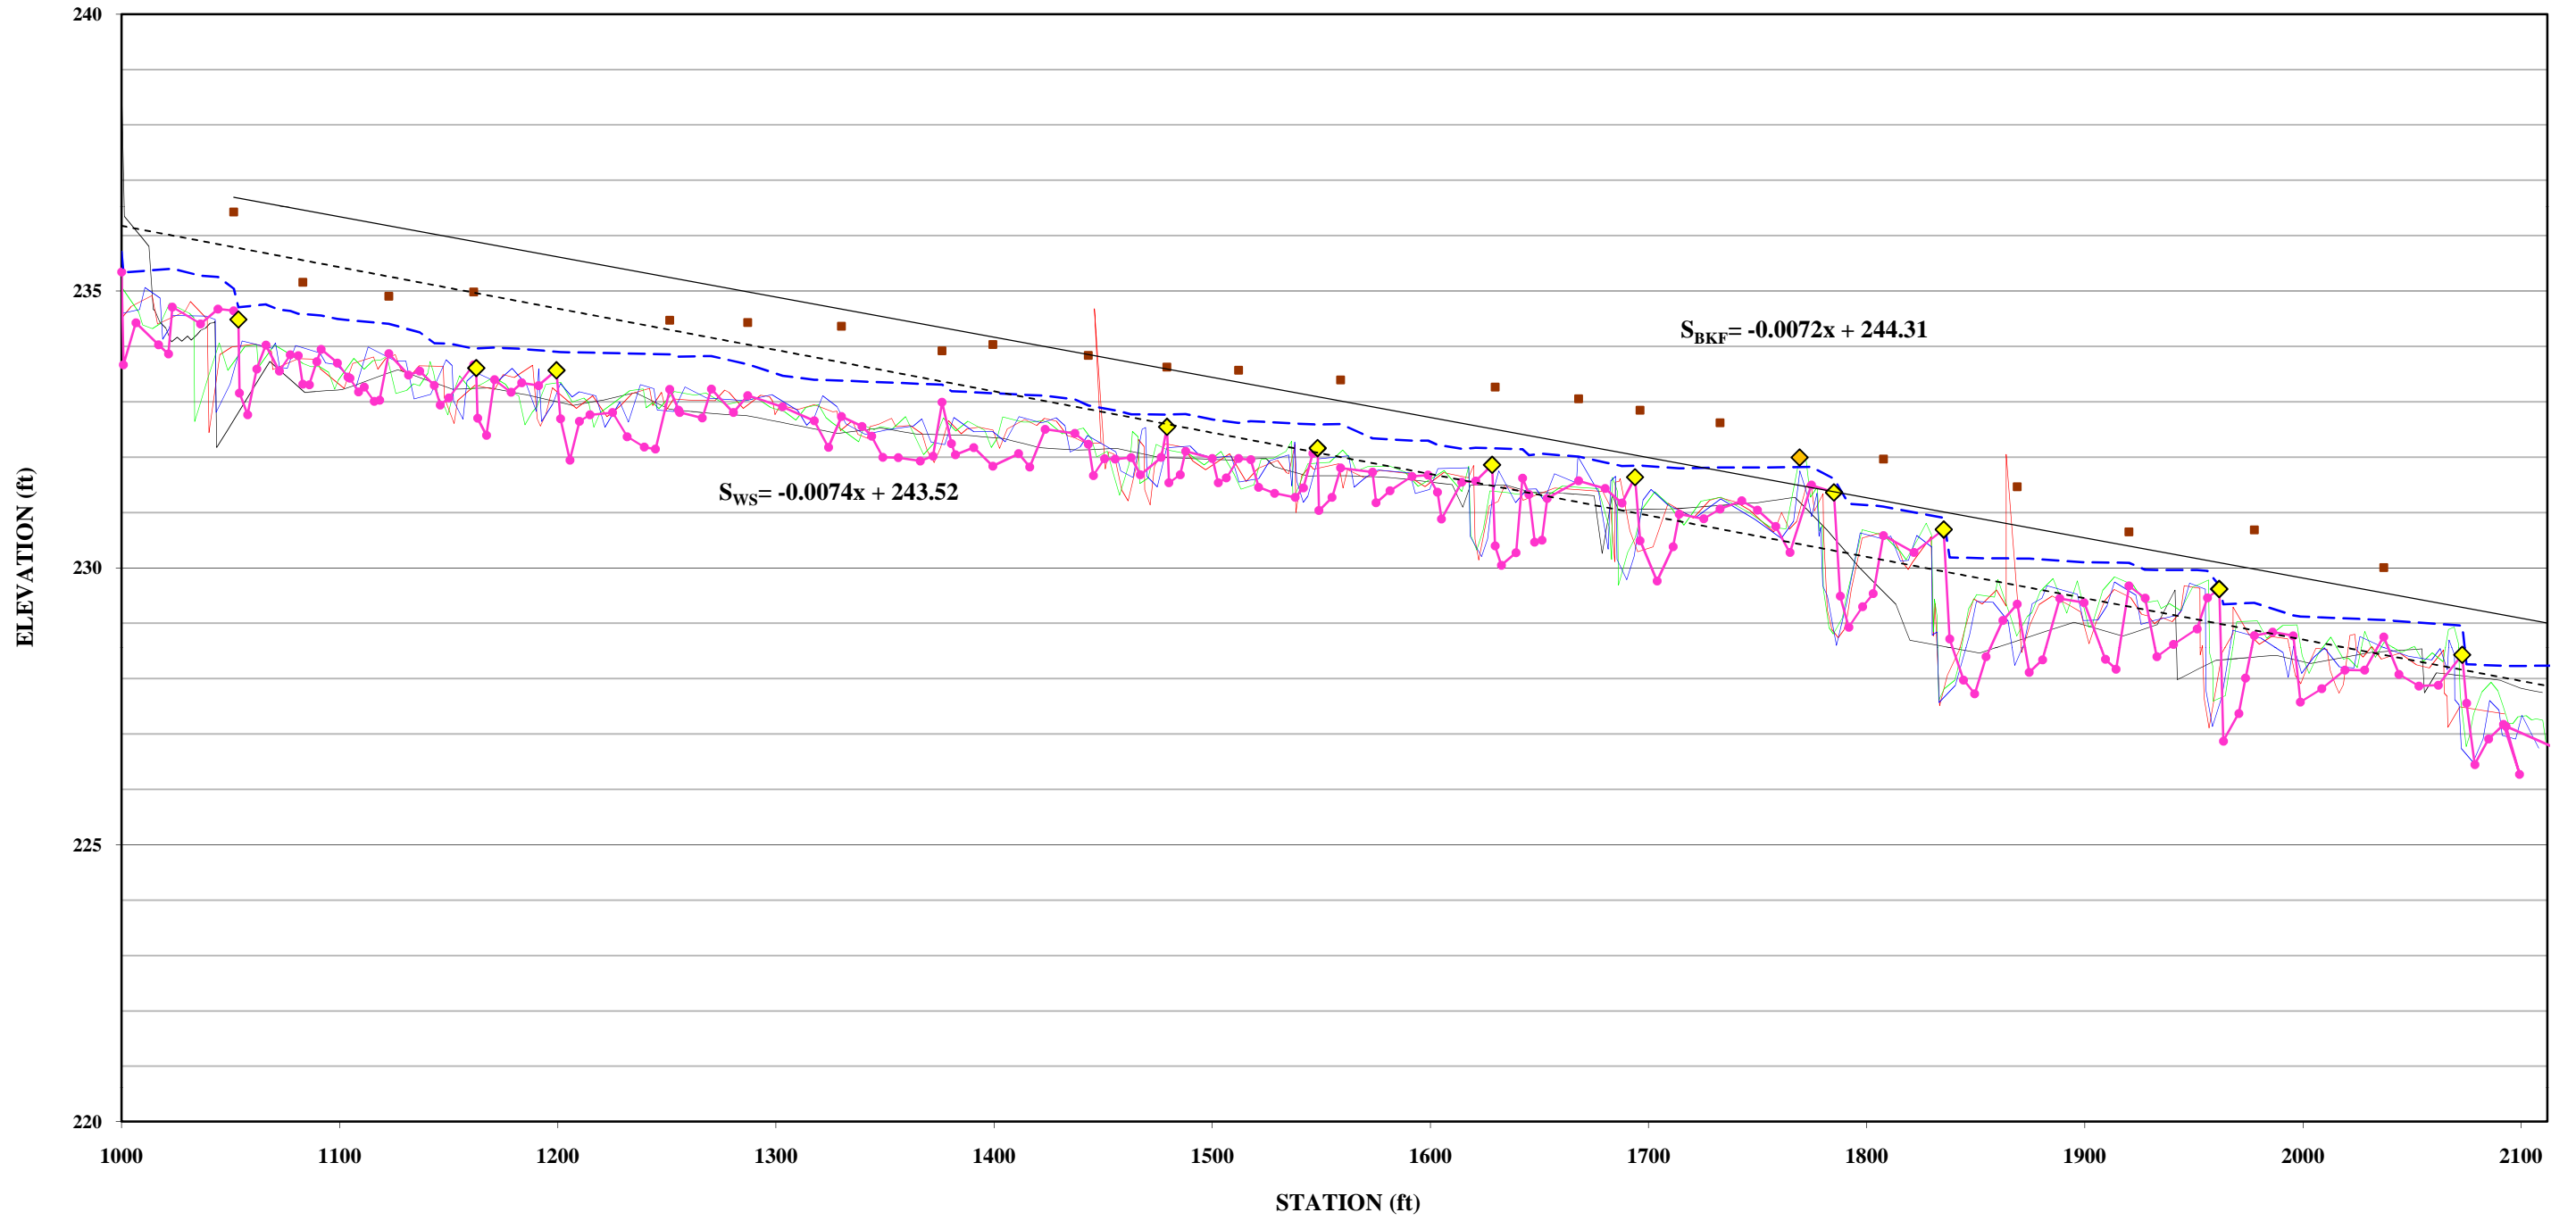
Longitudinal Profile
UT to Crooked Creek (Upper Reach), Franklin County
EEP Project Number 434 - MY04

The stream monitoring at the site involves surveying eight permanent cross-sections and a longitudinal profile along the entire length of UTCC. The stream assessment completed during the fourth year of monitoring found the stream to be functioning and holding grade. The site does not have any bank erosion problems or widespread bed incision or aggradation. Throughout the monitoring history of this project there have been a series of beaver dams constructed on the project channel. The beavers have been removed and the dams have been breached. Most of these dams collected fine sediment behind them, which caused small areas of bed aggradation. These breached beaver dams still create areas of backwater in the channel, which have been mapped on the Current Condition Plan View (CCPV). Another beaver dam is located below the restored channel, and it is causing backwater conditions in the downstream

portion of the lower reach. In 2011, EEP will conduct maintenance planting and remove active and relic beaver dams at the site.

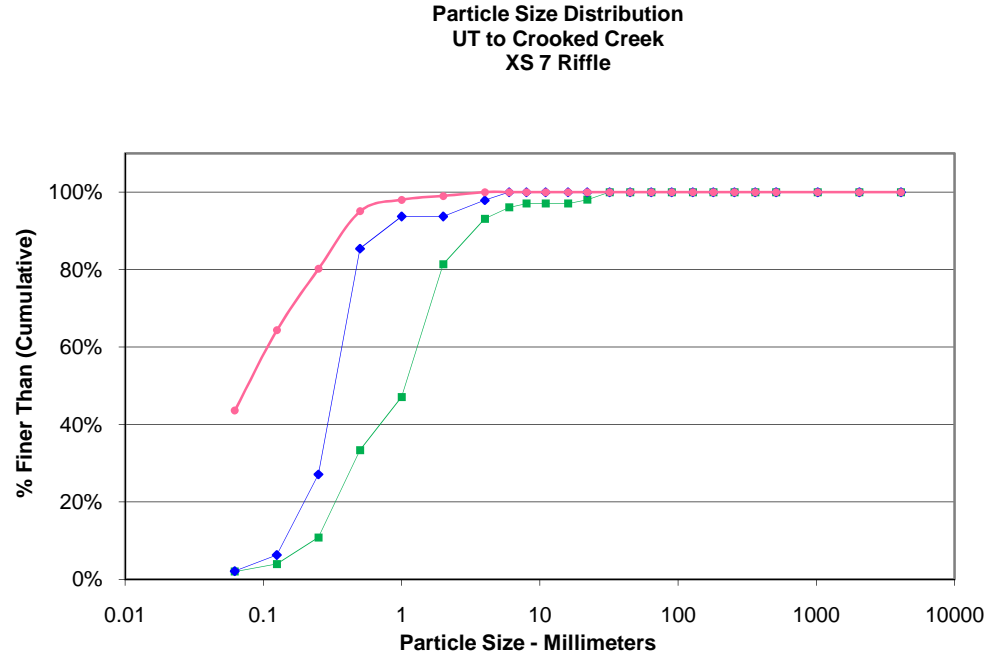
Size (mm)	
D16	0.062
D35	0.062
D50	0.077
D65	0.13
D84	0.3
D95	0.5

Size Distribution	
mean	0.1
dispersion	2.6
skewness	0.30

Type	
silt/clay	44%
sand	55%
gravel	1%
cobble	0%
boulder	0%
bedrock	0%
hardpan	0%
wood/det	0%
artificial	0%

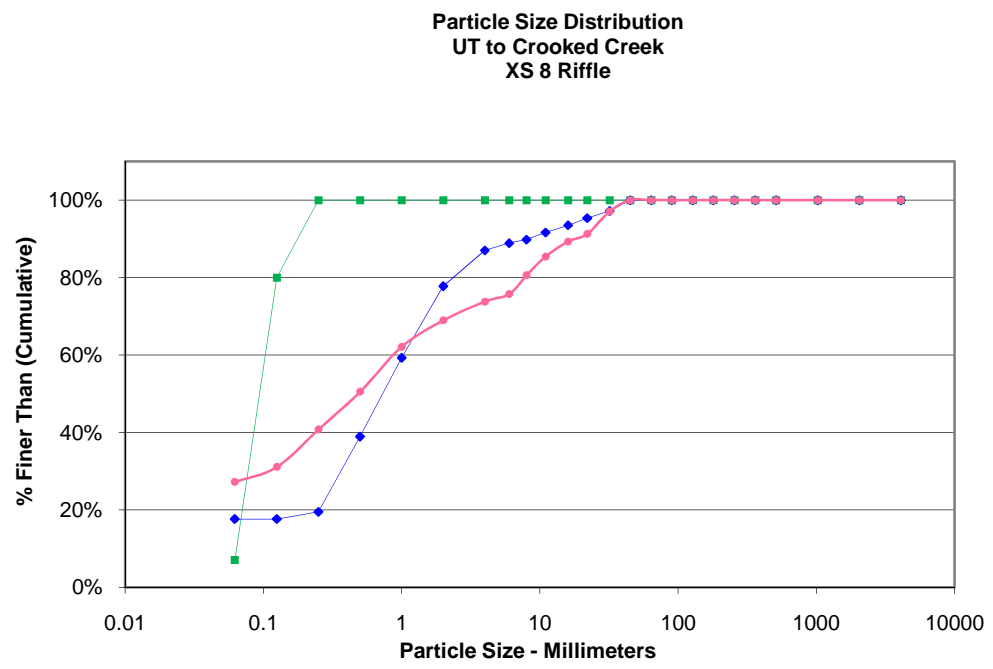
Size (mm)	
D16	0.062
D35	0.17
D50	0.48
D65	1.3
D84	10
D95	28

Size Distribution	
mean	0.8
dispersion	14.3
skewness	0.14
