**UT to Crooked Creek
Stream Restoration Monitoring Report
EEP Project # 434
Monitoring Year 05**

**Data Collection: 2011
Construction Completed: July 2006
Submitted: December 2011**

UT CROOKED CREEK
 FRANKLIN COUNTY, NORTH CAROLINA
 EEP PROJECT NUMBER 434 - MY05
 STATION 10+00 TO STATION 21+28

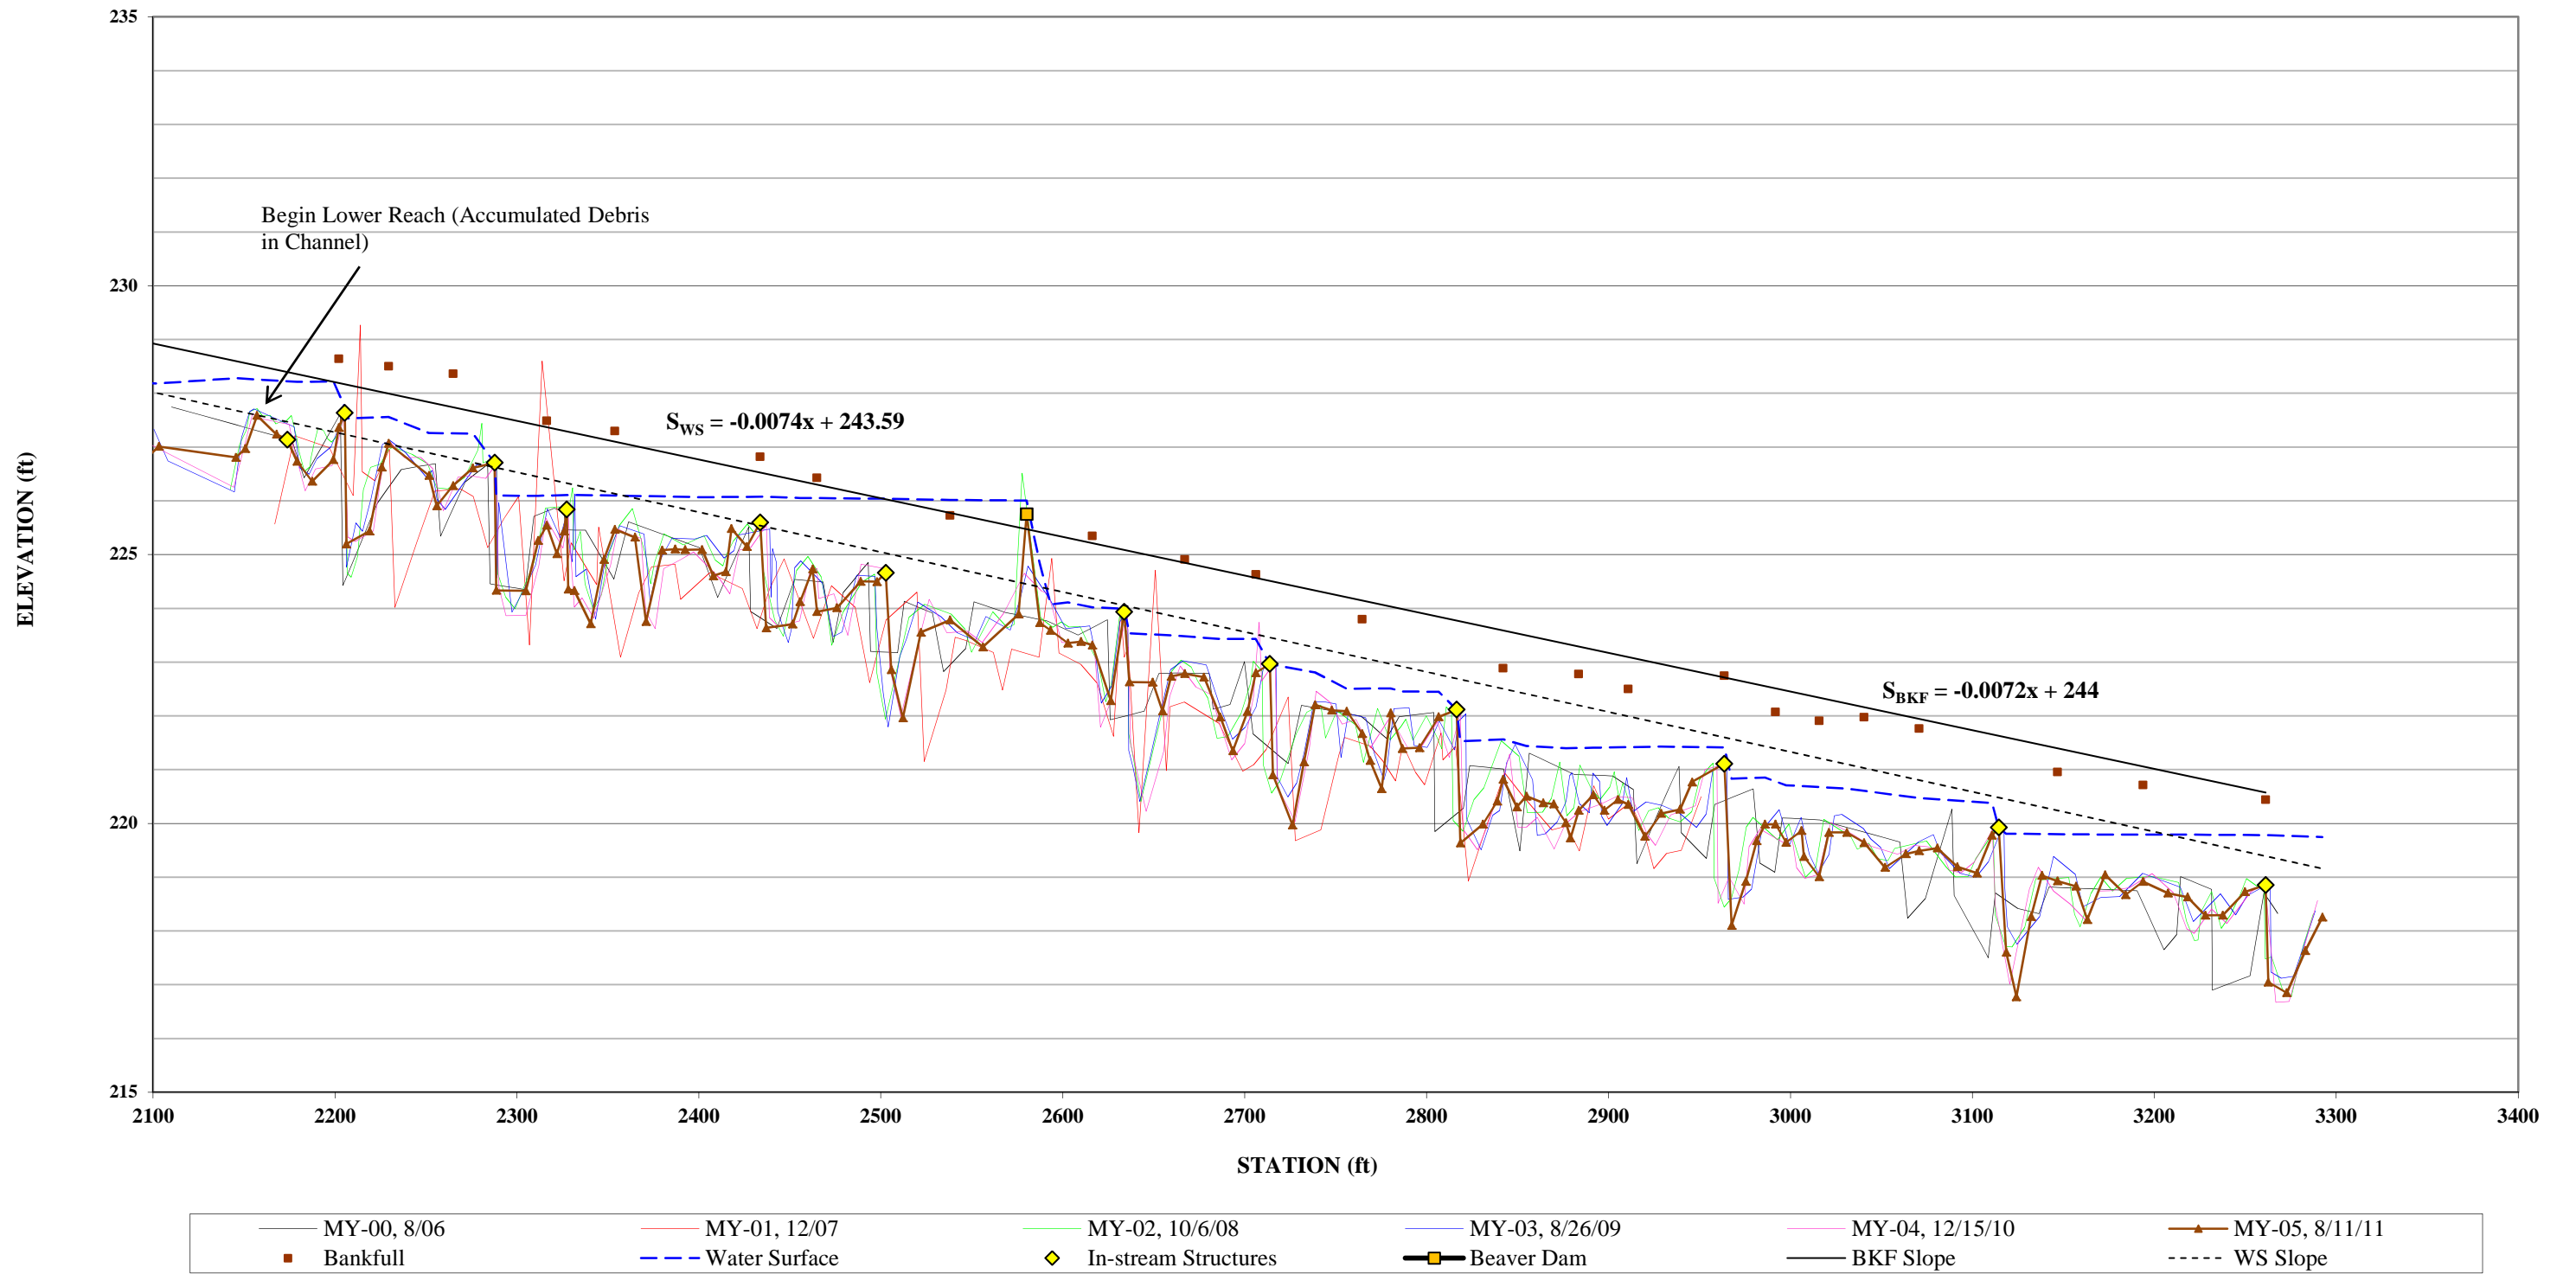
Longitudinal Profile
UT to Crooked Creek (Lower Reach), Franklin County
EEP Project Number 434 - MY05

Note: MY-01 profile data ends at Station 29+50. A survey error affected the elevations from Station 29+50 to the end of the profile.
