FINAL
ANNUAL MONITORING REPORT
YEAR 1 (2012)
HAUSER CREEK STREAM RESTORATION SITE
DAVIE COUNTY, NORTH CAROLINA
(EEP Project No. 92471, Contract No. 004804)
Construction Completed August 2011

February 2013

Prepared by:
Axiom Environmental, Inc.
218 Snow Avenue
Raleigh, North Carolina 27603

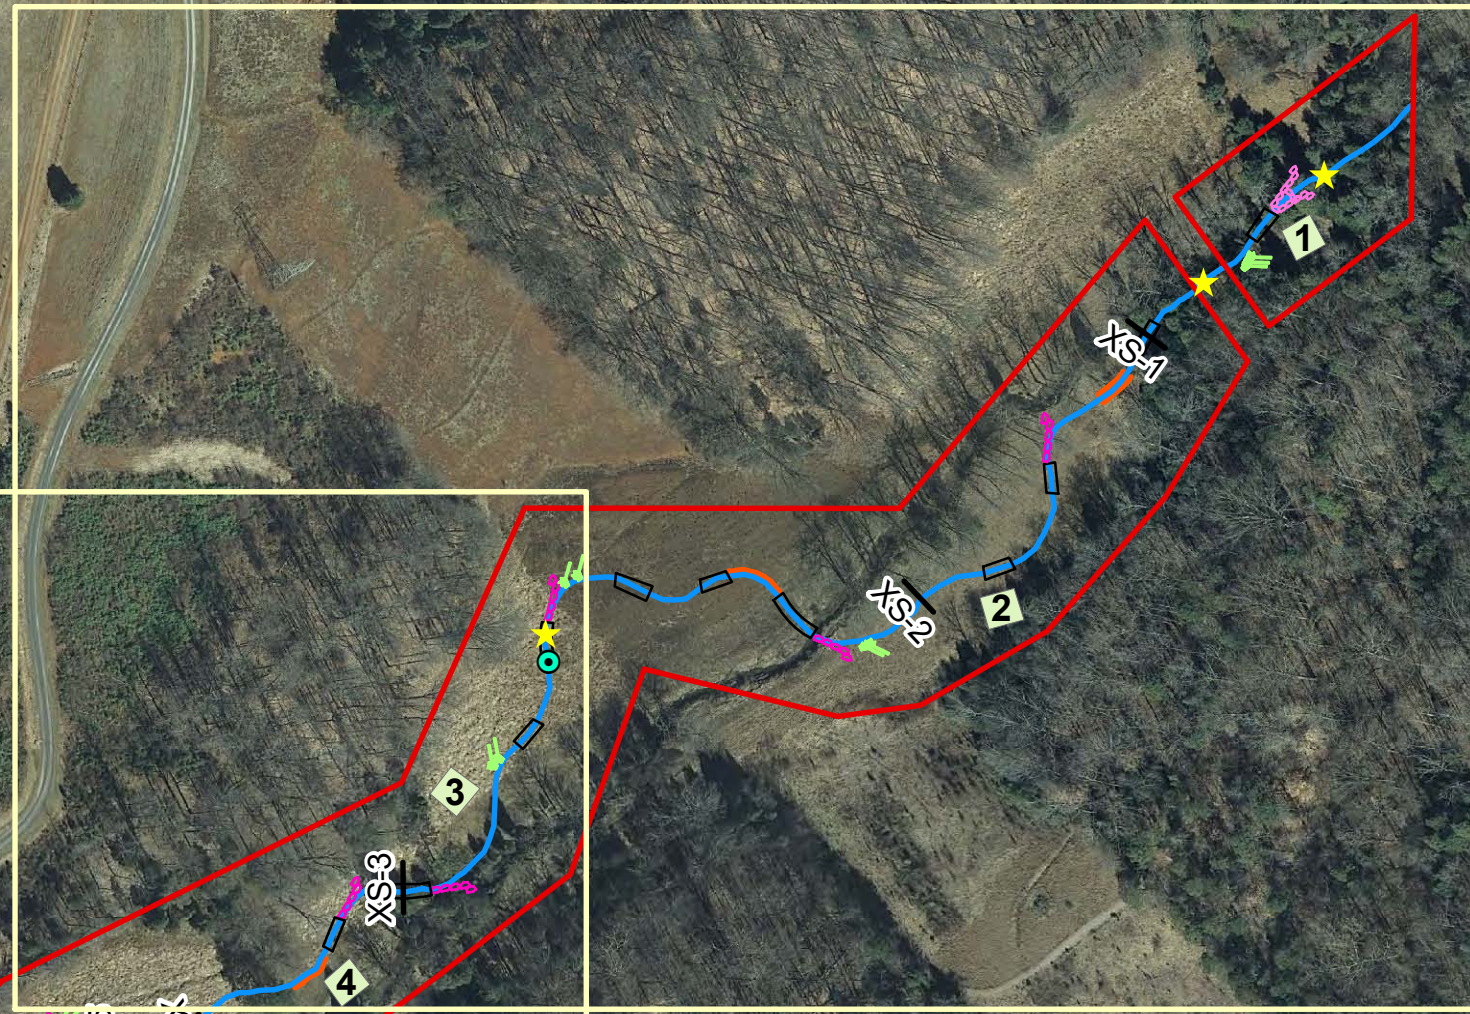
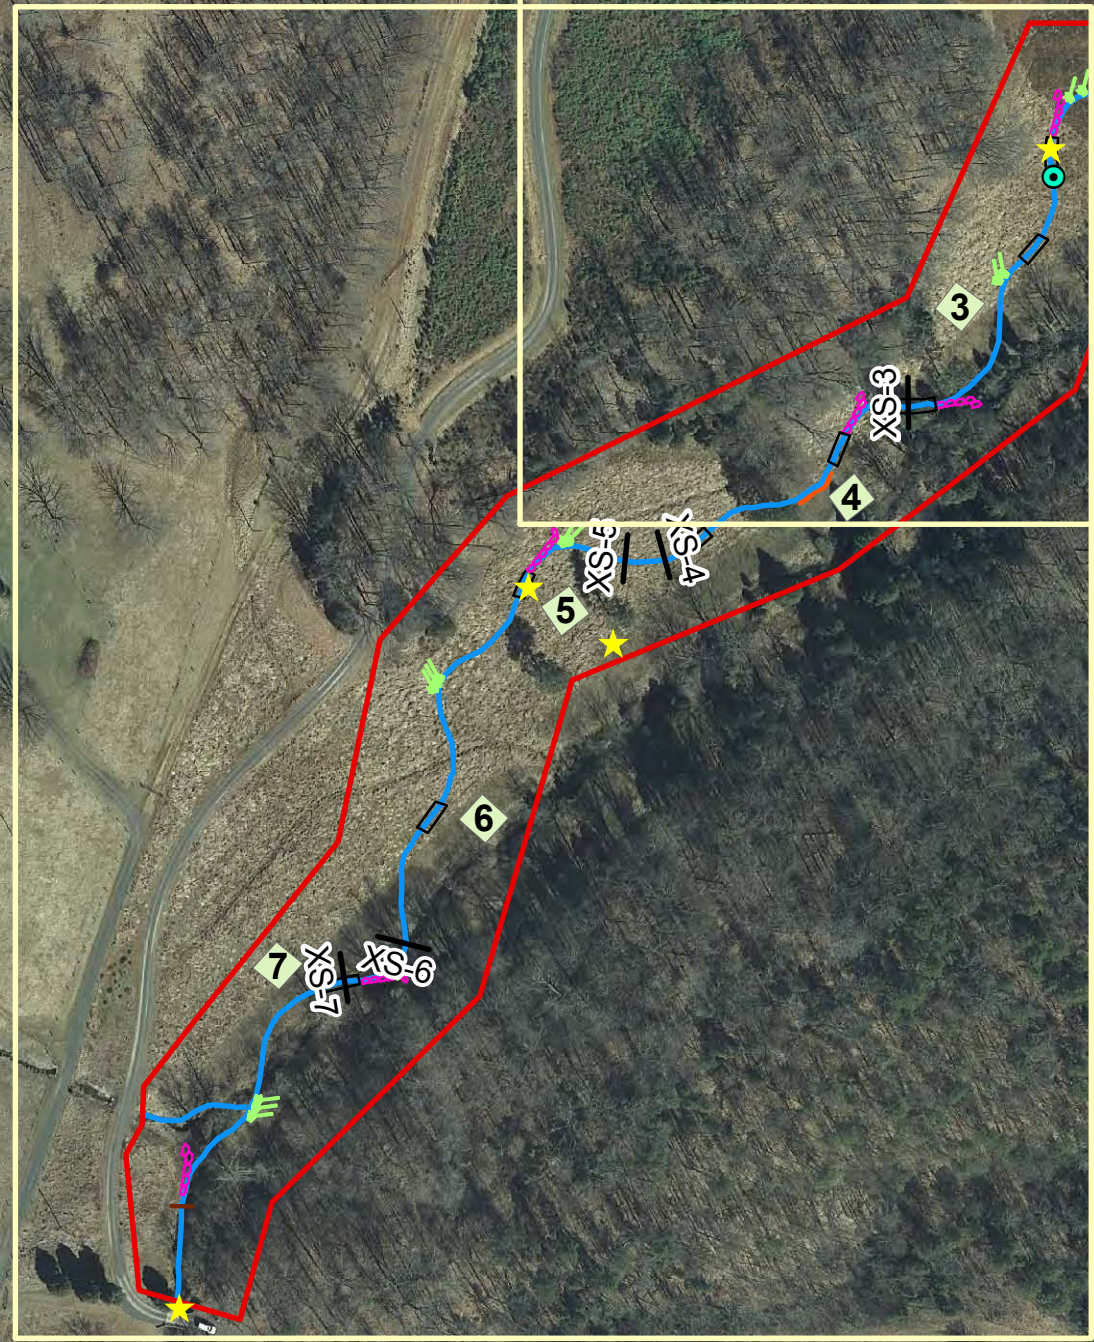
Fig. 2A

Overall, the stream is functioning properly and as designed. Three areas of minor bank erosion were noted in Figures 2A-2B in Appendix B, but these areas are not causing additional issues up or downstream and vegetation is establishing.

Map Label*	Station	Notes
PA-1	22+50	Minor erosion on both banks; vegetation is establishing
PA-2	18+75	Minor erosion and undercut bank on outer/left bank; vegetation is establishing
PA-3	12+00	Minor undercutting on outer/right bank; vegetation is establishing
