**FINAL**  
**ANNUAL MONITORING REPORT**  
**YEAR 2 (2013)**  
**HAUSER CREEK STREAM RESTORATION SITE**  
**DAVIE COUNTY, NORTH CAROLINA**  
**(EEP Project No. 92471, Contract No. 004804)**  
**Construction Completed August 2011**

Submitted to:  
North Carolina Department of Environment and Natural Resources  
Ecosystem Enhancement Program  
Raleigh, North Carolina

November 2013

Prepared by:  
Axiom Environmental, Inc.  
218 Snow Avenue  
Raleigh, North Carolina 27603

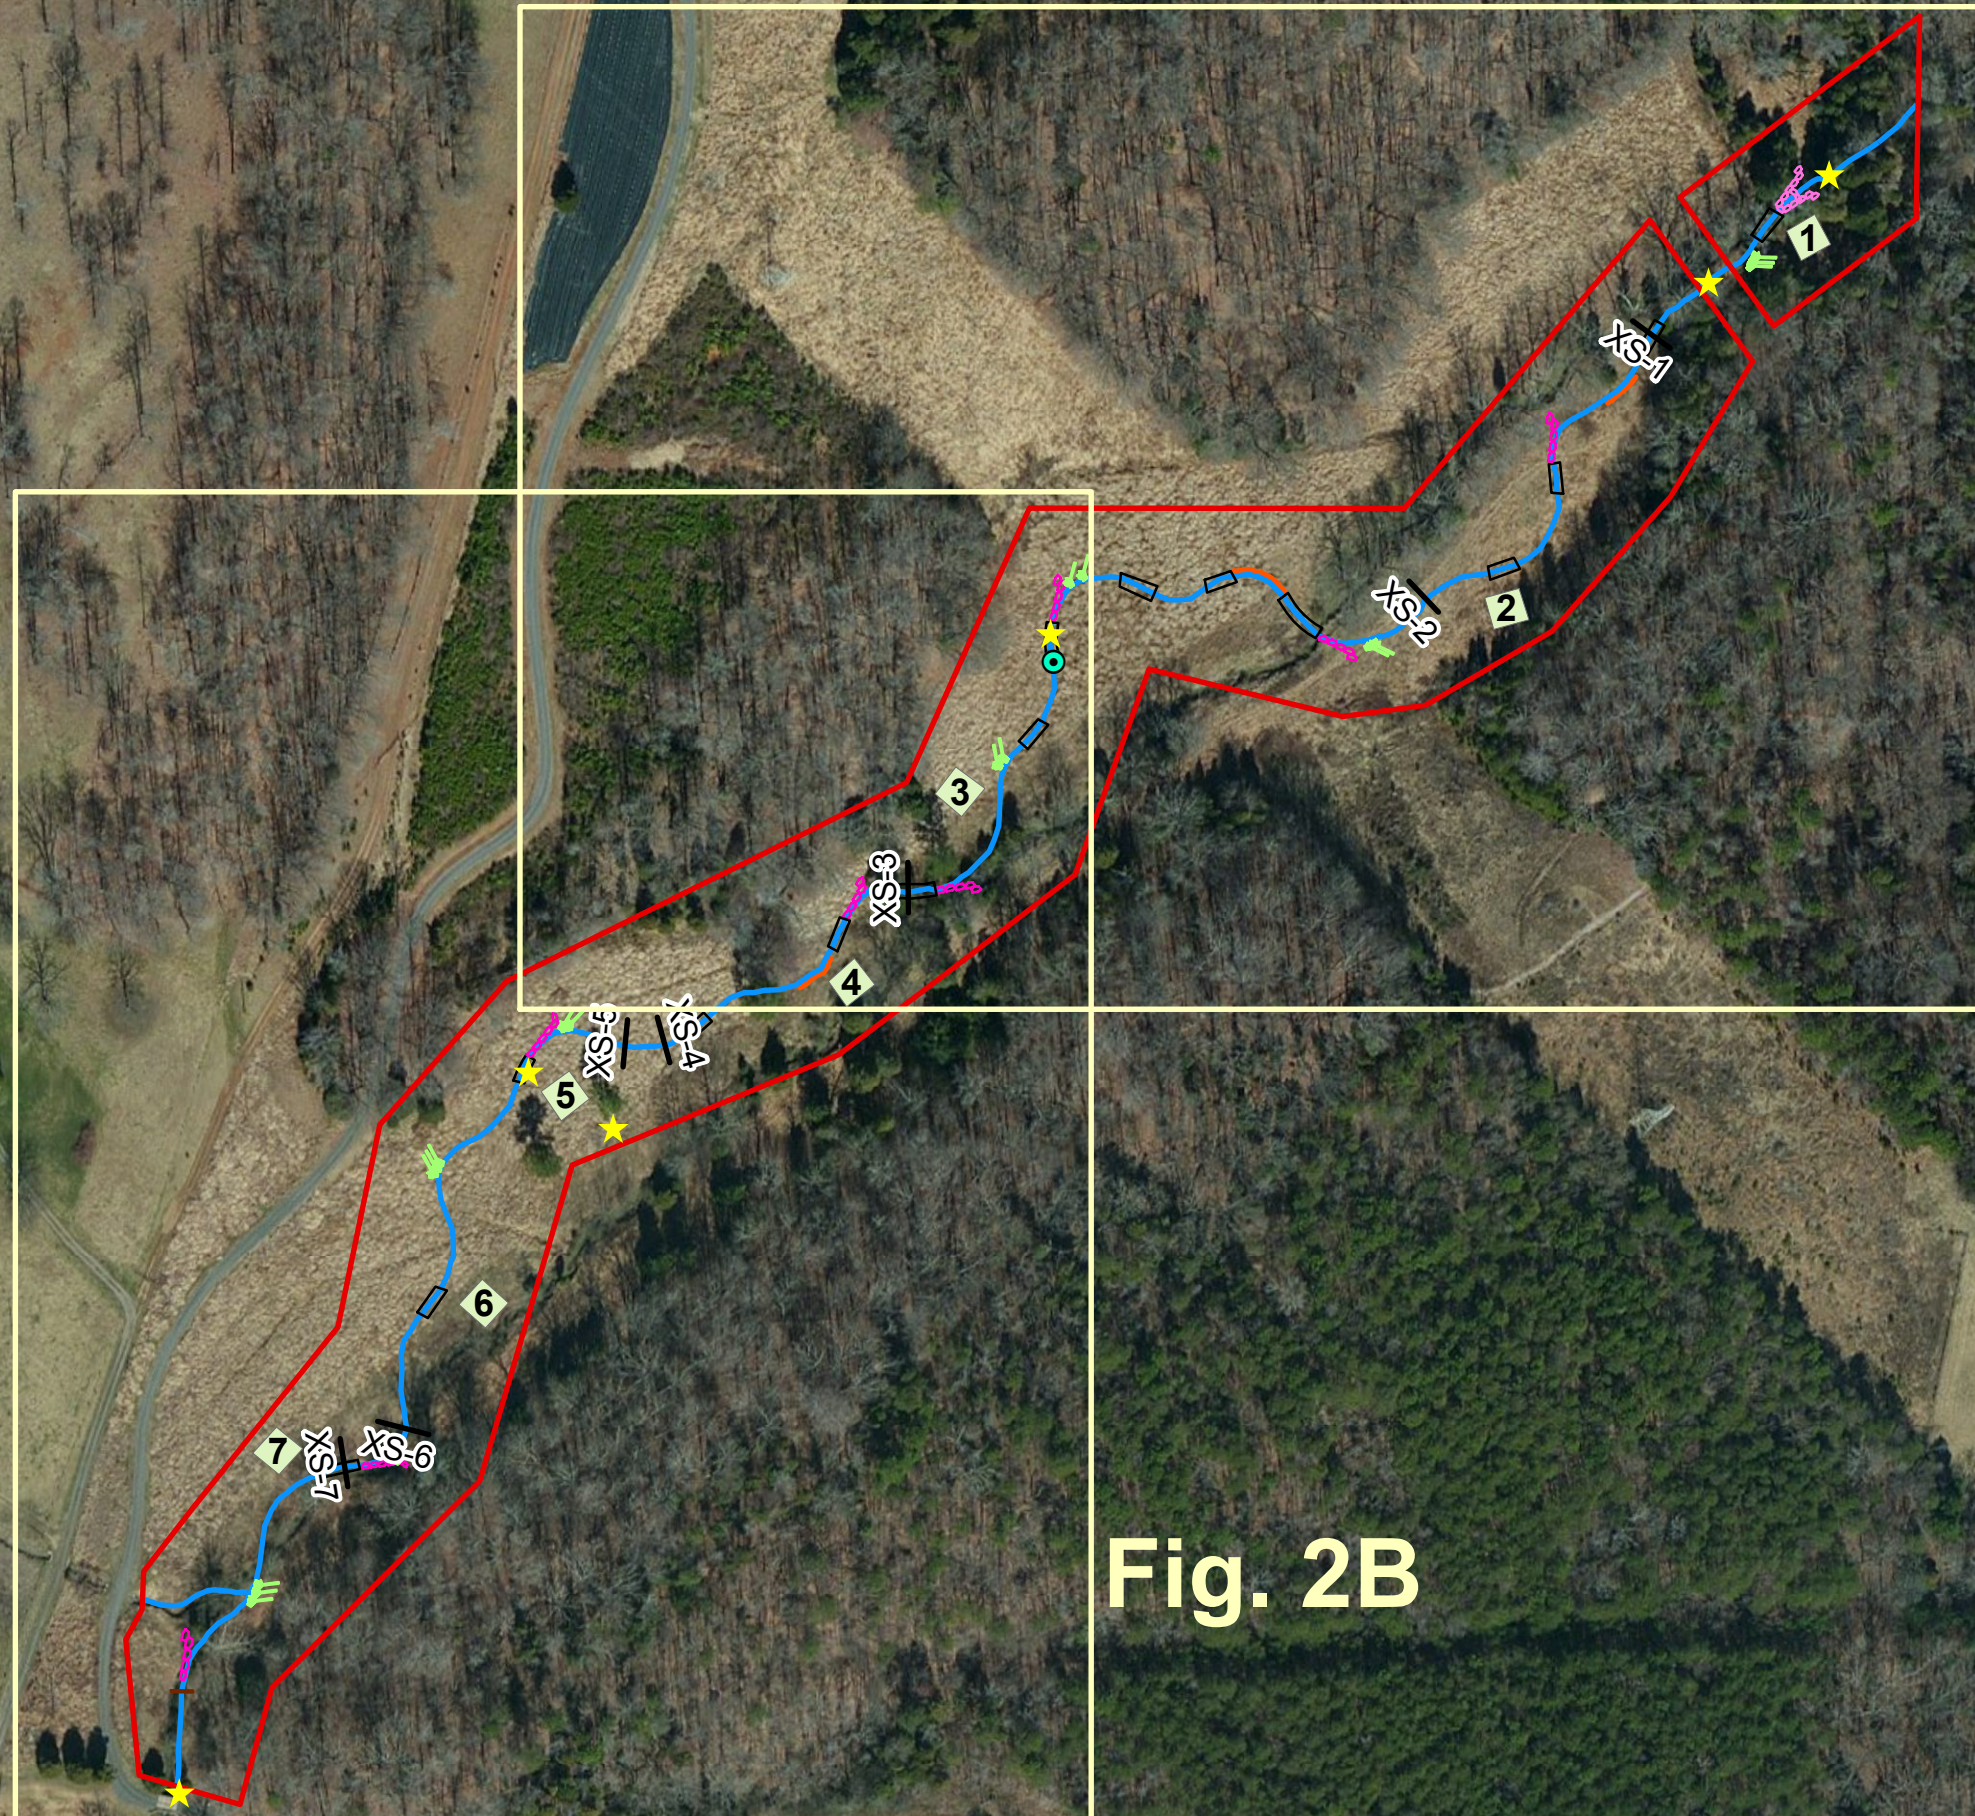
Overall, the stream is functioning properly and as designed. Three areas of minor bank erosion were noted in Figures 2A-2B (Appendix B); however, these areas are not causing additional issues up or downstream and vegetation is establishing.

Map Label*	Station	Notes
SAC-1	22+50	Erosion and sloughing of approximately 10 feet along the right bank of an outer bend
SAC-2	18+75	Erosion and sloughing of approximately 15 feet along the left bank of an outer bend
SAC-3	12+00	Erosion and sloughing of approximately 10 feet along the right bank of an outer bend

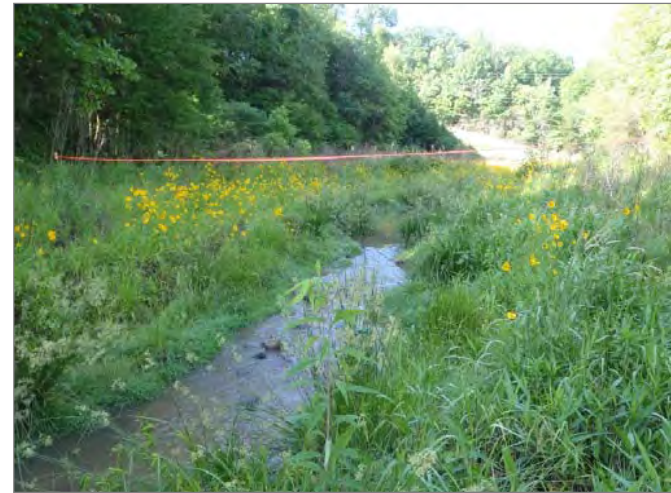
<b>Site</b>	Hauser Creek
<b>Watershed:</b>	Yadkin Pee Dee
<b>XS ID</b>	XS - 1, Riffle
<b>Feature</b>	Riffle
<b>Date:</b>	5/31/2013
<b>Field Crew:</b>	Perkinson, Jernigan

SUMMARY DATA	
<b>Bankfull Elevation:</b>	98.8
<b>Bankfull Cross-Sectional Area:</b>	59.2
<b>Bankfull Width:</b>	29.0
<b>Flood Prone Area Elevation:</b>	102.3
<b>Flood Prone Width:</b>	150.0
<b>Max Depth at Bankfull:</b>	3.5
<b>Mean Depth at Bankfull:</b>	2.0
<b>W / D Ratio:</b>	14.2
<b>Entrenchment Ratio:</b>	5.2
<b>Bank Height Ratio:</b>	1.0

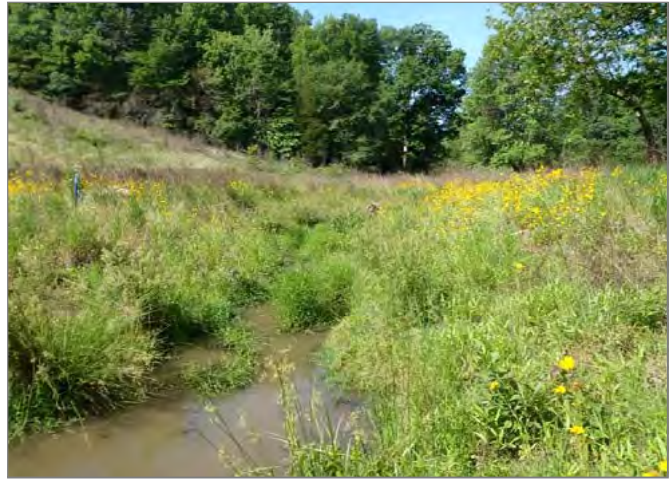
<b>Site</b>	Hauser Creek
<b>Watershed:</b>	Yadkin Pee Dee
<b>XS ID</b>	XS - 2, Riffle
<b>Feature</b>	Riffle
<b>Date:</b>	5/31/2013
<b>Field Crew:</b>	Perkinson, Jernigan

SUMMARY DATA	
<b>Bankfull Elevation:</b>	99.3
<b>Bankfull Cross-Sectional Area:</b>	49.6
<b>Bankfull Width:</b>	26.8
<b>Flood Prone Area Elevation:</b>	103.1
<b>Flood Prone Width:</b>	150.0
<b>Max Depth at Bankfull:</b>	3.8
<b>Mean Depth at Bankfull:</b>	1.9
<b>W / D Ratio:</b>	14.5
<b>Entrenchment Ratio:</b>	5.6
<b>Bank Height Ratio:</b>	1.0

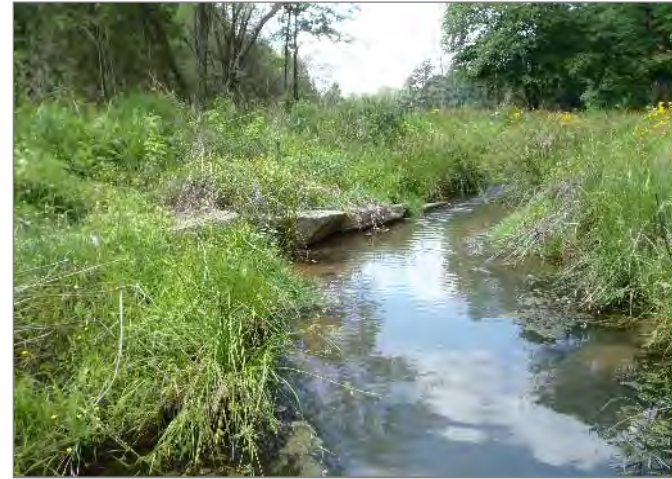
<b>Site</b>	Hauser Creek
<b>Watershed:</b>	Yadkin Pee Dee
<b>XS ID</b>	XS - 3, Riffle
<b>Feature</b>	Riffle
<b>Date:</b>	5/31/2013
<b>Field Crew:</b>	Perkinson, Jernigan

SUMMARY DATA	
<b>Bankfull Elevation:</b>	101.2
<b>Bankfull Cross-Sectional Area:</b>	70.2
<b>Bankfull Width:</b>	31.3
<b>Flood Prone Area Elevation:</b>	104.9
<b>Flood Prone Width:</b>	150.0
<b>Max Depth at Bankfull:</b>	3.7
<b>Mean Depth at Bankfull:</b>	2.2
<b>W / D Ratio:</b>	14.0
<b>Entrenchment Ratio:</b>	4.8
<b>Bank Height Ratio:</b>	1.0

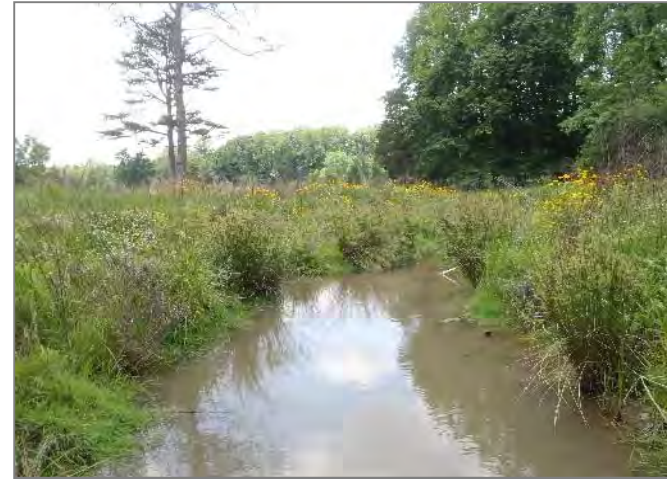
<b>Site</b>	Hauser Creek
<b>Watershed:</b>	Yadkin Pee Dee
<b>XS ID</b>	XS - 4, Pool
<b>Feature</b>	Pool
<b>Date:</b>	5/31/2013
<b>Field Crew:</b>	Perkinson, Jernigan

SUMMARY DATA	
<b>Bankfull Elevation:</b>	101.4
<b>Bankfull Cross-Sectional Area:</b>	91.3
<b>Bankfull Width:</b>	30.0
<b>Flood Prone Area Elevation:</b>	NA
<b>Flood Prone Width:</b>	NA
<b>Max Depth at Bankfull:</b>	6.1
<b>Mean Depth at Bankfull:</b>	3.0
<b>W / D Ratio:</b>	NA
<b>Entrenchment Ratio:</b>	NA
<b>Bank Height Ratio:</b>	1.0

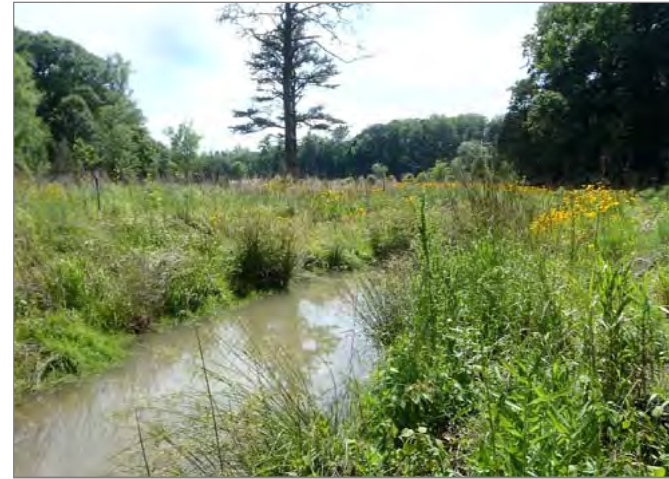
<b>Site</b>	Hauser Creek
<b>Watershed:</b>	Yadkin Pee Dee
<b>XS ID</b>	XS - 5, Riffle
<b>Feature</b>	Riffle
<b>Date:</b>	5/31/2013
<b>Field Crew:</b>	Perkinson, Jernigan

SUMMARY DATA	
<b>Bankfull Elevation:</b>	101.8
<b>Bankfull Cross-Sectional Area:</b>	82.5
<b>Bankfull Width:</b>	32.6
<b>Flood Prone Area Elevation:</b>	106.3
<b>Flood Prone Width:</b>	150.0
<b>Max Depth at Bankfull:</b>	4.5
<b>Mean Depth at Bankfull:</b>	2.5
<b>W / D Ratio:</b>	12.9
<b>Entrenchment Ratio:</b>	4.6
<b>Bank Height Ratio:</b>	1.0

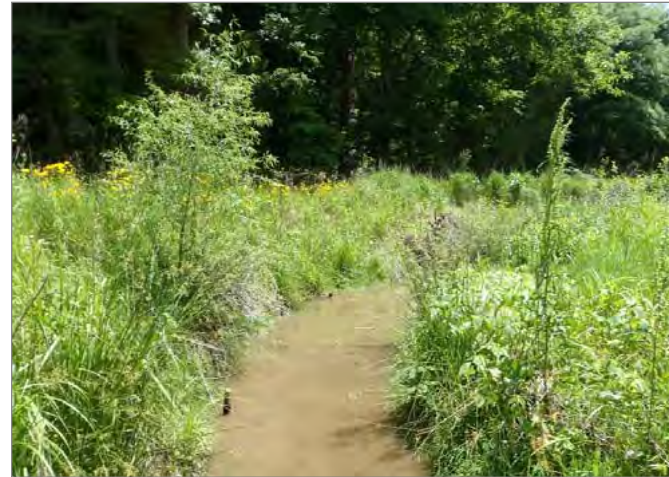
<b>Site</b>	Hauser Creek
<b>Watershed:</b>	Yadkin Pee Dee
<b>XS ID</b>	XS - 6, Pool
<b>Feature</b>	Pool
<b>Date:</b>	5/31/2013
<b>Field Crew:</b>	Perkinson, Jernigan

SUMMARY DATA	
<b>Bankfull Elevation:</b>	103.1
<b>Bankfull Cross-Sectional Area:</b>	110.6
<b>Bankfull Width:</b>	41.5
<b>Flood Prone Area Elevation:</b>	NA
<b>Flood Prone Width:</b>	NA
<b>Max Depth at Bankfull:</b>	5.7
<b>Mean Depth at Bankfull:</b>	2.7
<b>W / D Ratio:</b>	NA
<b>Entrenchment Ratio:</b>	NA
<b>Bank Height Ratio:</b>	1.0

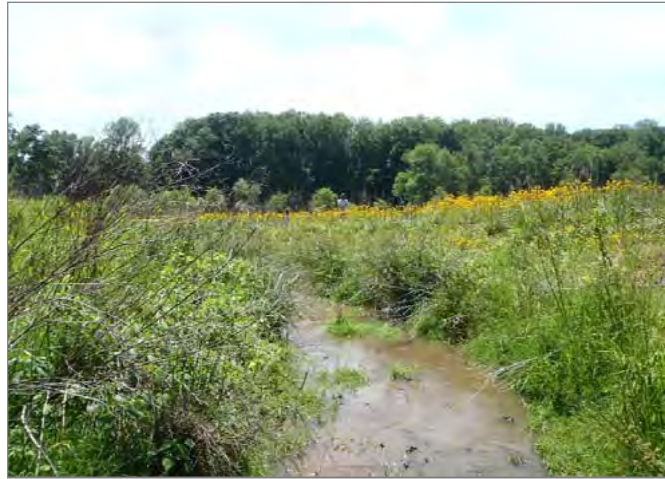
<b>Site</b>	Hauser Creek
<b>Watershed:</b>	Yadkin Pee Dee
<b>XS ID</b>	XS - 7, Riffle
<b>Feature</b>	Riffle
<b>Date:</b>	5/31/2013
<b>Field Crew:</b>	Perkinson, Jernigan

SUMMARY DATA	
<b>Bankfull Elevation:</b>	102.7
<b>Bankfull Cross-Sectional Area:</b>	74.8
<b>Bankfull Width:</b>	31.3
<b>Flood Prone Area Elevation:</b>	106.9
<b>Flood Prone Width:</b>	150.0
<b>Max Depth at Bankfull:</b>	4.2
<b>Mean Depth at Bankfull:</b>	2.4
<b>W / D Ratio:</b>	13.1
<b>Entrenchment Ratio:</b>	4.8
<b>Bank Height Ratio:</b>	1.0
