FINAL
ANNUAL MONITORING REPORT
YEAR 3 (2014)
HAUSER CREEK STREAM RESTORATION SITE
DAVIE COUNTY, NORTH CAROLINA
(EEP Project No. 92471, Contract No. 004804)
Construction Completed August 2011

October 2014

Prepared by:
Axiom Environmental, Inc.
218 Snow Avenue
Raleigh, North Carolina 27603

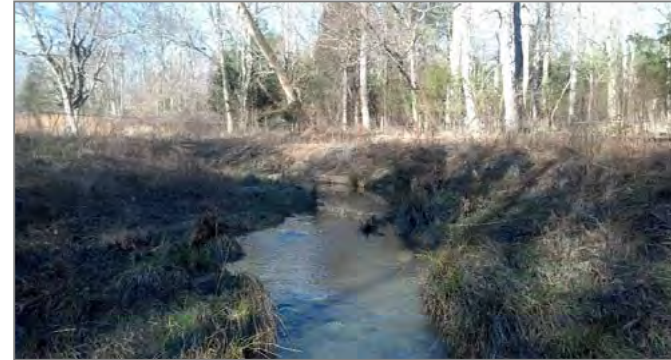
Site	Hauser Creek
Watershed:	Yadkin Pee Dee
XS ID	XS - 4, Pool
Feature	Pool
Date:	3/24/2014
Field Crew:	Perkinson, Jernigan

SUMMARY DATA	
Bankfull Elevation:	101.4
Bankfull Cross-Sectional Area:	98.1
Bankfull Width:	29.2
Flood Prone Area Elevation:	NA
Flood Prone Width:	NA
Max Depth at Bankfull:	6.8
Mean Depth at Bankfull:	3.4
W / D Ratio:	NA
Entrenchment Ratio:	NA
Bank Height Ratio:	1.0

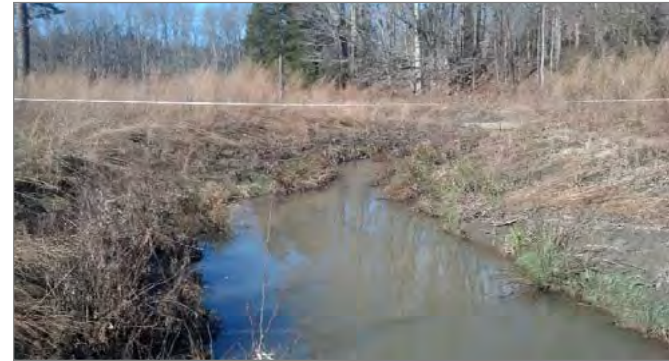
Site	Hauser Creek
Watershed:	Yadkin Pee Dee
XS ID	XS - 5, Riffle
Feature	Riffle
Date:	3/24/2014
Field Crew:	Perkinson, Jernigan

SUMMARY DATA	
Bankfull Elevation:	101.9
Bankfull Cross-Sectional Area:	80.8
Bankfull Width:	33.4
Flood Prone Area Elevation:	106.4
Flood Prone Width:	150.0
Max Depth at Bankfull:	4.5
Mean Depth at Bankfull:	2.4
W / D Ratio:	13.8
Entrenchment Ratio:	4.5
Bank Height Ratio:	1.0

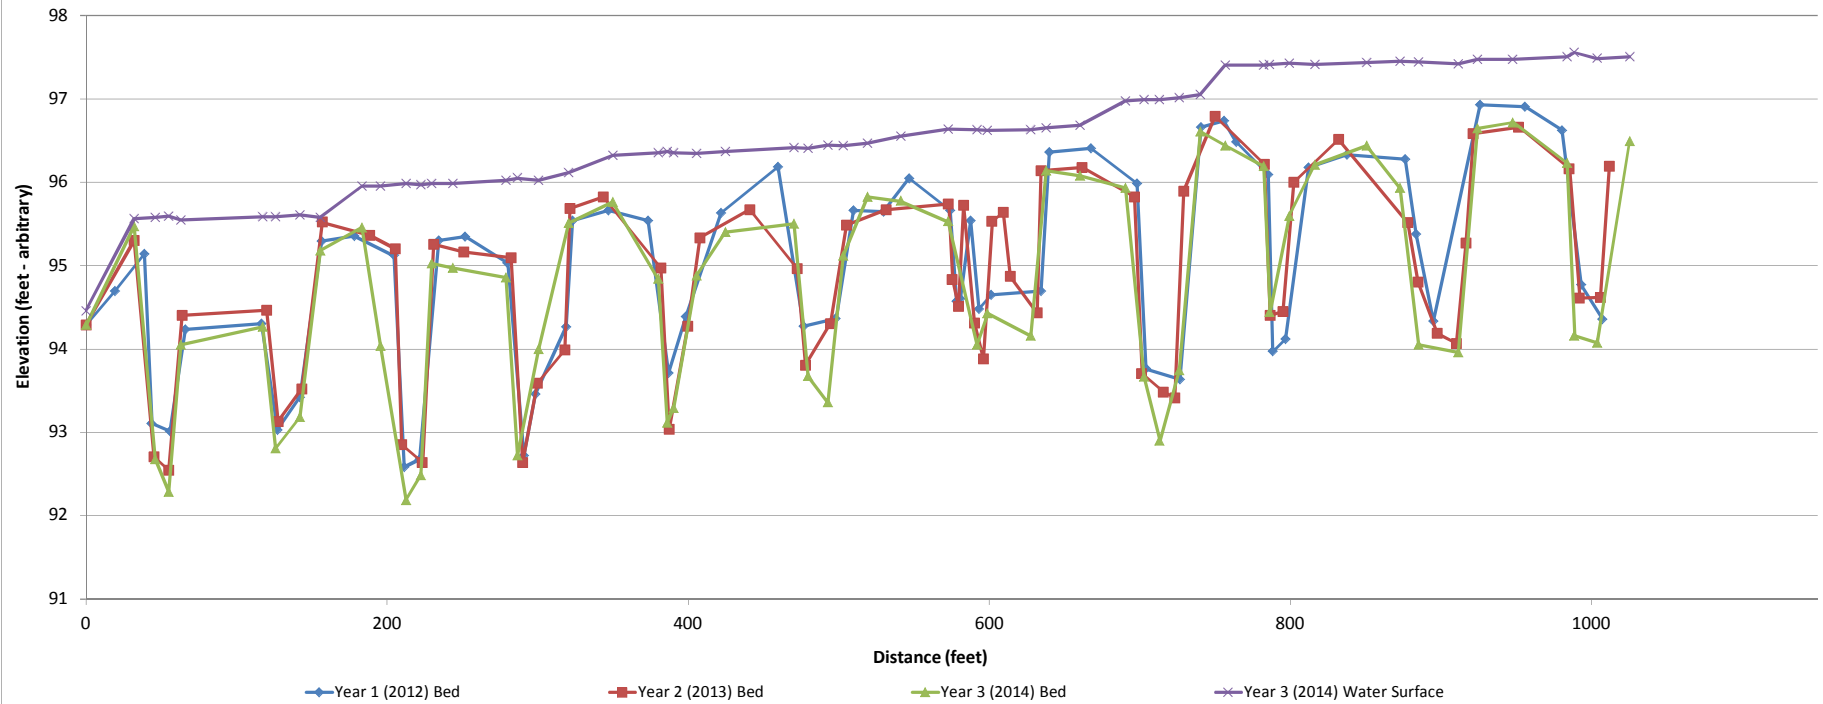
Hauser Creek Year 3 (2014) Profile - Reach 00+00 to 10+00

Project Name	Hauser Creek - Year 3 (2014) Profile	Avg. Water Surface Slope	2012 0.0022	2013 0.0022	2014 0.0022	2015	
Reach	Main Reach (00+00 - 10+00)	Riffle Length	48	56	51		
Feature	Profile	Avg. Riffle Slope	0.0047	0.0039	0.0043		
Date	3/34/2014	Pool Length	16	18	21		
Crew	Perkinson, Dean, Jernigan	Avg. Pool Slope	0.0005	0.0004	0.0008

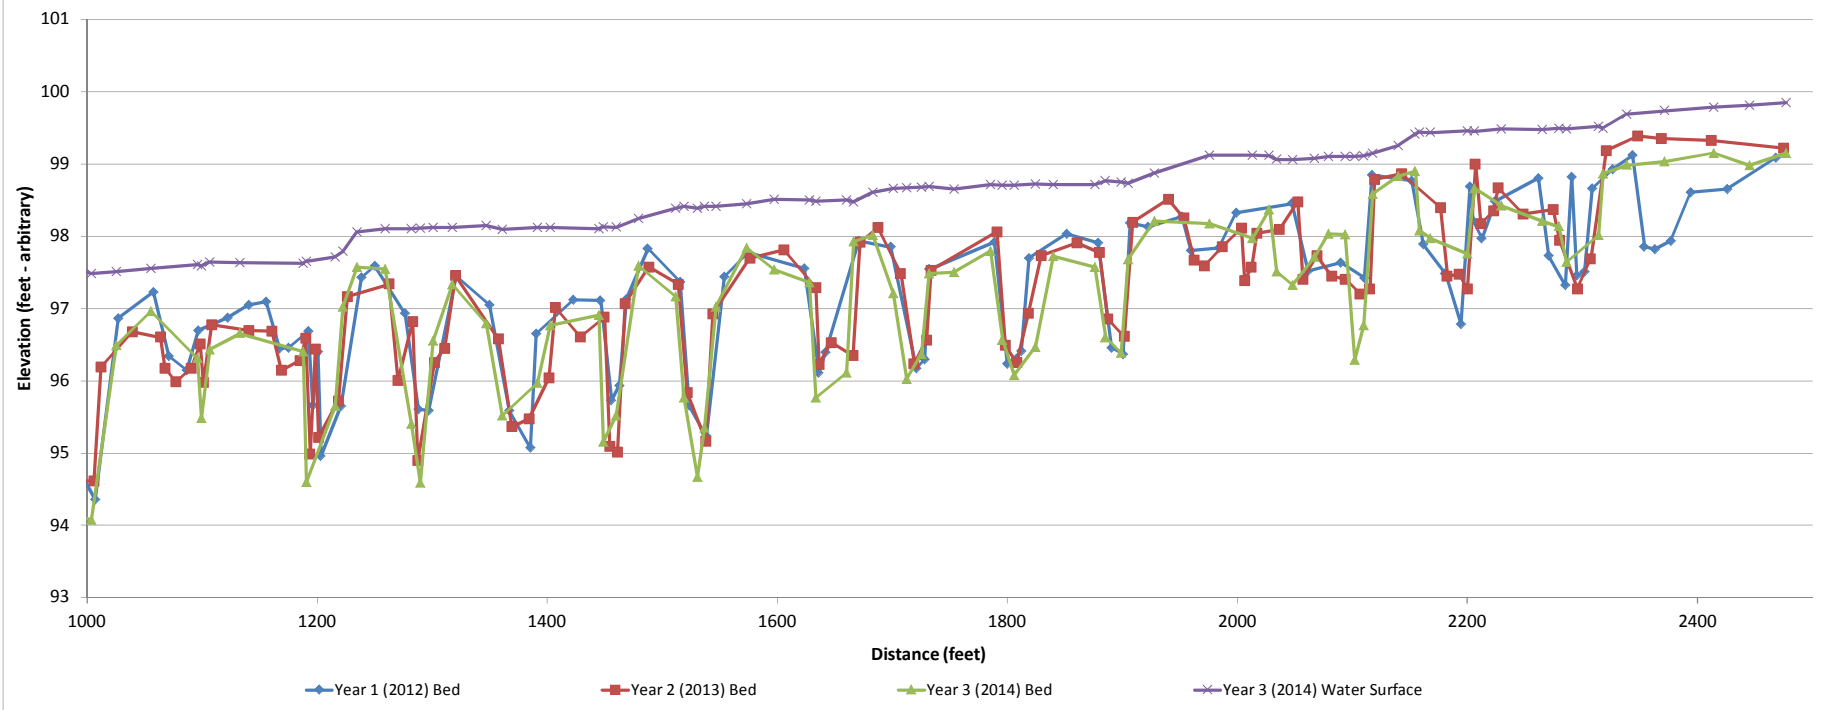
Hauser Creek Year 3 (2014) Profile - Reach 10+00 to 22+50

Project Name	Hauser Creek - Year 3 (2014) Profile	Avg. Water Surface Slope	2012 0.0022	2013 0.0022	2014 0.0022	2015	
Reach	Main Reach (10+00 - 22+50)	Riffle Length	48	56	51		
Feature	Profile	Avg. Riffle Slope	0.0047	0.0039	0.0043		
Date	3/34/2014	Pool Length	16	18	21		
Crew	Perkinson, Dean, Jernigan	Avg. Pool Slope	0.0005	0.0004	0.0008

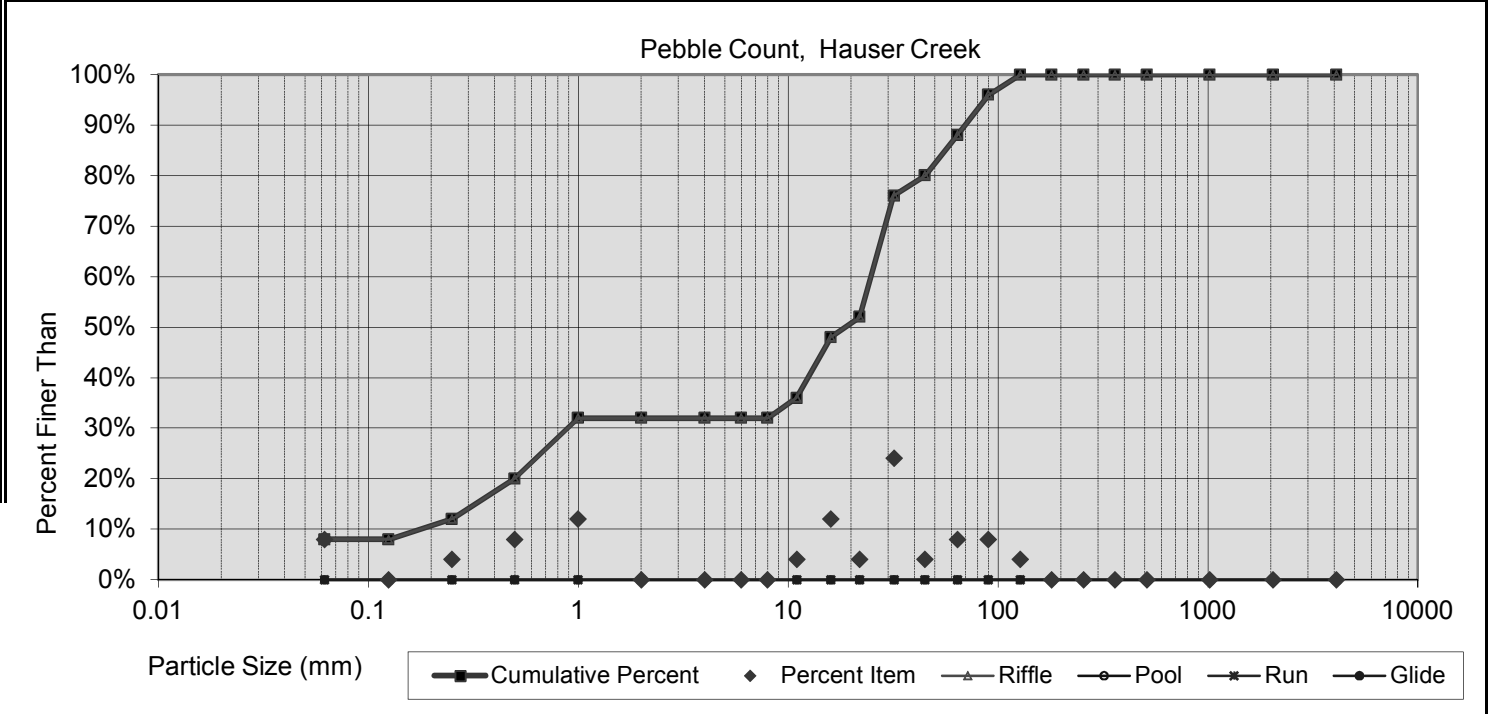
Note:	Cross Section 3

Size percent less than (mm)					Percent by substrate type					
D16	D35	D50	D84	D95	silt/clay	sand	gravel	cobble	boulder	bedrock
0.354	10.16	18.8	54	86	8%	24%	56%	12%	0%	0%

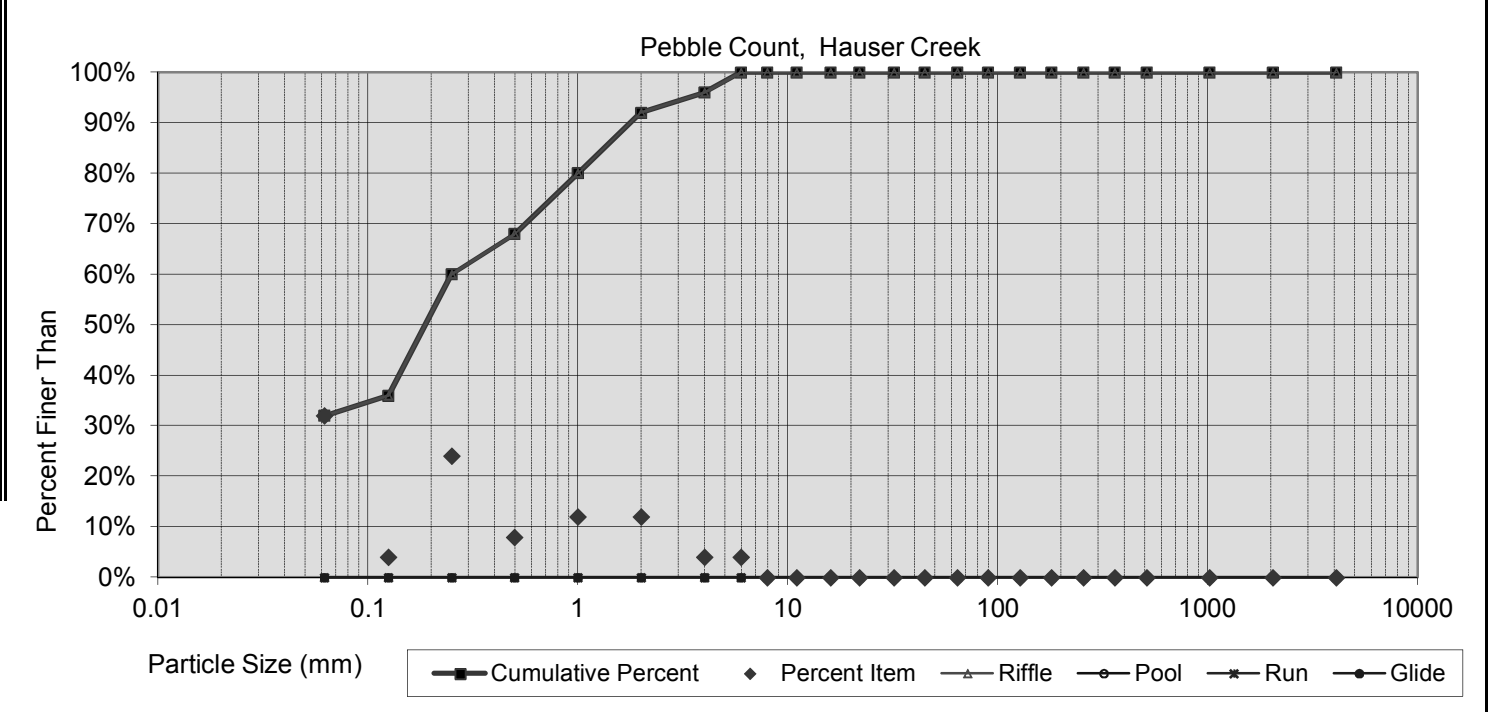
Note:	Cross Section 5

Size percent less than (mm)					Percent by substrate type					
D16	D35	D50	D84	D95	silt/clay	sand	gravel	cobble	boulder	bedrock
#N/A	0.10	0.2	1	3	32%	60%	8%	0%	0%	0%

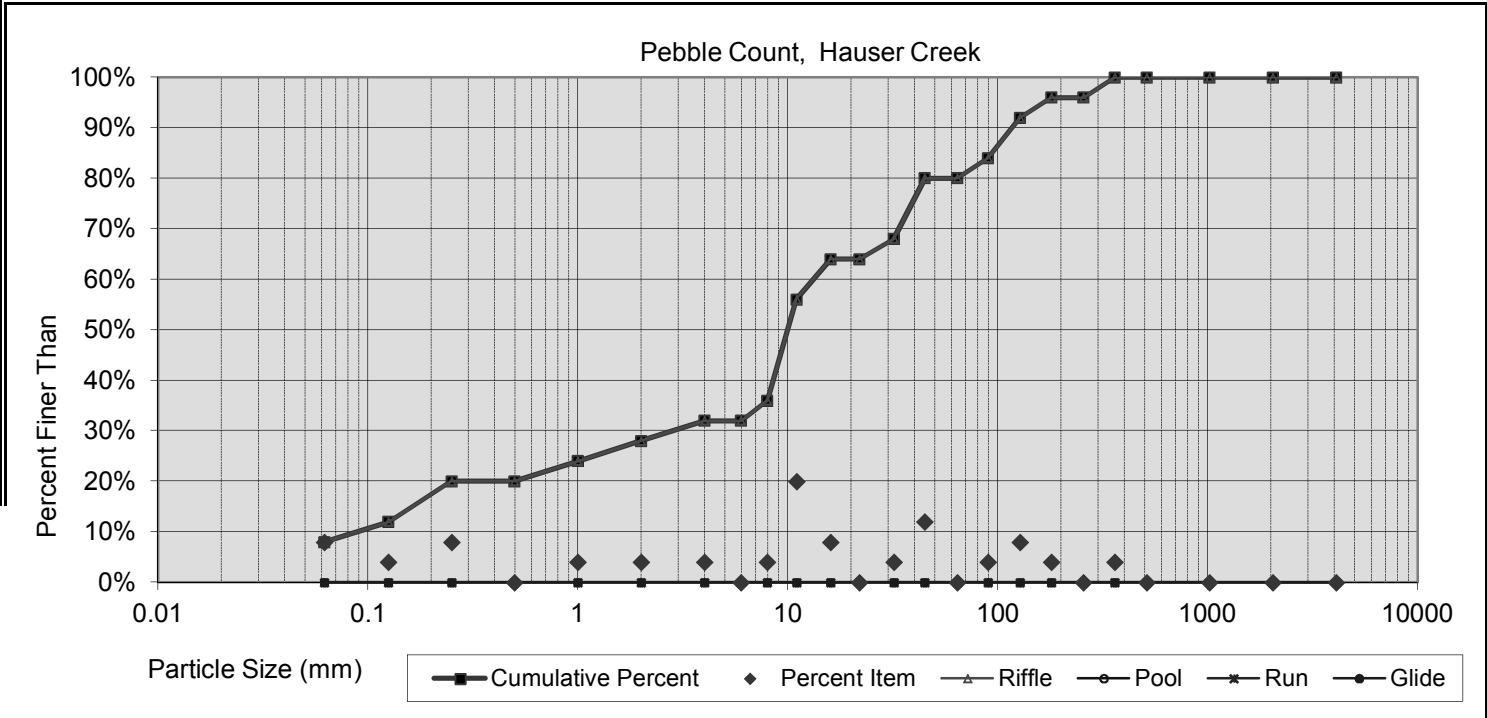
Note:	Cross Section 7

Size percent less than (mm)					Percent by substrate type					
D16	D35	D50	D84	D95	silt/clay	sand	gravel	cobble	boulder	bedrock
0.177	7.44	10.0	90	165	8%	20%	52%	16%	4%	0%

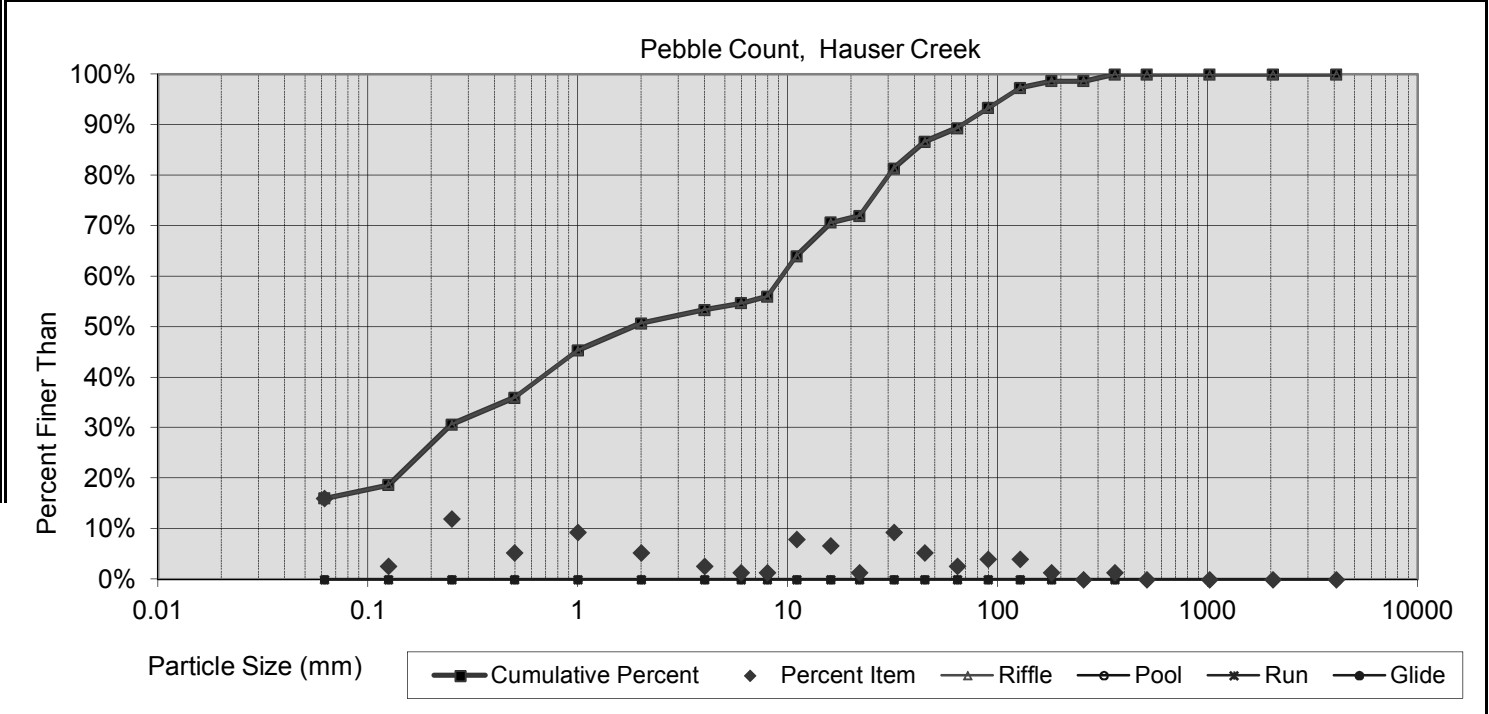
Note:	Reach Total

Size percent less than (mm)					Percent by substrate type					
D16	D35	D50	D84	D95	silt/clay	sand	gravel	cobble	boulder	bedrock
#N/A	0.44	1.8	38	104	16%	35%	39%	9%	1%	0%
