FINAL
ANNUAL MONITORING REPORT
YEAR 4 (2015)
HAUSER CREEK STREAM RESTORATION SITE
DAVIE COUNTY, NORTH CAROLINA
(DMS Project No. 92471, Contract No. 004804)
Construction Completed August 2011

December 2015

Prepared by:
Axiom Environmental, Inc.
218 Snow Avenue
Raleigh, North Carolina 27603

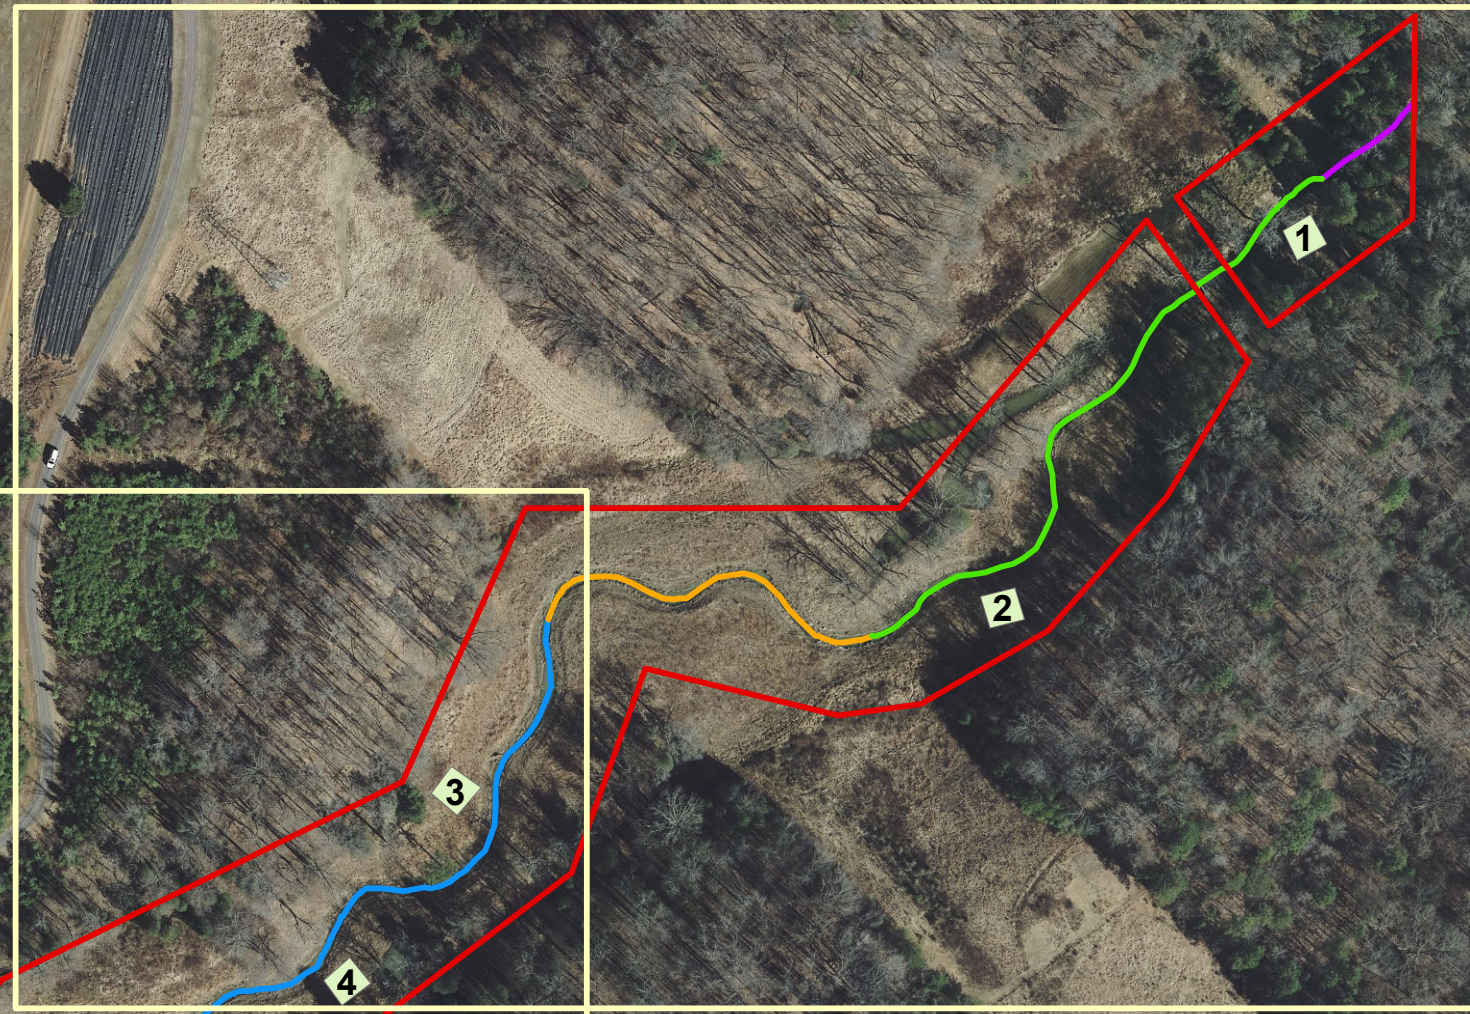
Fig. 2A

Overall, vegetation at the Site is thriving. One small population of Japanese honeysuckle was observed near and in vegetation plot 1 (Figure 2A, Appendix B). This area is small and does not appear to have spread during Year 4 (2015). It will continue to be closely monitored during subsequent monitoring years to determine if remedial activities should occur.

Map Label*	Station	Notes
SAC-1	22+50	Moderate erosion and sloughing of approximately 25 feet along the right bank of an outer bend
SAC-2	18+75	Severe erosion and sloughing of approximately 30 feet along the left bank of an outer bend as well as approximately 10 feet of the inner bend
SAC-3	12+00	Moderate erosion and sloughing of approximately 15 feet along the right bank of an outer bend
SAC-4	20+30 to 22+45	Streambed degradation – riffle and pool scour and loss of bed material throughout reach due to high flow events on approximately 215 feet of stream
SAC-5	14+05 to 18+20	Streambed degradation – riffle and pool scour and loss of bed material throughout reach due to high flow events on approximately 415 feet of stream

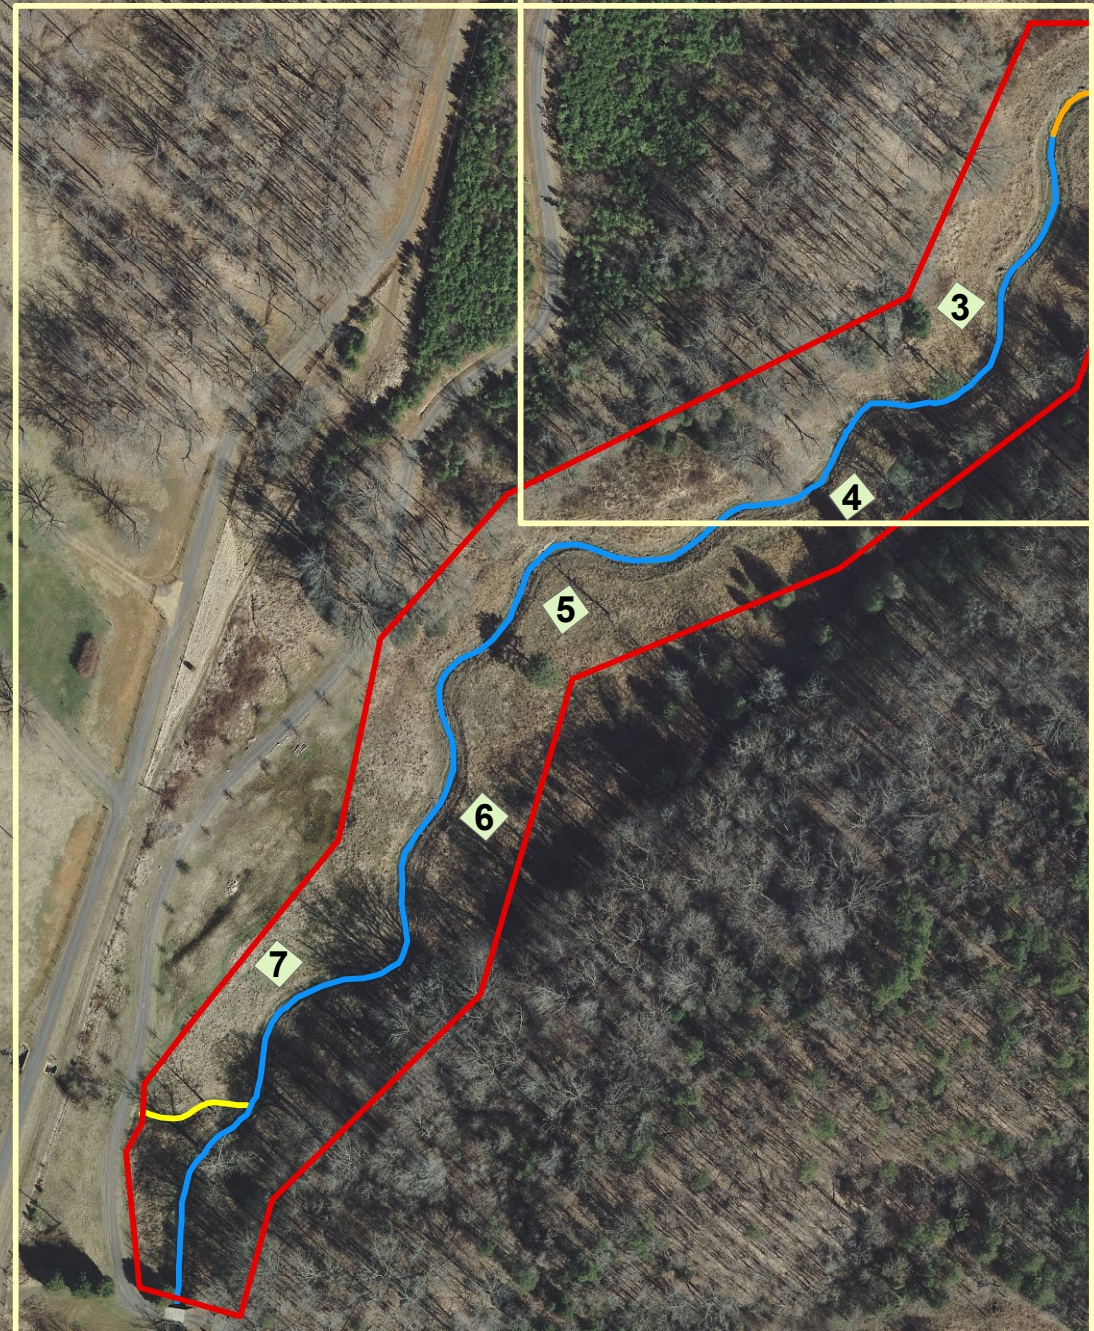
Fig. 2B

Additionally, two beaver dams were observed during an October 2015 walkthrough (Figures 2A-2B, Appendix B). Beaver activity will continue to be monitored throughout Year 5 (2016).

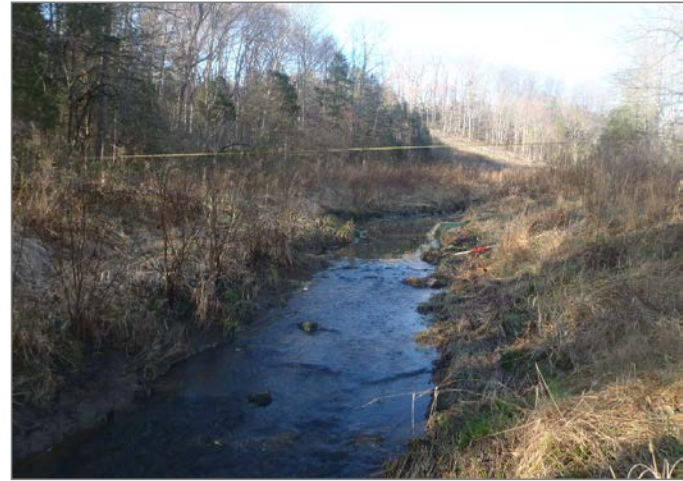
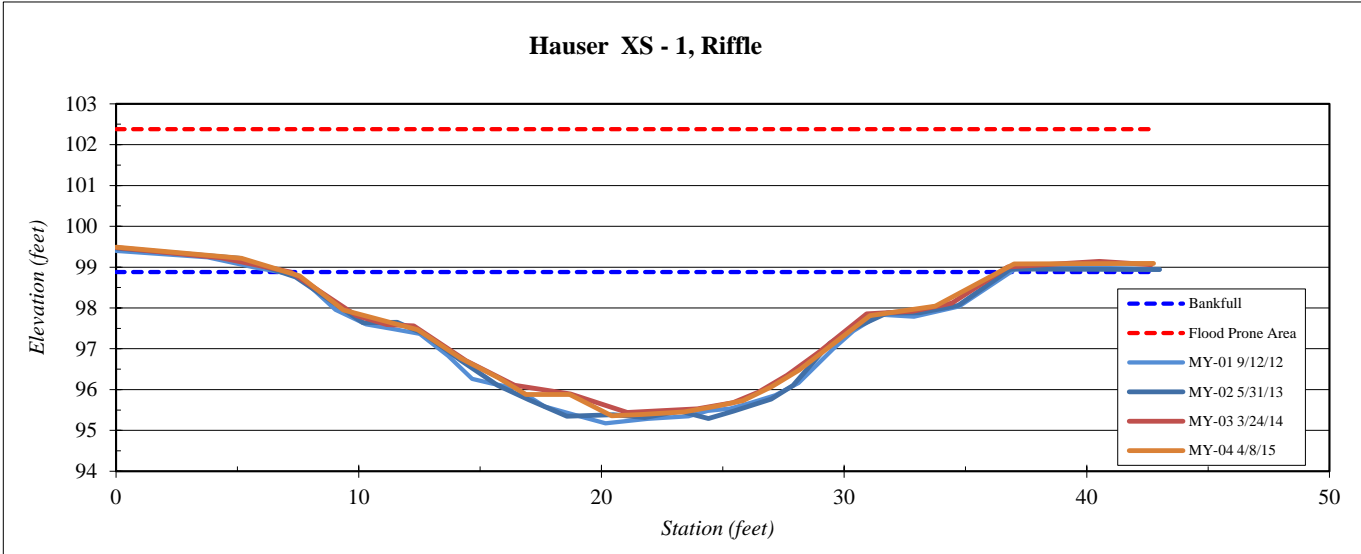
Site	Hauser Creek
Watershed:	Yadkin Pee Dee
XS ID	XS - 1, Riffle
Feature	Riffle
Date:	4/8/2015
Field Crew:	Perkinson, Gibbons

SUMMARY DATA	
Bankfull Elevation:	98.9
Bankfull Cross-Sectional Area:	59.1
Bankfull Width:	29.4
Flood Prone Area Elevation:	102.4
Flood Prone Width:	150.0
Max Depth at Bankfull:	3.5
Mean Depth at Bankfull:	2.0
W / D Ratio:	14.6
Entrenchment Ratio:	5.1
Bank Height Ratio:	1.0

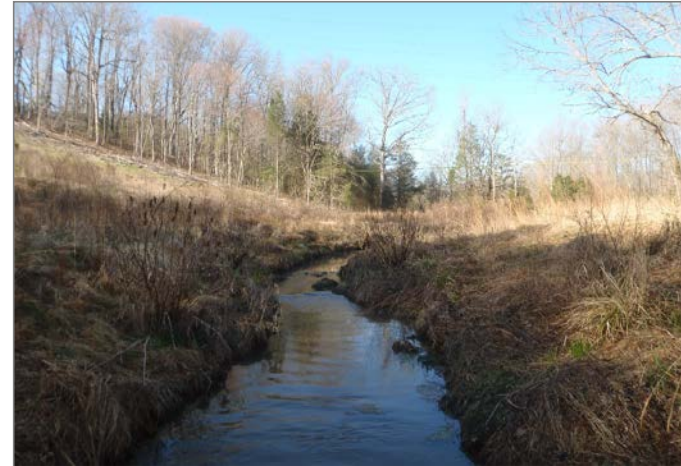
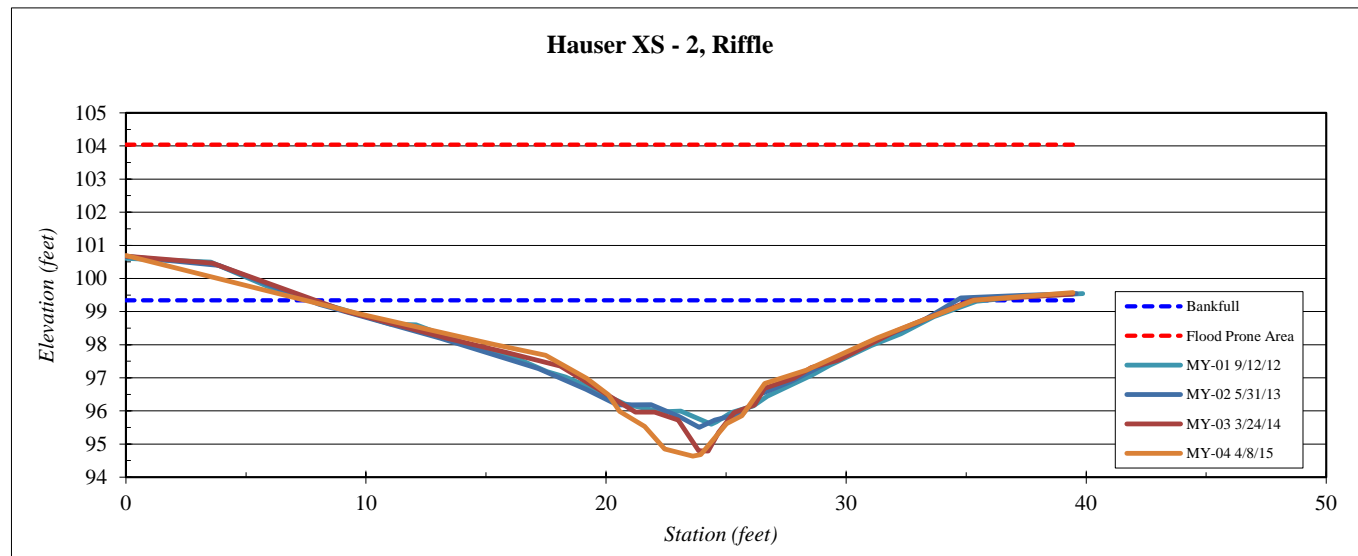
Site	Hauser Creek
Watershed:	Yadkin Pee Dee
XS ID	XS - 2, Riffle
Feature	Riffle
Date:	4/8/2015
Field Crew:	Perkinson, Gibbons

SUMMARY DATA	
Bankfull Elevation:	99.3
Bankfull Cross-Sectional Area:	50.6
Bankfull Width:	27.8
Flood Prone Area Elevation:	104.0
Flood Prone Width:	150.0
Max Depth at Bankfull:	4.7
Mean Depth at Bankfull:	1.8
W / D Ratio:	15.3
Entrenchment Ratio:	5.4
Bank Height Ratio:	1.0

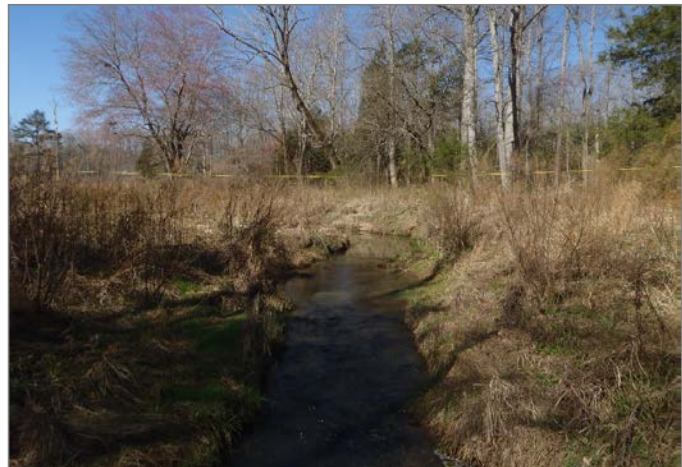
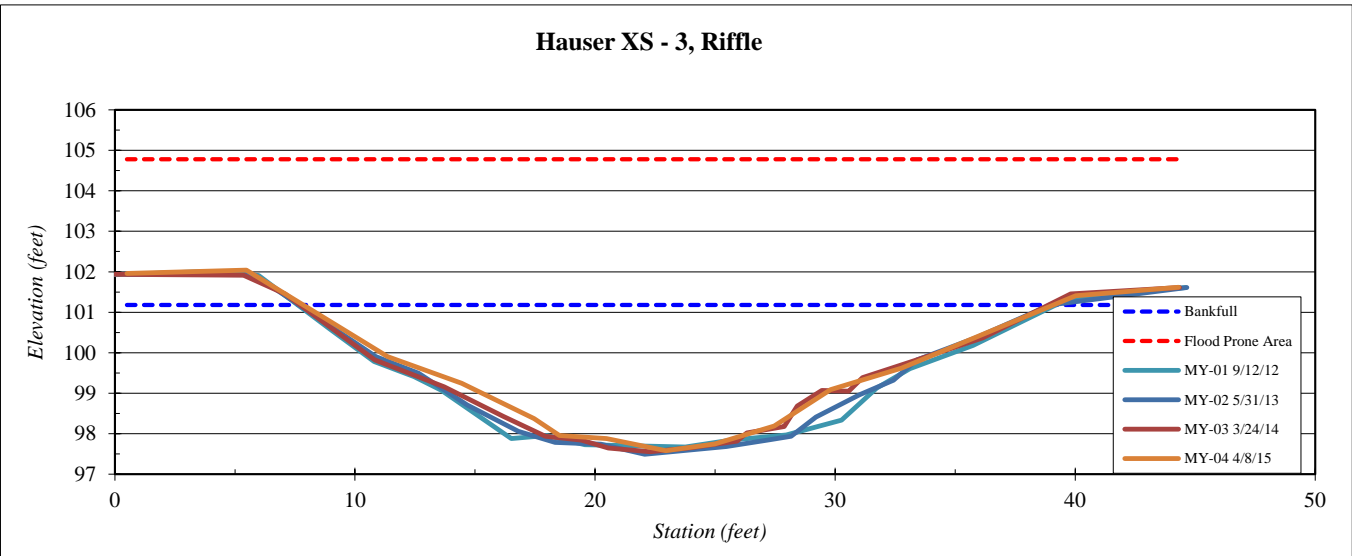
Site	Hauser Creek
Watershed:	Yadkin Pee Dee
XS ID	XS - 3, Riffle
Feature	Riffle
Date:	4/8/2015
Field Crew:	Perkinson, Gibbons

SUMMARY DATA	
Bankfull Elevation:	101.2
Bankfull Cross-Sectional Area:	63.9
Bankfull Width:	31.3
Flood Prone Area Elevation:	104.8
Flood Prone Width:	150.0
Max Depth at Bankfull:	3.6
Mean Depth at Bankfull:	2.0
W / D Ratio:	15.3
Entrenchment Ratio:	4.8
Bank Height Ratio:	1.0

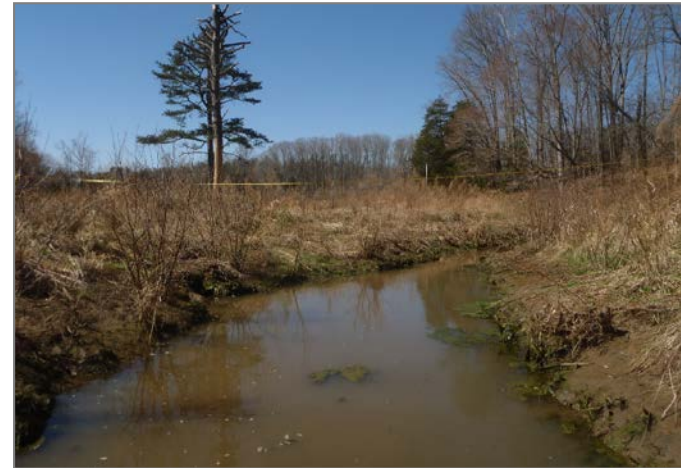
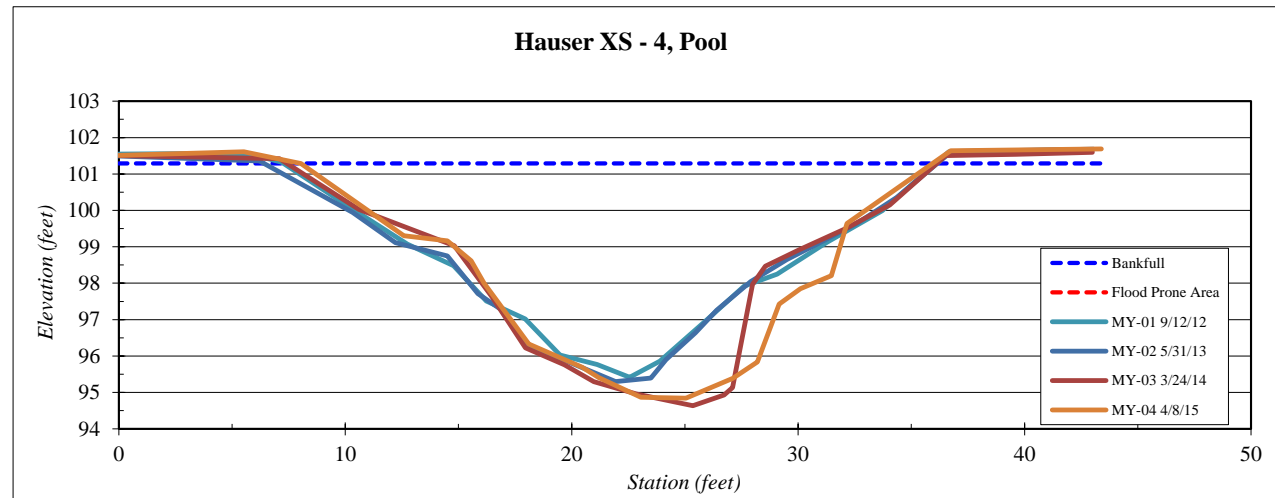
Site	Hauser Creek
Watershed:	Yadkin Pee Dee
XS ID	XS - 4, Pool
Feature	Pool
Date:	4/8/2015
Field Crew:	Perkinson, Gibbons

SUMMARY DATA	
Bankfull Elevation:	101.3
Bankfull Cross-Sectional Area:	97.8
Bankfull Width:	27.9
Flood Prone Area Elevation:	NA
Flood Prone Width:	NA
Max Depth at Bankfull:	6.4
Mean Depth at Bankfull:	3.5
W / D Ratio:	NA
Entrenchment Ratio:	NA
Bank Height Ratio:	1.0

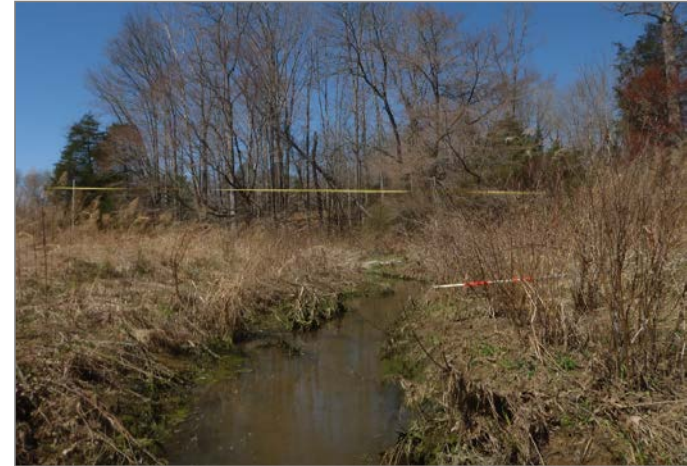
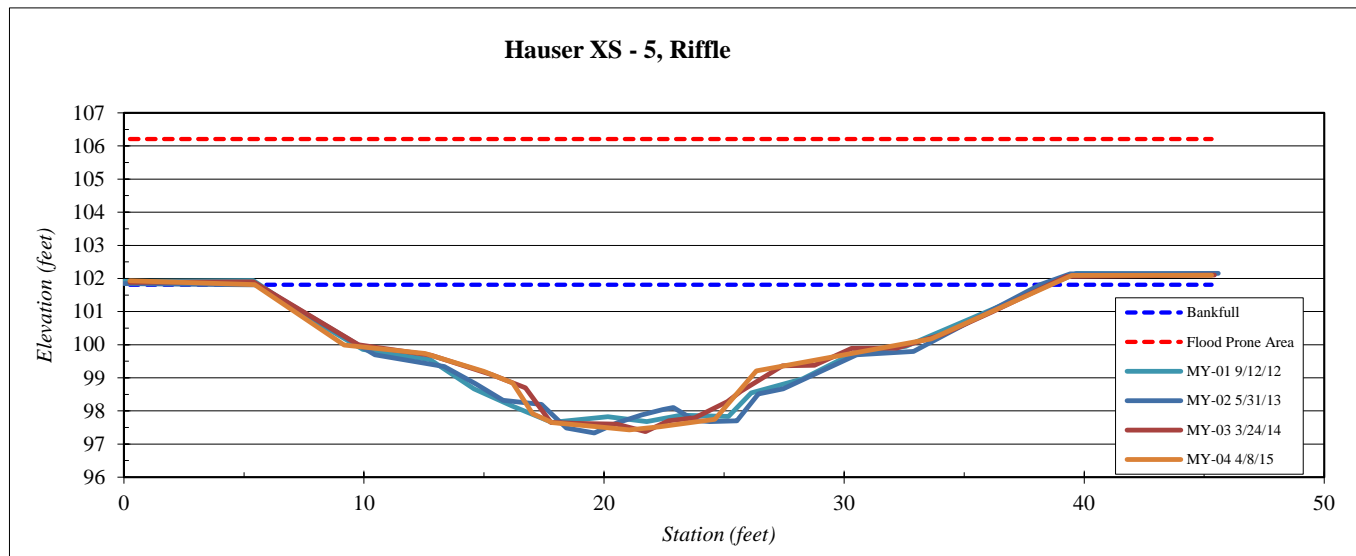
Site	Hauser Creek
Watershed:	Yadkin Pee Dee
XS ID	XS - 5, Riffle
Feature	Riffle
Date:	4/8/2015
Field Crew:	Perkinson, Gibbons

SUMMARY DATA	
Bankfull Elevation:	101.8
Bankfull Cross-Sectional Area:	79.2
Bankfull Width:	33.2
Flood Prone Area Elevation:	106.2
Flood Prone Width:	150.0
Max Depth at Bankfull:	4.4
Mean Depth at Bankfull:	2.4
W / D Ratio:	13.9
Entrenchment Ratio:	4.5
Bank Height Ratio:	1.0

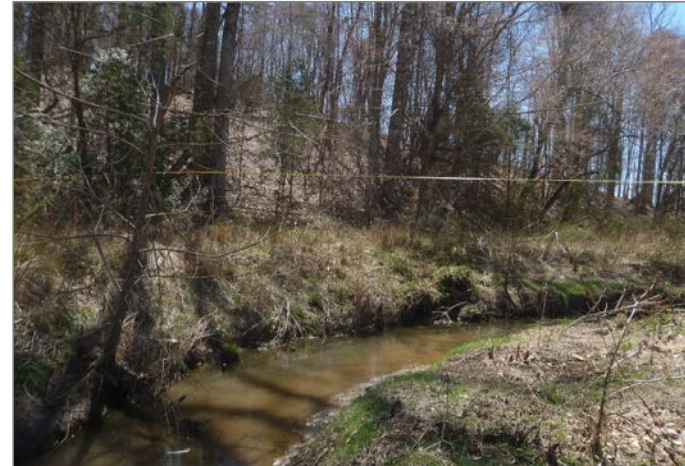
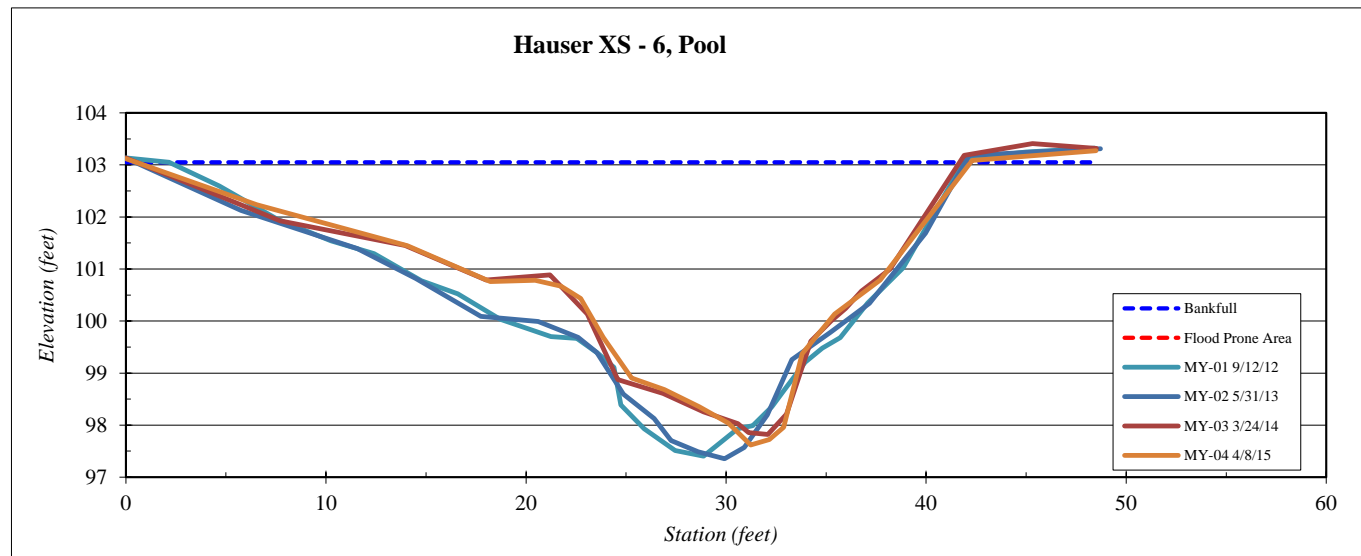
Site	Hauser Creek
Watershed:	Yadkin Pee Dee
XS ID	XS - 6, Pool
Feature	Pool
Date:	4/8/2015
Field Crew:	Perkinson, Gibbons

SUMMARY DATA	
Bankfull Elevation:	103.1
Bankfull Cross-Sectional Area:	95.8
Bankfull Width:	41.7
Flood Prone Area Elevation:	NA
Flood Prone Width:	NA
Max Depth at Bankfull:	5.4
Mean Depth at Bankfull:	2.3
W / D Ratio:	NA
Entrenchment Ratio:	NA
Bank Height Ratio:	1.0

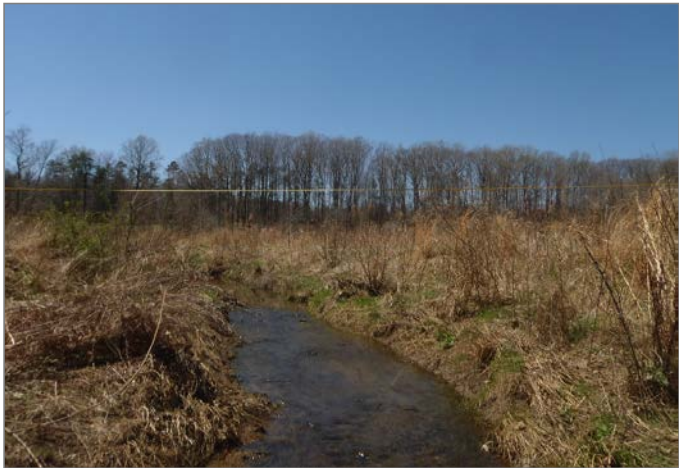
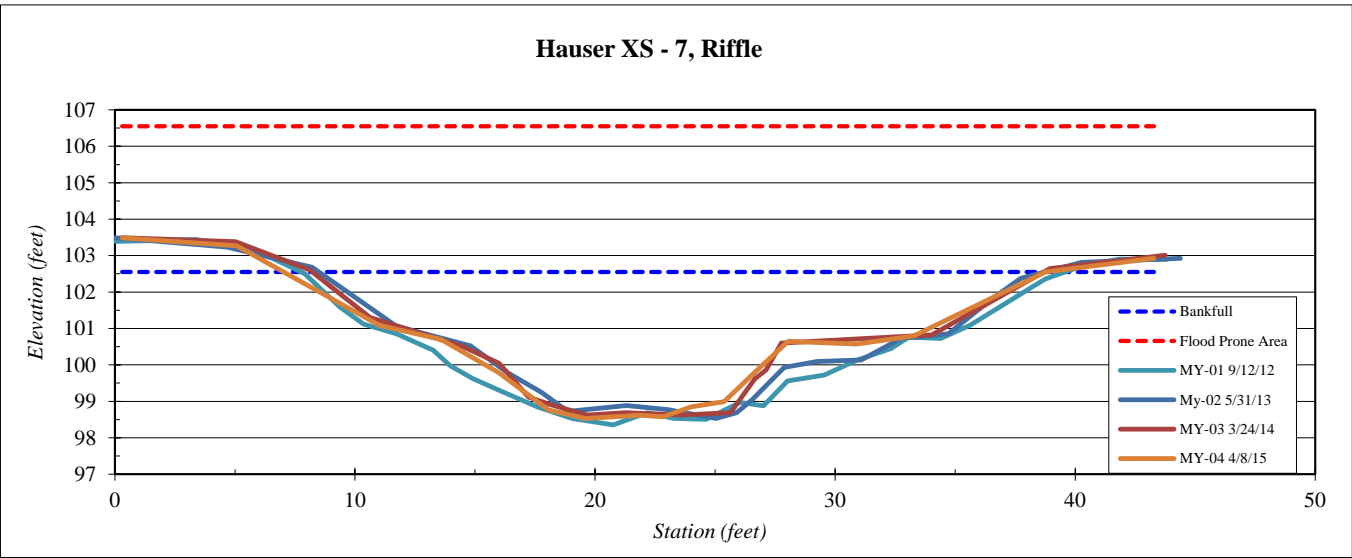
Site	Hauser Creek
Watershed:	Yadkin Pee Dee
XS ID	XS - 7, Riffle
Feature	Riffle
Date:	4/8/2015
Field Crew:	Perkinson, Gibbons

Bankfull Elevation:	102.6
Bankfull Cross-Sectional Area:	69.9
Bankfull Width:	31.7
Flood Prone Area Elevation:	106.6
Flood Prone Width:	150.0
Max Depth at Bankfull:	4.0
Mean Depth at Bankfull:	2.2
W / D Ratio:	14.4
Entrenchment Ratio:	4.7
Bank Height Ratio:	1.0
