FINAL
ANNUAL MONITORING REPORT
YEAR 5 (2016)
HAUSER CREEK STREAM RESTORATION SITE
DAVIE COUNTY, NORTH CAROLINA
(DMS Project No. 92471, Contract No. 004804)
Construction Completed August 2011

November 2016

Prepared by:
Axiom Environmental, Inc.
218 Snow Avenue
Raleigh, North Carolina 27603

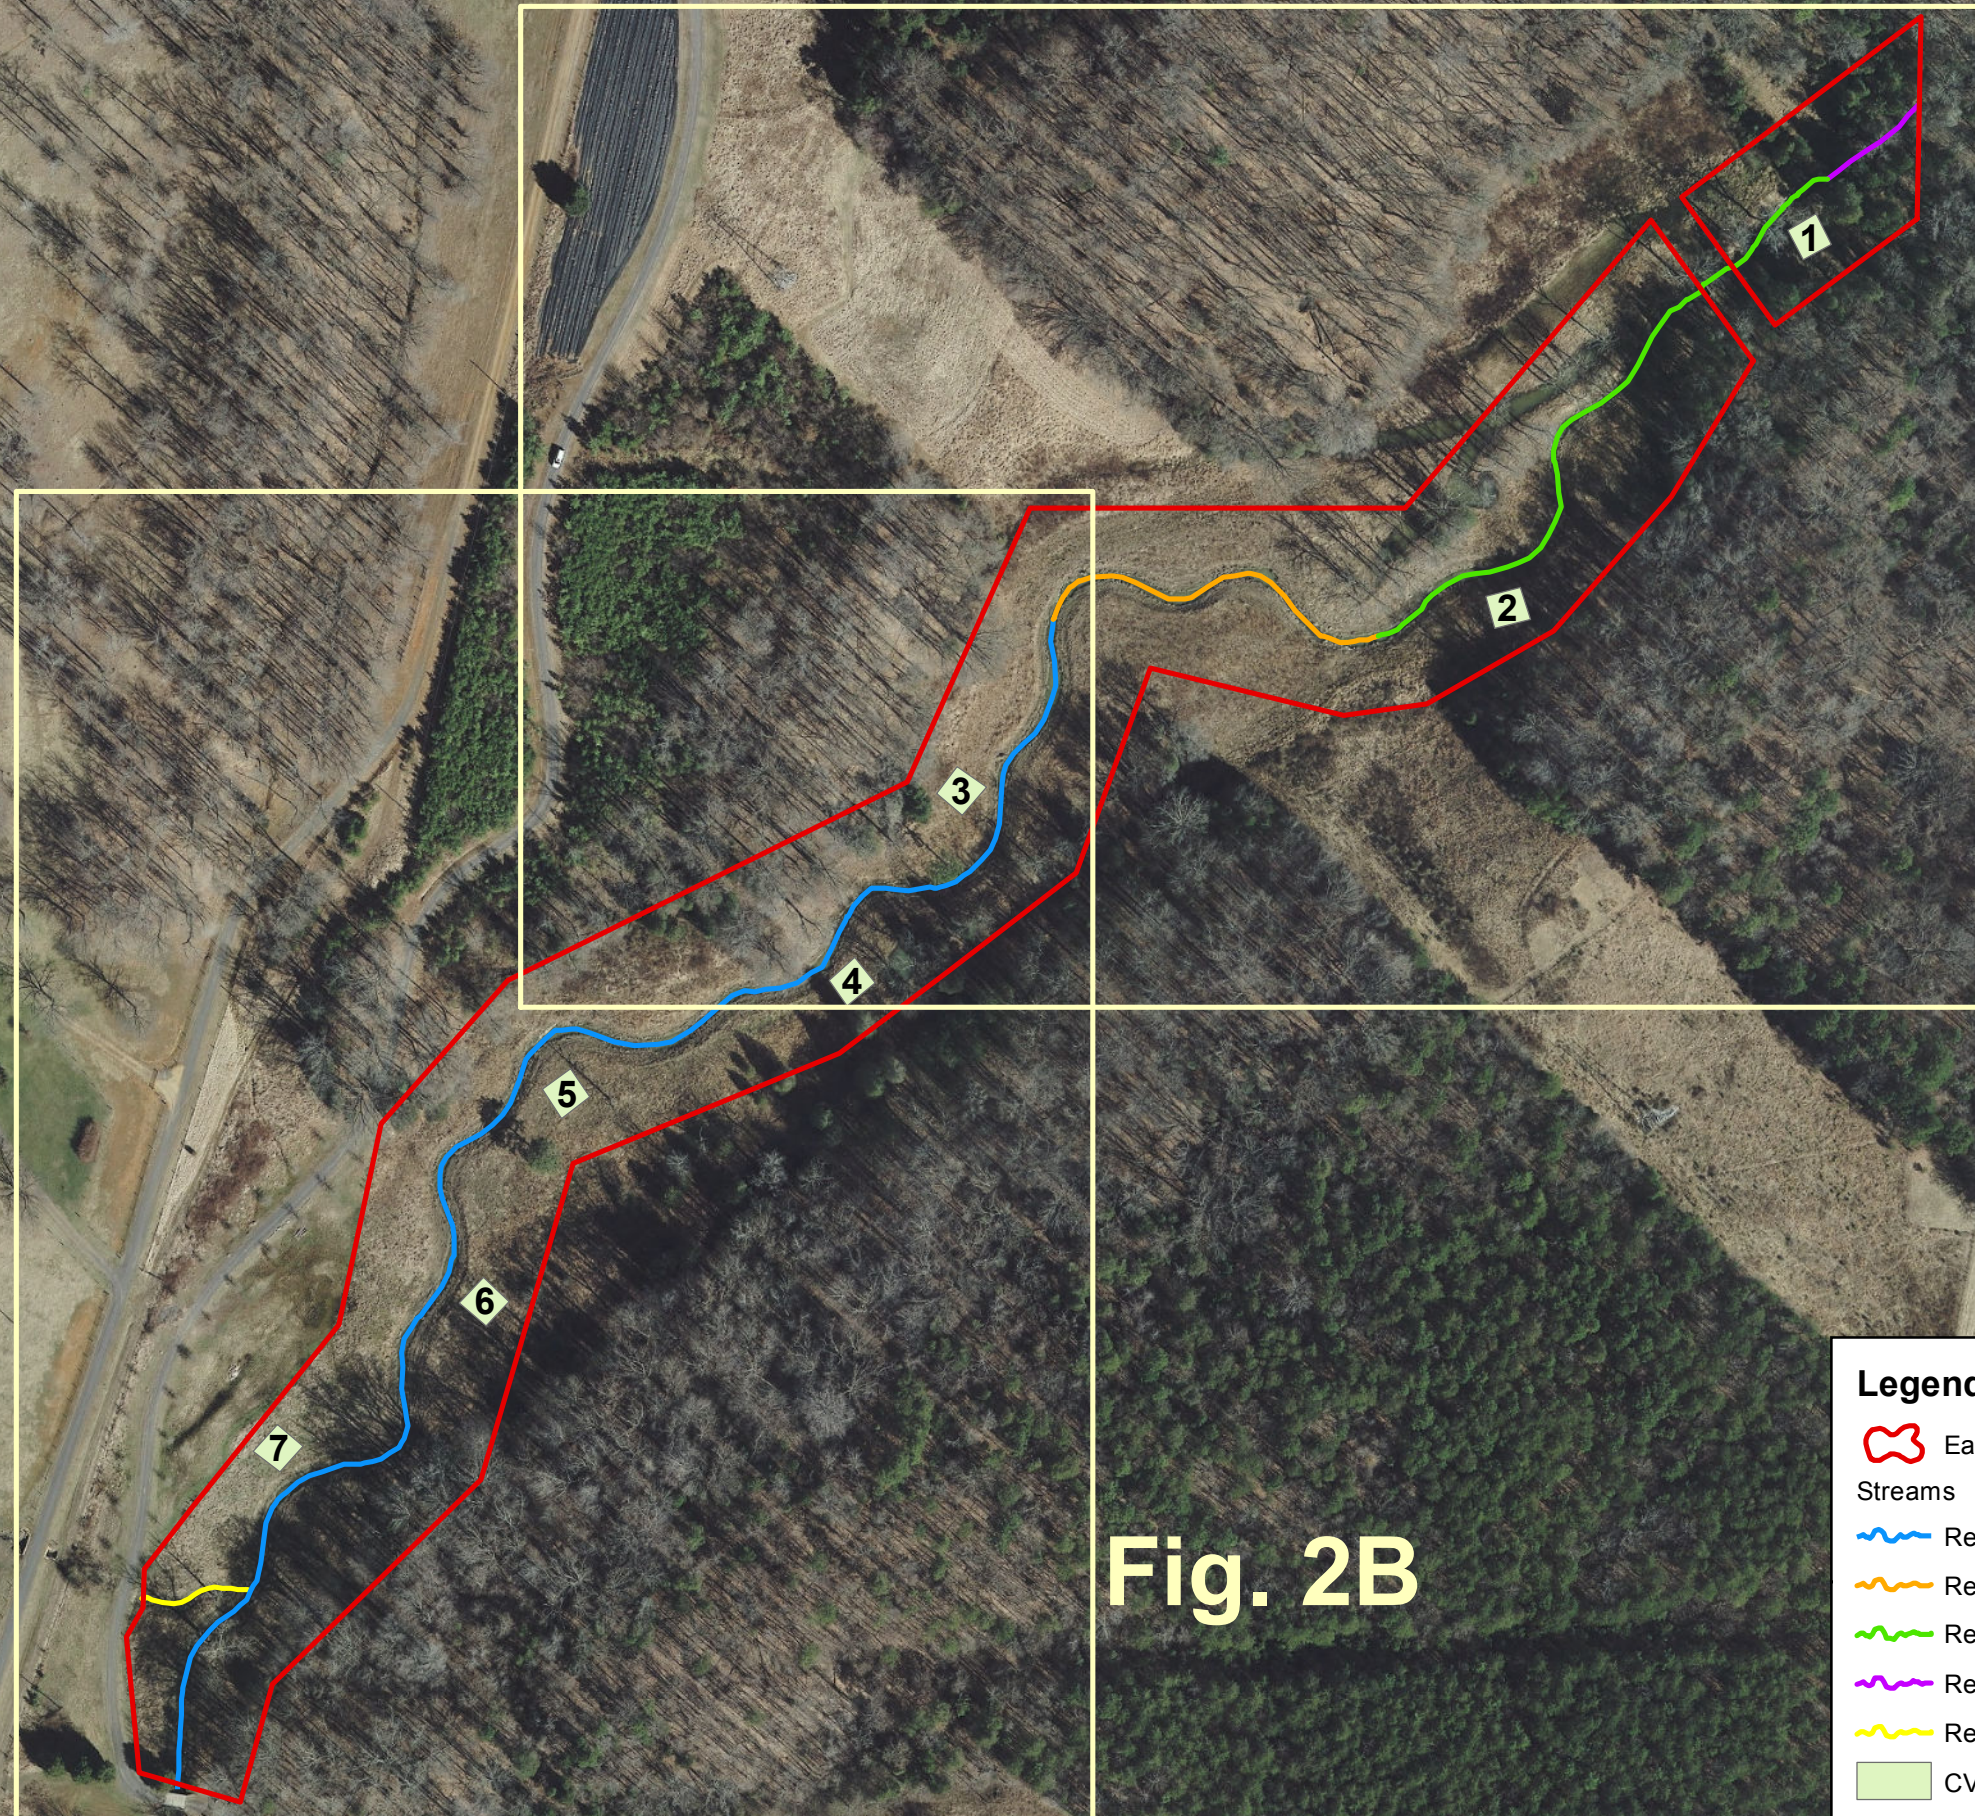
FIGURE
2A

Overall, the stream is functioning properly and as designed. Three areas of bank erosion were observed in past monitoring years, and they continued to erode during Year 5 (2016). This bank erosion has slowed as woody vegetation has established on the stream banks, and it is expected to continue to do so as roots continue to establish, but the erosion remains concerning. Additionally, several high flow rain events during Year 4 (2015) and Year 5 (2015) resulted in two areas of streambed degradation. All areas of concern are noted in Figures 2A-2B (Appendix B) and are listed in the table below.

Map Label*	Station	Notes
SAC-1	22+50	Moderate erosion and sloughing of approximately 25 feet along the right bank of an outer bend
SAC-2	18+75	Severe erosion and sloughing of approximately 35 feet along the left bank of an outer bend as well as approximately 10 feet of the inner bend
SAC-3	12+00	Moderate erosion and sloughing of approximately 15 feet along the right bank of an outer bend
SAC-4	20+30 to 22+45	Streambed degradation – riffle and pool scour and loss of bed material throughout reach due to high flow events on approximately 215 feet of stream
SAC-5	14+05 to 18+20	Streambed degradation – riffle and pool scour and loss of bed material throughout reach due to high flow events on approximately 415 feet of stream

Additionally, beaver activity has been an ongoing issue throughout the monitoring period. Two beaver dams were observed during an October 2016 Site visit (Figures 2A-2B, Appendix B).

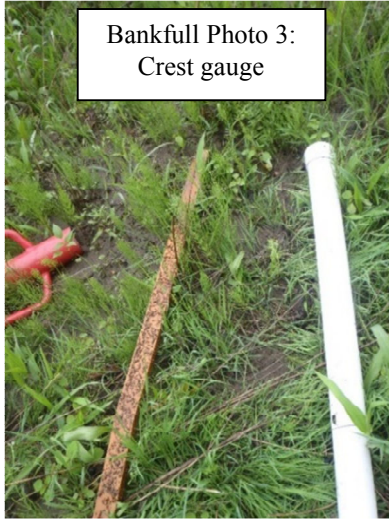
Bankfull Photo 3:
Crest gauge
