# Year 2 Annual Monitoring Document

UT to Haw River (#747)

Alamance County

Data Collection Period: October 16, 2013

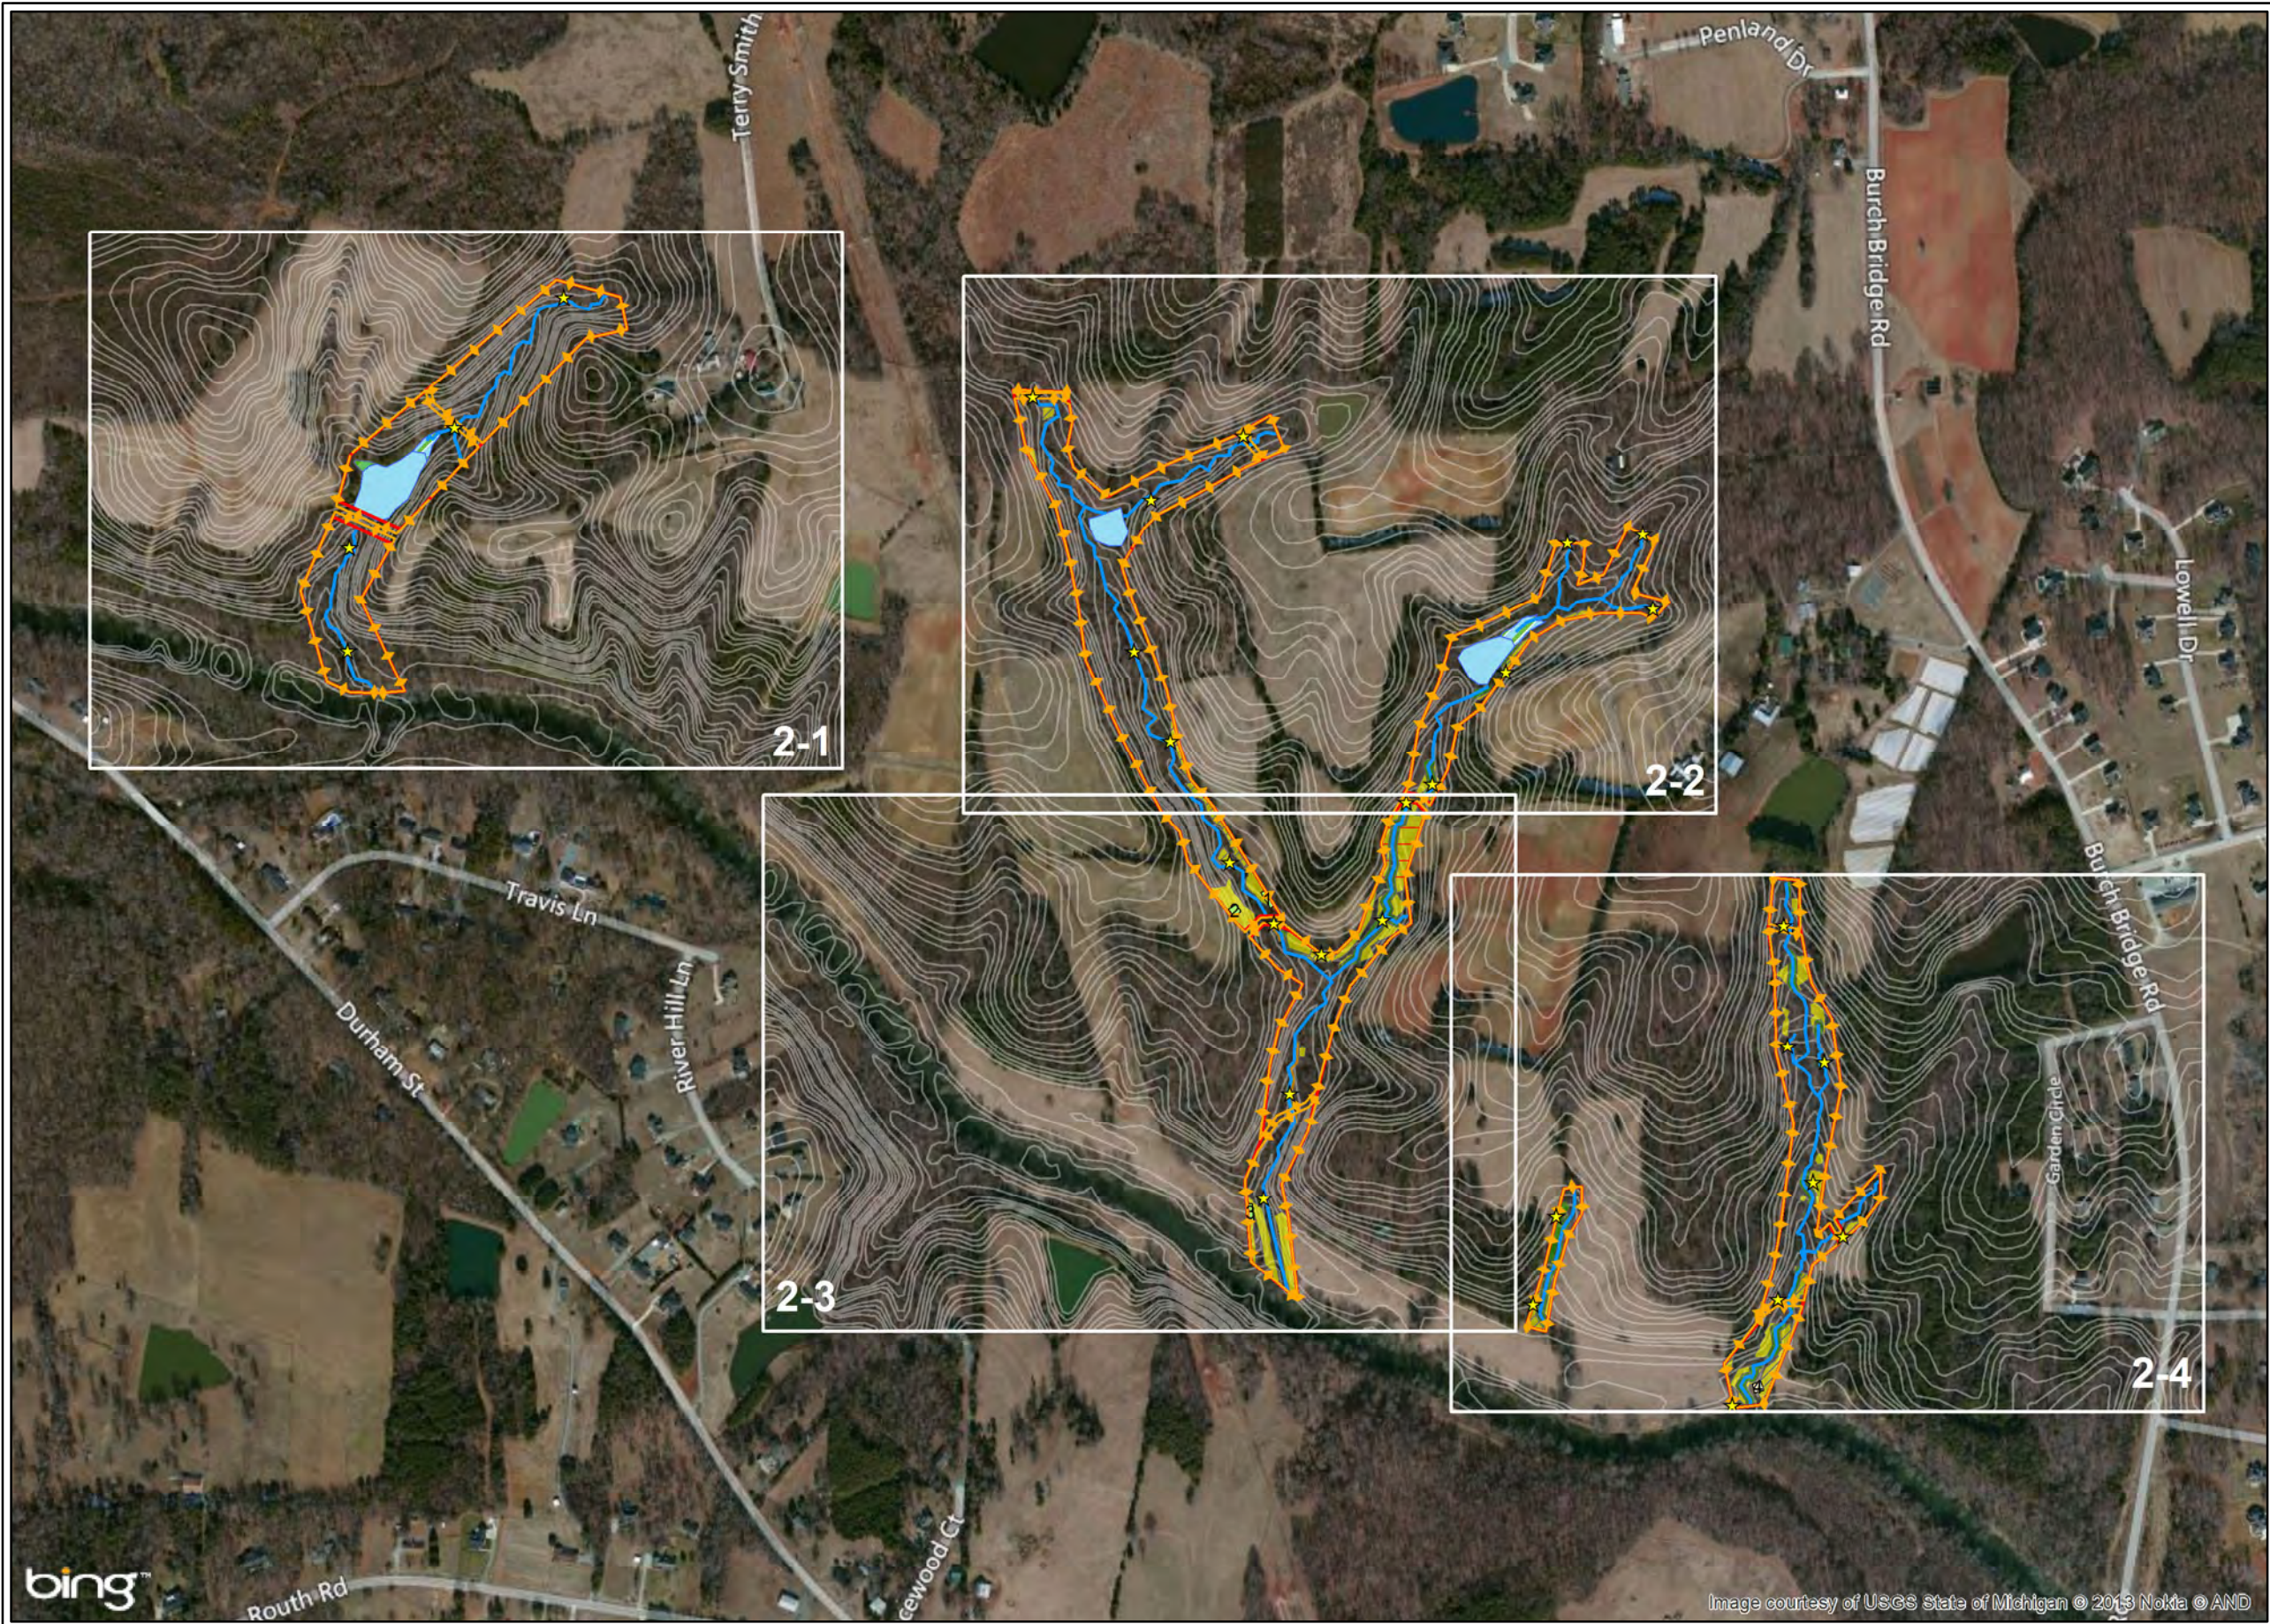
**CURRENT CONDITION PLAN VIEW**

Numerous small stems of Chinese privet (*Ligustrum sinense*) are located inside the easement boundary along Trib C2 north of Trib C2-c. The locations of these populations are mapped on the Current Condition Plan View (CCPV) map (Figure 2). Additionally, sporadic stems of multiflora rose (*Rosa multiflora*) are located along Trib C2 south of the pond, however, these stems are isolated and very small in size. Invasive/exotic vegetation is not currently compromising the vegetative success of the site.
