**UT to Little Coharie Creek
(Roseboro Site)
Stream Restoration Project
Sampson County
North Carolina**

**CU: 030030006
SCO# 040634201A
EEP Project No. 314**

**Monitoring Year 2 of 5
Data Collection: June through October 2010
Submission Date: March 31, 2011**

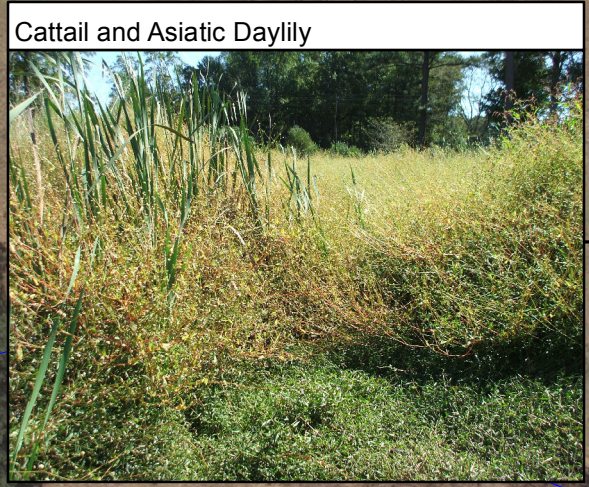
FIGURE 2

Stream Problem Areas			
UT to Little Coharie Stream Restoration Project - EEP No. 314			
Feature Issue	Station Number	Suspected Cause	Photo Number
Aggradation	Northern 11+40 to 12+40	Trapped Sediment/Low Flow	Figure 2

Vegetation Problem Areas			
UT to Little Coharie Stream Restoration Project - EEP No. 314			
Feature Category	Station Number	Suspected Cause	Photo Number
Cattail	Throughout	Low Flow Conditions	Figure 2
Invasive Vegetation	Various, Refer to Figure to for Location	Offsite seed source	VPA1
