YEAR 1 MONITORING REPORT

UT TO THE LUMBER RIVER SITE

Robeson County, North Carolina

Contract No. 002027

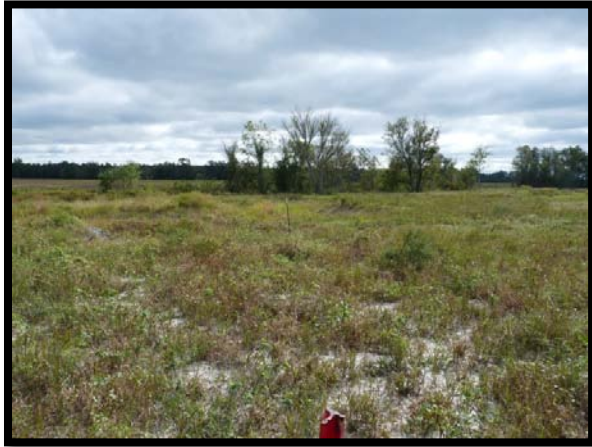
3.2 Vegetation Plot 2

Species	Common Name	Type	Annual Means				Notes:
			MY1 (2010)		BL/AB (2010)		
			P	T	P	T	
<i>Fraxinus pennsylvanica</i>	green ash	Tree	2.64	2.64	2.64	N/A	<p>Plot 2: The baseline data for plot 2 were entered incorrectly. This was corrected in the baseline CVS data and for the YR 1 report.</p> <p>Plot 4: One tree noted as a <i>Taxodium distichum</i> in the Baseline was actually <i>Nyssa biflora</i>. This was changed in YR 1 data.</p> <p>Plot 6: One tree noted as a <i>Taxodium Distichum</i> in the Baseline was actually <i>Quercus larifolia</i>. This was changed in YR 1 data.</p> <p>Plot 8: Two trees noted as a <i>Quercus lyrata</i> and <i>Nyssa biflora</i> in the Baseline were actually both <i>Quercus michauxii</i>. This was changed in YR 1 data.</p> <p>Plot 12: One tree noted as a <i>Quercus lyrata</i> in the Baseline was actually <i>Quercus michauxii</i>. This was changed in YR 1 data.</p> <p>Plot 13: One planted <i>Taxodium distichum</i> was discovered that was not counted in the Baseline. It was added to YR 1 data.</p> <p>Plot 14: One planted <i>Quercus lyrata</i> was discovered that was not counted in the Baseline. It was added to YR 1 data.</p>
