# ***YEAR 2 MONITORING REPORT***

## **UT TO THE LUMBER RIVER SITE**

Robeson County, North Carolina

Contract No. 002027, EEP IMS No. 94068

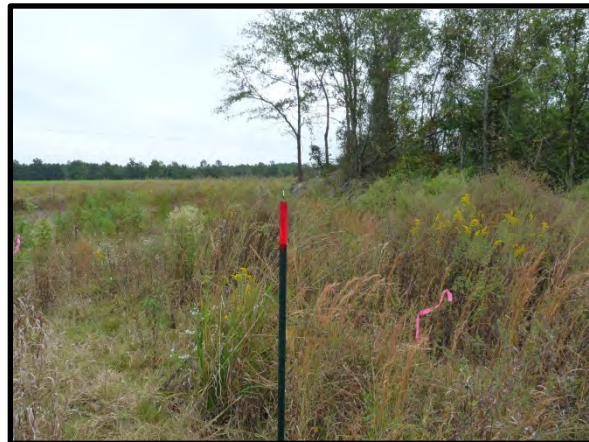
**3.4 Vegetation Plot 4**

Four small clusters of cattail (*Typha latifolia*) were observed in the floodplain and are noted on the Current Condition Plan View (CCPV) map. Sericea lespedeza (*Lespedeza cuneata*) was also

observed adjacent to Vegetation Plot 4 and is depicted on the CCPV. No corrective action is recommended at this time. Invasive/exotic vegetation is not currently compromising the vegetative success of the site.
