YEAR 3 MONITORING REPORT

UT TO THE LUMBER RIVER SITE

Robeson County, North Carolina

Contract No. 002027, EEP IMS No. 94068

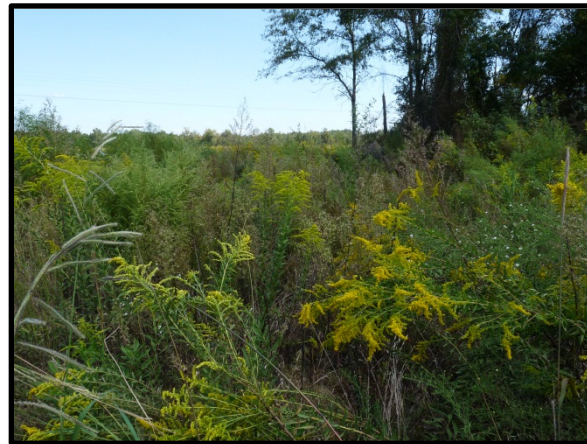
3.4 Vegetation Plot 4

Eight small clusters of cattail (*Typha latifolia*) were observed in the floodplain and are noted on the Current Condition Plan View (CCPV) map. *Sericea lespedeza* (*Lespedeza cuneata*) was also observed adjacent to Vegetation Plot 4 and is depicted on the CCPV. No corrective action is recommended at this time. Invasive/exotic vegetation is not currently compromising the vegetative success of the site.
