YEAR 4 MONITORING REPORT

UT TO THE LUMBER RIVER SITE

Robeson County, North Carolina

Contract No. 002027, EEP IMS No. 94068

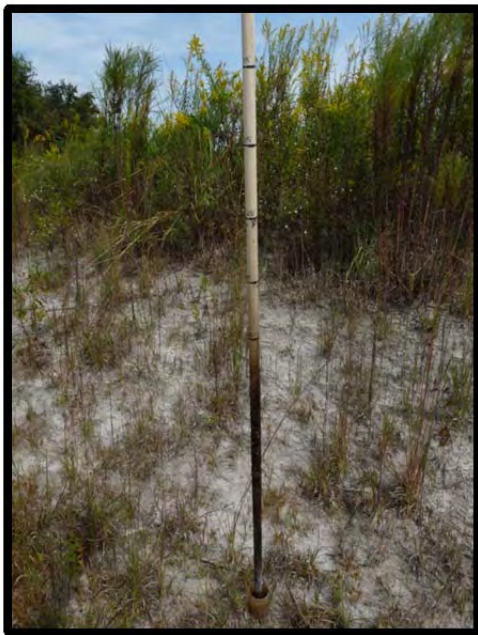
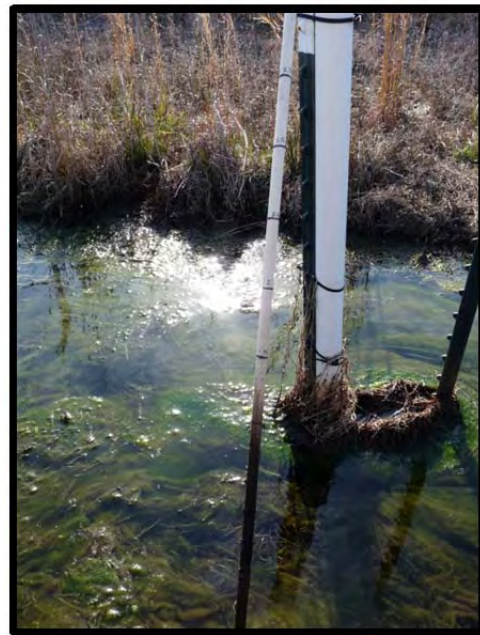
Figures 6.1 & 6.2 2012 Crest Gauge Photos

Date	Crest Gauge Info		Gauge Reading (ft)	Gauge Elevation (ft)	Crest Elevation (ft)	Bankfull Elevation (ft)	Height above Bankfull (ft)	Photo
	Site	Sta.						
9/28/2012	XS 16	48+13	2.2	146.9	149.1	148.4	0.7	6.1
2/16/2012	XS 8	30+90	1.5	149.5	151.0	150.8	0.2	6.2
3/14/2013	XS 8	30+90	1.75	149.5	151.25	150.8	0.45	6.3
