YEAR 5 MONITORING REPORT

UT TO THE LUMBER RIVER SITE

Robeson County, North Carolina

Contract No. 002027, EEP IMS No. 94068

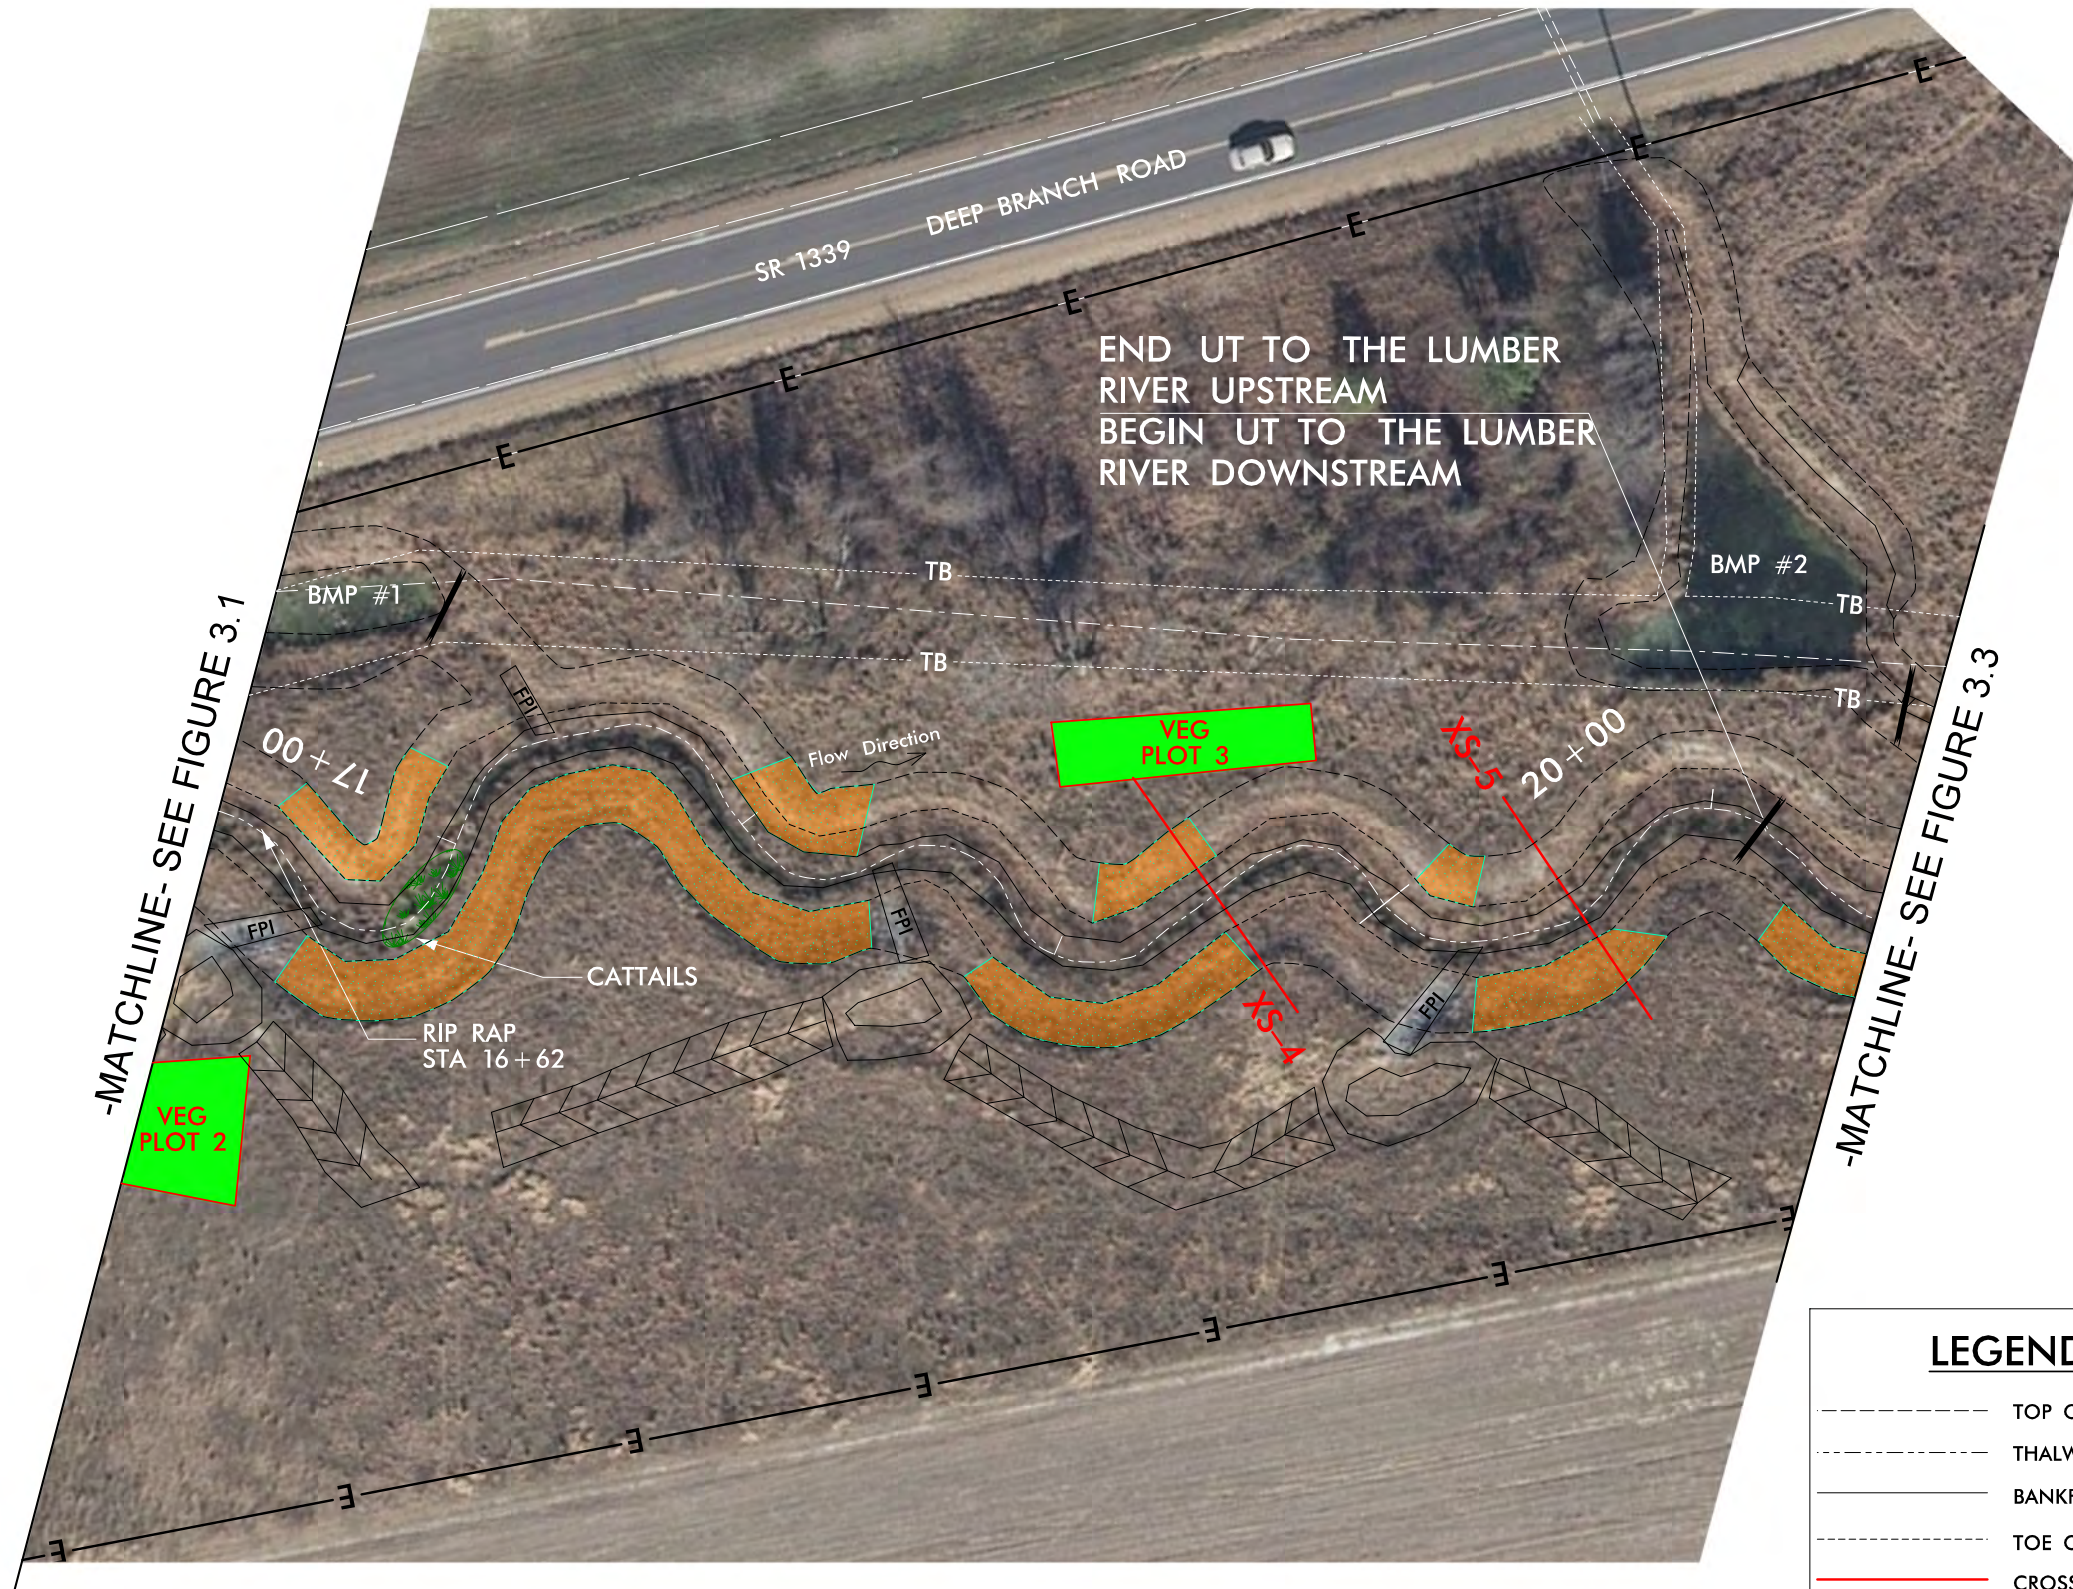
Figure 3.2

Beaver activity was observed in the channel near station 24+50, and a small beaver dam affected vegetation between stations 24+50 and 25+25. The beavers were removed in the spring of 2014 and woody vegetation is expected to regenerate in the absence of the beaver dam. Additional planting is not recommended at this time.
