**FINAL**  
**YEAR 4 (2017) MONITORING REPORT**  
**UT TO MARTIN'S CREEK (CONTRERAS) MITIGATION PROJECT**  
Cherokee County, North Carolina  
DMS Project No. 92766 (Contract No. 005717)  
USACE Action ID No. 2010-00961/DWR Project No. 2010-00448  
SCO No. 08-07249-01

**Data Collection – March-November 2017**

Hiwassee River Basin  
Cataloging Unit 06020002170010

**December 2017**

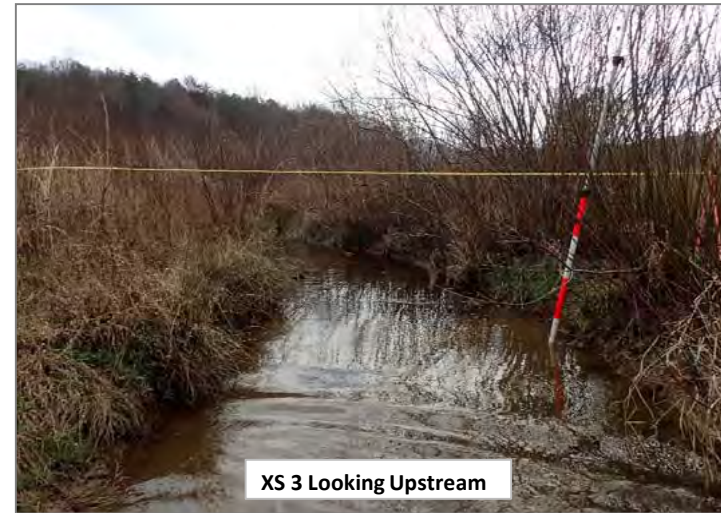
XS 3 Looking Upstream

SUMMARY DATA	
<b>Bankfull Elevation:</b>	93.9
<b>Bankfull Cross-Sectional Area:</b>	19.7
<b>Bankfull Width:</b>	17.7
<b>Flood Prone Area Elevation:</b>	NA
<b>Flood Prone Width:</b>	NA
<b>Max Depth at Bankfull:</b>	2.5
<b>Mean Depth at Bankfull:</b>	1.1
<b>W / D Ratio:</b>	NA
<b>Entrenchment Ratio:</b>	NA
<b>Bank Height Ratio:</b>	1.0

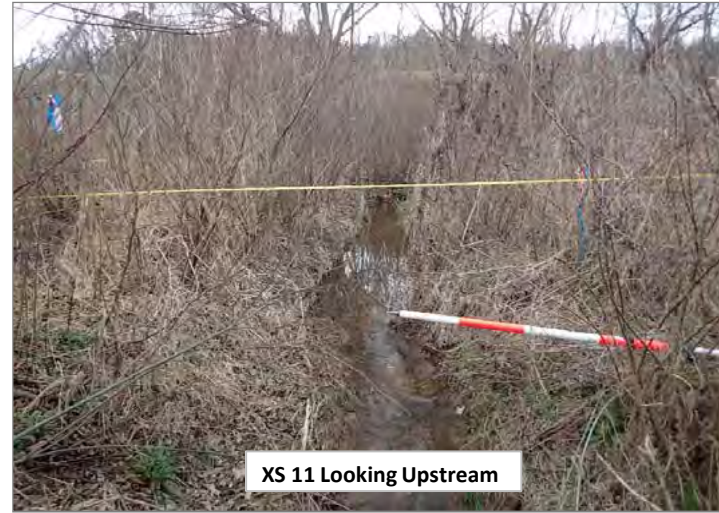
XS 11 Looking Upstream

SUMMARY DATA	
<b>Bankfull Elevation:</b>	100.4
<b>Bankfull Cross-Sectional Area:</b>	8.6
<b>Bankfull Width:</b>	11.3
<b>Flood Prone Area Elevation:</b>	102.0
<b>Flood Prone Width:</b>	50.0
<b>Max Depth at Bankfull:</b>	1.6
<b>Mean Depth at Bankfull:</b>	0.8
<b>W / D Ratio:</b>	14.8
<b>Entrenchment Ratio:</b>	4.4
<b>Bank Height Ratio:</b>	1.0
