CANE & MARYS STREAM RESTORATION PROJECTS

MONITORING REPORT (YEAR 1 OF 5)

Alamance County, North Carolina
SCO Project Number 01055150A
EEP Project Number CMC/CPF/02

Status of Plan: Draft
Submission Date: March 2007

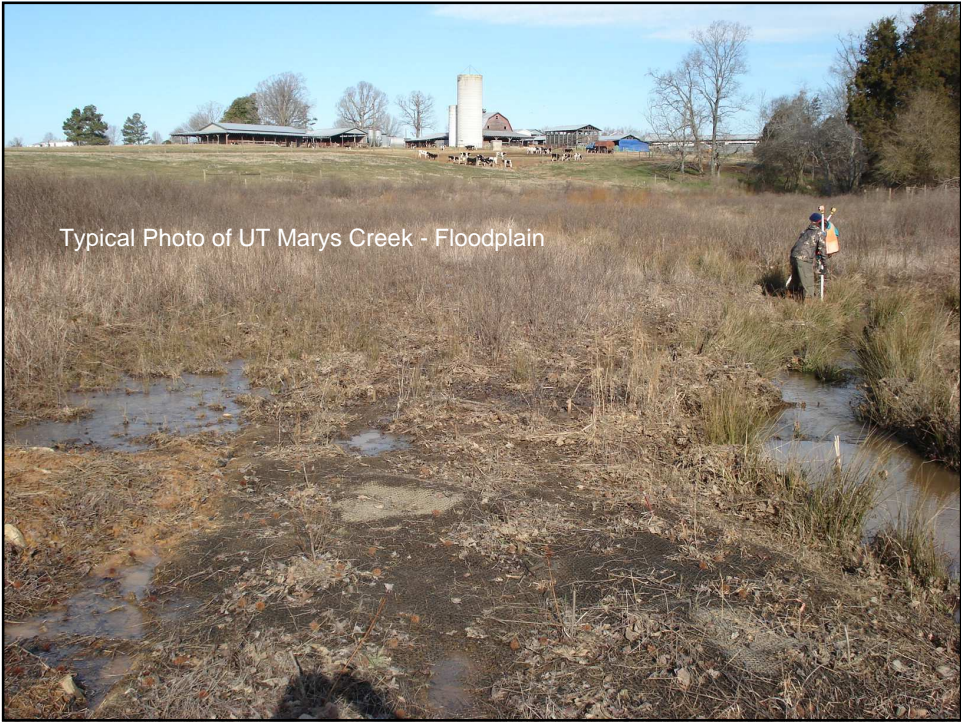
Typical Photo of UT Marys Creek - Floodplain

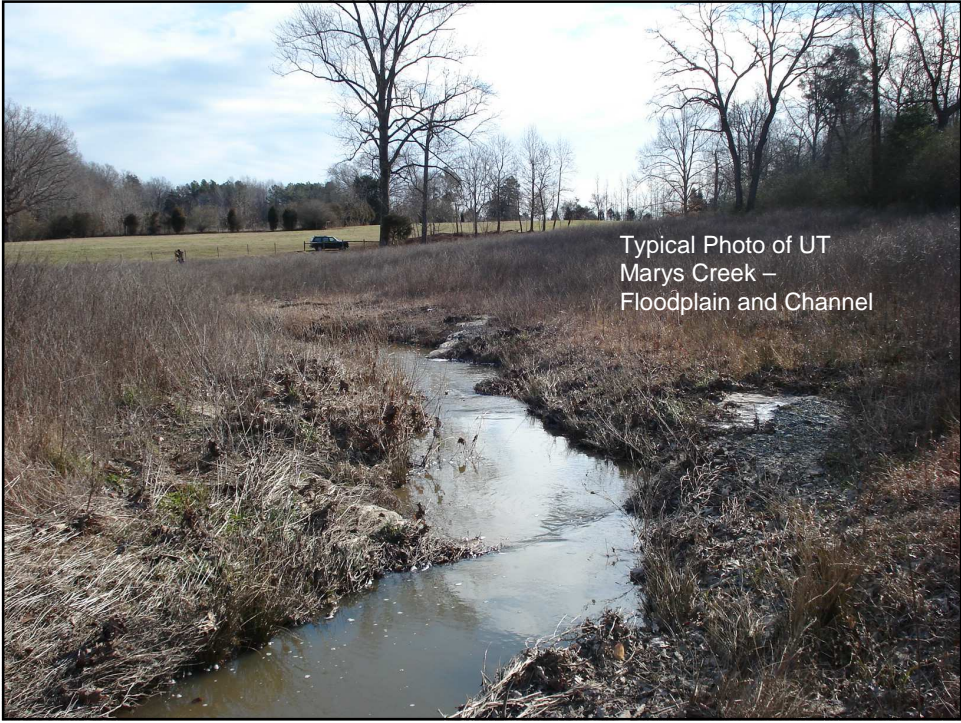
Typical Photo of UT
Marys Creek –
Floodplain and Channel

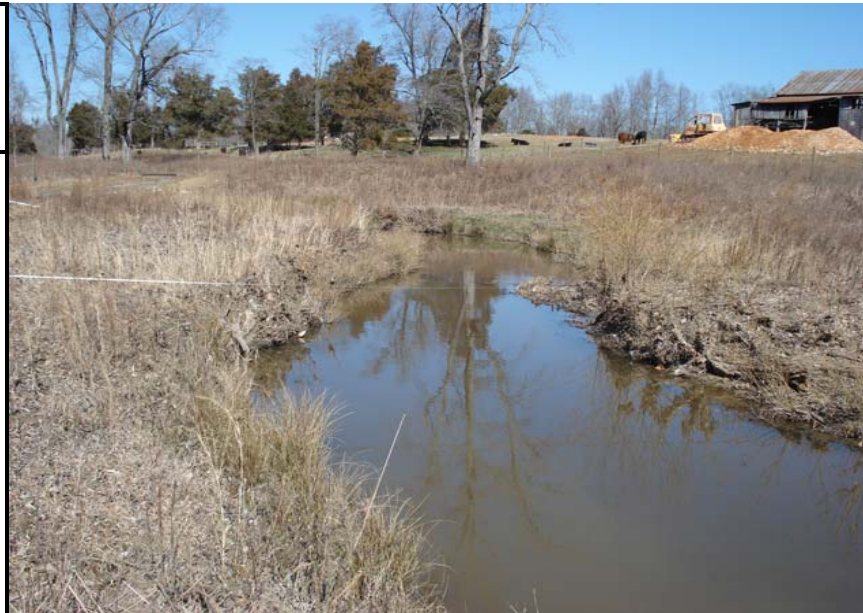
Photo of Cross-Section 2 - Looking Downstream @ As built STA 18+05

Summary	Year 1 - 2007	AS-BUILT 2006	Inner Berm 2007
Area	53.6	56.5	20.1
Width	24.2	26.2	15.9
Mean Depth	2.2	2.2	1.3
Max Depth	3.6	3.7	1.8
W/D	11.0	12.1	12.6

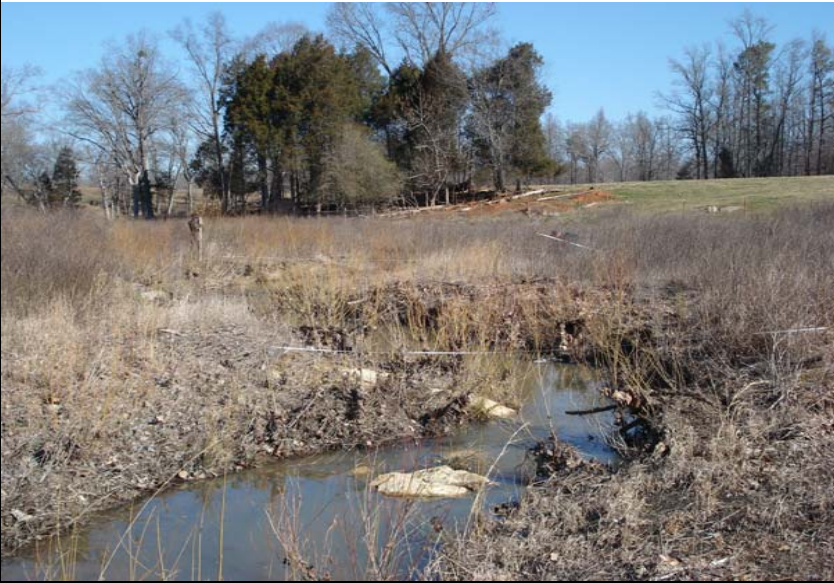
Photo of Cross-Section 1 - Looking Downstream @ As built STA 12+87

Summary	Year 1 - 2007	AS-BUILT 2006	Inner Berm 2007
Area	27.3	30.4	9.0
Width	18.3	19.7	10.0
Mean Depth	1.5	1.5	0.9
Max Depth	2.8	3.0	1.6
W/D	12.3	12.8	11.1

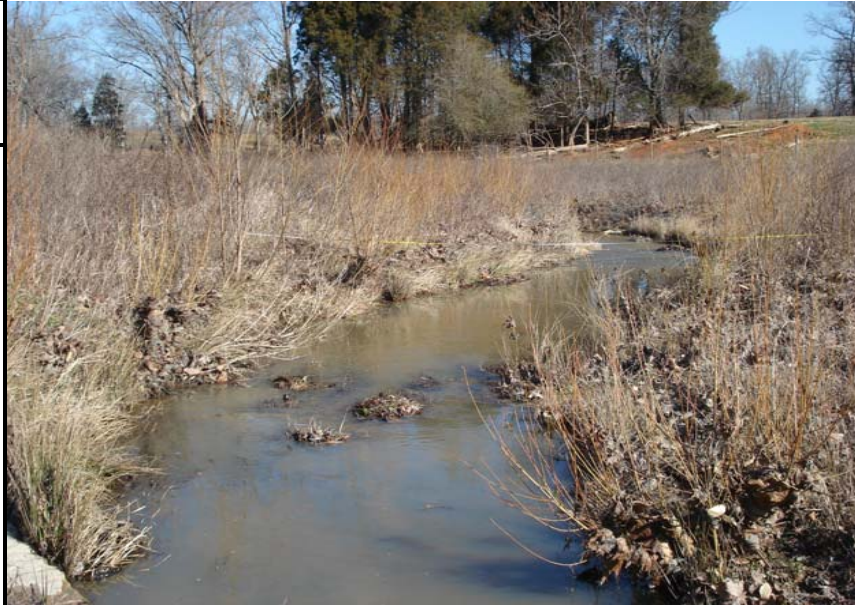
Photo of Cross-Section 2 - Looking Downstream @ As built STA 13+61

Summary	Year 1 - 2007	AS-BUILT 2006	Inner Berm 2007
Area	26.6	28.1	9.0
Width	26.6	26.5	10.0
Mean Depth	1.0	1.1	0.9
Max Depth	2.2	2.1	1.6
W/D	26.6	25.0	11.1

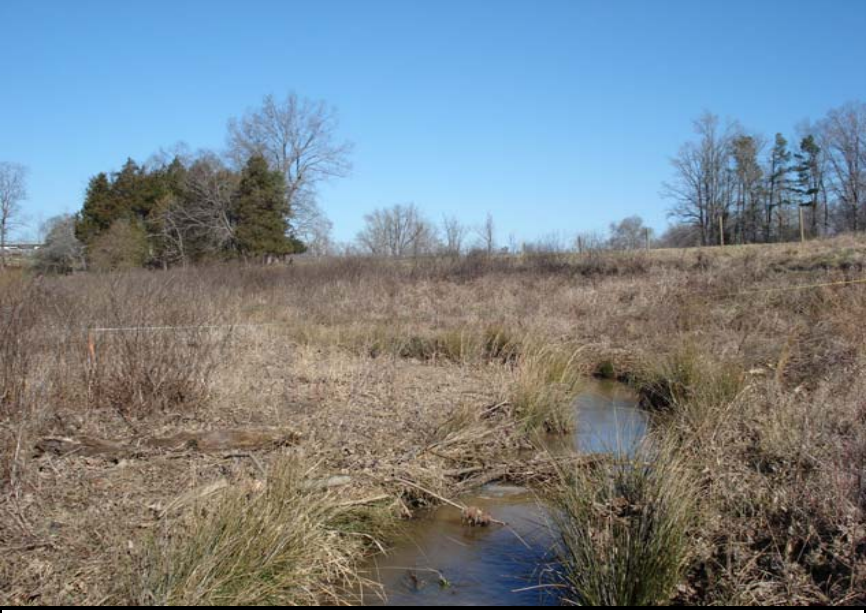
Photo of Trib Cross-Section 1 - Looking Downstream @ As built STA 11+01

Summary	Year 1 - 2007	AS-BUILT 2006
Area	13.0	17.2
Width	14.7	15.1
Mean Depth	0.9	1.1
Max Depth	1.8	2.1
W/D	16.5	13.3

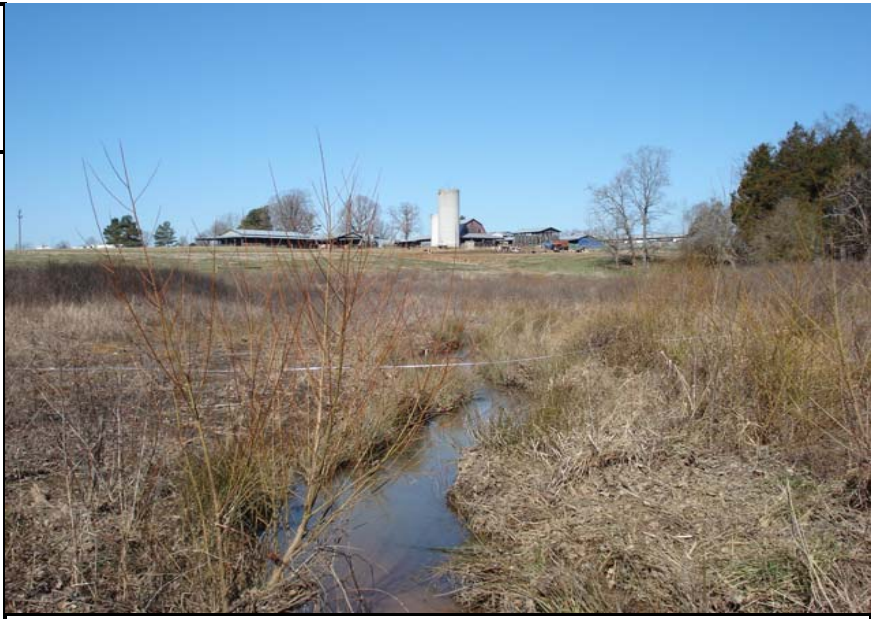
Photo of Trib Cross-Section 2 - Looking Downstream @ As built STA 11+89

Summary	Year 1 - 2007	AS-BUILT 2006
Area	8.8	10.0
Width	11.2	11.8
Mean Depth	0.8	0.8
Max Depth	1.4	1.4
W/D	14.3	13.9

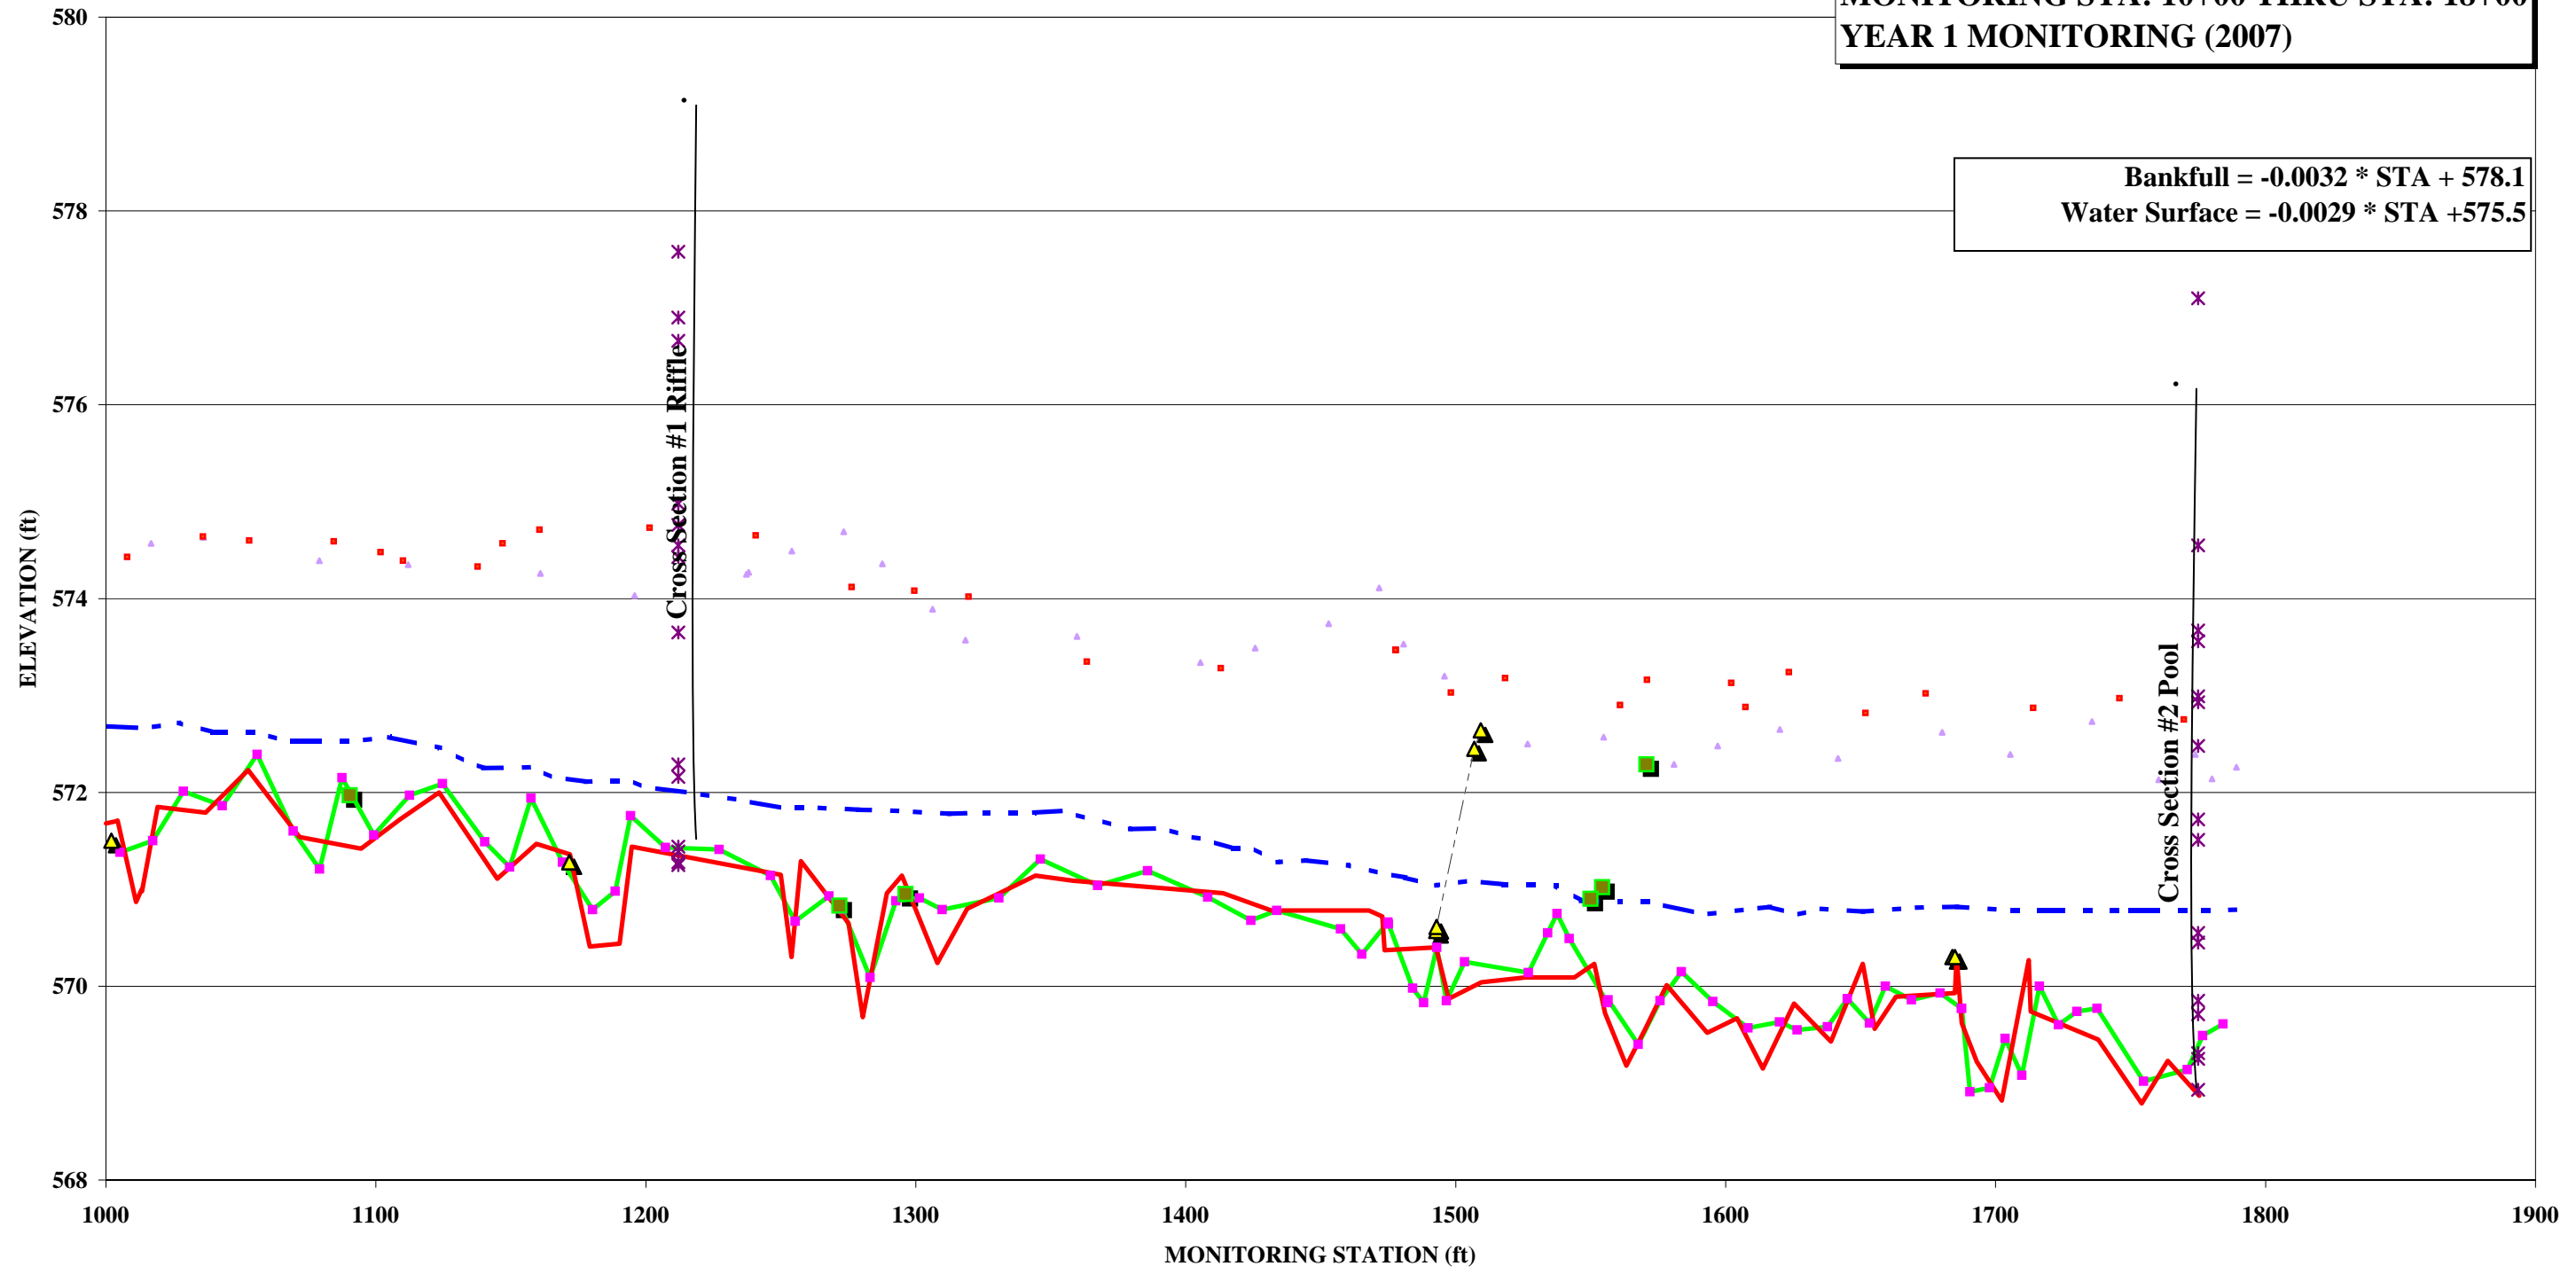
FIGURE B.7.1
UT CANE CREEK - LONG PROFILE
MONITORING STA: 10+00 THRU STA: 18+00
YEAR 1 MONITORING (2007)

Bankfull = $-0.0032 * STA + 578.1$
 Water Surface = $-0.0029 * STA + 575.5$

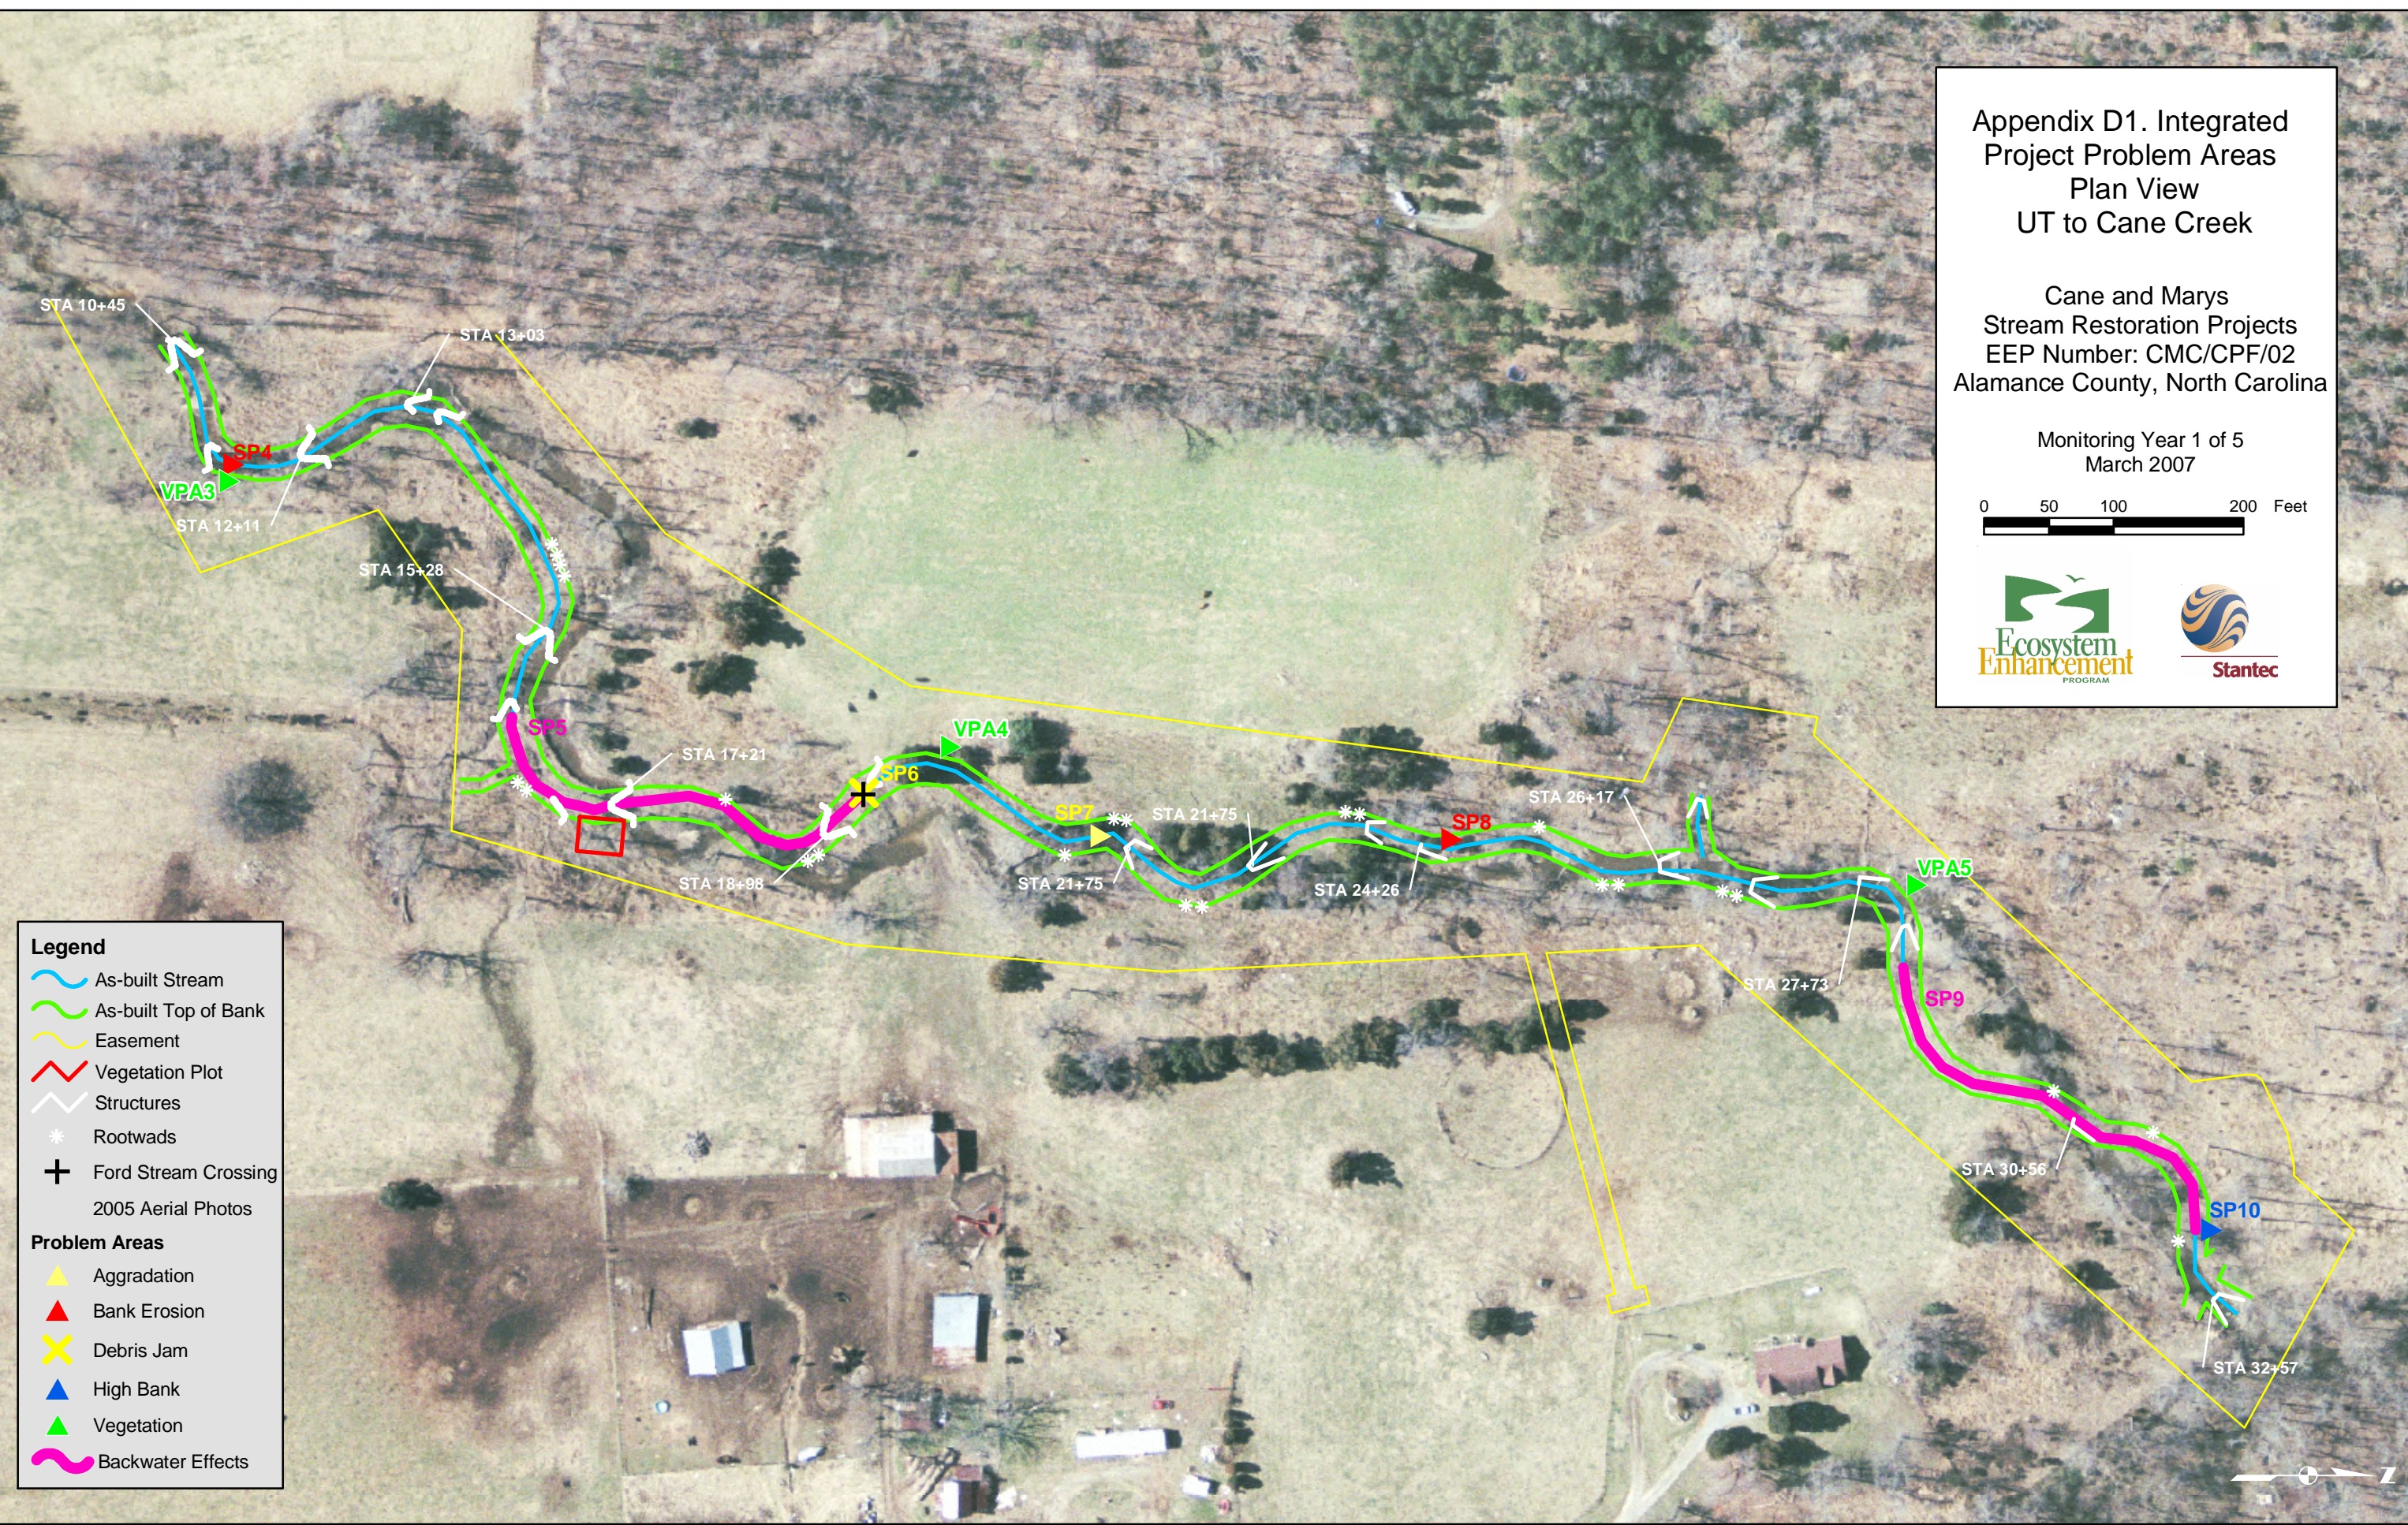
Left Bank STA 14+90 Confluence of the Main reach and the UT – There is minor bank erosion and undermining of rootwad structures. The cause of this minor instability is due to the construction of higher banks at a confluence and the installation of rootwads to armor the banks of this unnatural feature. Confluences should have the lowest bank heights relative to the reach directly upstream or downstream of the confluence.

STA 19+50 Left Vane Arm – This vane arm was installed very steep and stubby. The armor was repaired because of piping but there is currently minor bank erosion occurring on the vane arm. The causes of the instability are due to too much of a drop and incorrect vertical angles, horizontal angles, and arm lengths on the vane arms. Many of the vanes on this project reach have been installed incorrectly but most of the vanes are still providing the intended function, this vane has the risk of piping and failure to provide the intended function.

STA 21+25 Culverts– There is a bedrock vertical constraint downstream that limits the slope through this culvert. There is a steep slope upstream of the culvert that is efficient at routing sediments. The downstream backward coupled with a flat culvert slope encourages deposition in the culvert. The deposition both directly upstream and in the culvert limits the capacity of water that can be routed through the culvert. With the limited capacity water backs up and floods over the road crossing during high flows. This is an urgent problem that needs to be addressed or the road crossing will fail and the stream will cut a new channel to the right of the installed culverts.

Right Bank STA 11+50 – The outside of this meander bend has very poor establishment of vegetation, that has led to excess bank erosion underneath a degrading erosion control matting. The causes of the instability might be due to over compaction of the soil during construction.

STA 16+00 thru 19+50 – There is channel aggradation occurring for approximately 350 ft on the lower end of the monitoring reach. The cause of the instability is due to the ford crossing being installed too high.
