UT to Mary's Creek Stream Restoration Site

2008 Annual Monitoring Report (Year 2)

Alamance County
EEP Project No. 241
Design Firm: Stantec Consulting Services, Inc.

May 2009

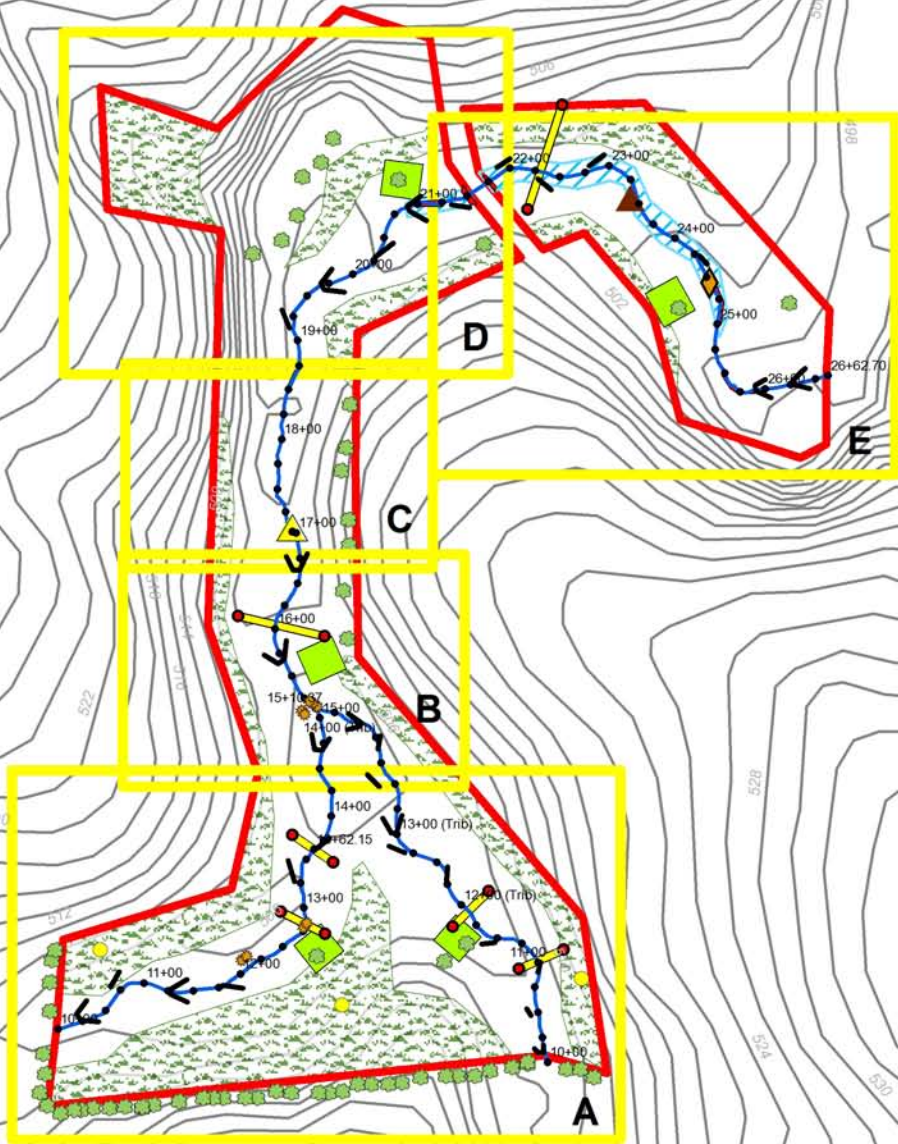
UT to Mary's Creek Stream Restoration Site
Integrated Vegetation and Stream
Current Conditions Plan View
 Alamance County, North Carolina

Overall Mary's Creek has problem areas that are limited in number and extent; a 30 foot segment of bank erosion, one structure that has limited piping, erosion and deposition around the stream crossing, and the beaver impacts. The main area of concern is the condition of the stream crossing, which has significant erosion on the upstream side roadway embankment and will most likely continue to degrade. The over-widened channel built for the triple culverts have narrowed to a single channel width centered on the middle culvert on the upstream and downstream side of the culverts, thereby limiting the culverts capacity to pass large storm events. It appears that the road has been overtopped during storm events since upstream roadway embankment has eroded several feet exposing the culverts. The overflow is causing the stone on the roadway to wash into the stream. The culverts are flooded to an approximate depth of 1.8 feet during normal flows which are approximately 2/3 of the available culvert area. Sediment deposits just upstream and downstream of the culverts have formed elevated riffles.

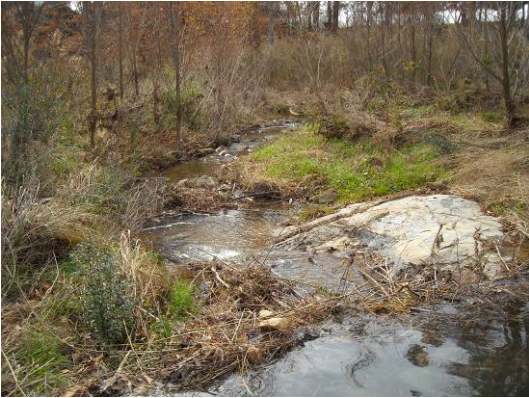
Photo Station 14. Downstream view with beaver dam in foreground.

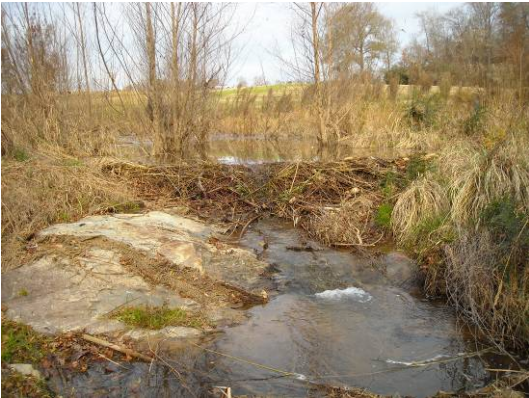
The beaver dam also has significant effects on Mary's Creek. The dam elevation is 498.6 feet and is located on a bedrock outcrop with an elevation 497.6 feet at station 24+67. It is causing backwater for a distance of approximately 365 feet to station 21+00. The location of the dam downstream of the culverts is adversely impacting their functionality. It should be noted that a bedrock outcrop exists at the beaver dam location, which, in the absence of the beaver dam, would still cause some backwater effects. Problem area photos are located in Appendix B for Mary's Creek.

Photo Station 15. Upstream view of beaver dam.

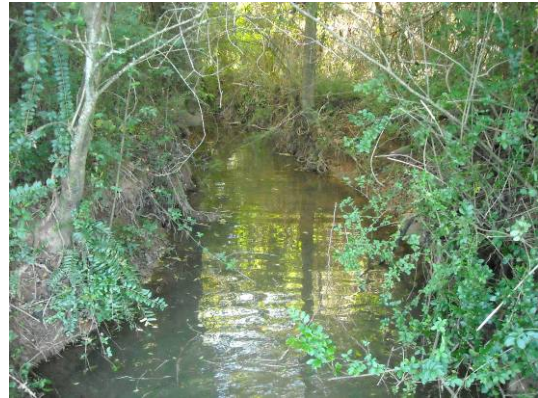
Photo Station 18. Upstream view of tributary outside of the easement.

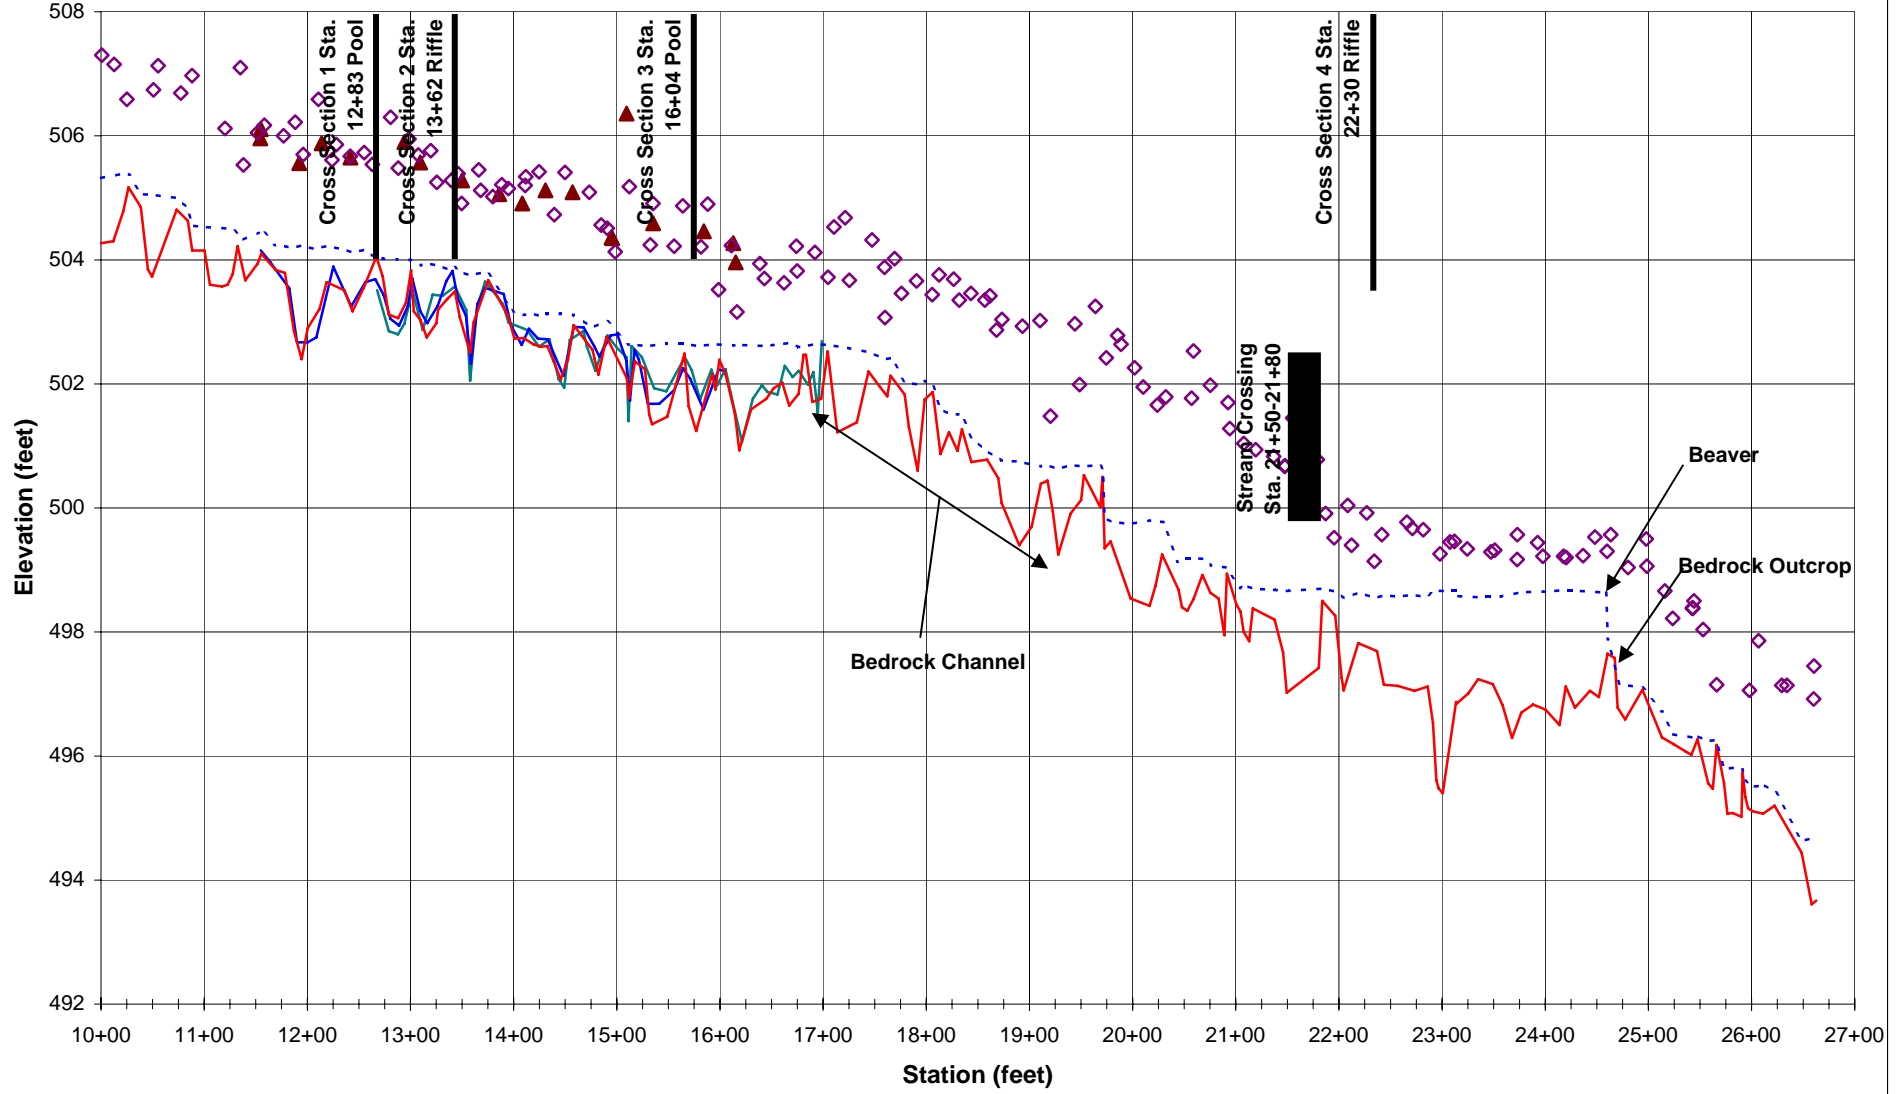
**Mary's Creek
Longitudinal Profile
Main Channel: Station 10+00-26+62**

The meanders, thalweg, bank, and structures are all stable throughout the tributary. The tributary bed at the top of the reach is experiencing aggradation due to the incoming sediment load from the degraded upstream channel, as evident in the longitudinal profile plot located in Appendix B. Although the channel is stable, the riffles and pools show low performance in Table B2, 54% and 42%, respectively. The aggradation has filled some pools within the upper reach and resulted in the migration of some features into inappropriate plan form locations within the channel. The aggradation of the channel in the upstream end of the reach has shifted the stream slope from 0.0037% to 0.0062% over the year two monitoring period. This change in slope may be temporary as the sediment input upstream decreases and the aggraded soil passes through the system during future storm events. The tributary longitudinal profile obtained in next years monitoring will provide additional data to quantify the aggradation as a temporary or a long term issue.
