YEAR 1 MONITORING REPORT

UT MILLERS CREEK

Duplin County, North Carolina

DMS Project ID No. 95719, Contract No. 5000, USACE Action ID No. SAW-2013-00386

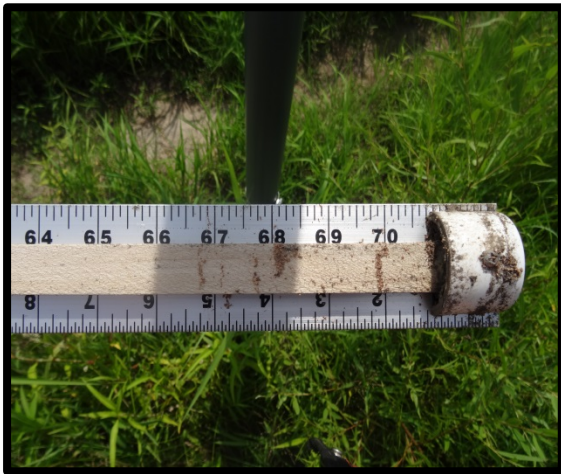
5.1 Crest Gauge 1 (7/14/2015)

Date	Crest Gauge Info		Gauge Reading (ft)	Gauge Elevation (ft)	Crest Elevation (ft)	Bankfull Elevation (ft)	Height above Bankfull (ft)	Photo
	Site	Sta.						
7/14/2015	1	10+62	0.42	111.46	111.88	112.07	-0.19	5.1
7/14/2015	2	37+03	2.29	107.16	109.45	107.71	1.74	5.2
10/19/2015	1	10+62	1.50	111.46	112.96	112.07	0.89	5.3
