## **YEAR 2 MONITORING REPORT**

### **UT MILLERS CREEK**

Duplin County, North Carolina

DMS Project ID No. 95719, Contract No. 5000, USACE Action ID No. SAW-2013-00386

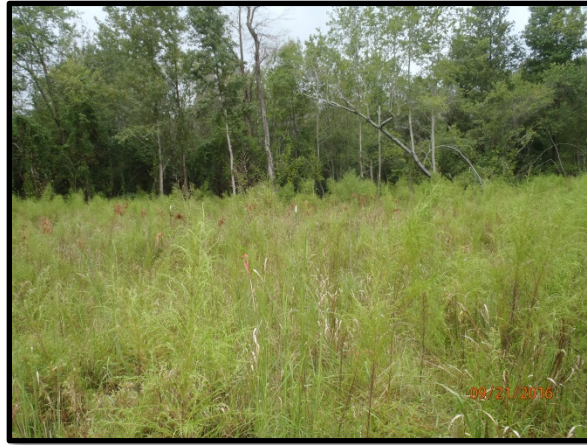
**3.1 Vegetation Plot 1**

A small amount of morning glory (*Ipomoea sp.*) was noted within Plot 1, however the cover totaled less than 5% of the plot. It is not expected that morning glory will lead to reduced survival rates on-site; however, HDR|ICA will continue to monitor the status of this species.

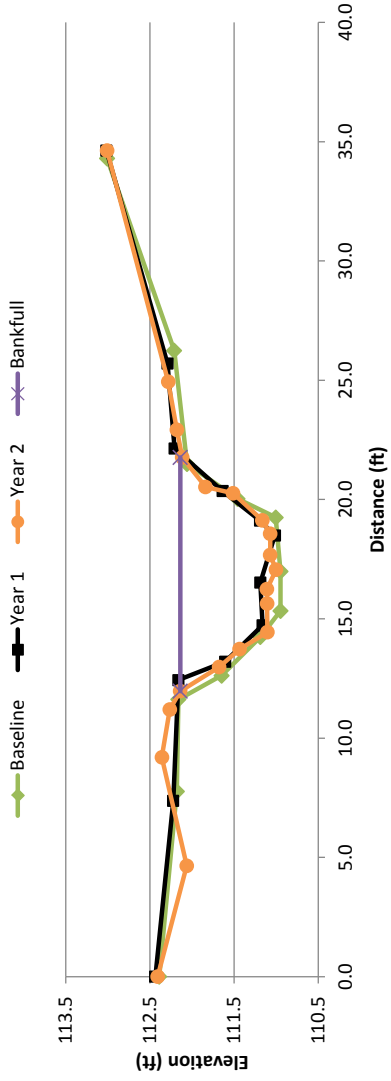
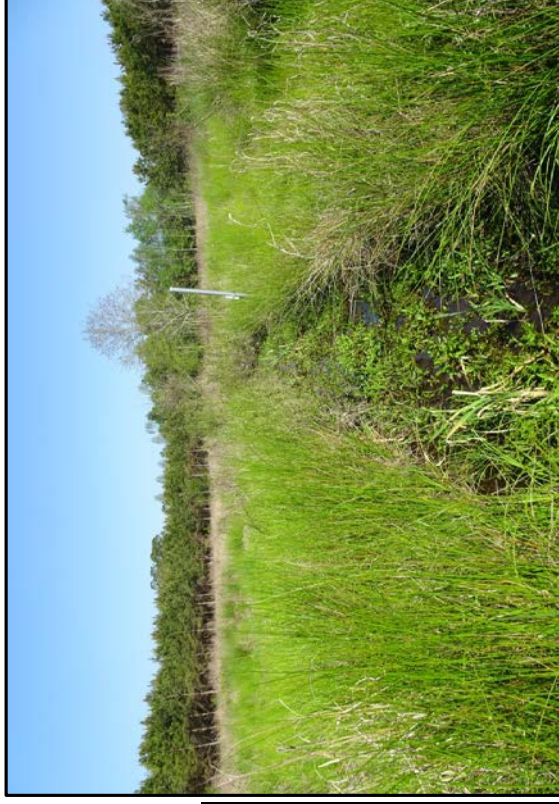
**Figure 4.1, XS-1 Riffle**

Dimension	Cross Section 1 (Riffle)					
	Base	MY1	MY2	MY3	MY4	MY5
<b>Based on fixed baseline bankfull elevation</b>						
Bankfull Width (ft)	9.7	9.6	9.6			
Floodprone Width (ft)	195.2	195.2	195.2			
Bankfull Mean Depth (ft)	0.8	0.8	0.7			
Bankfull Max Depth (ft)	1.1	1.1	1.1			
Bankfull Cross Sectional Area (ft <sup>2</sup> )	7.7	7.3	6.8			
Bankfull Width/Depth Ratio	12.2	12.6	13.5			
Bankfull Entrenchment Ratio	20.2	20.3	20.3			
Bankfull Bank Height Ratio	1.0	1.0	1.0

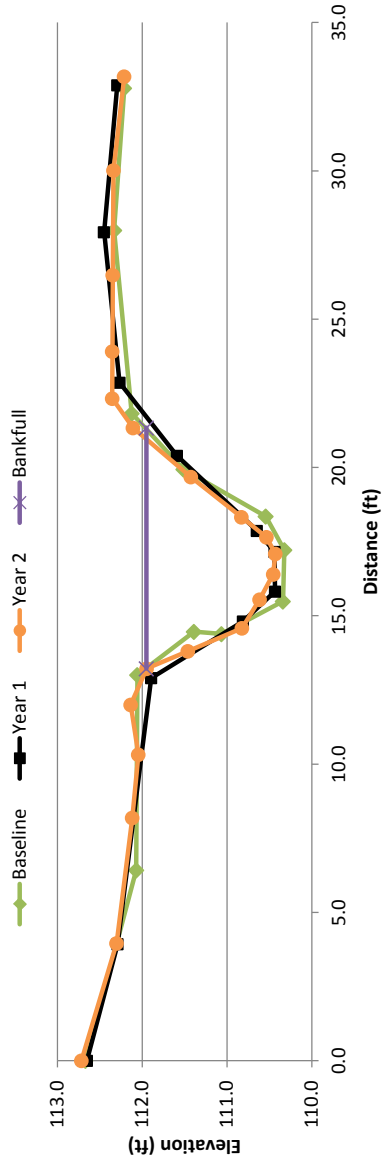
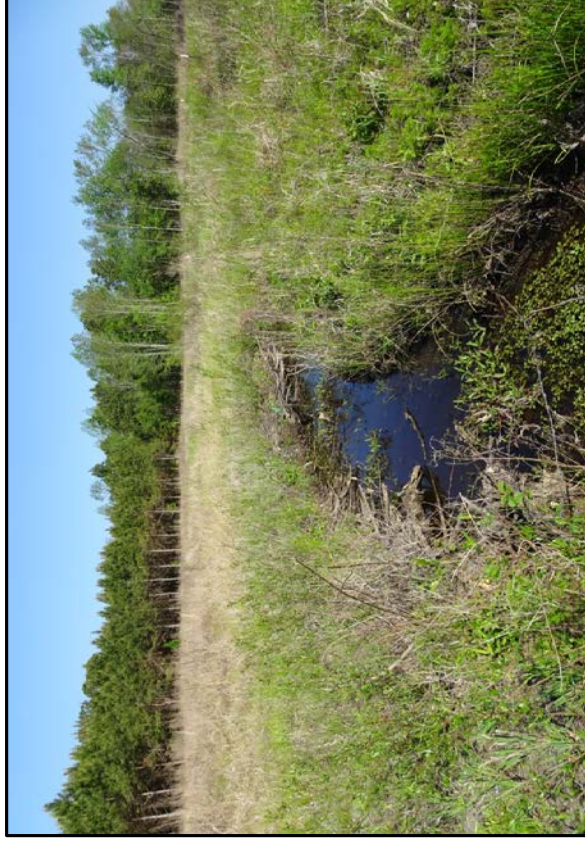
**Figure 4.2, XS-2 Pool**

Dimension	Cross Section 2 (Pool)					
	Base	MY1	MY2	MY3	MY4	MY5
<b>Based on fixed baseline bankfull elevation</b>						
Bankfull Width (ft)	8.6	8.6	7.80			
Floodprone Width (ft)						
Bankfull Mean Depth (ft)	1.0	0.9	1.00			
Bankfull Max Depth (ft)	1.7	1.5	1.50			
Bankfull Cross Sectional Area (ft <sup>2</sup> )	8.8	7.3	7.30			
Bankfull Width/Depth Ratio						
Bankfull Entrenchment Ratio						
Bankfull Bank Height Ratio

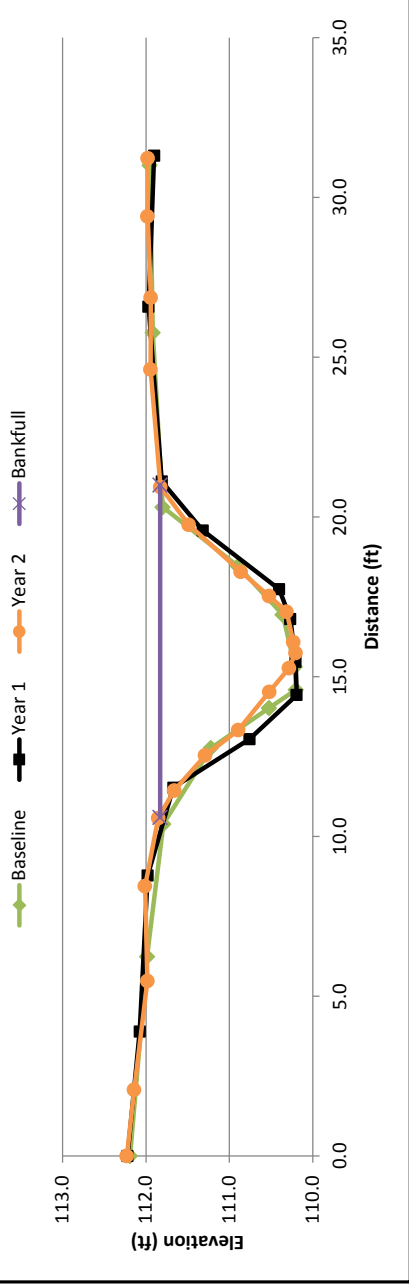
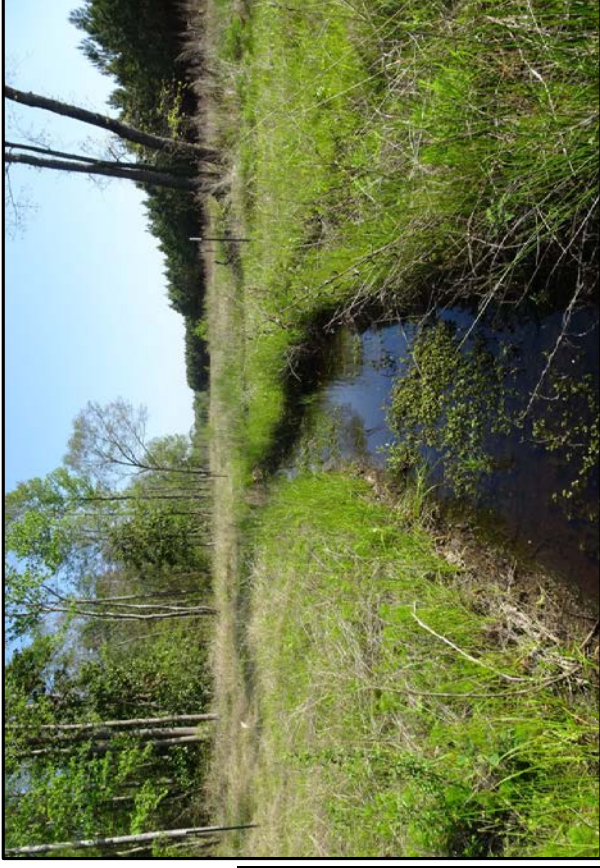
**Figure 4.3, XS-3 Riffle**

Dimension	Cross Section 3 (Riffle)					
	Base	MY1	MY2	MY3	MY4	MY5
<b>Based on fixed baseline bankfull elevation</b>						
Bankfull Width (ft)	9.9	9.2	10.40			
Floodprone Width (ft)	126.3	126.3	126.30			
Bankfull Mean Depth (ft)	0.9	1.0	0.90			
Bankfull Max Depth (ft)	1.6	1.5	1.60			
Bankfull Cross Sectional Area (ft <sup>2</sup> )	8.8	8.7	9.00			
Bankfull Width/Depth Ratio	11.1	9.6	12.10			
Bankfull Entrenchment Ratio	12.8	13.7	12.20			
Bankfull Bank Height Ratio	1.0	1.0	1.00

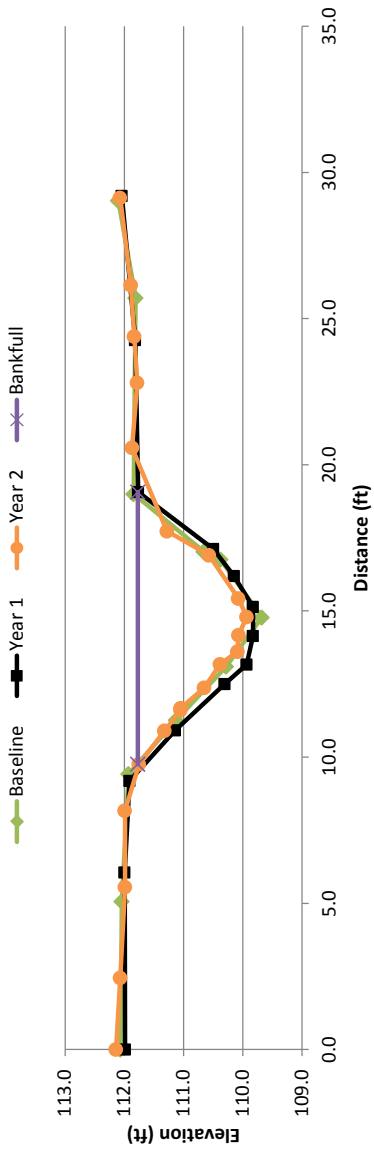
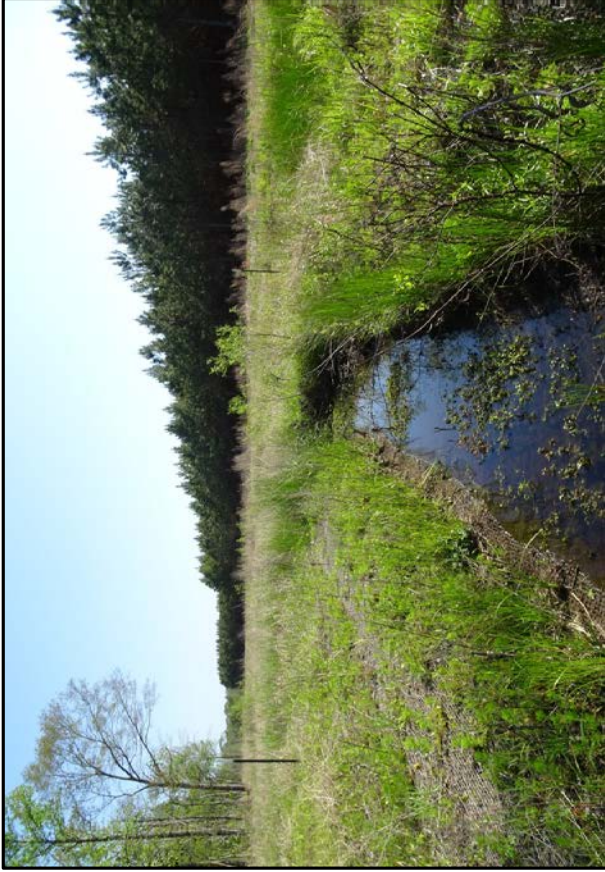
**Figure 4.4, XS-4 Pool**

Dimension	Cross Section 4 (Pool)					
	Base	MY1	MY2	MY3	MY4	MY5
<b>Based on fixed baseline bankfull elevation</b>						
Bankfull Width (ft)	9.4	9.8	10.20			
Floodprone Width (ft)						
Bankfull Mean Depth (ft)	1.2	1.2	0.90			
Bankfull Max Depth (ft)	2.2	1.9	1.80			
Bankfull Cross Sectional Area (ft <sup>2</sup> )	10.9	11.4	9.40			
Bankfull Width/Depth Ratio						
Bankfull Entrenchment Ratio						
Bankfull Bank Height Ratio

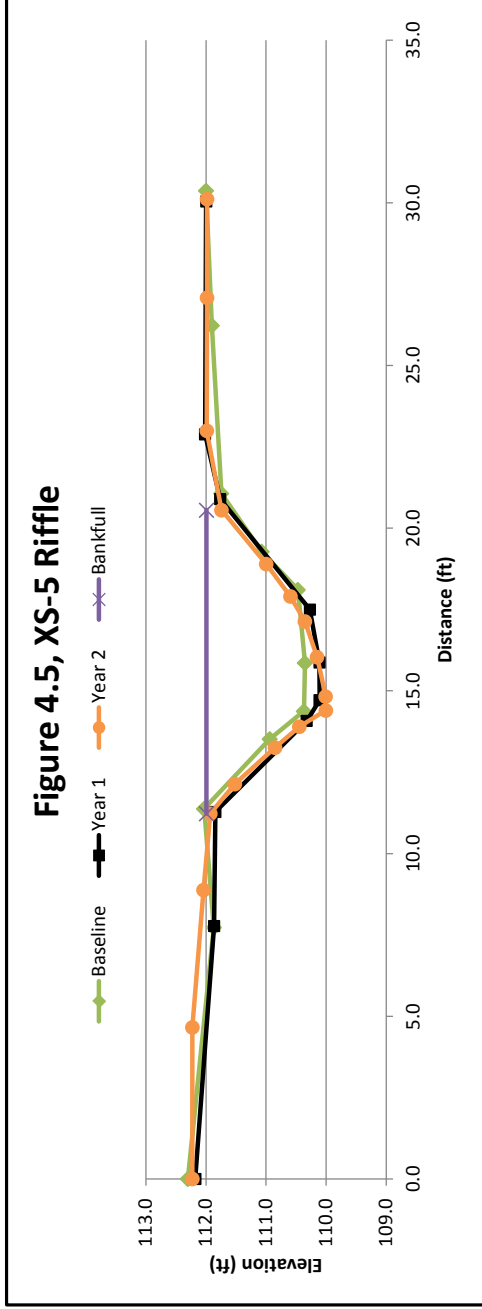
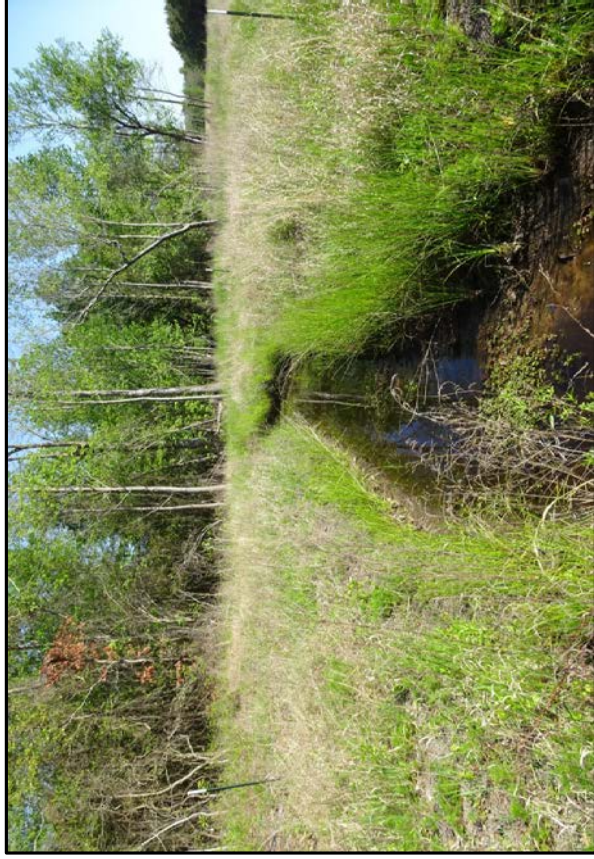
**Figure 4.5, XS-5 Riffle**

Dimension	Cross Section 5 (Riffle)					
	Base	MY1	MY2	MY3	MY4	MY5
<b>Based on fixed baseline bankfull elevation</b>						
Bankfull Width (ft)	9.1	10.2	8.90			
Floodprone Width (ft)	182.9	182.9	182.90			
Bankfull Mean Depth (ft)	0.9	1.0	1.00			
Bankfull Max Depth (ft)	1.4	1.7	1.70			
Bankfull Cross Sectional Area (ft <sup>2</sup> )	8.4	10.7	9.10			
Bankfull Width/Depth Ratio	10.0	9.8	8.70			
Bankfull Entrenchment Ratio	20.0	17.9	20.50			
Bankfull Bank Height Ratio	1.0	1.0	1.00

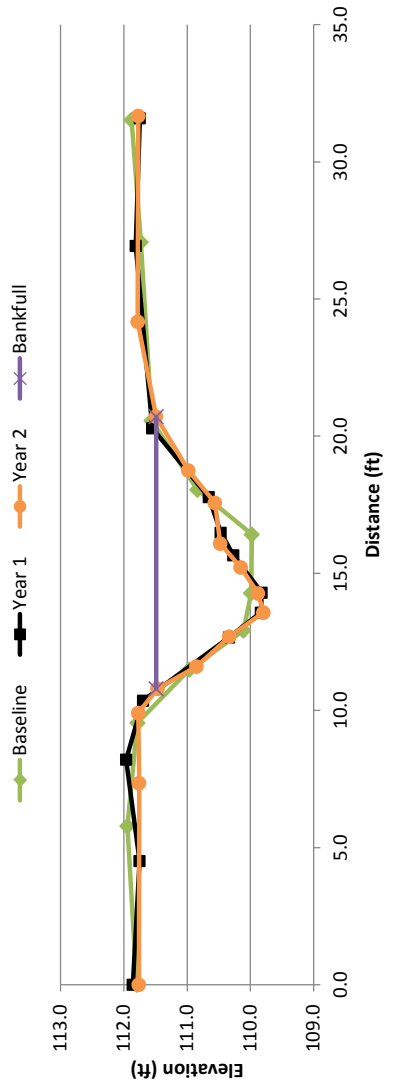
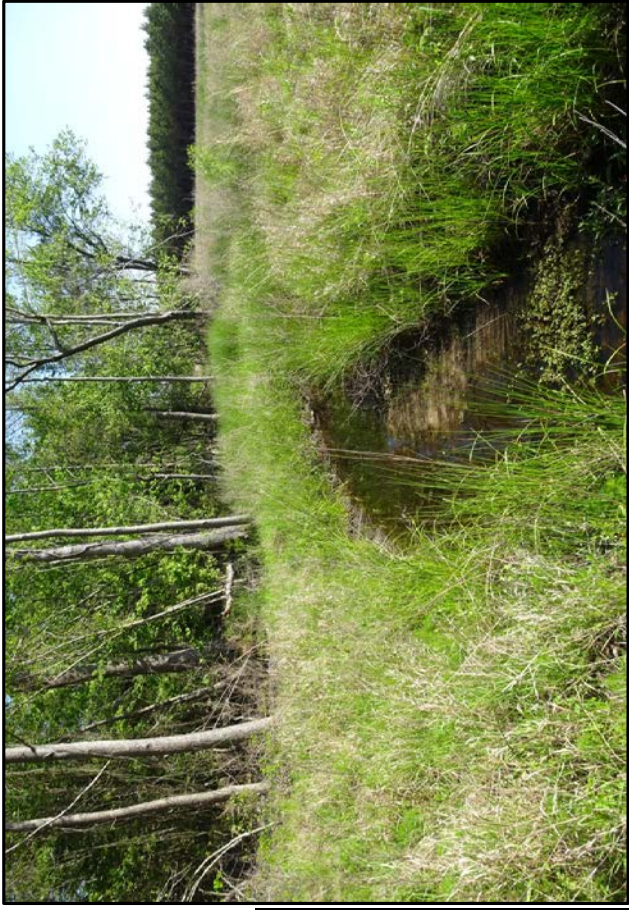
**Figure 4.6, XS-6 Pool**

Dimension	Cross Section 6 (Pool)					
	Base	MY1	MY2	MY3	MY4	MY5
<b>Based on fixed baseline bankfull elevation</b>						
Bankfull Width (ft)	10.5	9.7	9.80			
Floodprone Width (ft)						
Bankfull Mean Depth (ft)	1.0	1.0	0.90			
Bankfull Max Depth (ft)	1.6	1.7	1.70			
Bankfull Cross Sectional Area (ft <sup>2</sup> )	10.1	9.3	8.70			
Bankfull Width/Depth Ratio						
Bankfull Entrenchment Ratio						
Bankfull Bank Height Ratio

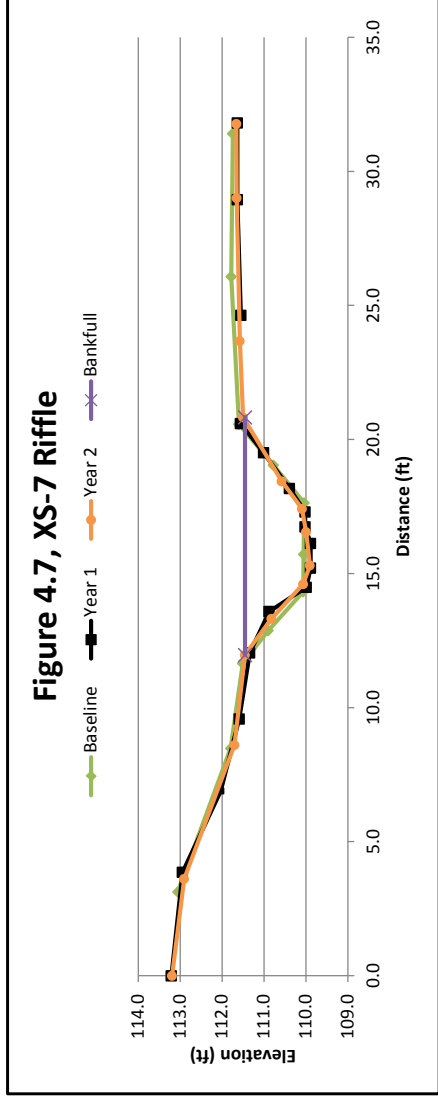
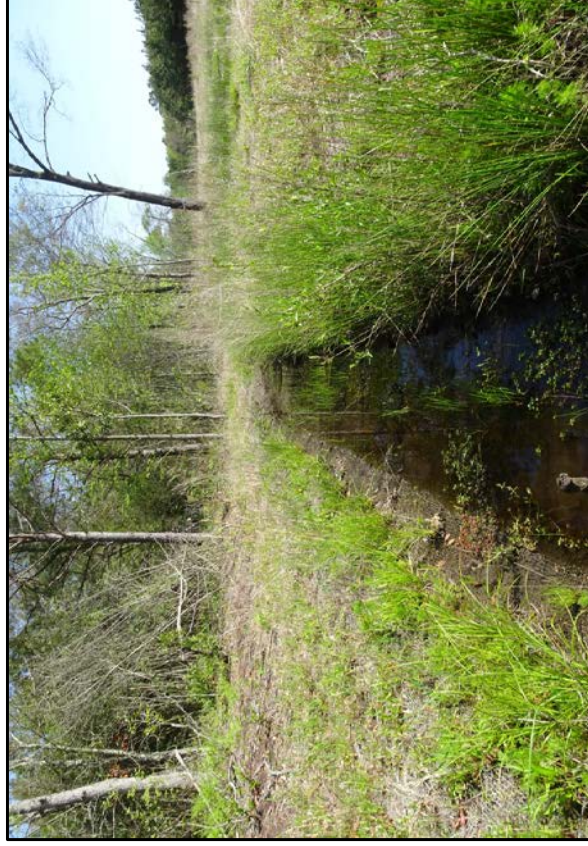
\*Baseline cross-section was not started on left pin

Dimension	Cross Section 7 (Riffle)					
	Base	MY1	MY2	MY3	MY4	MY5
<b>Based on fixed baseline bankfull elevation</b>						
Bankfull Width (ft)	8.8	8.1	8.70			
Floodprone Width (ft)	162.2	162.2	162.20			
Bankfull Mean Depth (ft)	1.0	0.9	0.90			
Bankfull Max Depth (ft)	1.5	1.4	1.60			
Bankfull Cross Sectional Area (ft <sup>2</sup> )	8.7	7.0	8.00			
Bankfull Width/Depth Ratio	8.8	9.4	9.60			
Bankfull Entrenchment Ratio	18.5	19.9	18.60			
Bankfull Bank Height Ratio	1.0	1.0	1.00

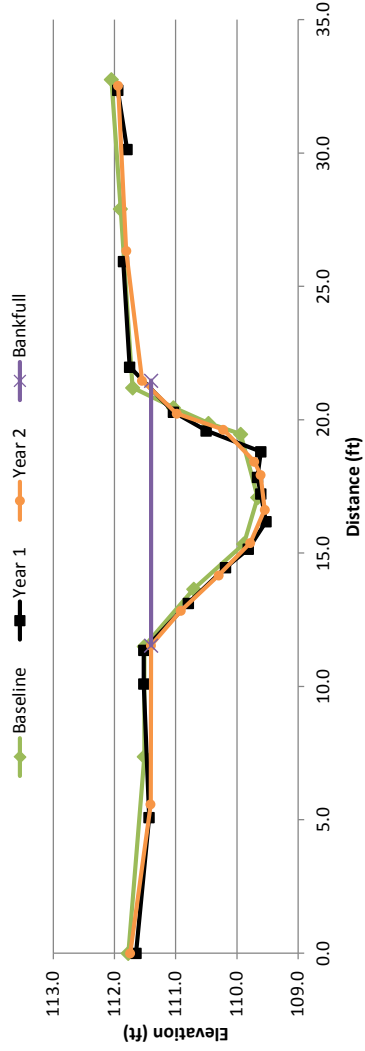
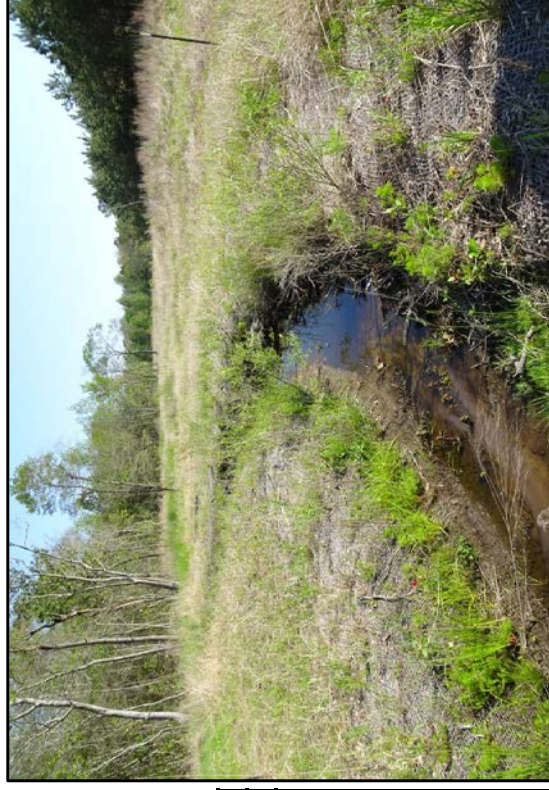
**Figure 4.8, XS-8 Pool**

Dimension	Cross Section 8 (Pool)					
	Base	MY1	MY2	MY3	MY4	MY5
<b>Based on fixed baseline bankfull elevation</b>						
Bankfull Width (ft)	9.5	10.0	9.60			
Floodprone Width (ft)						
Bankfull Mean Depth (ft)	1.2	1.2	1.10			
Bankfull Max Depth (ft)	1.9	2.0	1.90			
Bankfull Cross Sectional Area (ft <sup>2</sup> )	11.1	11.9	10.80			
Bankfull Width/Depth Ratio						
Bankfull Entrenchment Ratio						
Bankfull Bank Height Ratio

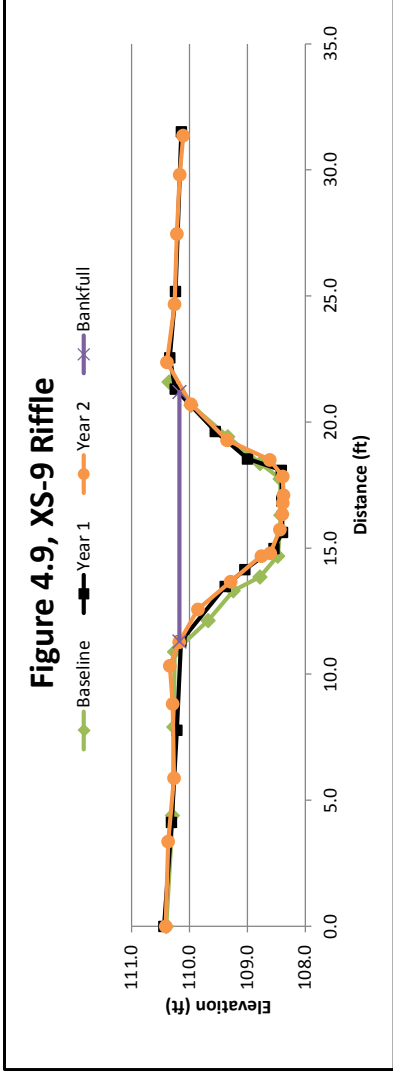
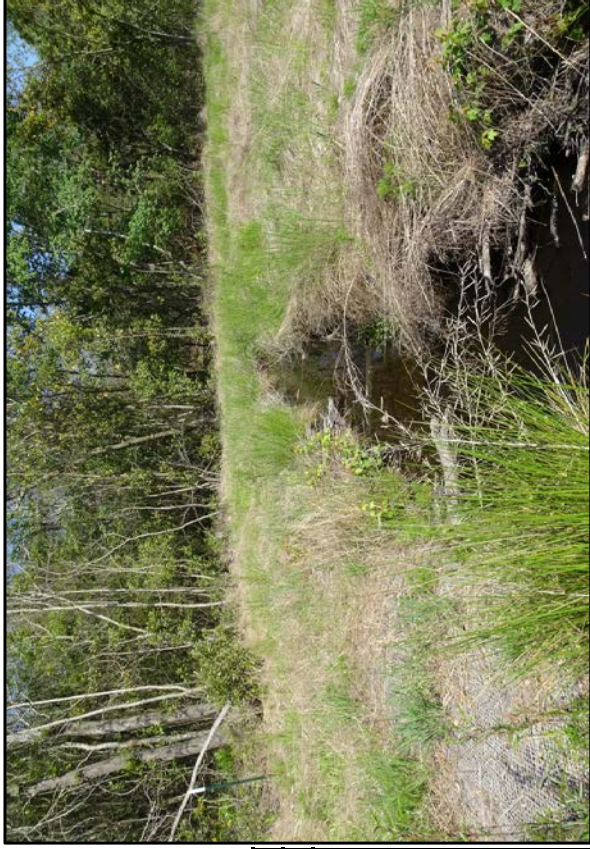
Dimension	Cross Section 9 (Riffle)					
	Base	MY1	MY2	MY3	MY4	MY5
<b>Based on fixed baseline bankfull elevation</b>						
Bankfull Width (ft)	10.5	9.9	9.8			
Floodprone Width (ft)	219.0	219.0	219.0			
Bankfull Mean Depth (ft)	1.1	1.0	1.0			
Bankfull Max Depth (ft)	1.8	1.8	1.7			
Bankfull Cross Sectional Area (ft <sup>2</sup> )	12.0	9.9	9.7			
Bankfull Width/Depth Ratio	9.1	9.9	9.9			
Bankfull Entrenchment Ratio	20.9	22.1	22.3			
Bankfull Bank Height Ratio	1.0	1.0	1.0

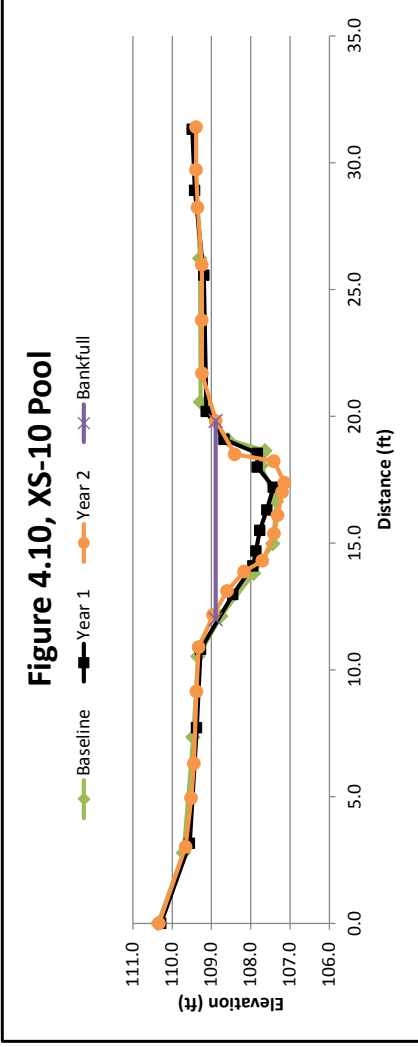
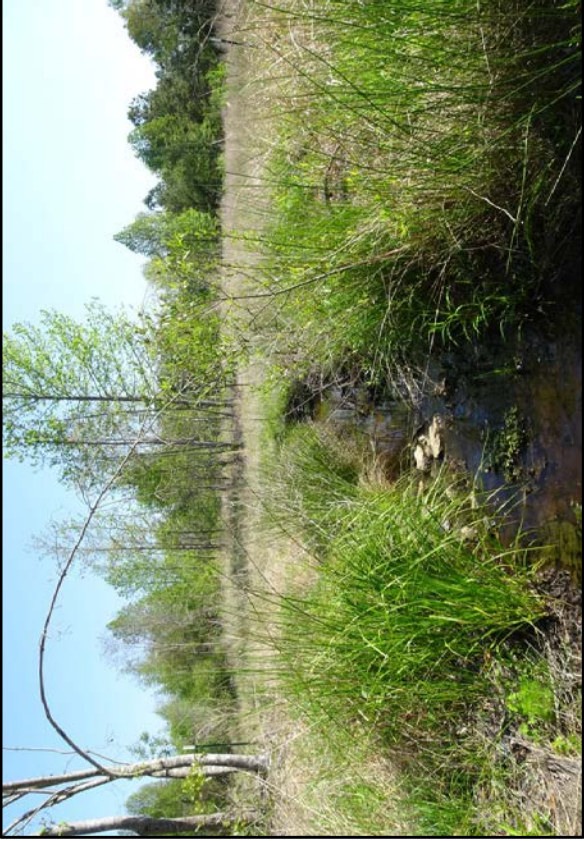
Dimension	Cross Section 10 (Pool)					
	Base	MY1	MY2	MY3	MY4	MY5
<b>Based on fixed baseline bankfull elevation</b>						
Bankfull Width (ft)	9.8	9.2	10.50			
Floodprone Width (ft)						
Bankfull Mean Depth (ft)	1.2	1.0	1.00			
Bankfull Max Depth (ft)	1.9	1.7	2.10			
Bankfull Cross Sectional Area (ft <sup>2</sup> )	11.4	8.7	10.70			
Bankfull Width/Depth Ratio						
Bankfull Entrenchment Ratio						
Bankfull Bank Height Ratio

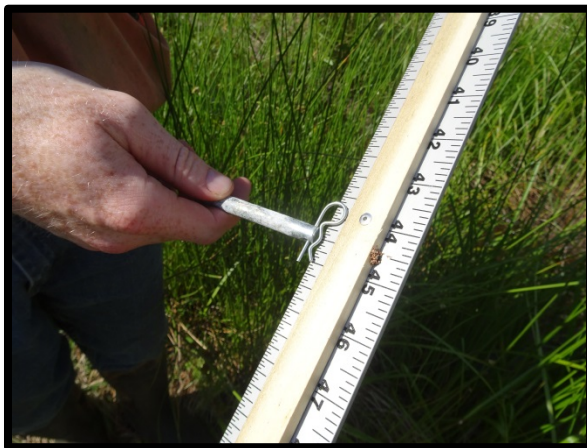
**5.1 Crest Gauge 2 (4/27/2016)**

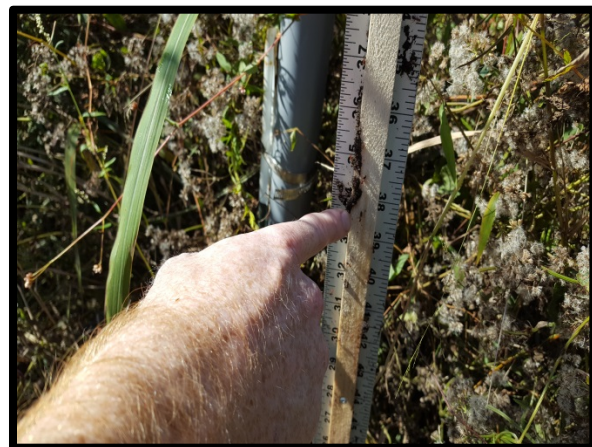
**5.2 Crest Gauge 1 (10/10/2016)**

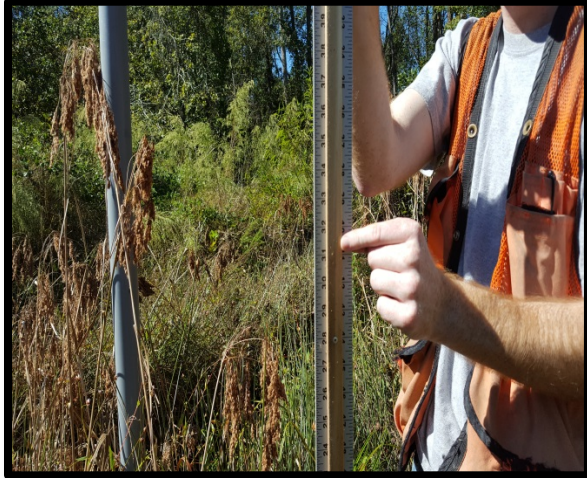
**5.3 Crest Gauge 2 (10/10/2016)**
