## **YEAR 3 MONITORING REPORT**

### **UT MILLERS CREEK**

Duplin County, North Carolina

DMS Project ID No. 95719, Contract No. 5000, USACE Action ID No. SAW-2013-00386

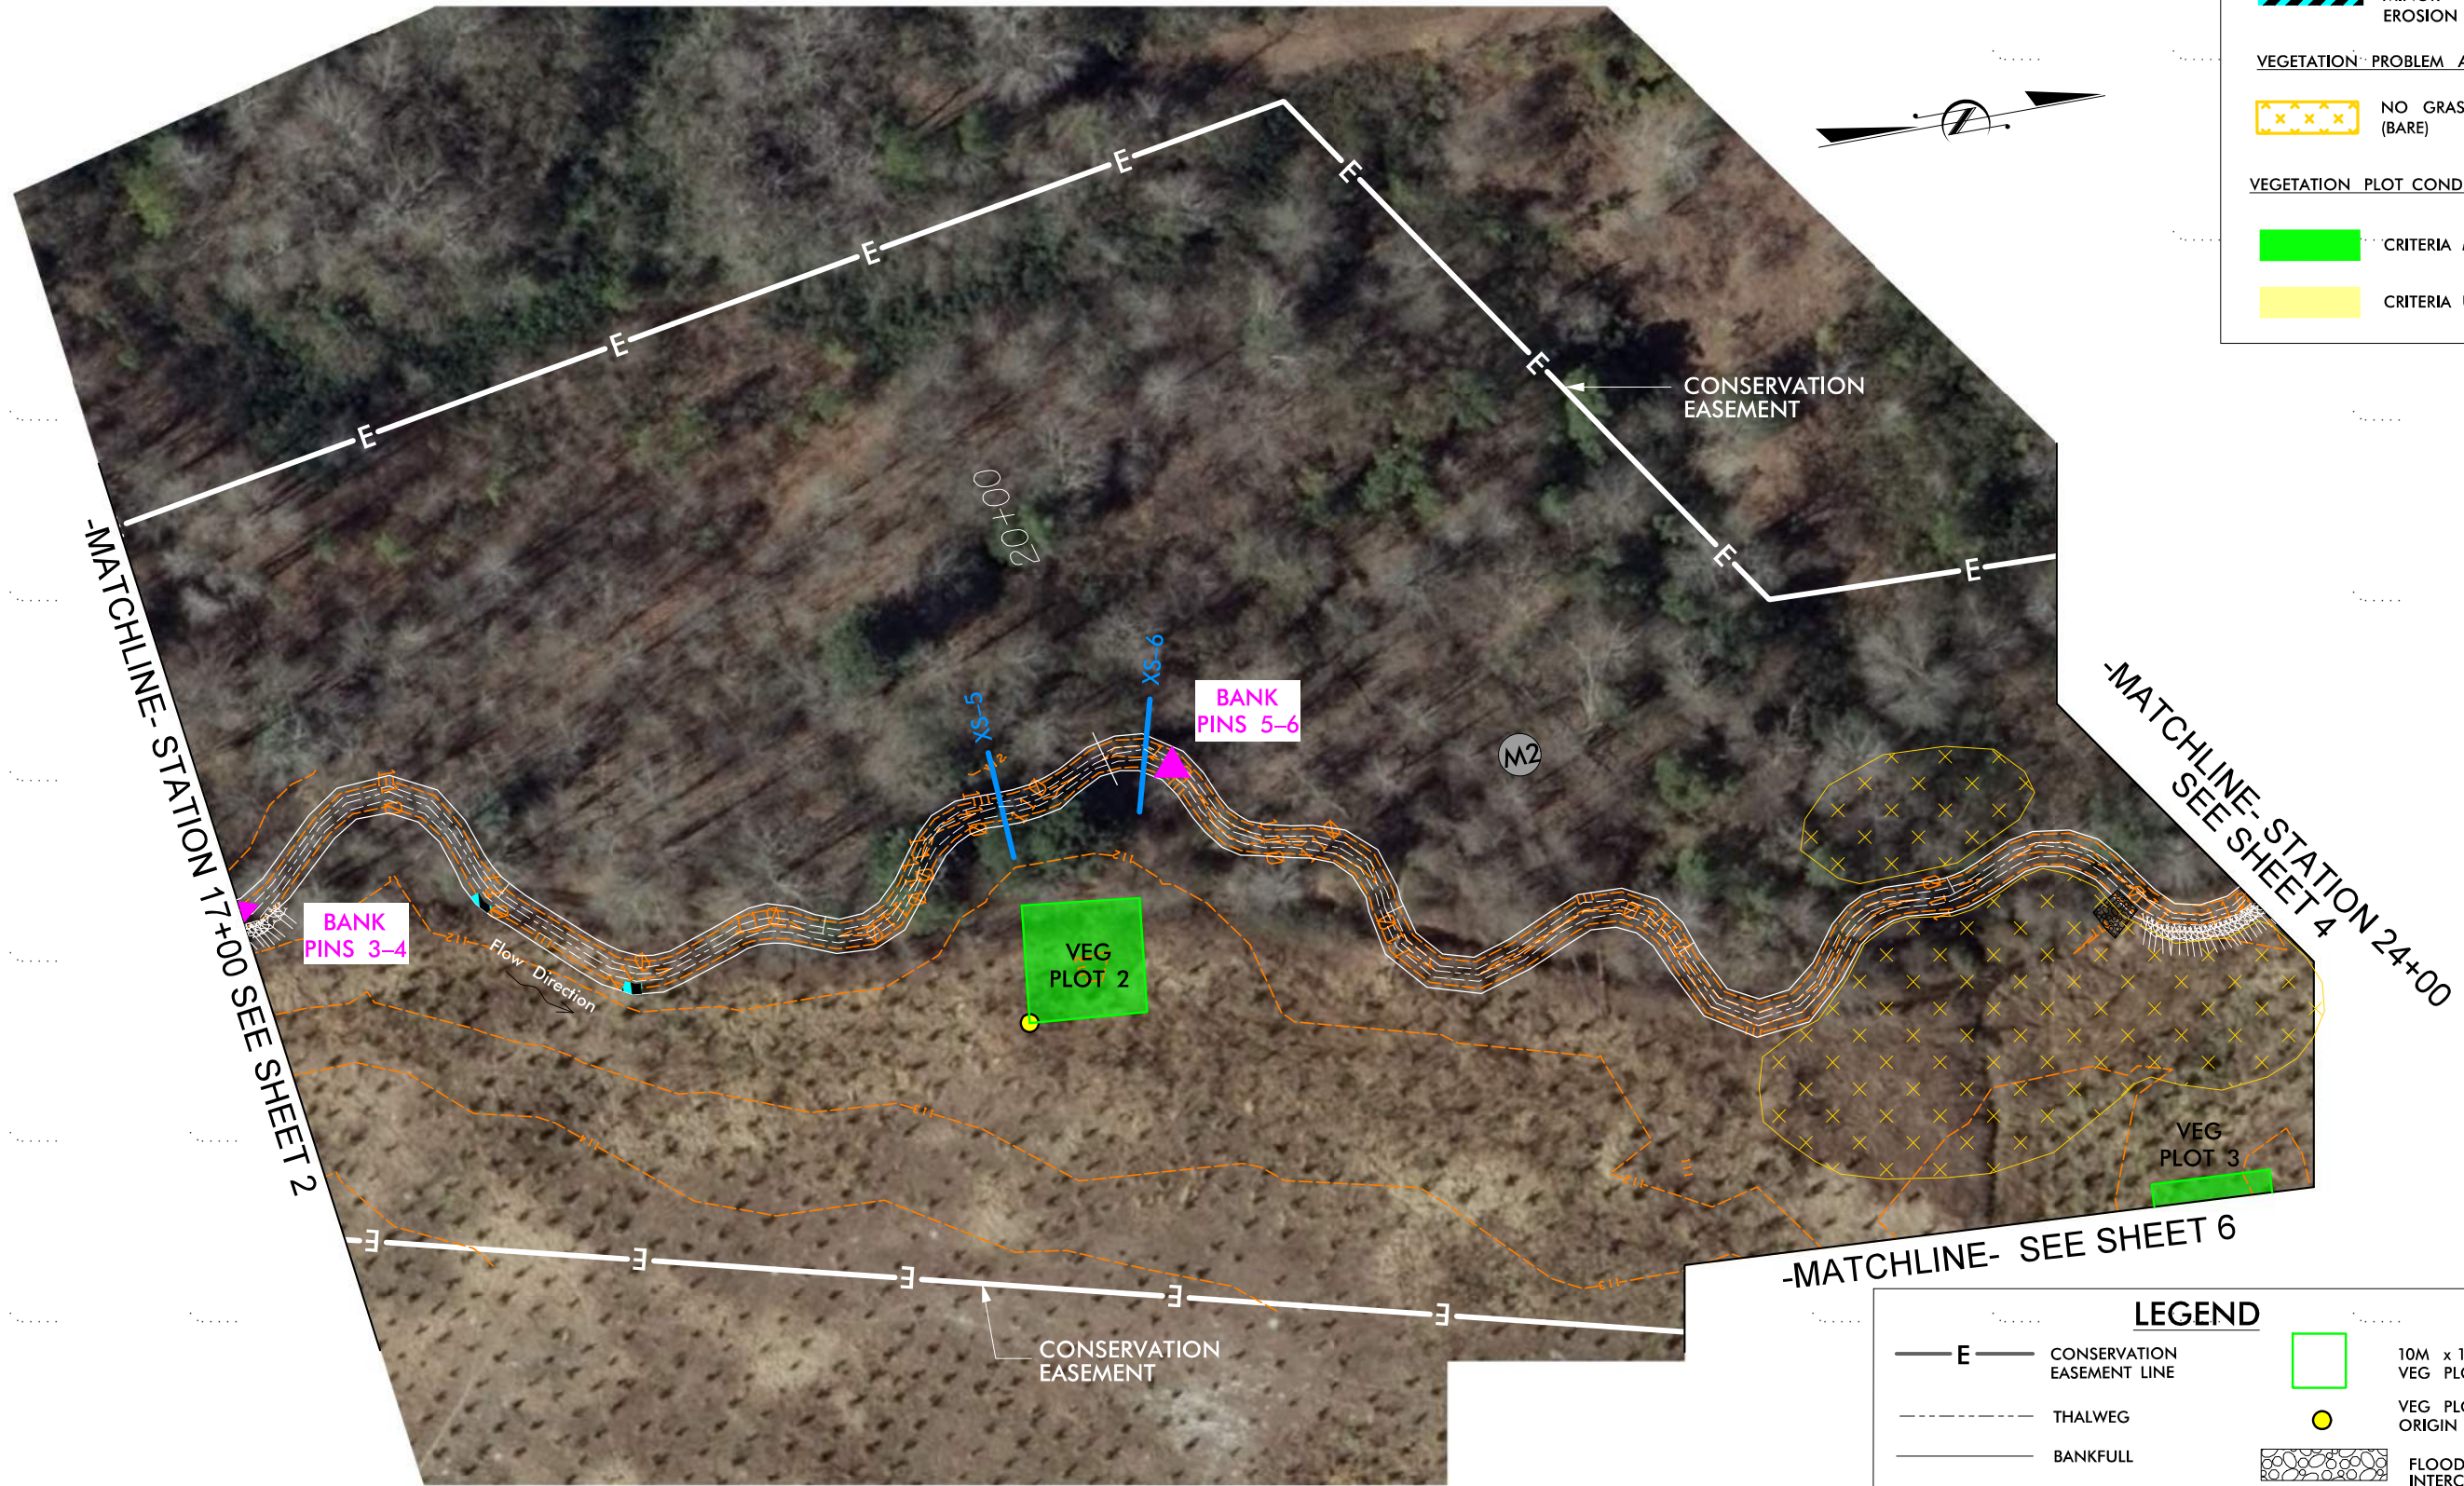
Channel bank stability continues to benefit from the maturation of vegetation along the channel toes and bank. Two areas of minor erosion have developed around soil lifts due to the sandy soil composition on-site. All instances of erosion noted during Year 3 monitoring were minor and will likely fill in with vegetation over time.

YEAR 3 CONDITIONS	
<b>BANK/BED CONDITION</b>	
	MINOR EROSION
<b>VEGETATION PROBLEM AREAS</b>	
	NO GRASS (BARE)
<b>VEGETATION PLOT CONDITIONS</b>	
	CRITERIA MET
	CRITERIA UNMET

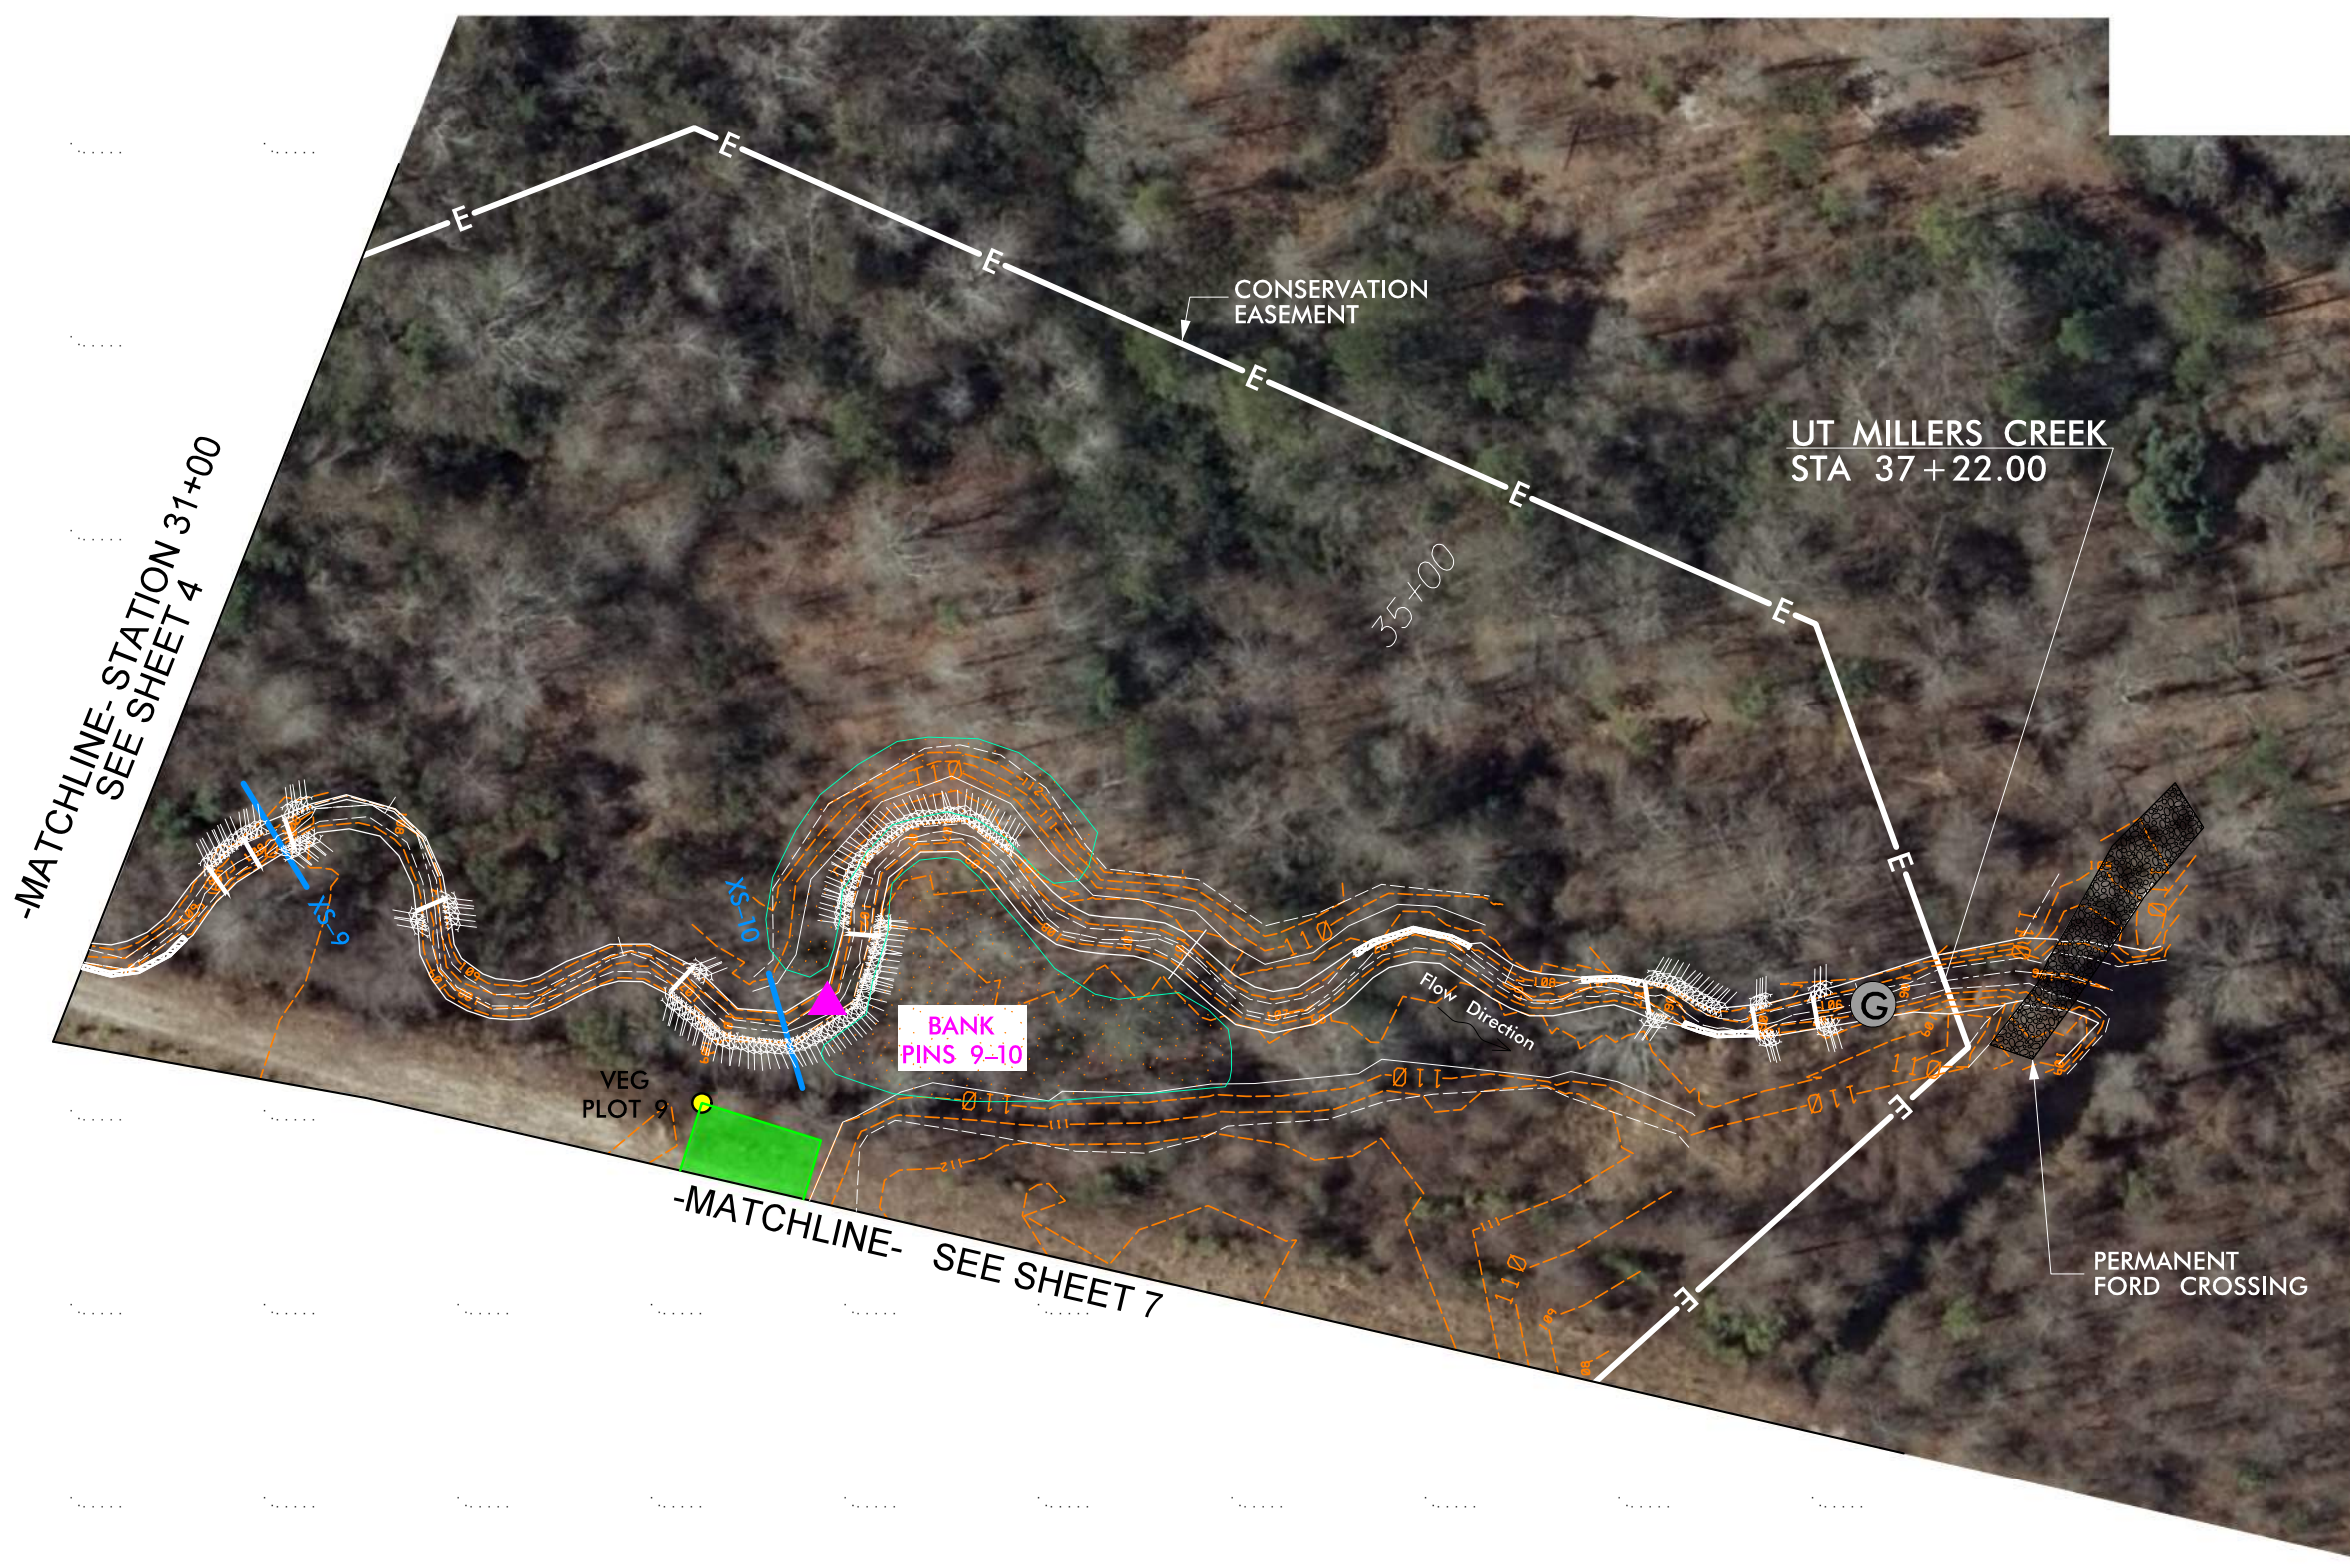
DATE: 12-19-16  
 CCVP YR3 PLAN  
 SHEET  
 5  
 OF 7

Two bare areas and two areas of thin grass remain present on-site. The thin grass areas noted near station 25+00 in Year 2 report appear to have filled in after supplemental seeding. In the two thin grass areas that remain near station 35+00, vegetation is beginning to establish. The total acreage of bare areas is 0.23 (1.9% of planted acreage) and the total acreage of thin grass is 0.14 (1% of planted acreage). Problem areas were reseeded in January and April of 2017. Following seeding, the thin grass area was reduced by 50% but bare areas have not improved.

- YEAR 3 CONDITIONS**
- VEGETATION PROBLEM AREAS**
- THIN GRASS
- VEGETATION PLOT CONDITIONS**
- CRITERIA MET
  - CRITERIA UNMET
