YEAR 4 MONITORING REPORT

UT MILLERS CREEK

Duplin County, North Carolina

DMS Project ID No. 95719, Contract No. 5000, USACE Action ID No. SAW-2013-00386

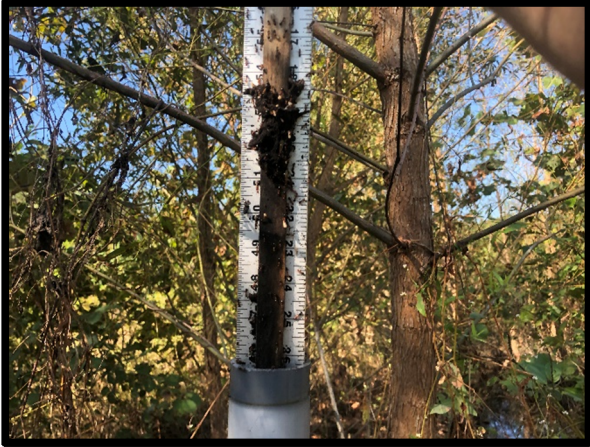
4.3 Crest Gauge 1 (9/12/2018)

The site has experienced several bankfull flows throughout the monitoring period. Bankfull event documentation can be found in Appendix C.

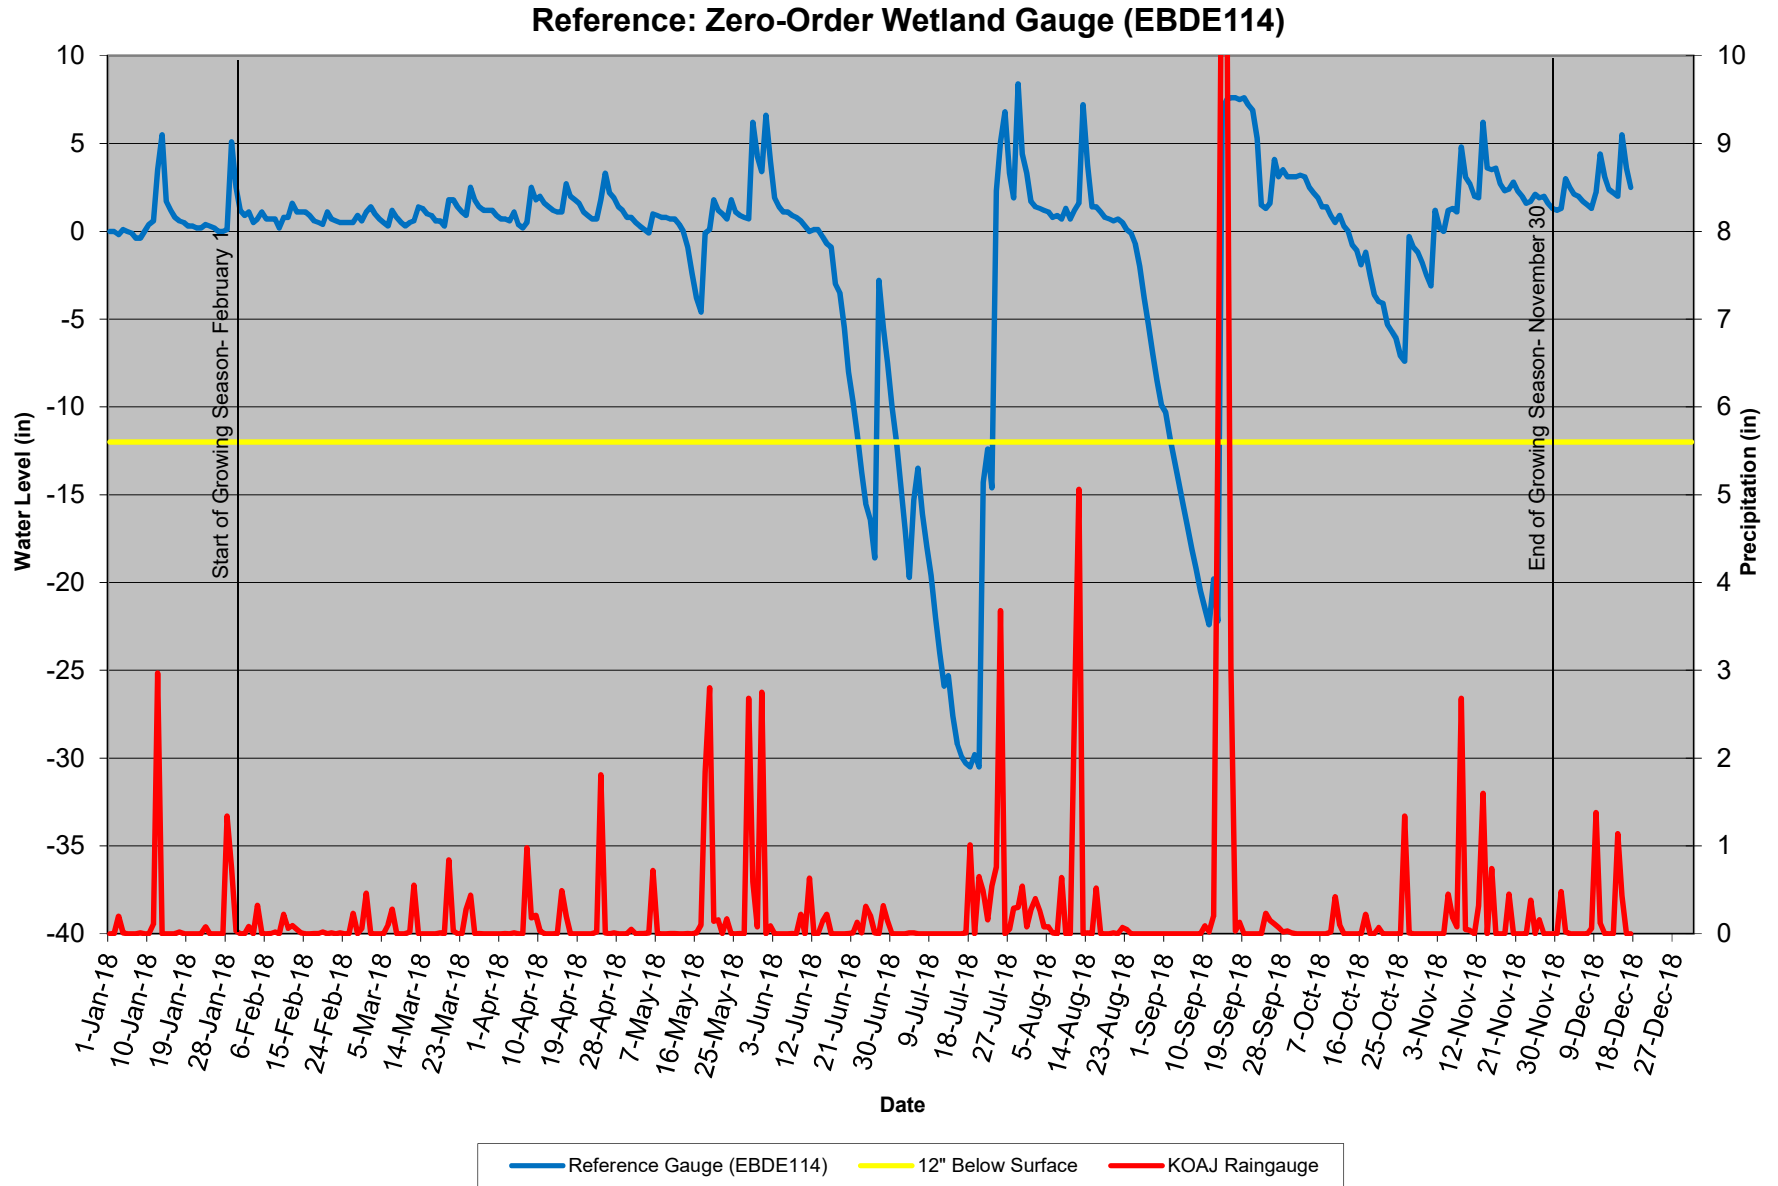
Figure 6.1 Zero-Order Wetland Gauge

All of the groundwater gauges located on the mitigation site exhibit hydrology indicative of jurisdictional wetlands (i.e. hydroperiods greater than 5% of the growing season), and all six gauges exceeded the minimum success criteria as outlined above. While the specific durations of wetland hydrology at each gauge varied across the site, each gauge also displayed prolonged wetland hydroperiods during normal rainfall conditions.
