## **YEAR 6 MONITORING REPORT**

### **UT MILLERS CREEK**

DMS Project ID No. 95719, Contract No. 5000, USACE Action ID No. SAW-2013-00386

Visual Assessment Data Collected: May 2020

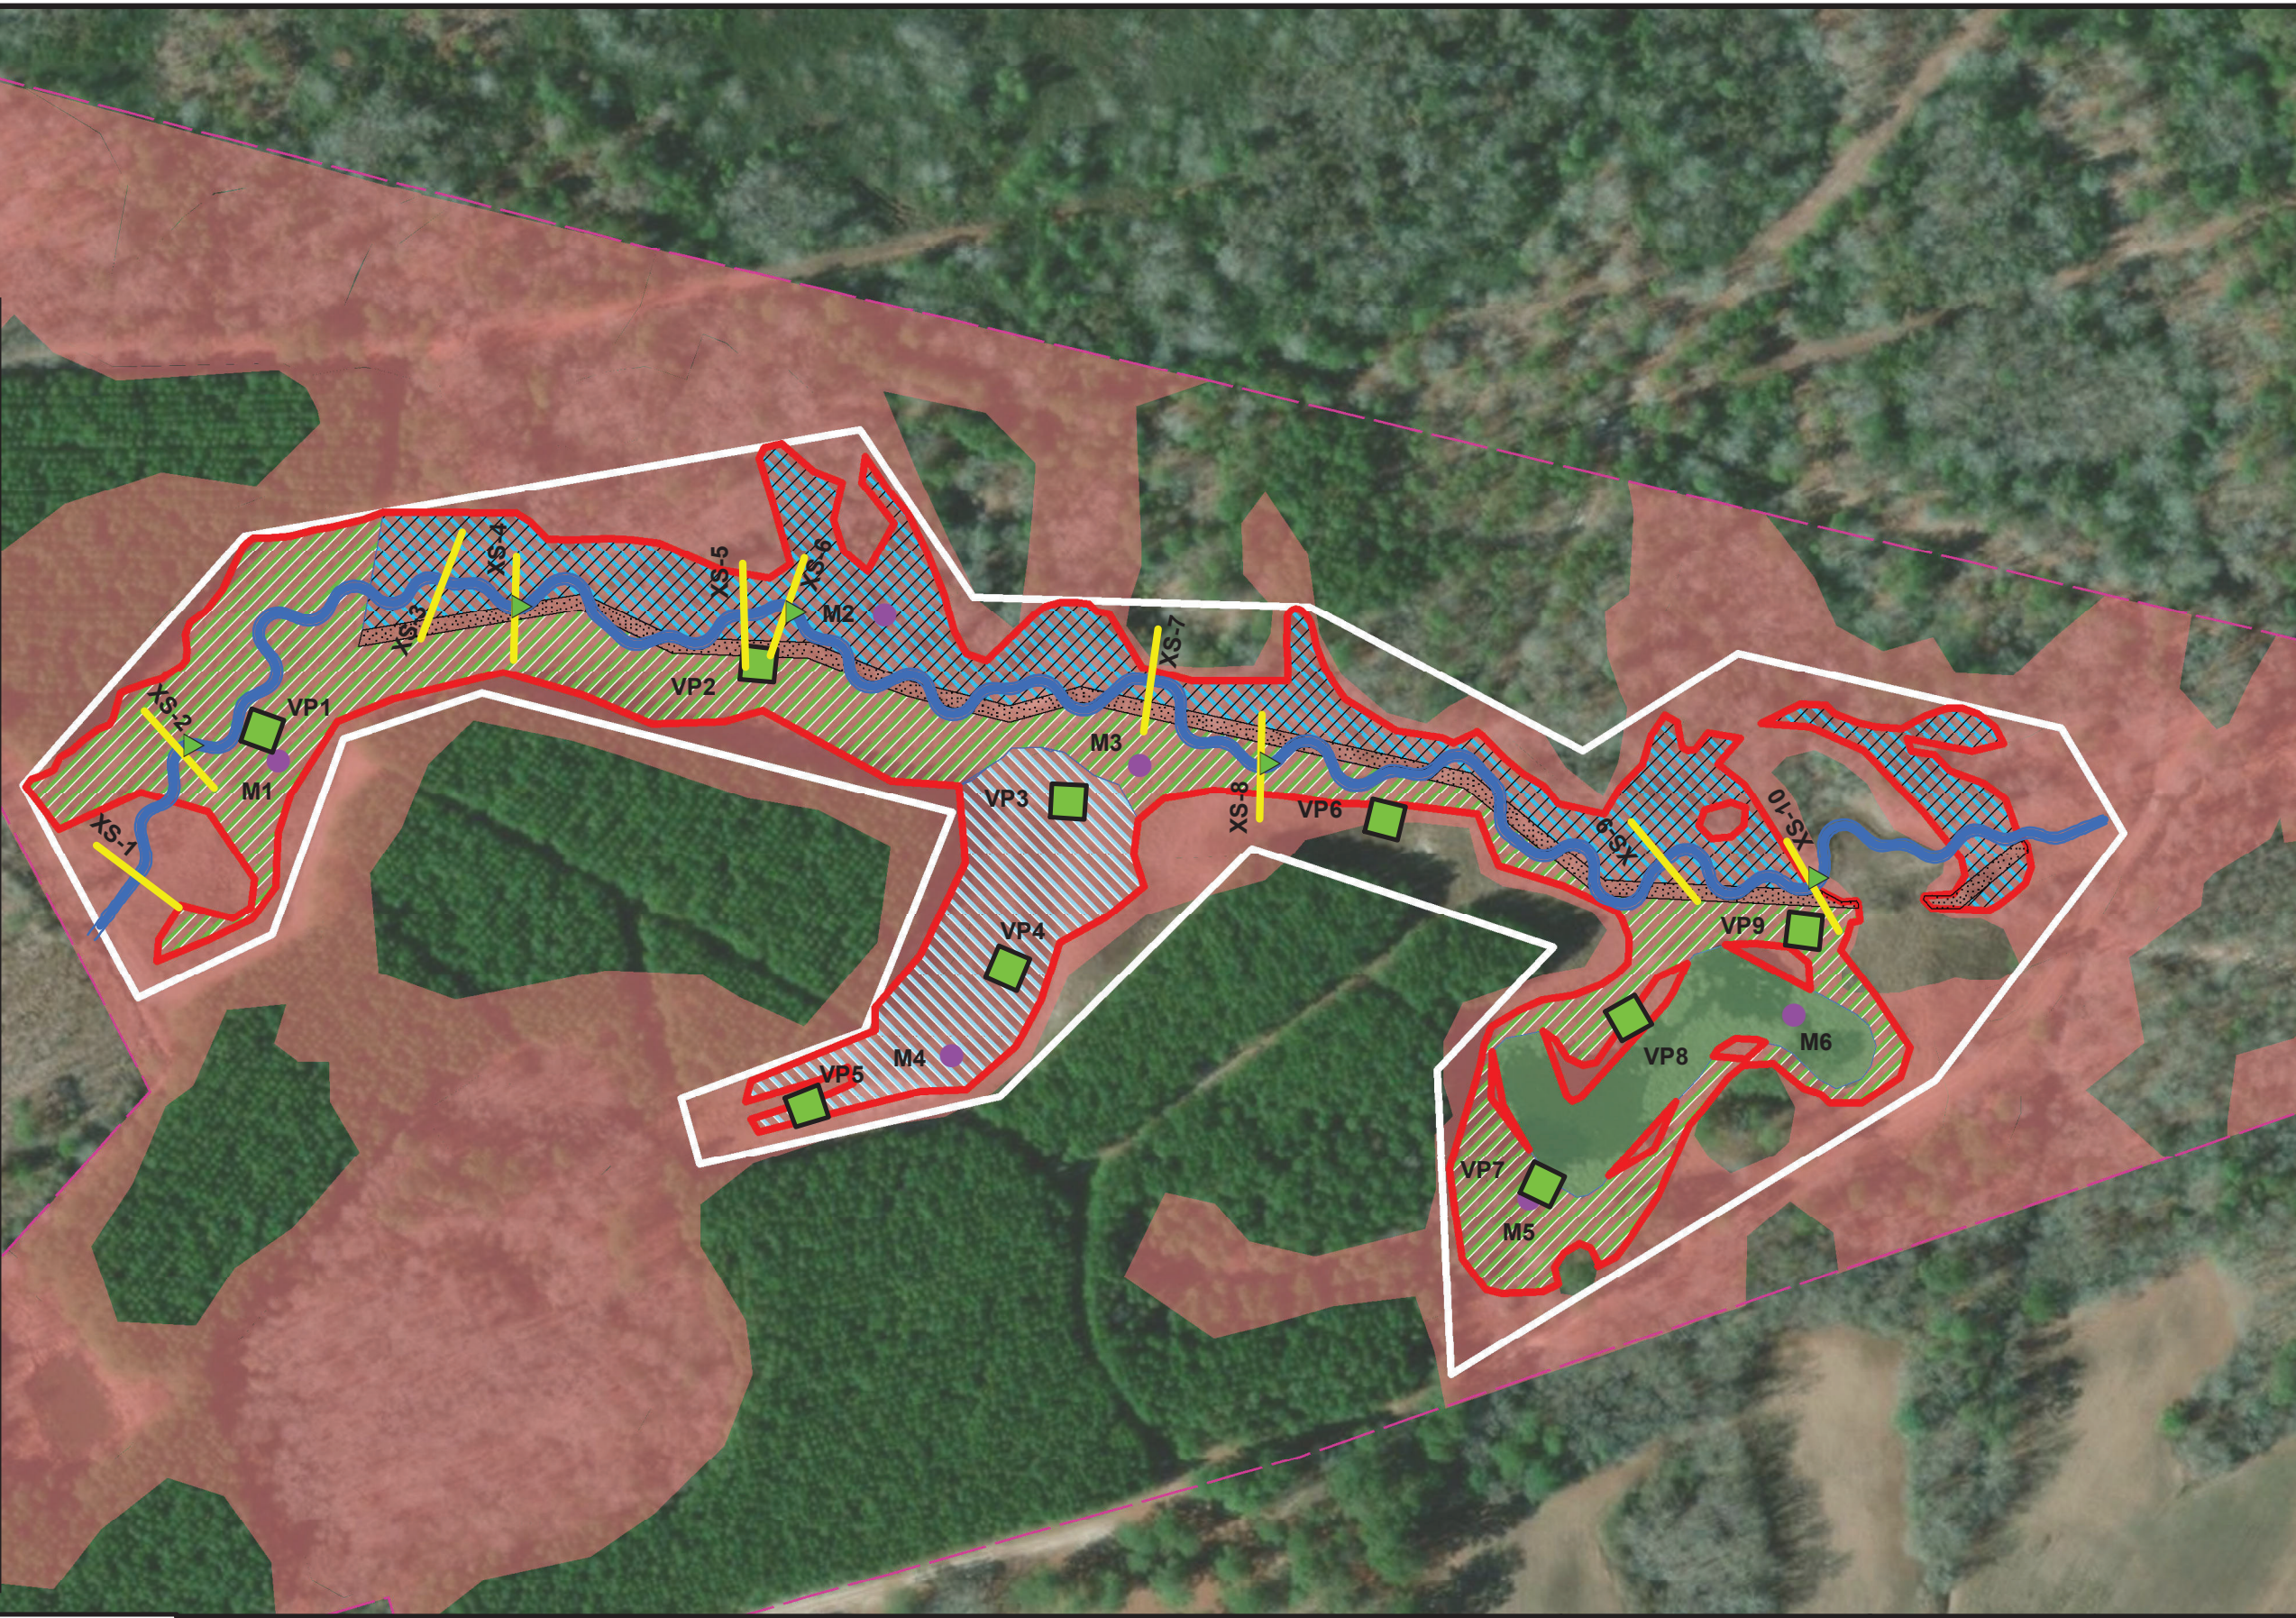
**Figure 2.1**

The summary of hydroperiods for each gauge is presented in Table 8 and gauge locations are depicted in Figure 2.1.

**Current Condition Plan View - Year 6**  
 UT Millers Creek, Duplin County, North Carolina

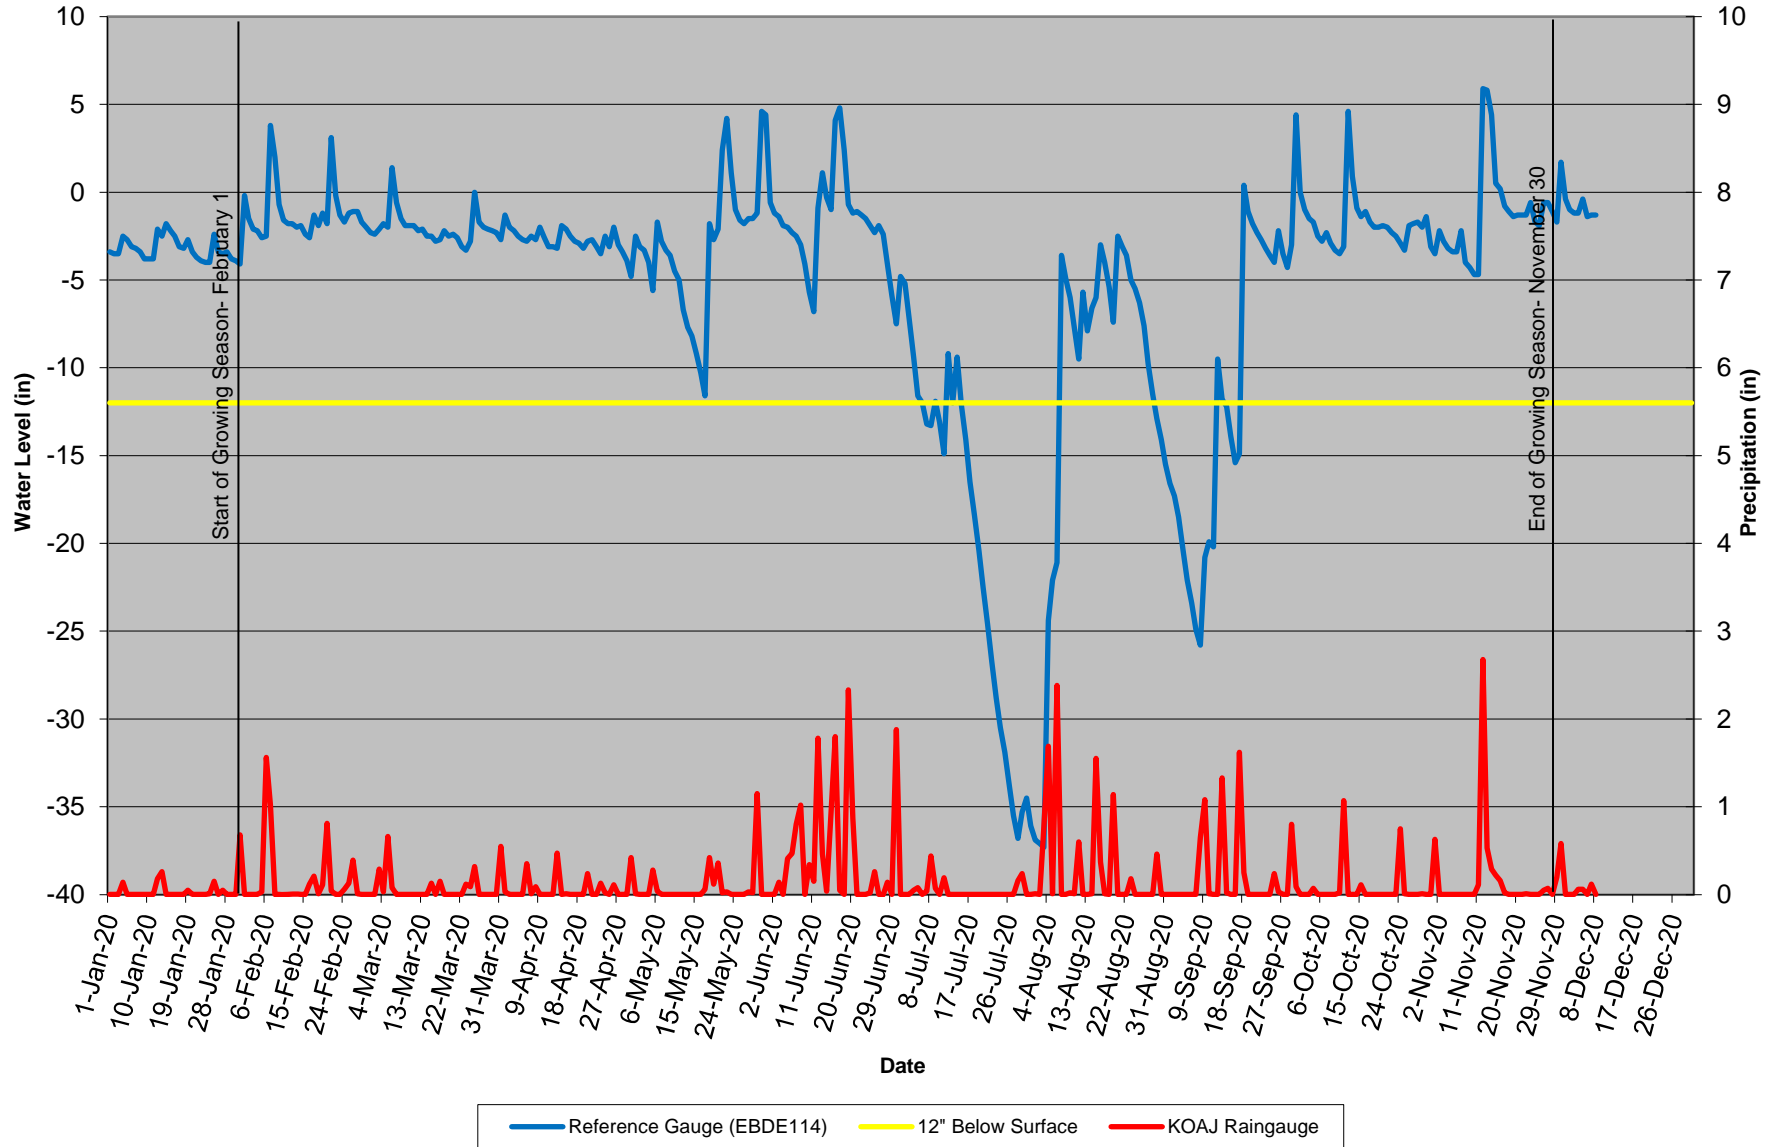
Figure 6.1: Reference: Zero-Order Wetland Gauge (EBDE114)

The UT Millers site exhibits a range of hydrologic conditions characteristic of small stream swamp wetland community types of the inner Coastal Plain of North Carolina. Several of the groundwater gauges documented elevated groundwater levels at or near the soil surface for extended periods of time during the growing season. In addition, portions of the site exhibited intermittent to prolonged periods of surface inundation. This most likely is attributed to the increased amount of rain the Site has experienced over the past year. It is worth noting that the Site exceeded the 70<sup>th</sup> percentile for monthly precipitation totals during the months of February, April, August, October, and November. Refer to the attached gauge hydrographs depicting recorded groundwater and surface water levels from February 1 through November 30.
