UT to Mill Swamp Restoration Project Year 1 Monitoring Report

Onslow County, North Carolina
NCEEP Project ID Number - 95019

Project Info: Monitoring Year: 1 of 7
 Year of Data Collection: 2013 & 2014
 Year of Completed Construction: 2013
 Submission Date: June 2014

Report Prepared and Submitted by Michael Baker Engineering, Inc.

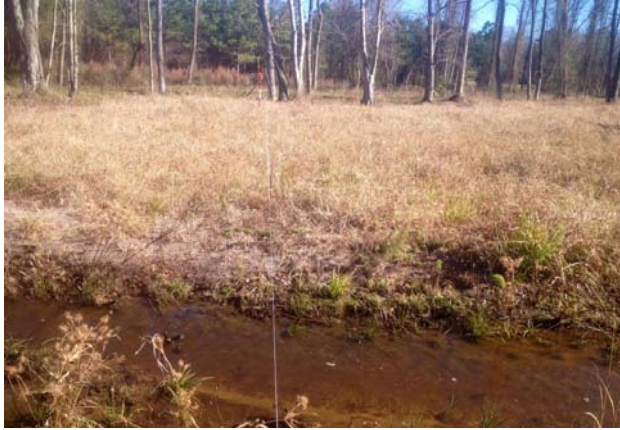
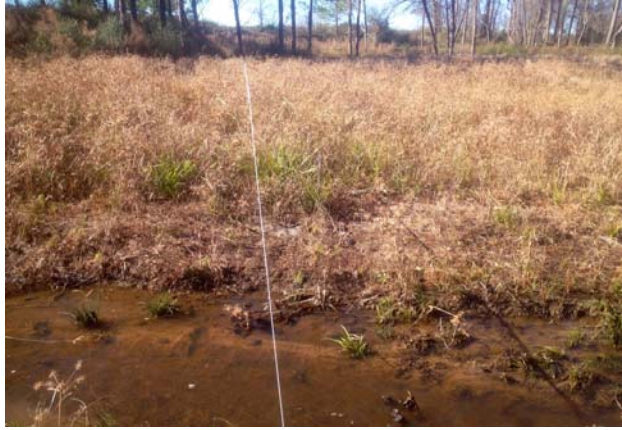
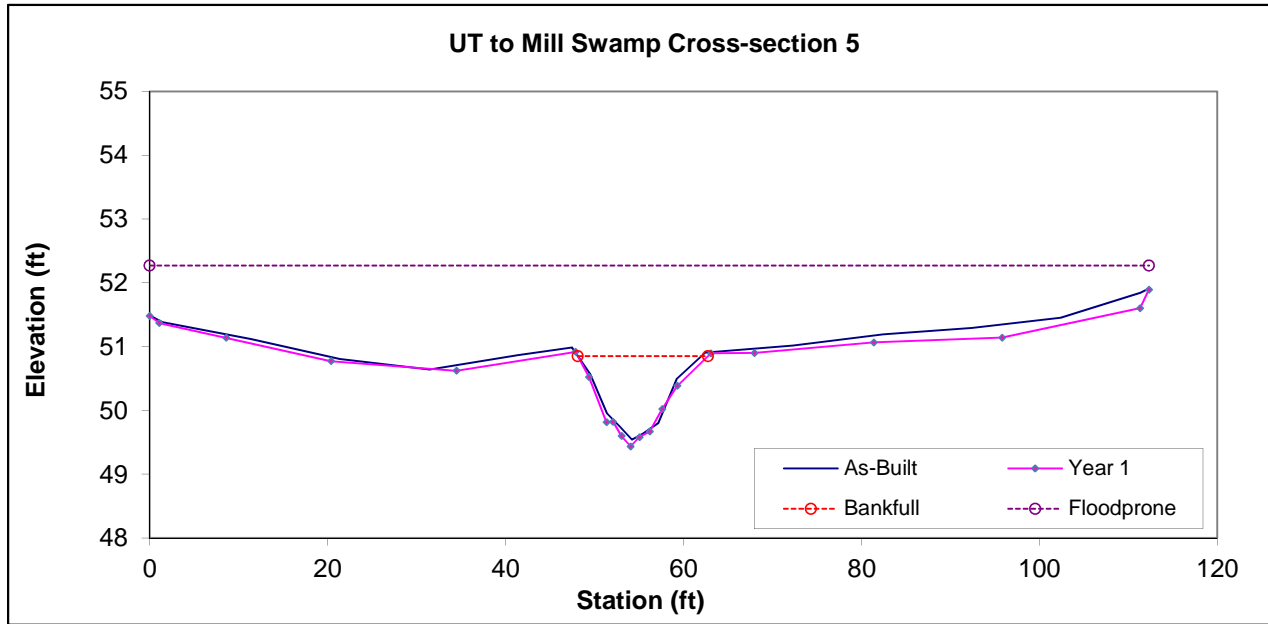
Permanent Cross-section 5
(Year 1 Data - Collected December 2013)

| Feature | Stream Type | BKF Area | BKF Width | BKF Depth | Max BKF Depth | W/D | BH Ratio | ER | BKF Elev | TOB Elev |
|---|---|---|---|---|---|---|---|---|---|---|
| Riffle | Cc | 10.8 | 14.63 | 0.74 | 1.42 | 19.78 | 1 | 7.7 | 50.85 | 50.89 |

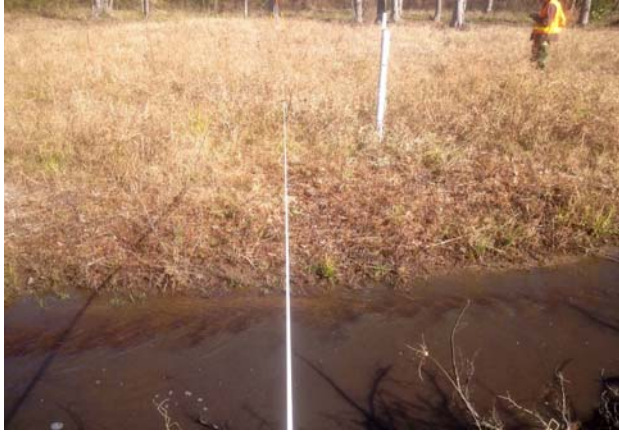
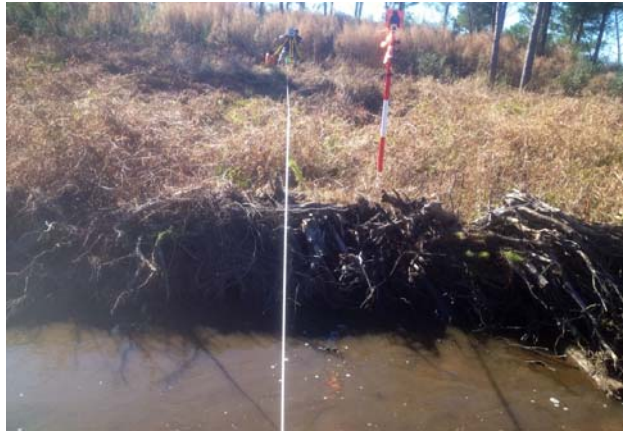
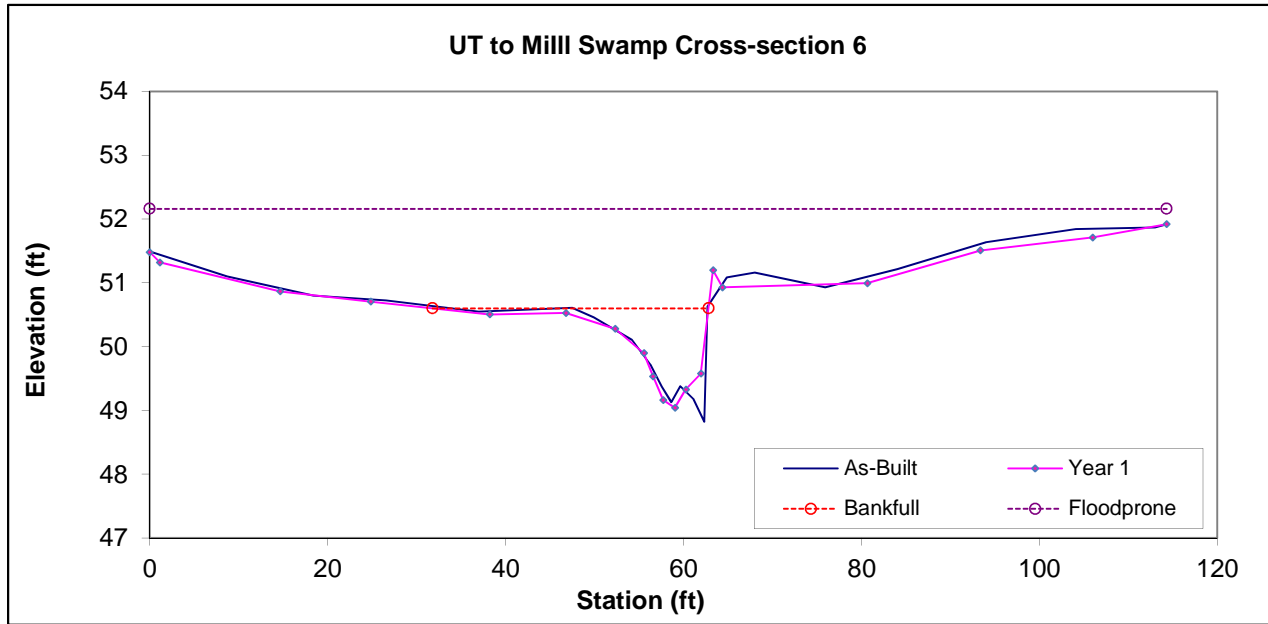
Permanent Cross-section 6
 (Year 1 Data - Collected December 2013)

| Feature | Stream Type | BKF Area | BKF Width | BKF Depth | Max BKF Depth | W/D | BH Ratio | ER | BKF Elev | TOB Elev |
|---|---|---|---|---|---|---|---|---|---|---|
| Pool | | 12.2 | 31.02 | 0.39 | 1.56 | 78.79 | 1 | 3.7 | 50.6 | 50.53 |

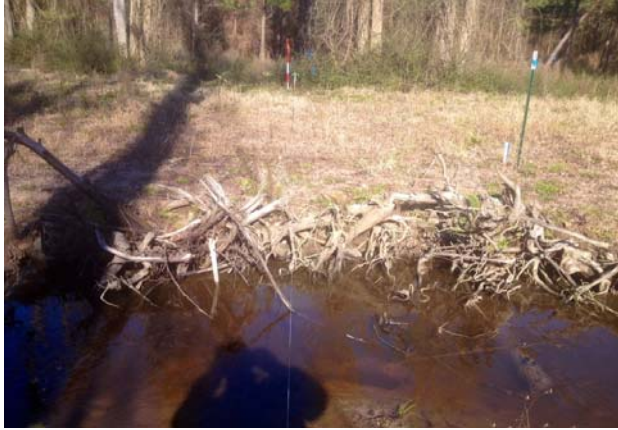
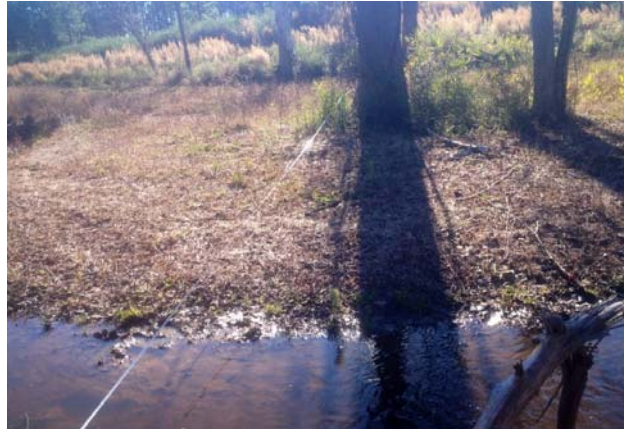
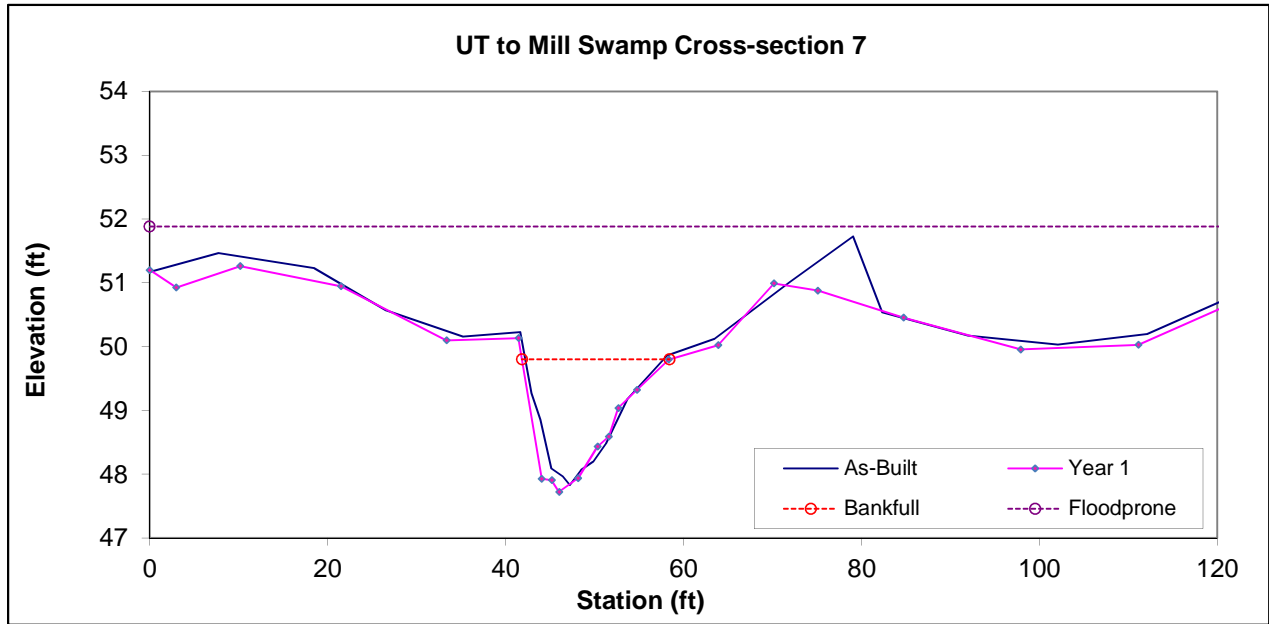
Permanent Cross-section 7
 (Year 1 Data - Collected December 2013)

| Feature | Stream Type | BKF Area | BKF Width | BKF Depth | Max BKF Depth | W/D | BH Ratio | ER | BKF Elev | TOB Elev |
|---|---|---|---|---|---|---|---|---|---|---|
| Pool | | 18.4 | 16.59 | 1.11 | 2.08 | 14.93 | 1 | 8 | 49.8 | 49.8 |

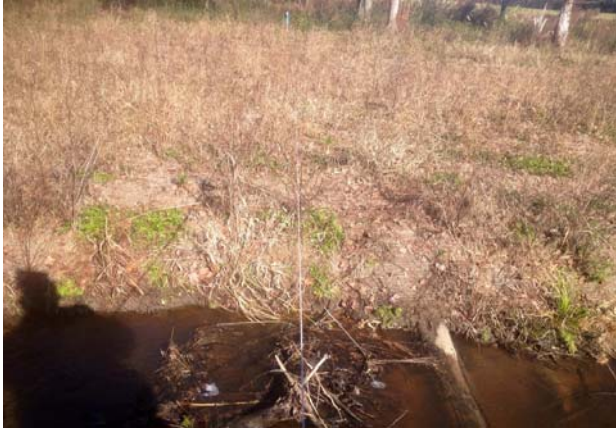
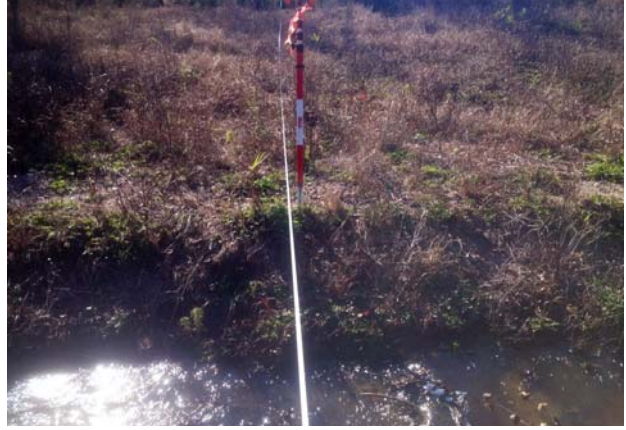
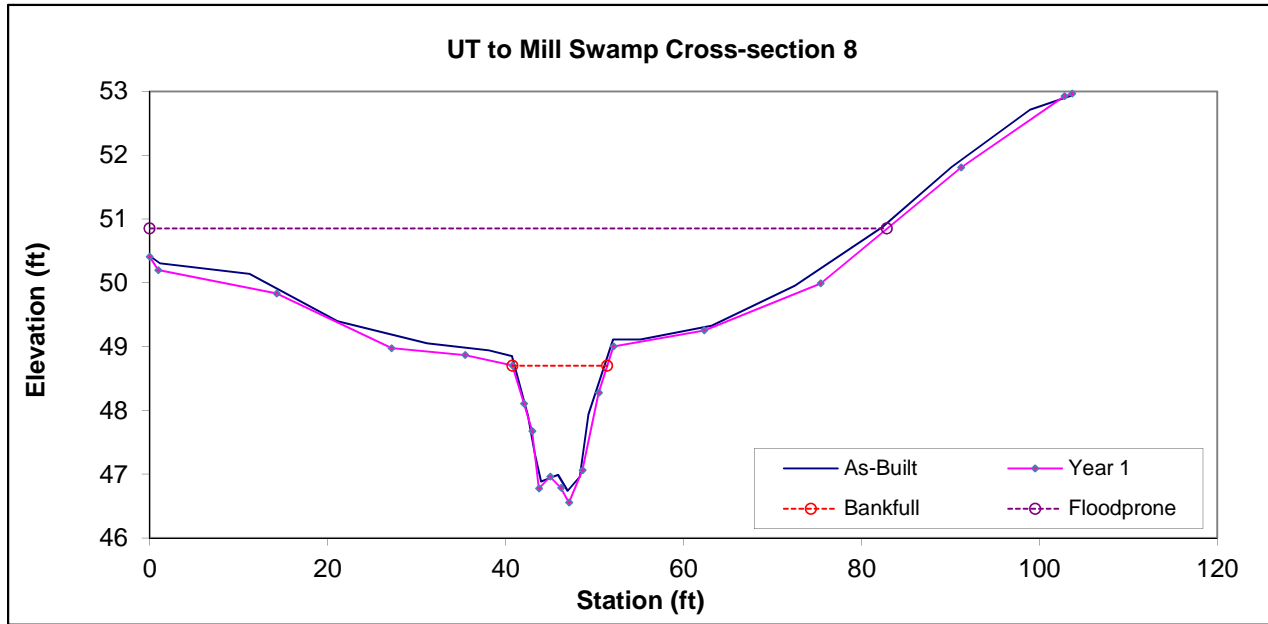
Permanent Cross-section 8
(Year 1 Data - Collected December 2013)

| Feature | Stream Type | BKF Area | BKF Width | BKF Depth | Max BKF Depth | W/D | BH Ratio | ER | BKF Elev | TOB Elev |
|---|---|---|---|---|---|---|---|---|---|---|
| Riffle | E | 13.6 | 10.65 | 1.27 | 2.15 | 8.38 | 1 | 7.8 | 48.7 | 48.7 |

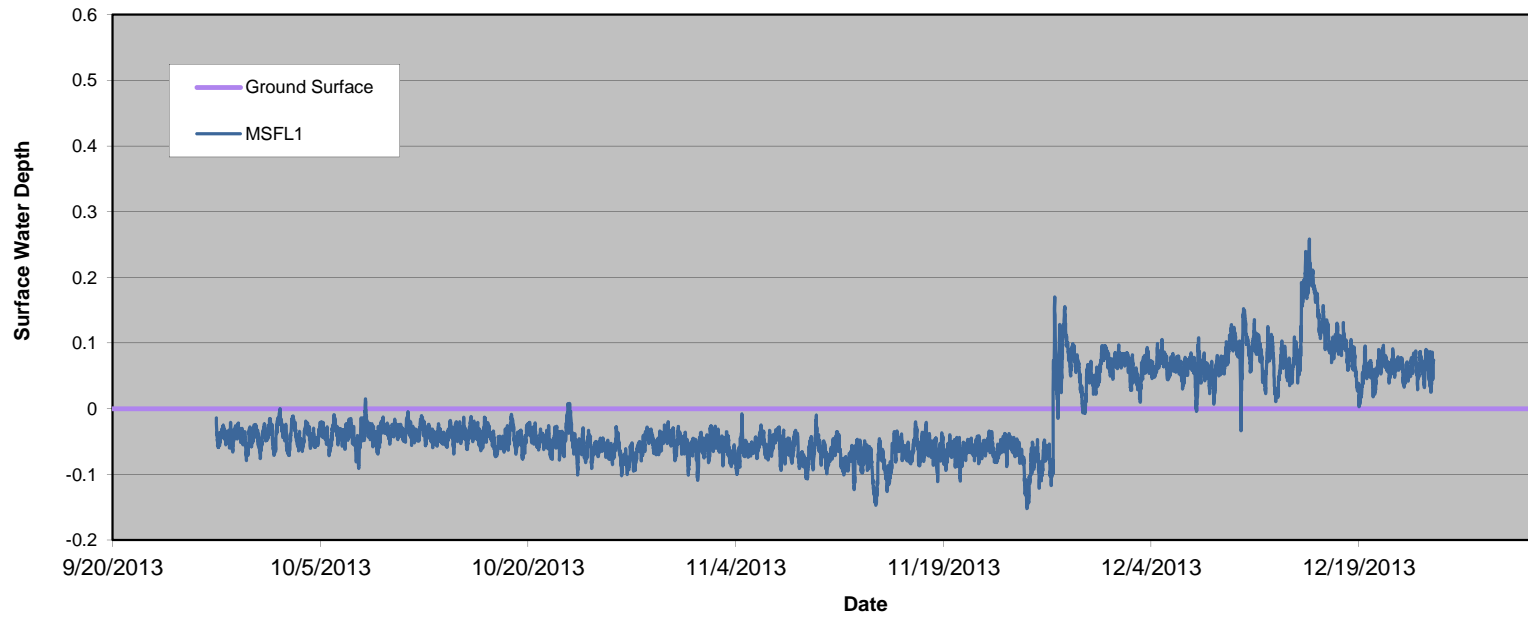
UT to Mill Swamp (Flow Gauge 1 - MSFL1) UT1B - Upstream

Two flow gauges (pressure transducers) were installed to document the occurrence of extended periods of shallow surface ponding, indicative of flow. The gauges document flooding connectivity between the restored UT1a and UT1b reaches for at least 30 consecutive days under normal climatic conditions. Flow data collected during Year 1 monitoring are located in Appendix E.

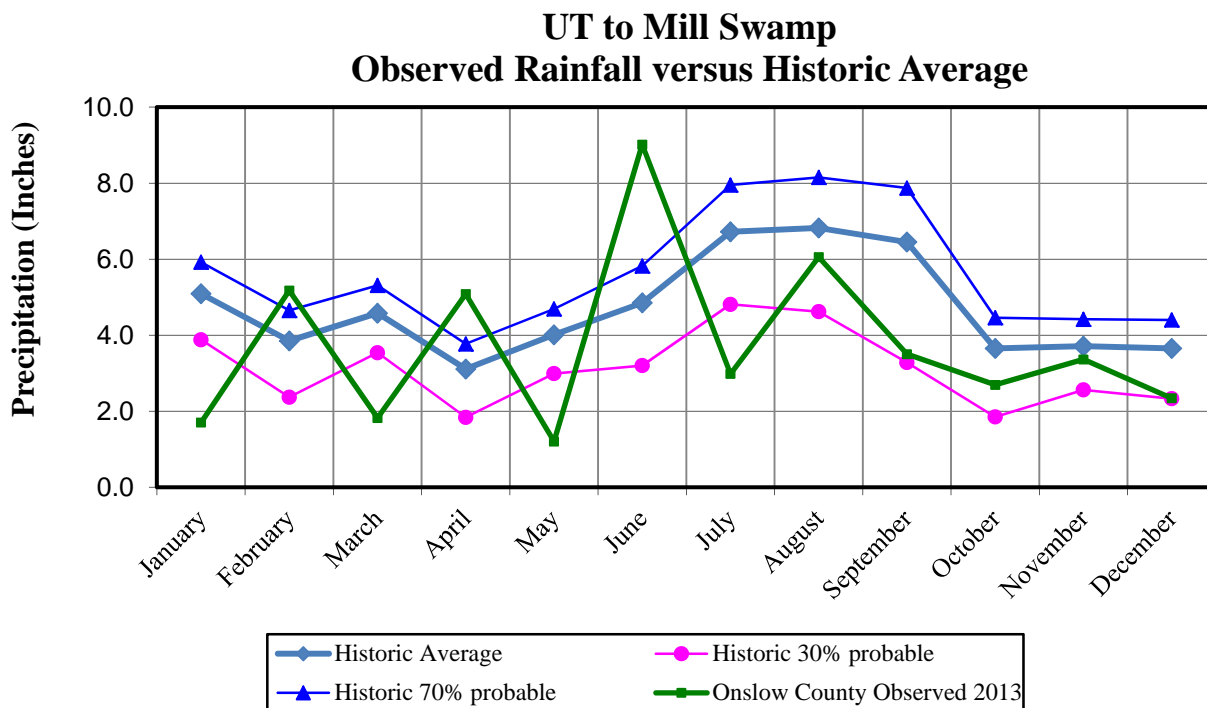
Figure 6. Observed Rainfall versus Historic Average

Total observed rainfall at the New River MCAS station for the period of January 2013 through December 2013 was 44.94 inches, as compared to the Onslow County WETS table of 55.96 inches annually. According to the New River MCAS gauge, total rainfall during the Year 1 monitoring period from January 2013 through December 2013 was 11.02 inches below the historic approximated average for Onslow County.
